Prestons Park Subdivision
GEOTECHNICAL REPORT FOR LOT 1023
CDL Land NZ Limited

19 January 2024
Revision: 1
Reference: 235361

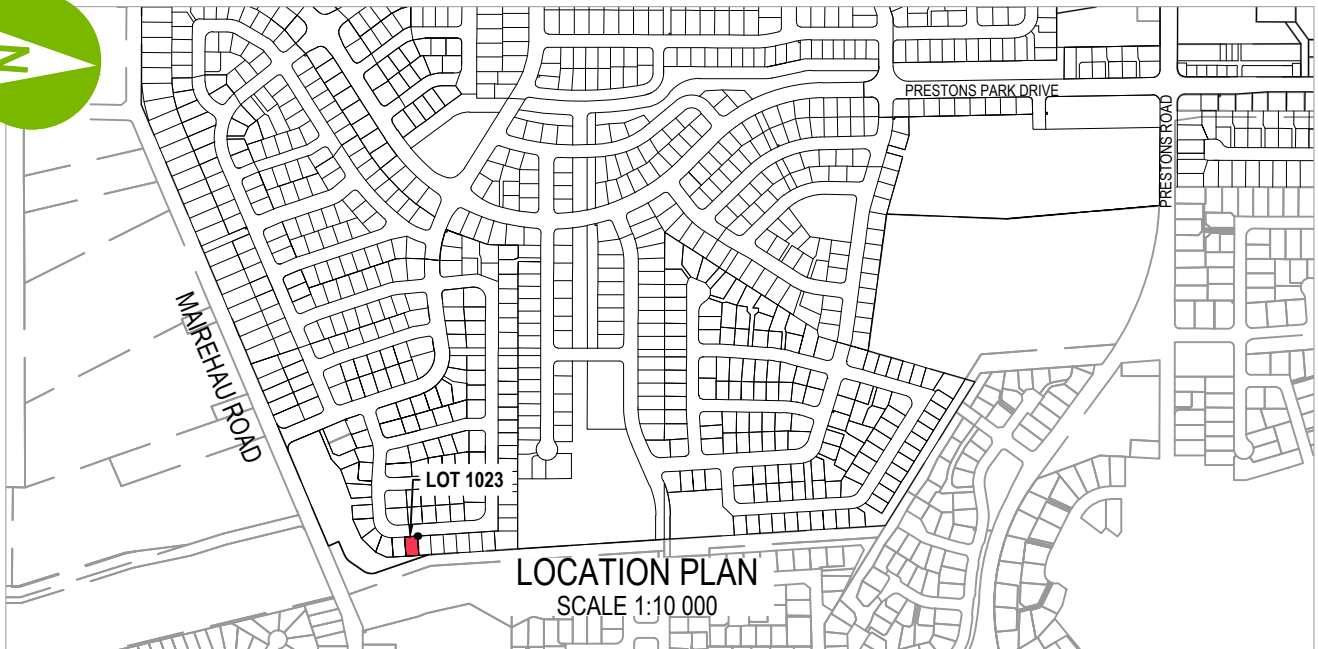
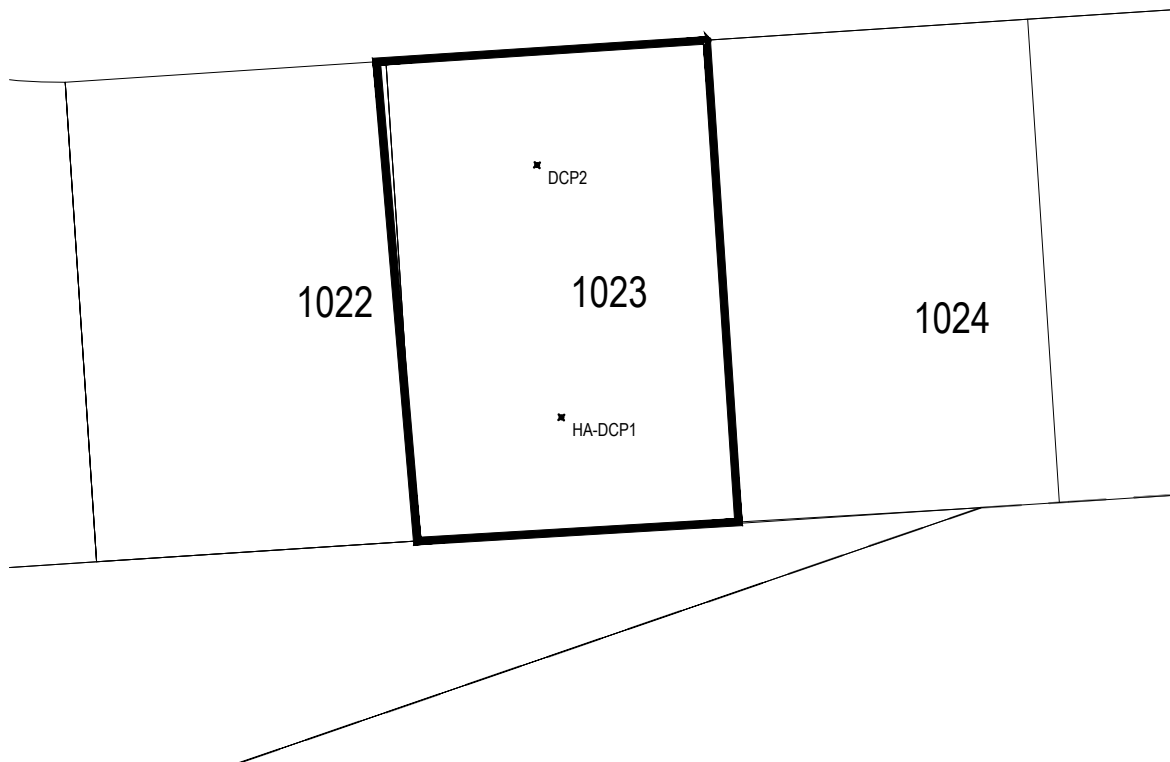
PROJECT	
PRESTONS PARK	
TITLE	
LOT 1023	
SITE LOCATION PLAN	
FIGURE 1

This building consent report is for Lot 1023 which is located in Stage 5 of the Prestons Park Subdivision development (refer Figure 1 in Appendix A). The lot is bordered by residential lots to the north and south and an access road to the west.

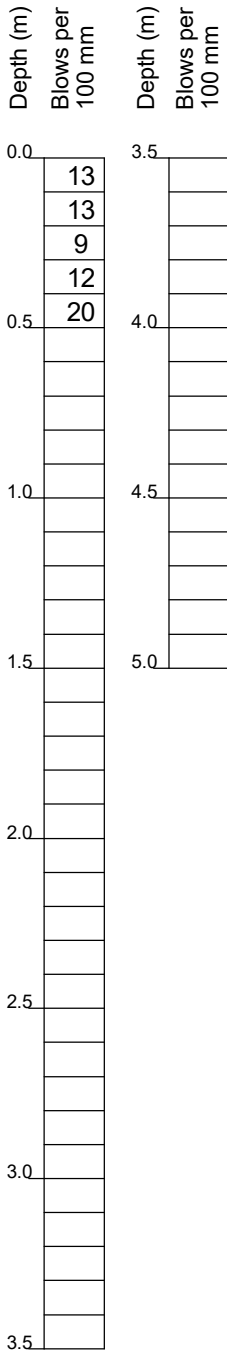
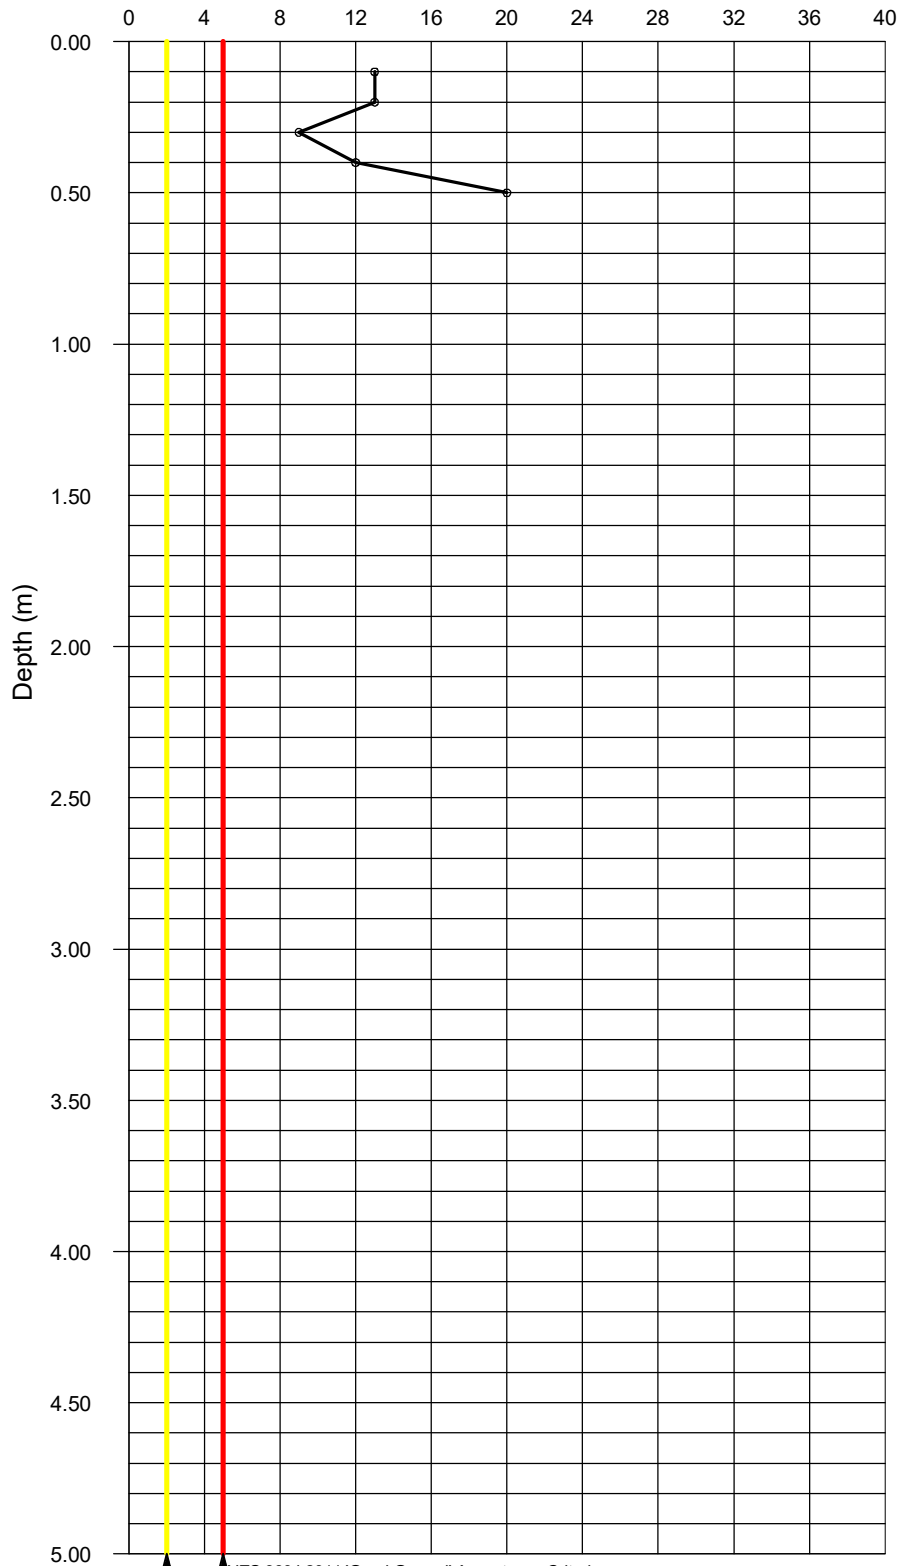
DCP logs indicate two blows per 100mm penetration, which is equivalent to an ultimate bearing capacity of 200kPa, was consistently encountered from shallow depths.

20 blows for 100mm in the last increment.
Co-ordinates recorded in the field with a mobile device.
RL from data survey based on design contours (Christchurch drainage datum).
Effective refusal, 20+ blows per 100mm

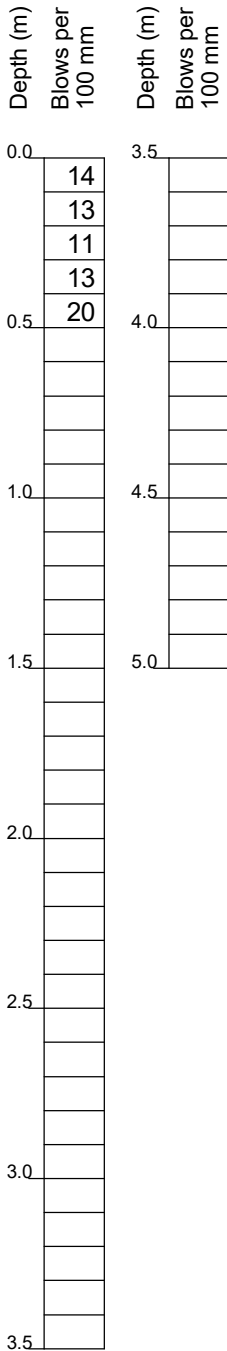
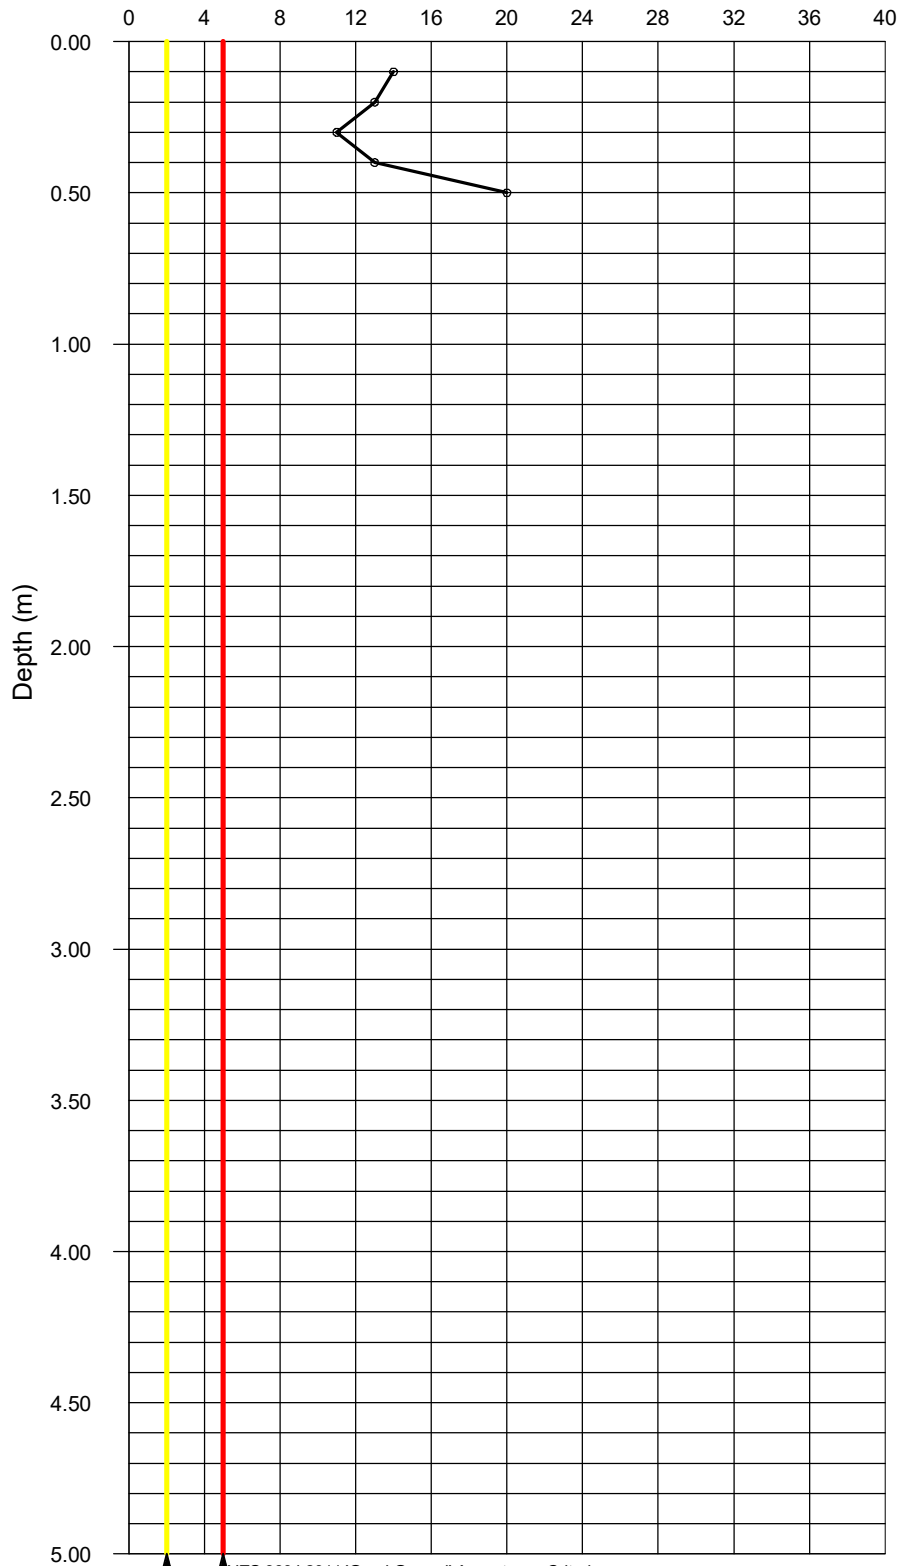
Remarks:
 20 blows for 100mm in the last increment.
 Co-ordinates recorded in the field with a mobile device.
 RL from data survey based on design contours (Christchurch drainage datum).
 Effective refusal, 20+ blows per 100mm
