**Prestons Park Subdivision**  
**GEOTECHNICAL REPORT FOR LOT 1024**  
**CDL Land NZ Limited**

**8 December 2023**  
**Revision: 1**  
**Reference: 235361**

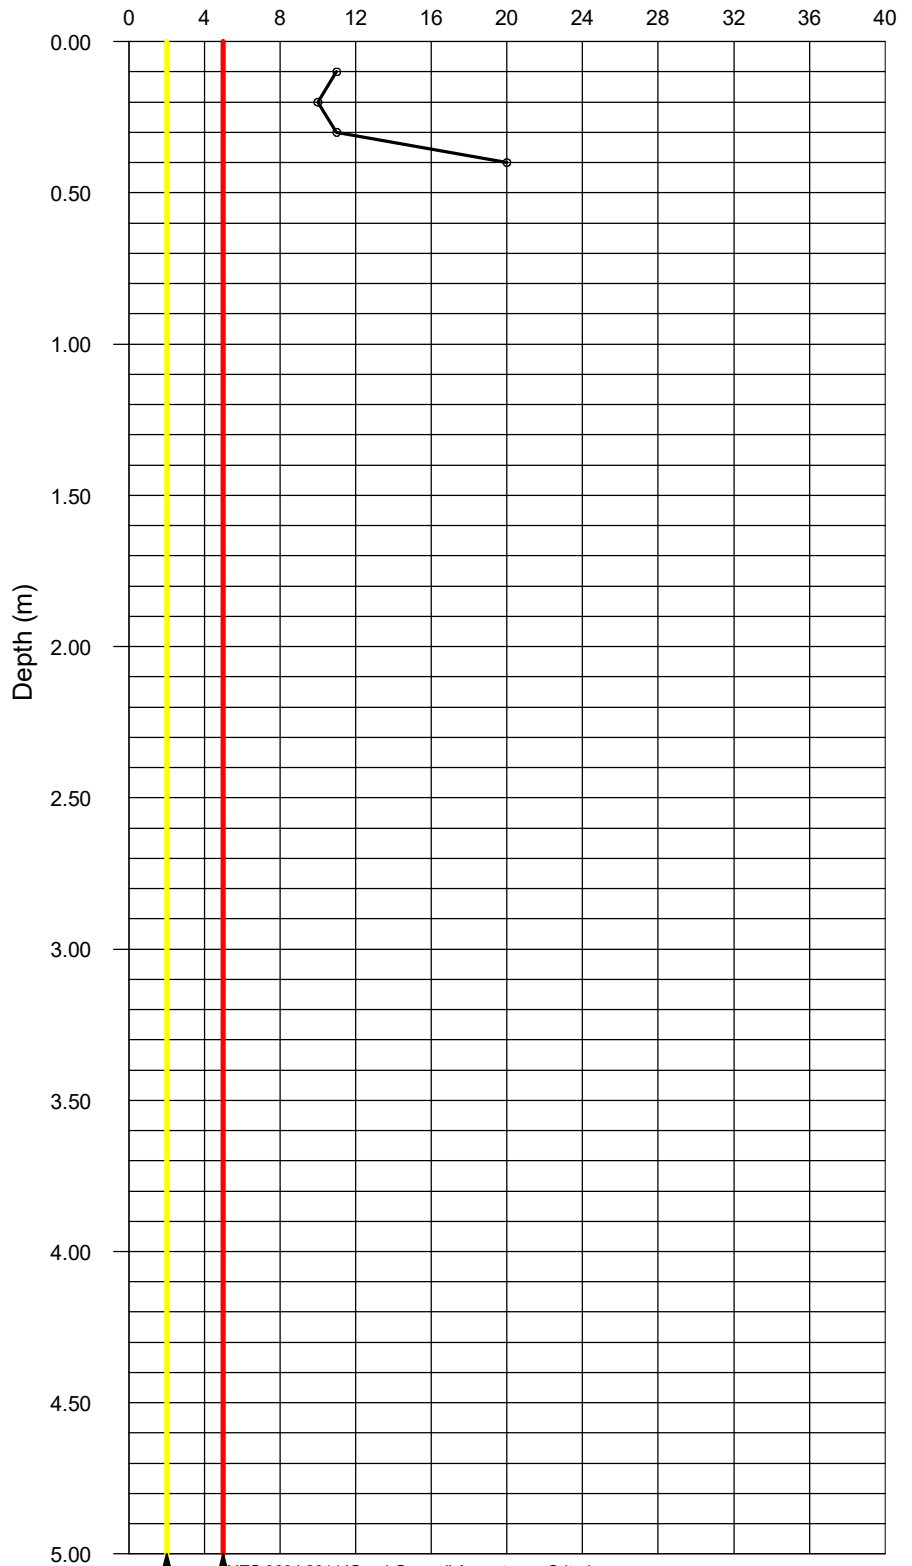
DCP logs indicate two blows per 100mm penetration, which is equivalent to an ultimate bearing capacity of 200kPa, was consistently encountered from shallow depths.

20 blows for 100mm in the last increment.  
Co-ordinates recorded in the field with a mobile device.  
RL from data survey based on design contours (Christchurch drainage datum).  
Effective refusal, 20+ blows per 100mm

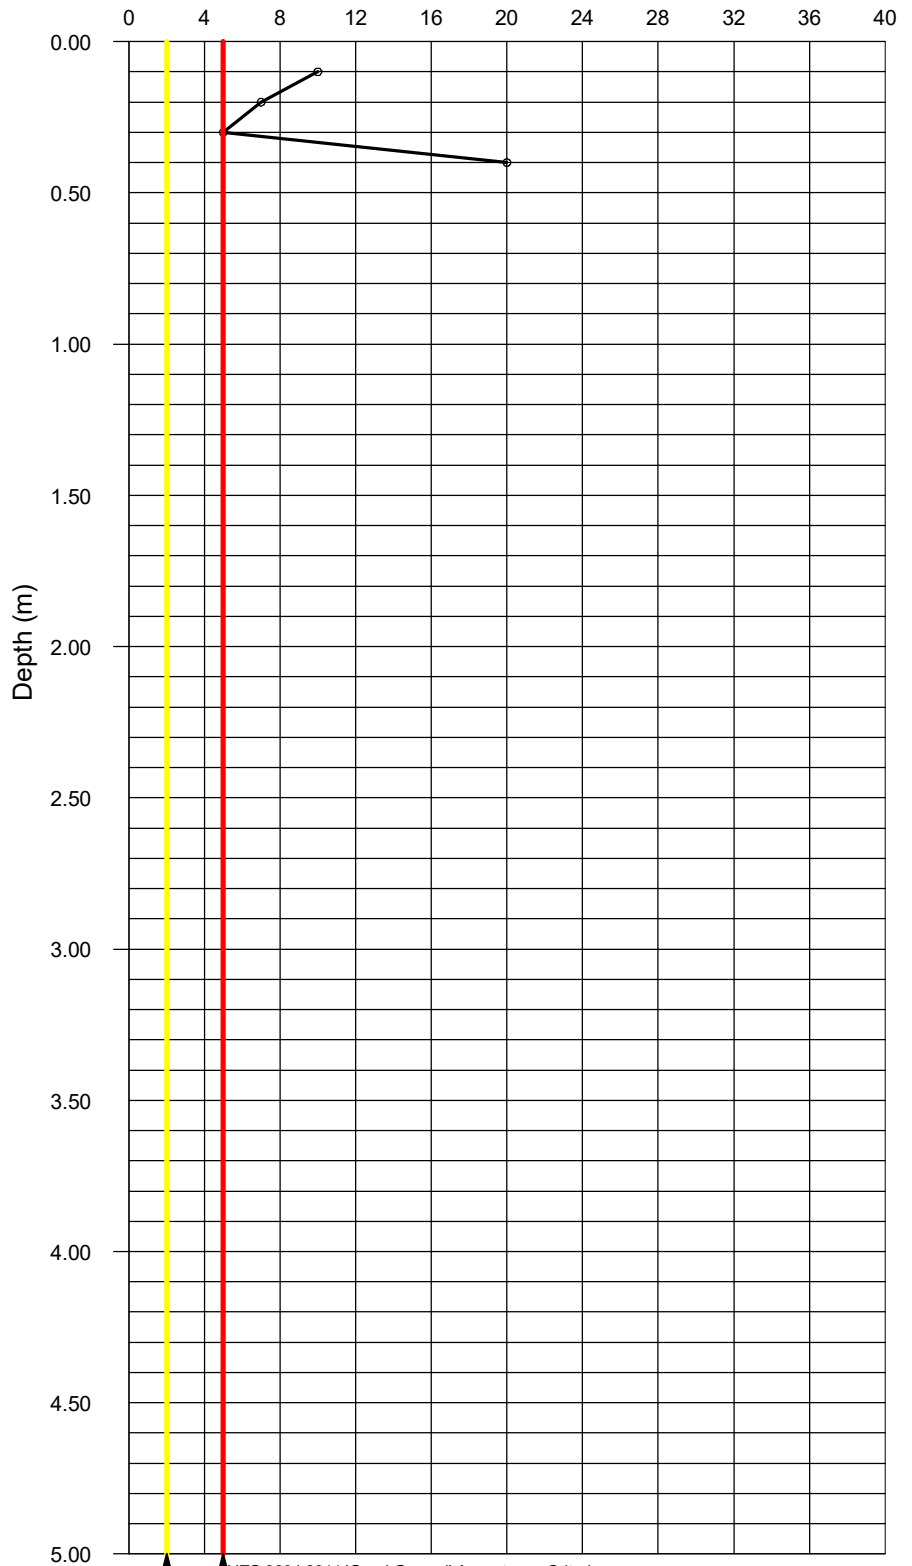
20 blows for 100mm in the last increment.  
Co-ordinates recorded in the field with a mobile device.  
RL from data survey based on design contours (Christchurch drainage datum).  
Effective refusal, 20+ blows per 100mm
