Prestons Park Subdivision
GEOTECHNICAL REPORT FOR LOT 1026
CDL Land NZ Limited

8 December 2023
Revision: 1
Reference: 235361

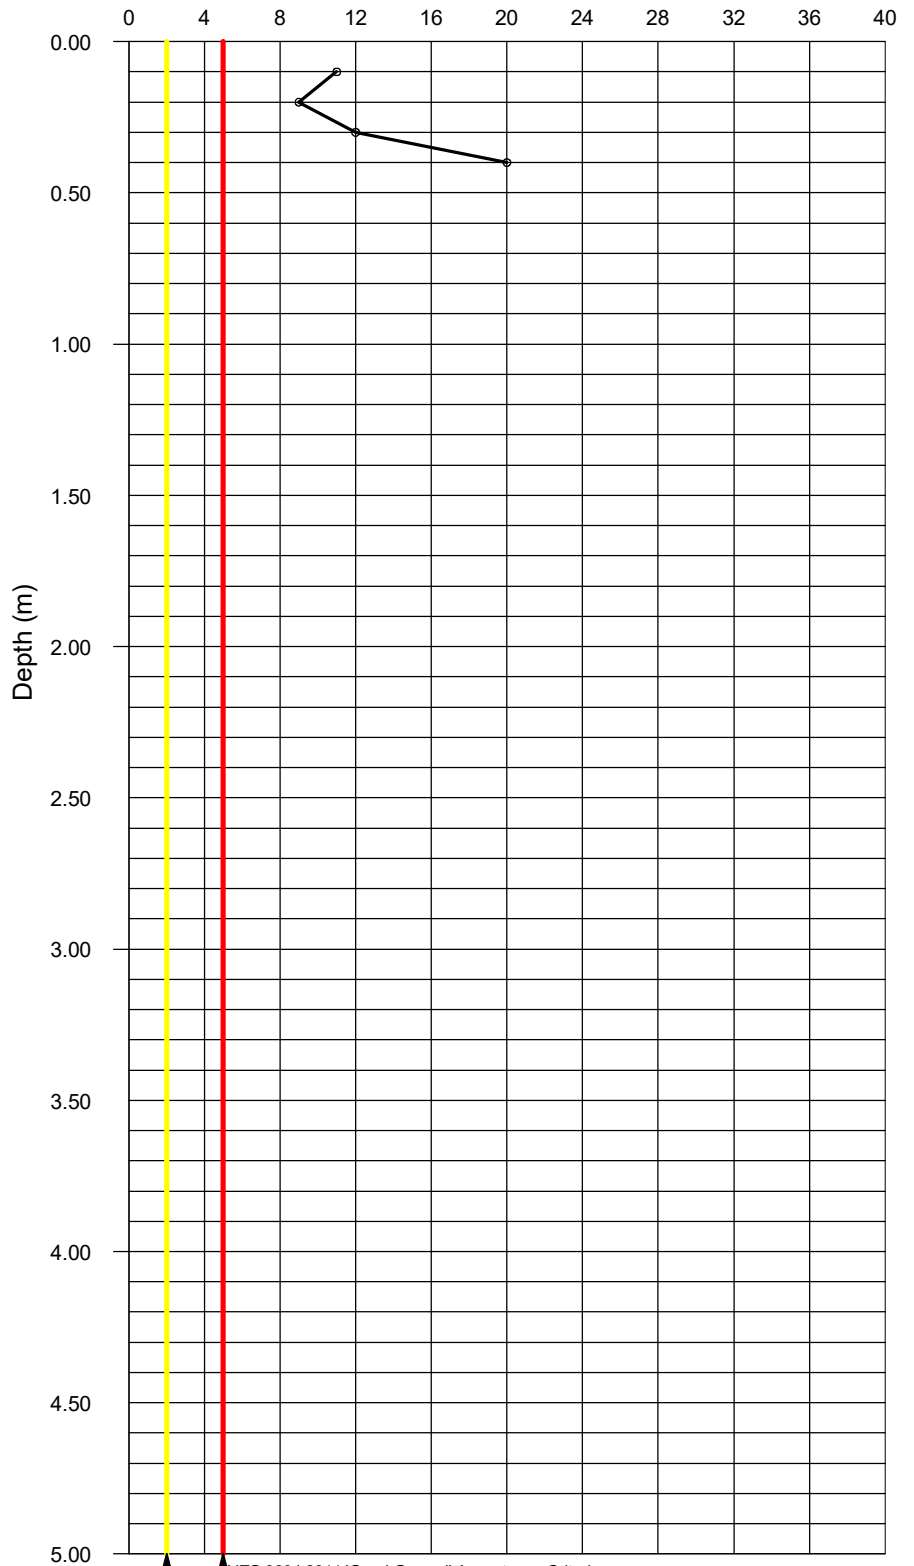
DCP logs indicate two blows per 100mm penetration, which is equivalent to an ultimate bearing capacity of 200kPa, was consistently encountered from shallow depths.

20 blows for 100mm in the last increment.
Co-ordinates recorded in the field with a mobile device.
RL from data survey based on design contours (Christchurch drainage datum).
Effective refusal, 20+ blows per 100mm

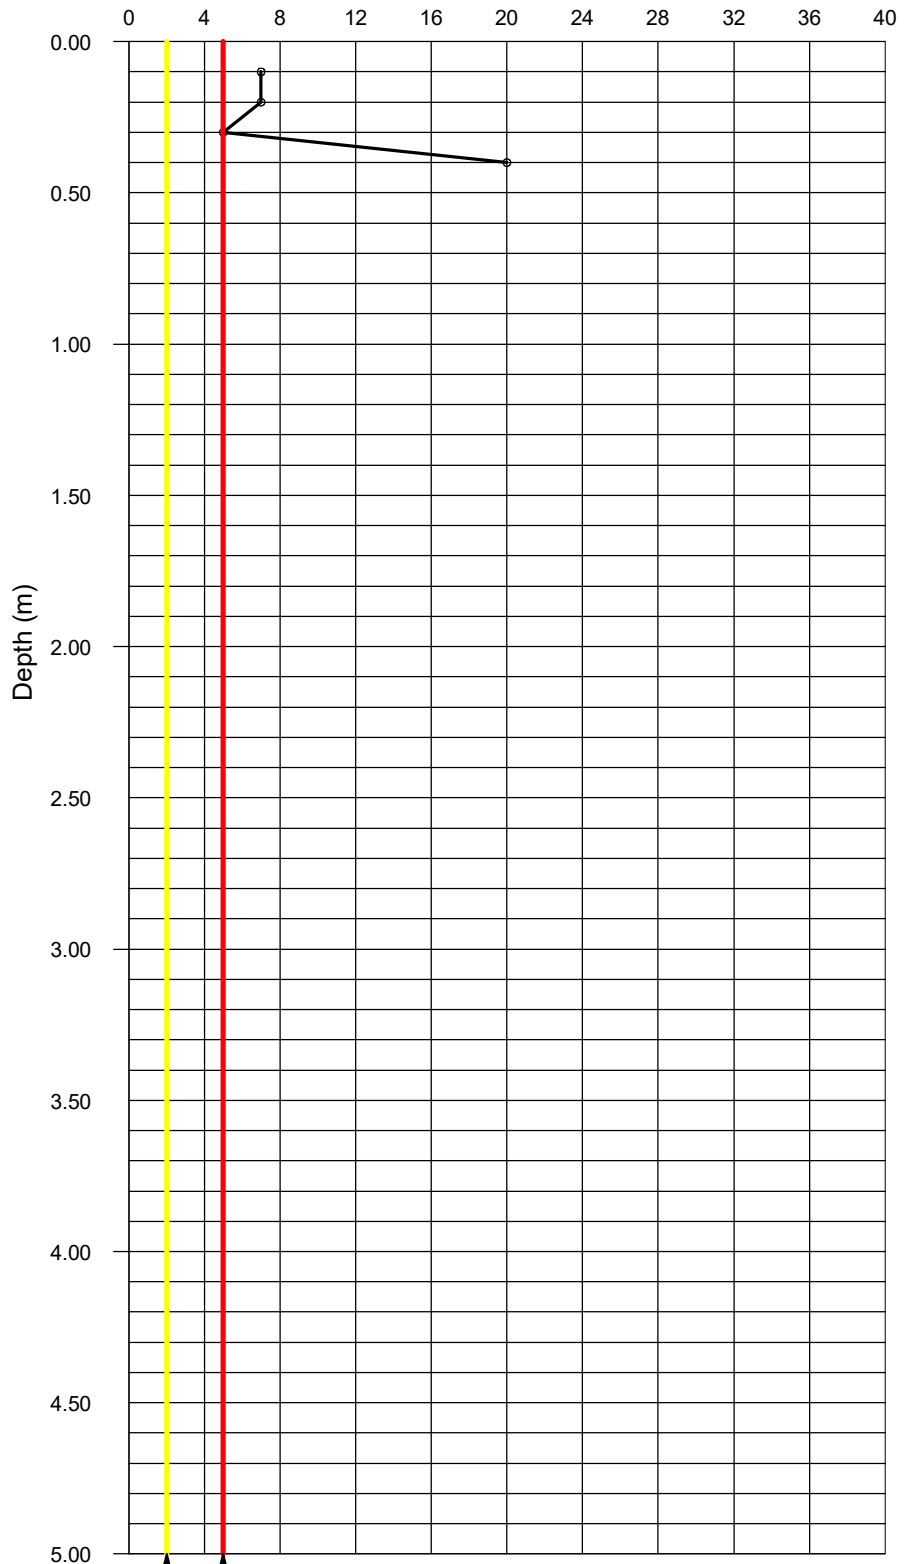
20 blows for 100mm in the last increment.
Co-ordinates recorded in the field with a mobile device.
RL from data survey based on design contours (Christchurch drainage datum).
Effective refusal, 20+ blows per 100mm
