**Prestons Park Subdivision**  
**GEOTECHNICAL REPORT FOR LOT 994**  
**CDL Land NZ Limited**

**10 January 2024**  
**Revision: 1**  
**Reference: 235361**

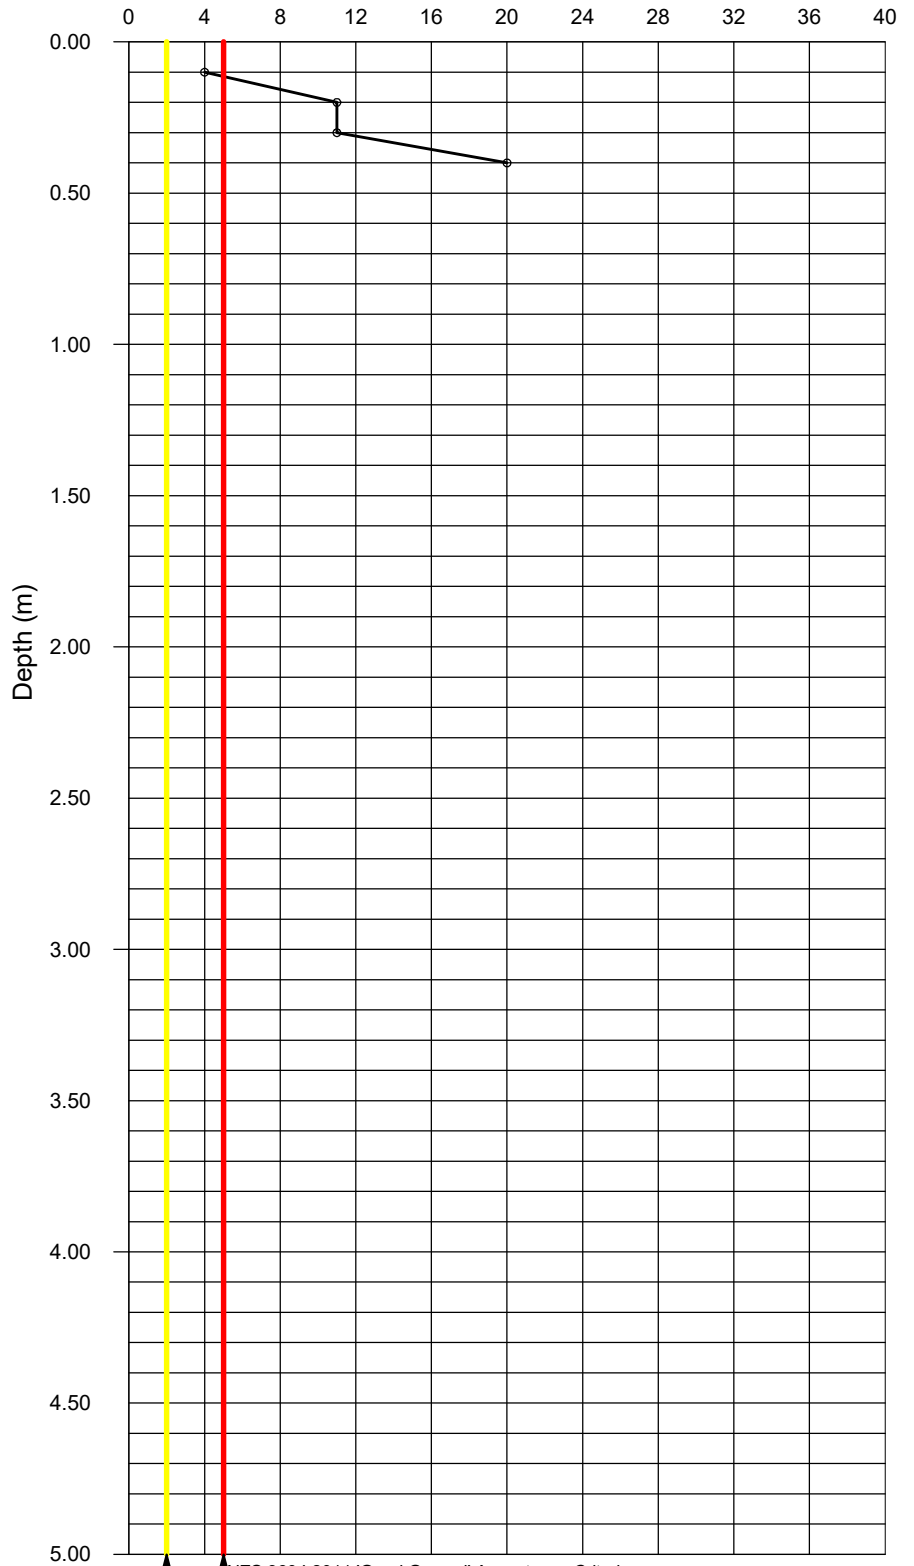
Depth (m)	Blows per 100 mm	Depth (m)	Blows per 100 mm
0.0	4	3.5	
0.1	11		
0.2	11		
0.3	20		
0.4		4.0	
0.5			
1.0		4.5	
1.5		5.0	
2.0			
2.5			
3.0			
3.5

20 blows for 100mm in the last increment.

Effective refusal, 20+ blows per 100mm

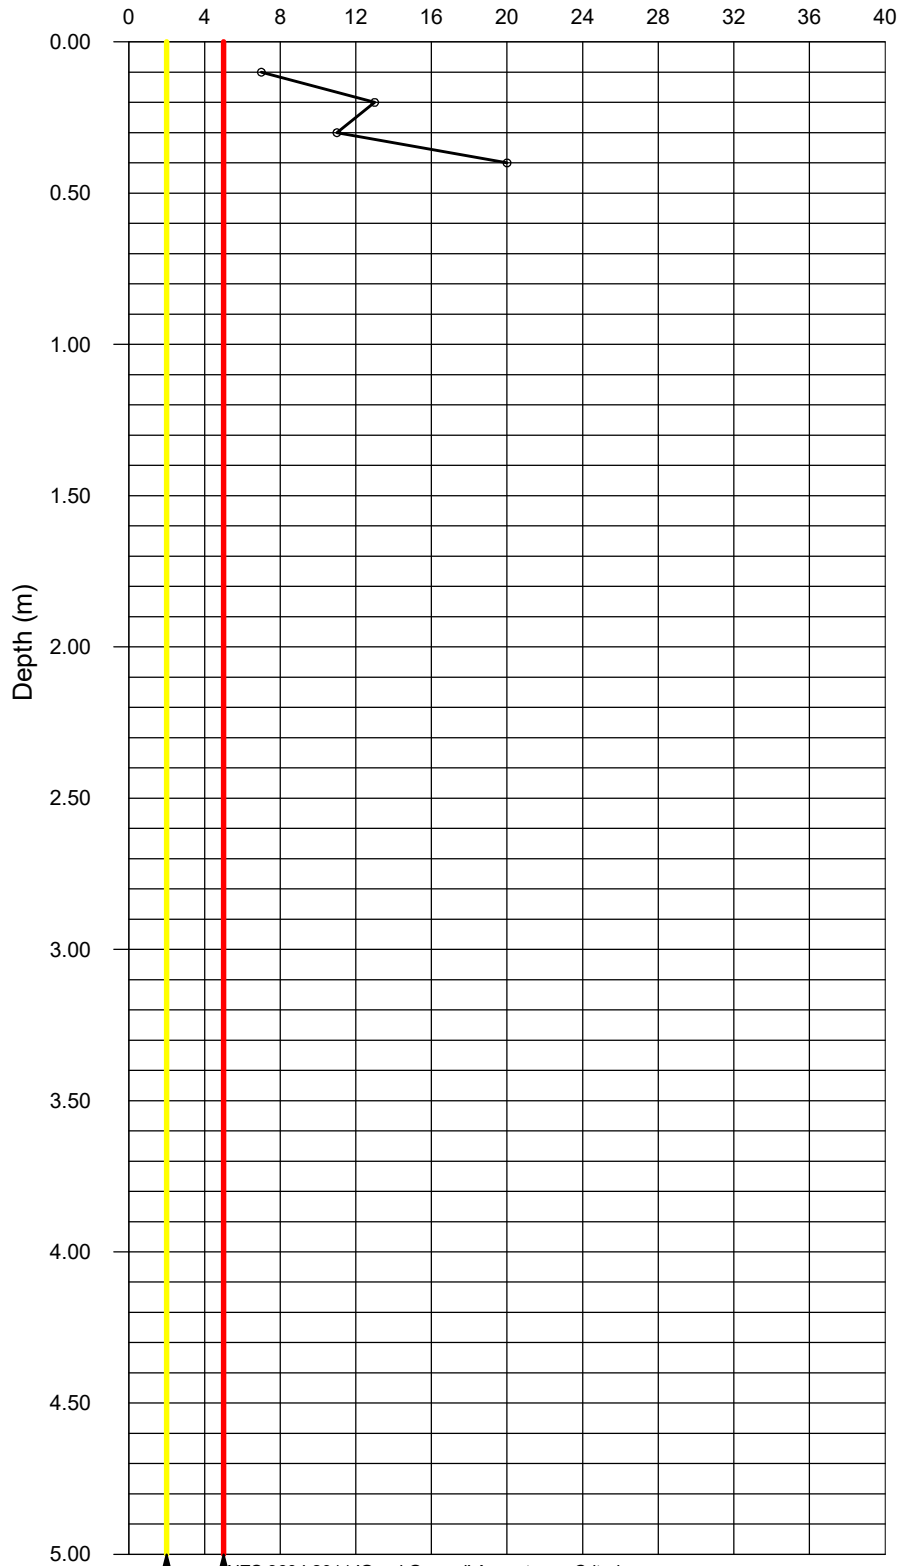
Depth (m)	Blows per 100 mm	Depth (m)	Blows per 100 mm
0.0	7	3.5	
0.1	13		
0.2	11		
0.3	20		
0.4		4.0	
0.5			
1.0		4.5	
1.5		5.0	
2.0			
2.5			
3.0			
3.5

20 blows for 100mm in the last increment.  
Co-ordinates recorded in the field with a mobile device.  
RL from data survey based on design contours (+/- 10cm) (Christchurch Drainage Datum).  
Effective refusal, 20+ blows per 100mm
