Prestons Park Subdivision
GEOTECHNICAL REPORT FOR LOT 1000
CDL Land NZ Limited

10 January 2024
Revision: 1
Reference: 235361

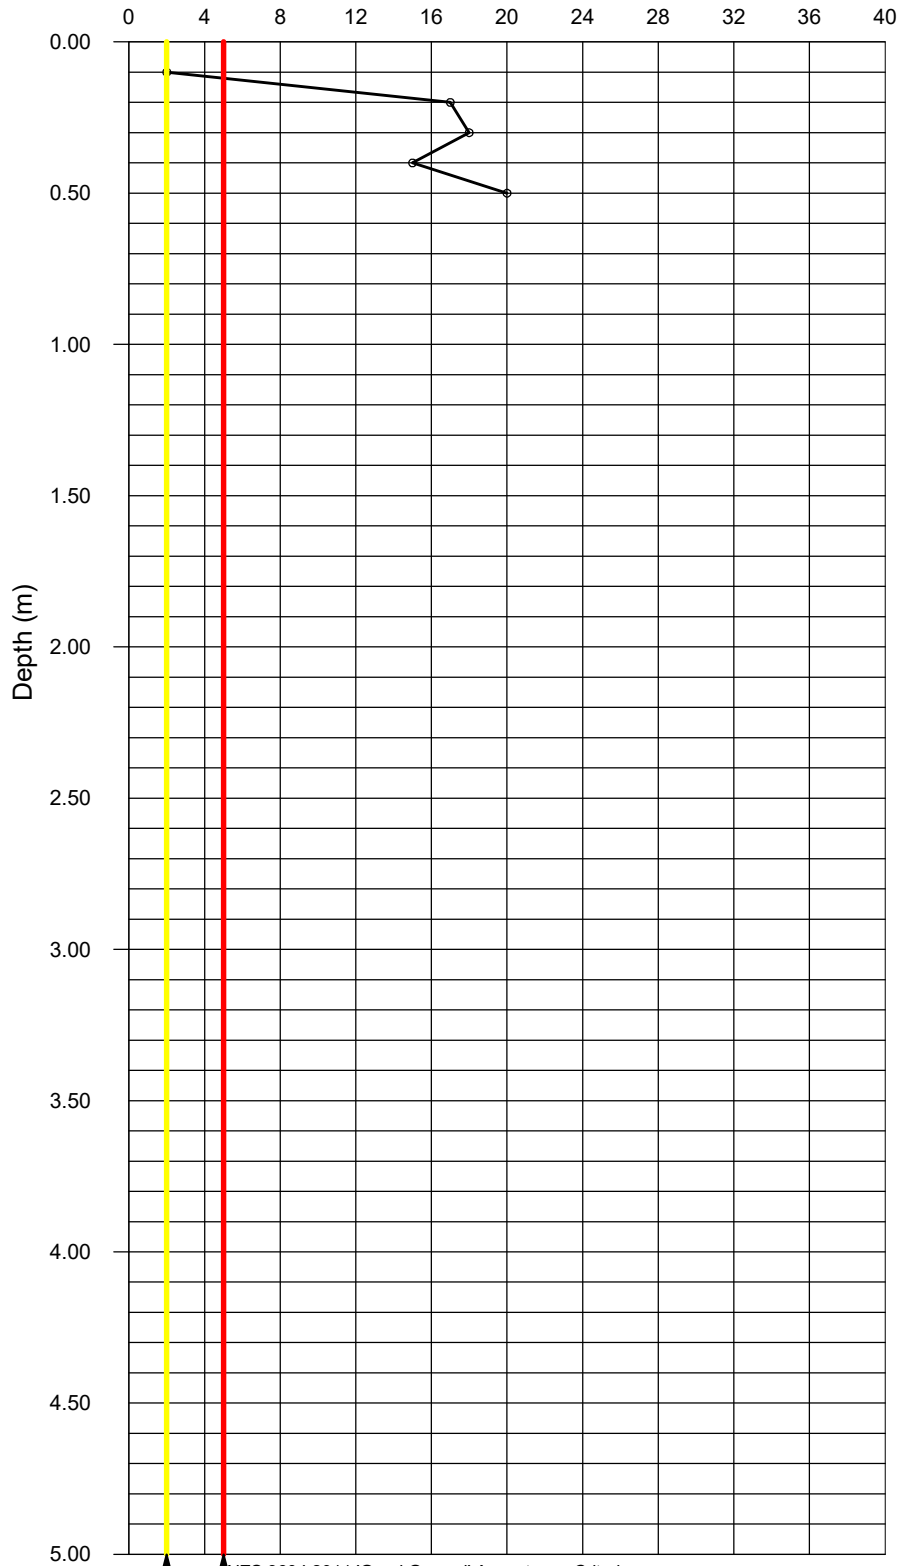
DCP logs indicate 5 blows per 100mm penetration, which is equivalent to an ultimate bearing capacity of 300kPa, was consistently encountered from shallow depths.

20 blows for 100mm in the last increment.

Effective refusal, 20+ blows per 100mm

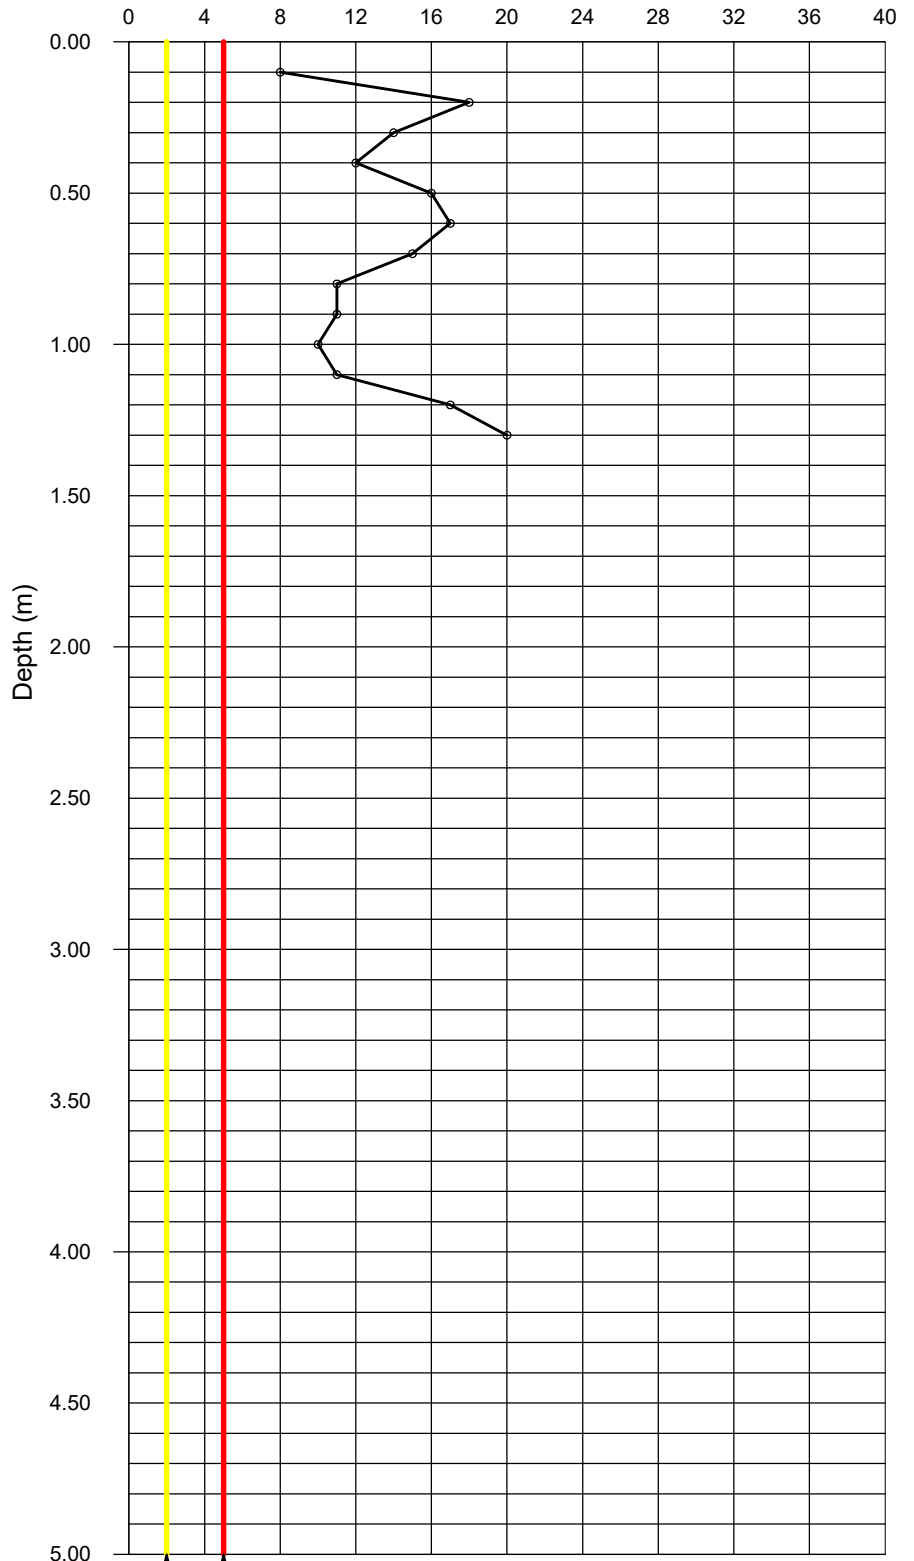
20 blows for 100mm in the last increment.
Co-ordinates recorded in the field with a mobile device.
RL from data survey based on design contours (+/- 10cm) (Christchurch Drainage Datum).
Effective refusal, 20+ blows per 100mm
