Prestons Park Subdivision
GEOTECHNICAL REPORT FOR LOT 1001
CDL Land NZ Limited

10 January 2024
Revision: 1
Reference: 235361

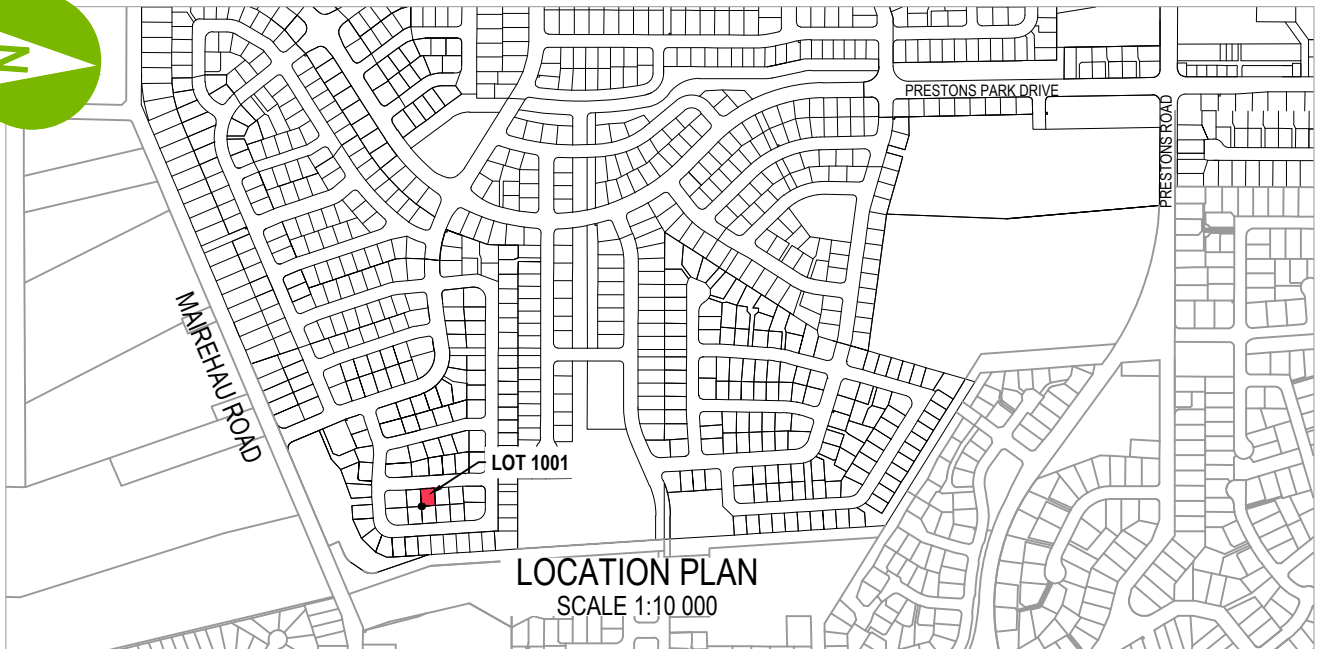
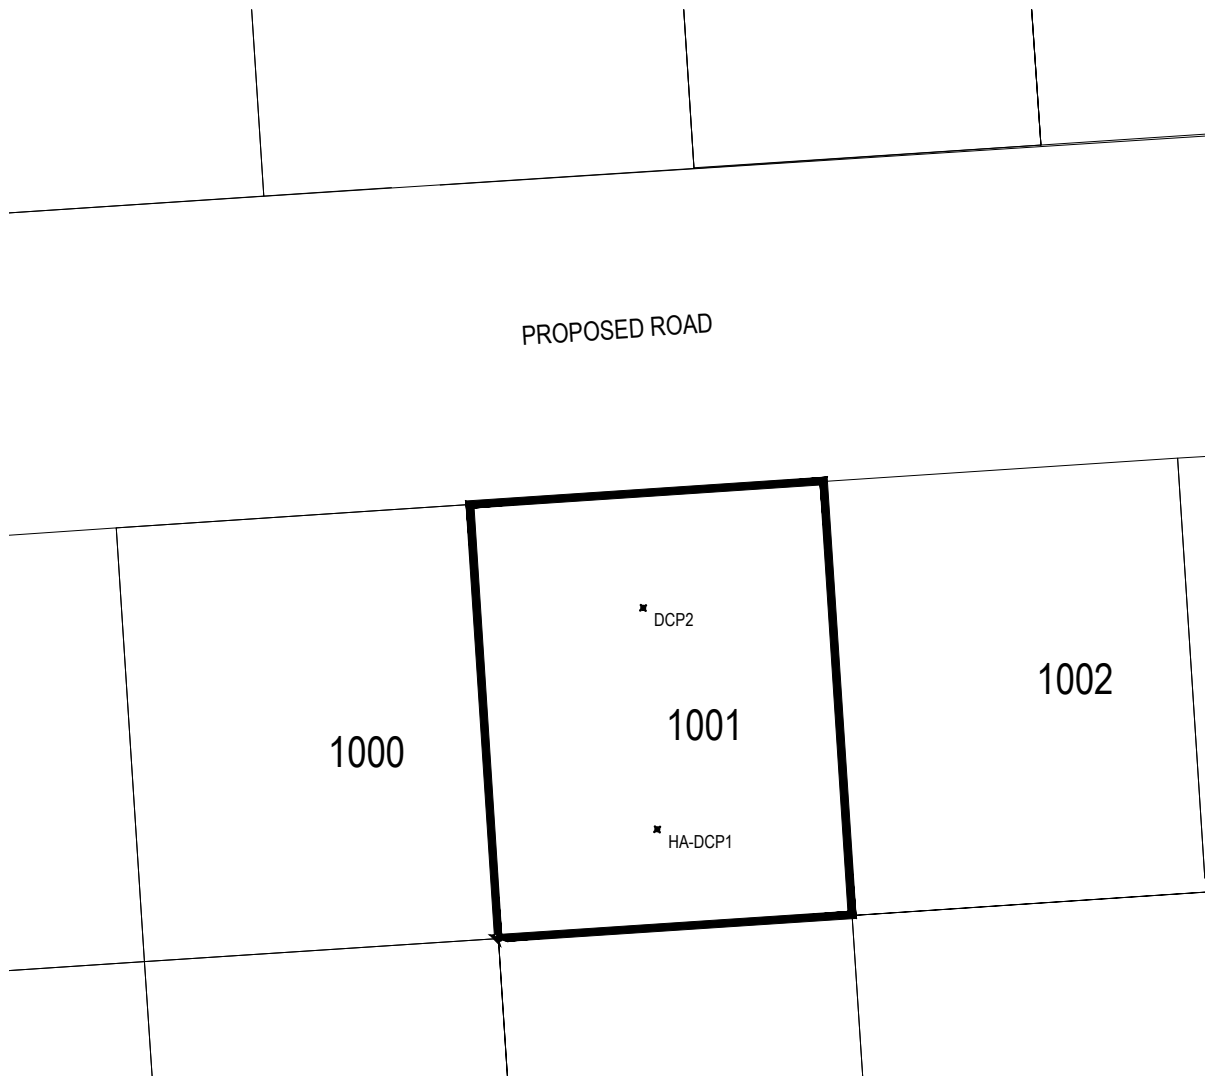
This building consent report is for Lot 1001 which is located in Stage 5 of the Prestons Park Subdivision development (refer Figure 1 in Appendix A). The lot is bordered by residential lots to the north, east and south and an access road to the west.

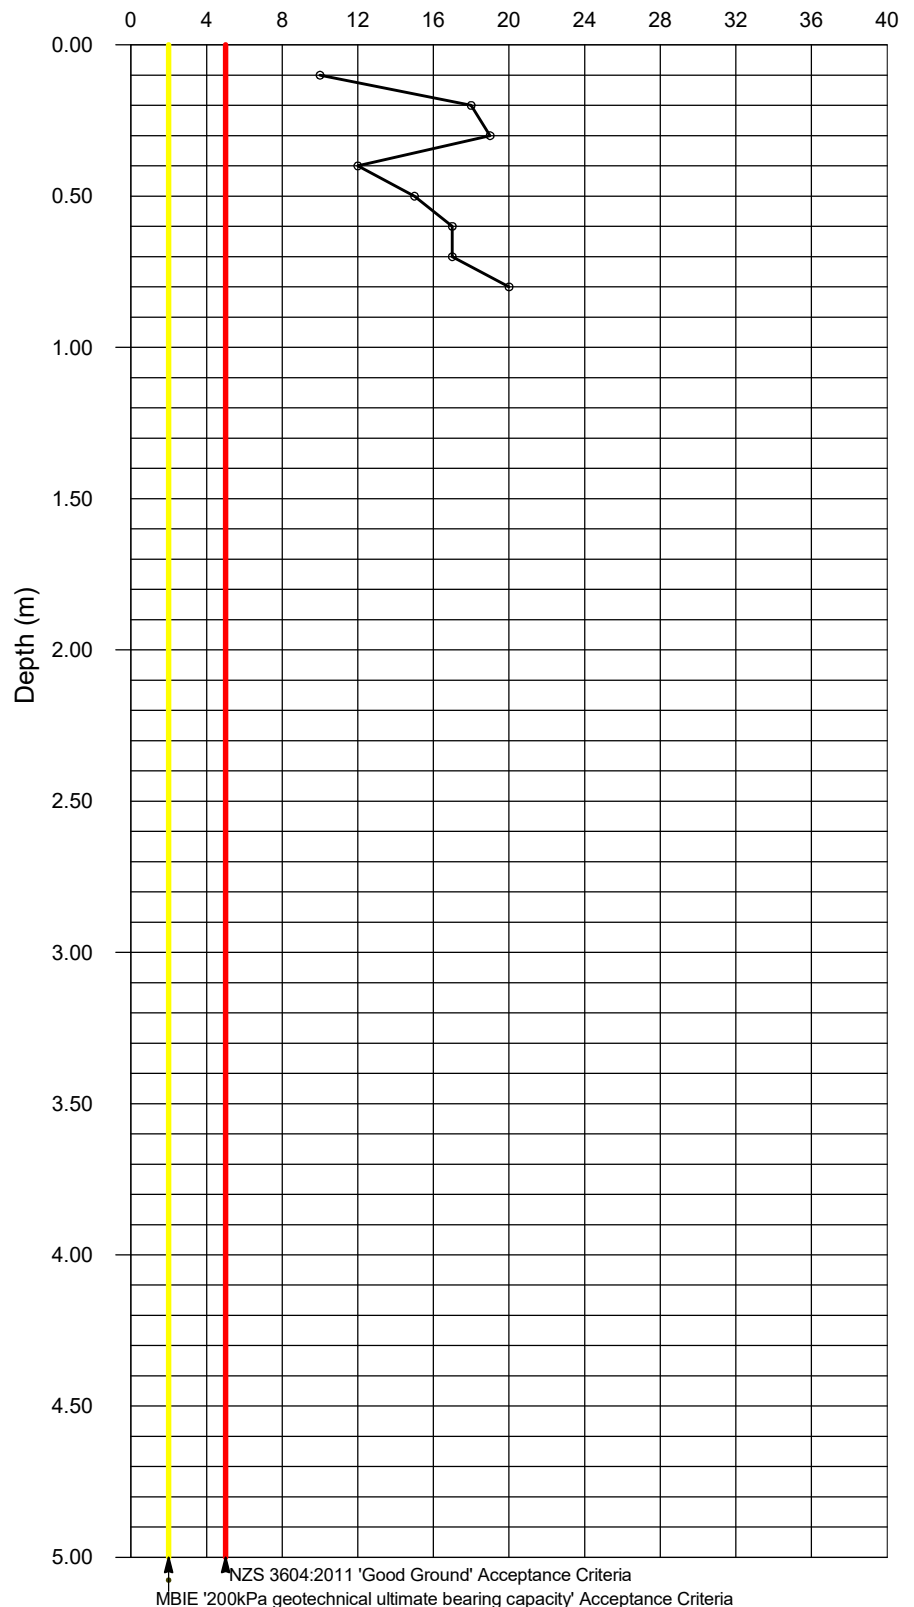
DCP logs indicate 5 blows per 100mm penetration, which is equivalent to an ultimate bearing capacity of 300kPa, was consistently encountered from shallow depths.

Depth (m)	Blows per 100 mm	Depth (m)	Blows per 100 mm
0.0	10	3.5	
	18		
	19		
	12		
0.5	15	4.0	
	17		
	17		
	20		
1.0		4.5	
1.5		5.0	
2.0			
2.5			
3.0			
3.5

20 blows for 100mm in the last increment.

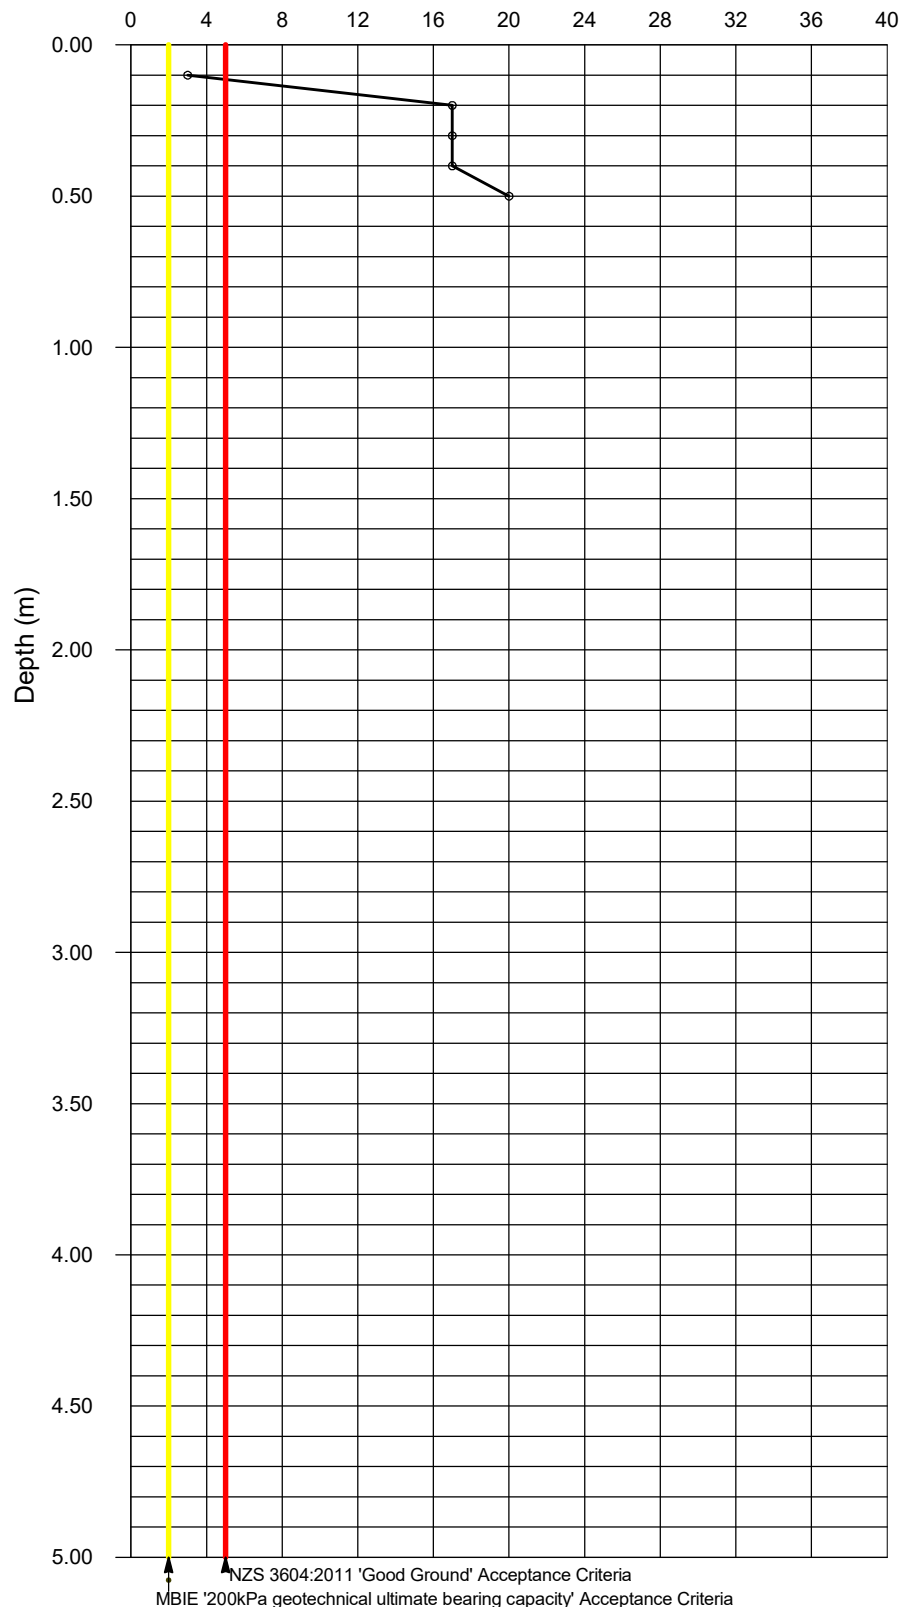
Lot 1001 - DCP2

Depth (m)	Blows per 100 mm	Depth (m)	Blows per 100 mm
0.0	3	3.5	
	17		
	17		
	17		
0.5	20	4.0	
1.0		4.5	
1.5		5.0	
2.0			
2.5			
3.0			
3.5

20 blows for 100mm in the last increment.
