Prestons Park Subdivision
GEOTECHNICAL REPORT FOR LOT 1002
CDL Land NZ Limited

10 January 2024
Revision: 1
Reference: 235361

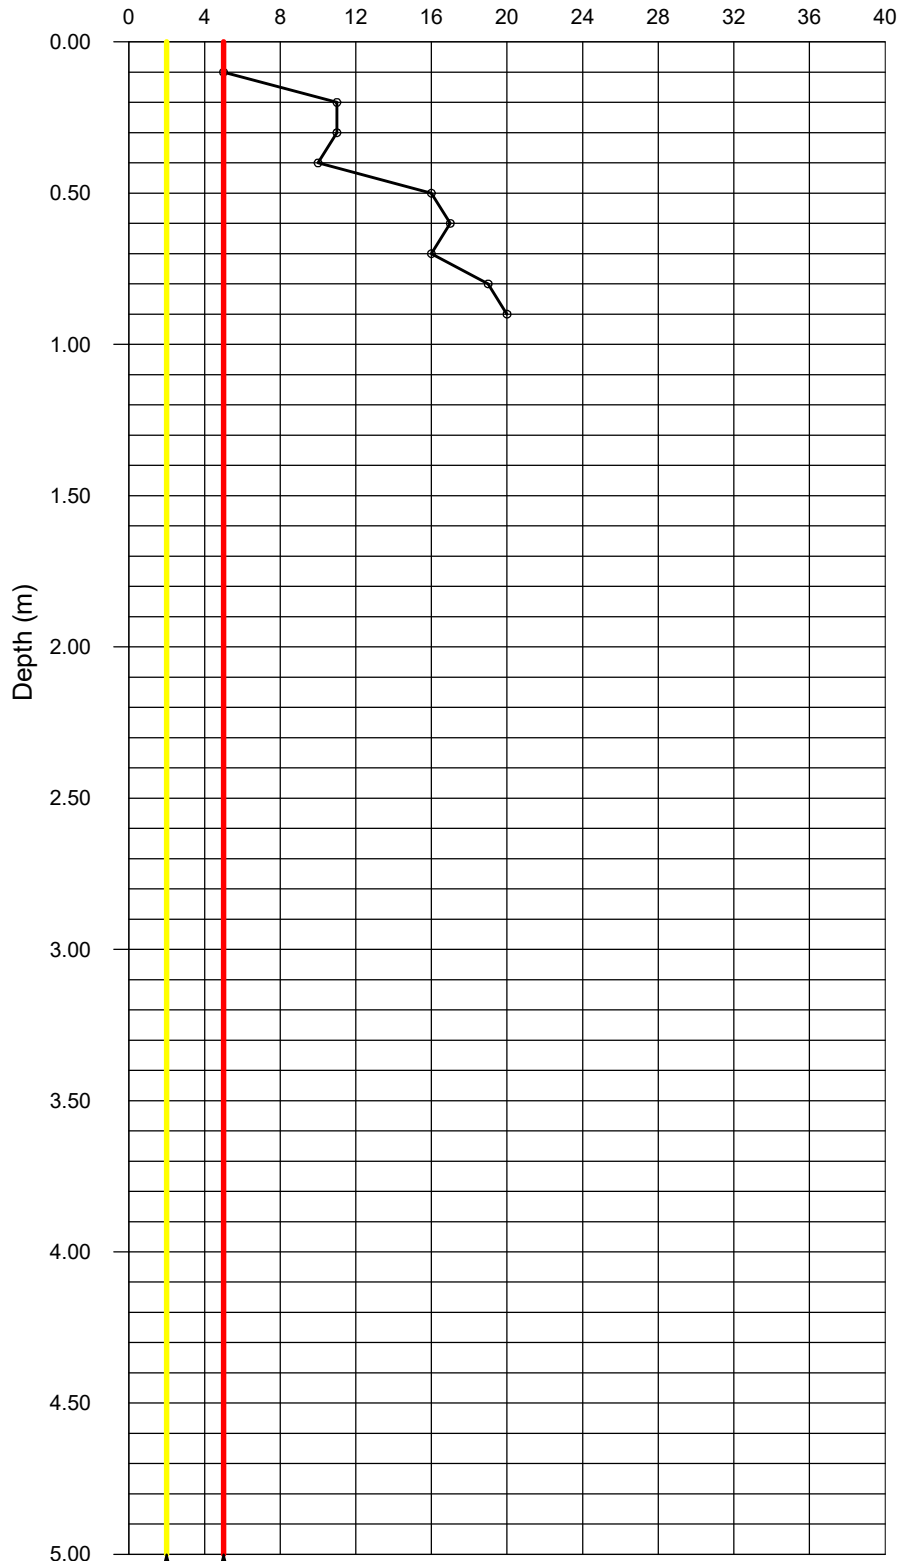
DCP logs indicate two blows per 100mm penetration, which is equivalent to an ultimate bearing capacity of 200kPa, was consistently encountered from shallow depths.

20 blows for 100mm in the last increment.
Co-ordinates recorded in the field with a mobile device.
RL from data survey based on design contours (+/- 10cm) (Christchurch Drainage Datum).
Effective refusal, 20+ blows per 100mm

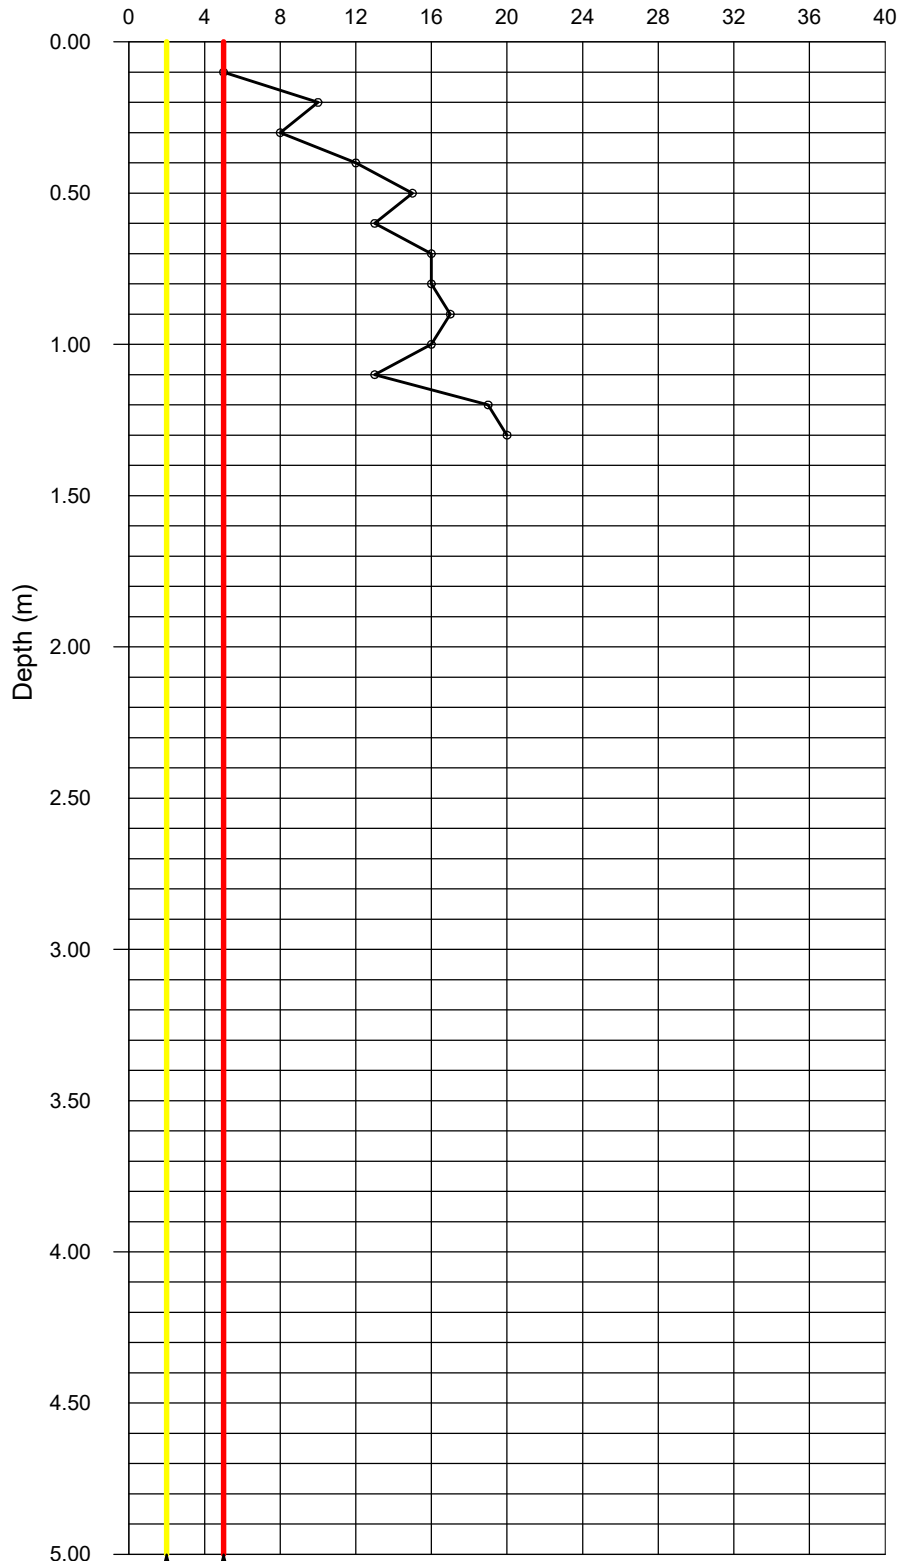
20 blows for 100mm in the last increment.
Co-ordinates recorded in the field with a mobile device.
RL from data survey based on design contours (+/- 10cm) (Christchurch Drainage Datum).
Effective refusal, 20+ blows per 100mm
