Prestons Park Subdivision
GEOTECHNICAL REPORT FOR LOT 1015
CDL Land NZ Limited

8 December 2023
Revision: 1
Reference: 235361

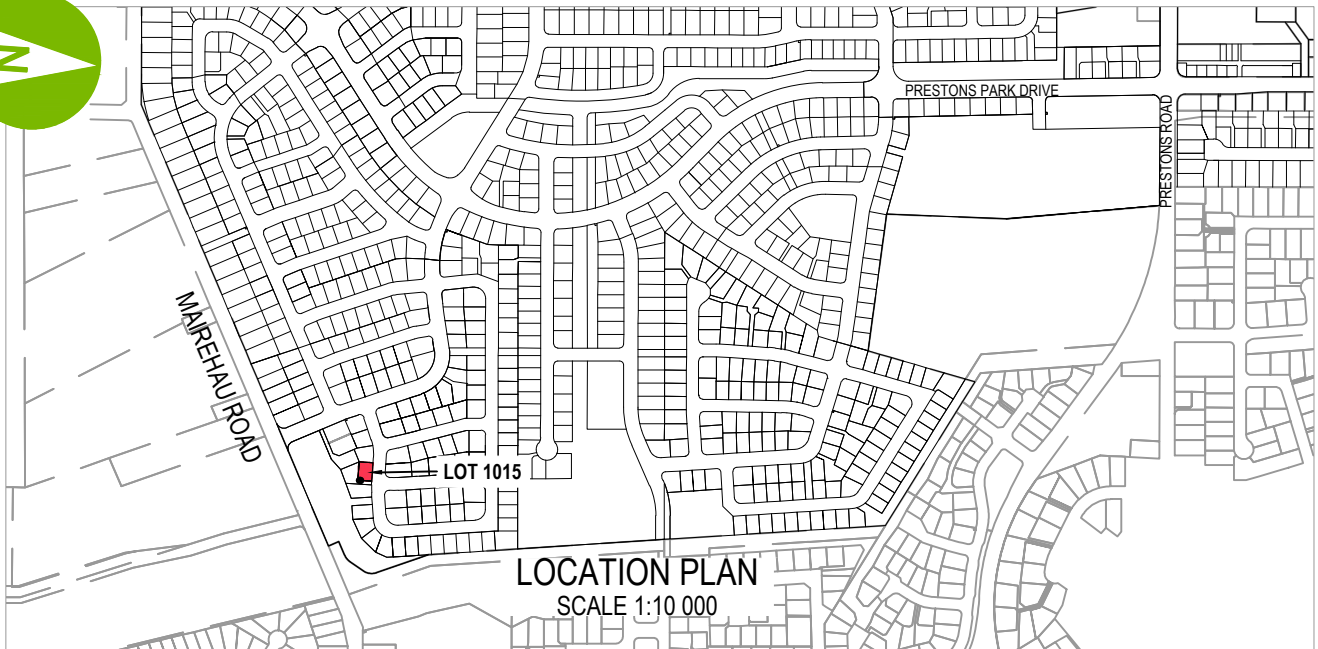
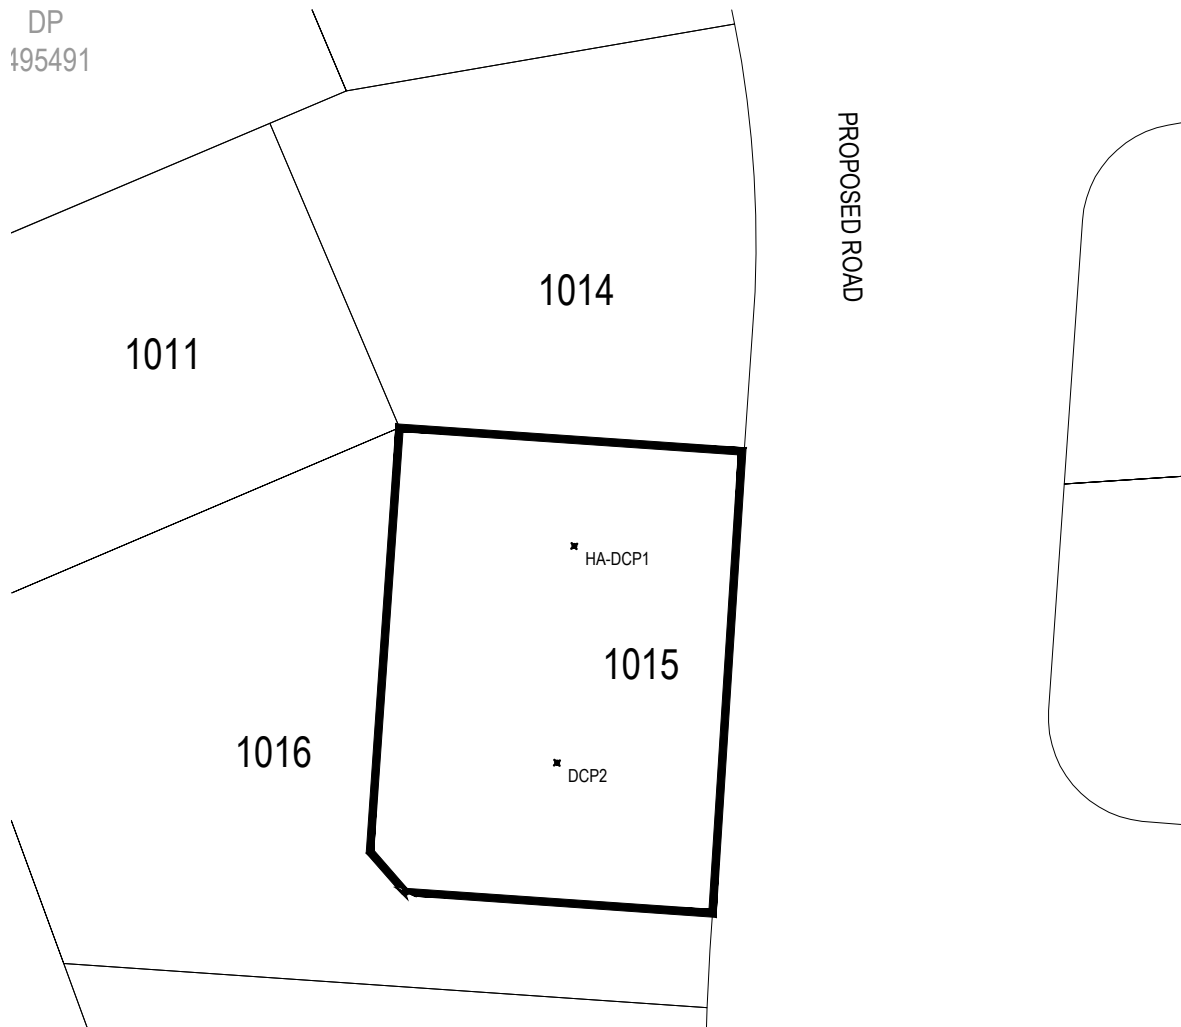
PROJECT	
PRESTONS PARK	
TITLE	
LOT 1015 SITE LOCATION PLAN FIGURE 1

This building consent report is for Lot 1015 which is located in Stage 5 of the Prestons Park Subdivision development (refer Figure 1 in Appendix A). The lot is bordered by residential lots to the east, south and west and an access road to the north.

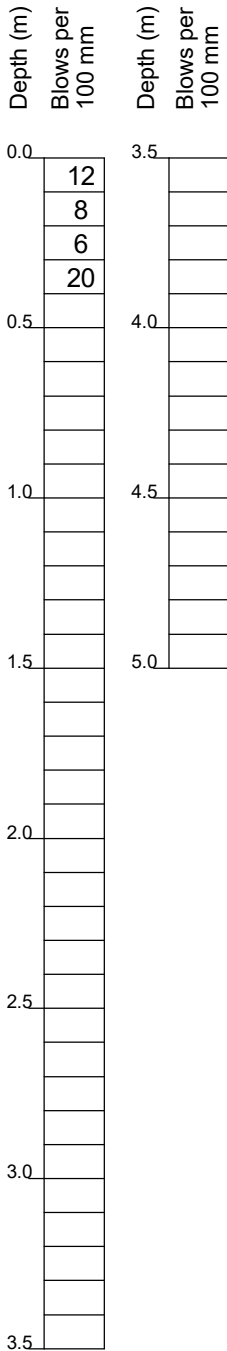
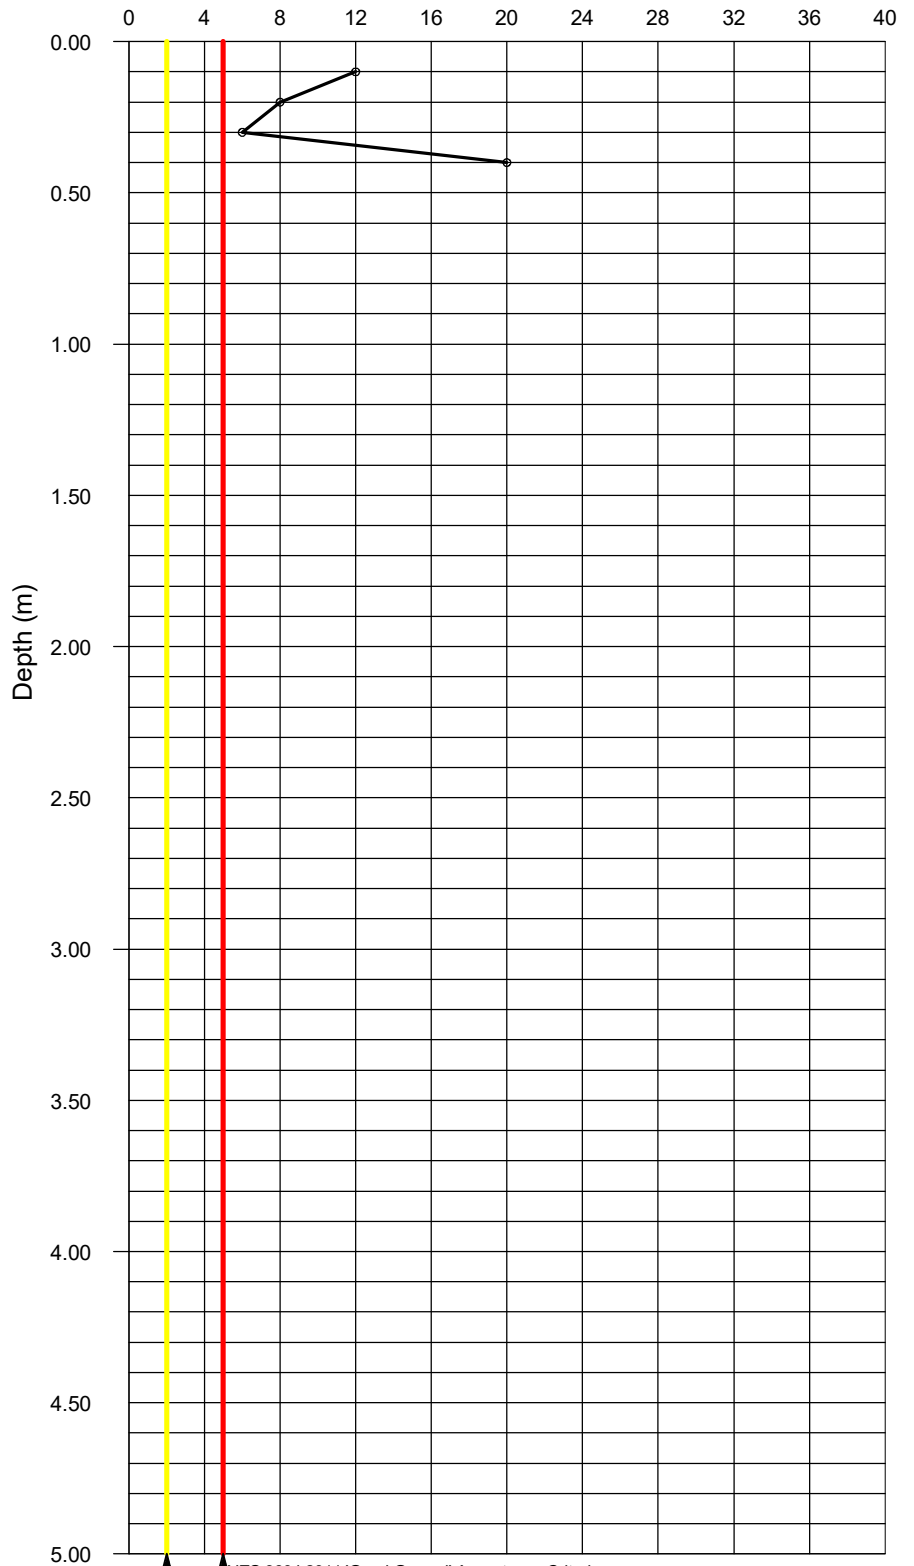
DCP logs indicate 5 blows per 100mm penetration, which is equivalent to an ultimate bearing capacity of 300kPa, was consistently encountered from shallow depths.

20 blows for 100mm in the last increment.
Co-ordinates recorded in the field with a mobile device.
RL from data survey based on design contours (Christchurch drainage datum).
Effective refusal, 20+ blows per 100mm

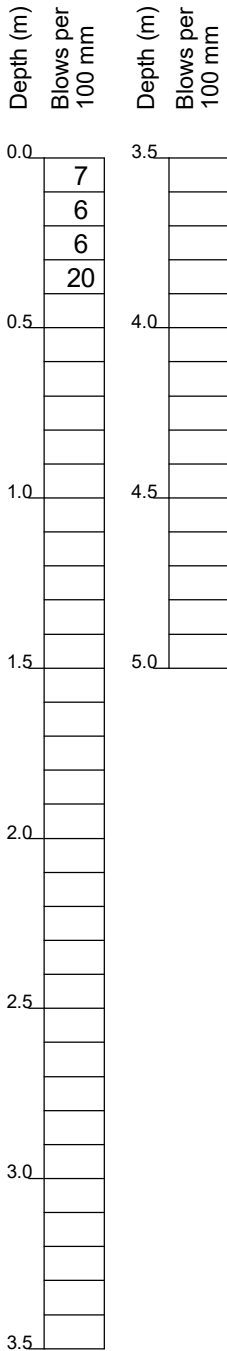
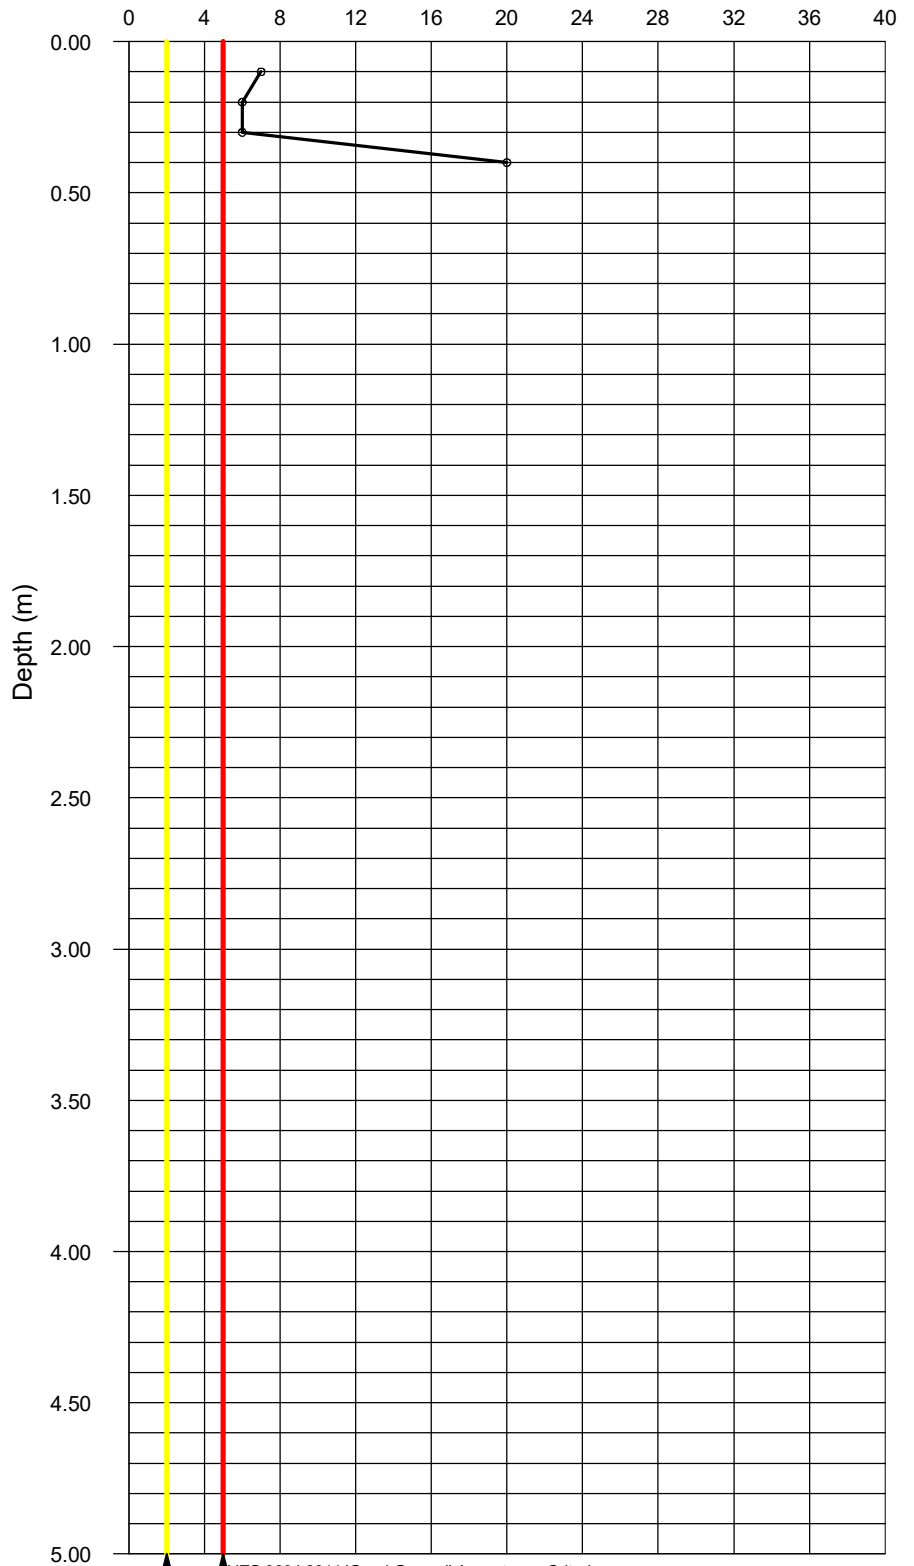
20 blows for 100mm in the last increment.
Co-ordinates recorded in the field with a mobile device.
RL from data survey based on design contours (Christchurch drainage datum).
Effective refusal, 20+ blows per 100mm
