Prestons Park Subdivision
GEOTECHNICAL REPORT FOR LOT 989
CDL Land NZ Limited

30 January 2024
Revision: 1
Reference: 235361

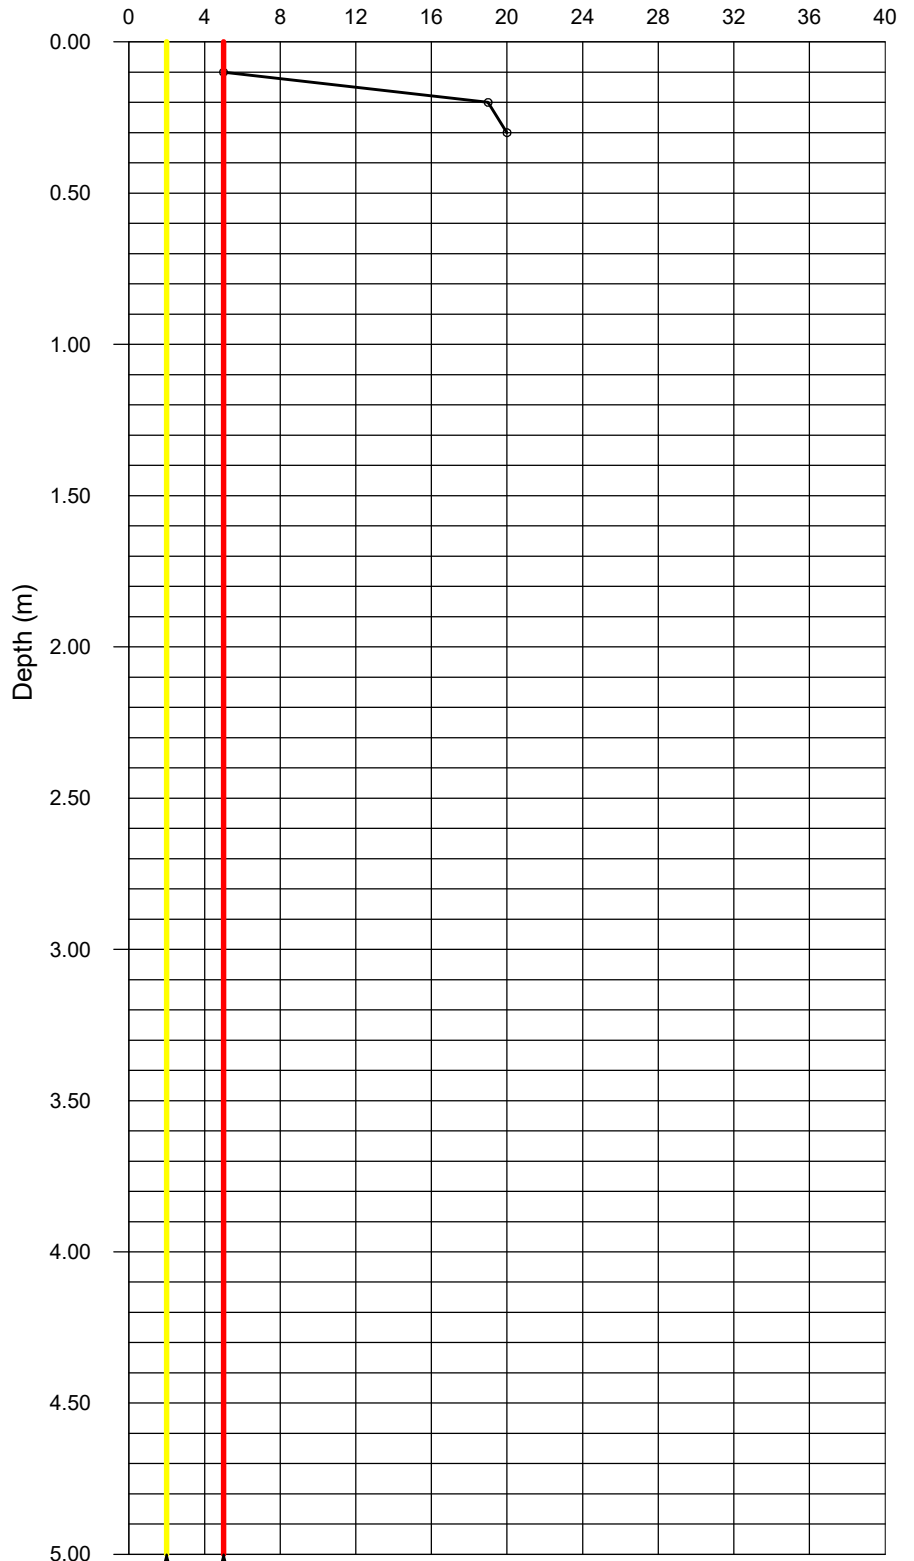
DCP logs indicate 5 blows per 100mm penetration, which is equivalent to an ultimate bearing capacity of 300kPa, was consistently encountered from shallow depths.

20 blows for 100mm in the last increment.
Co-ordinates recorded in the field with a mobile device (+/- 5m).
RL from data survey based on design contours (+/- 100mm) (Christchurch drainage datum).
Effective refusal, 20+ blows per 100mm

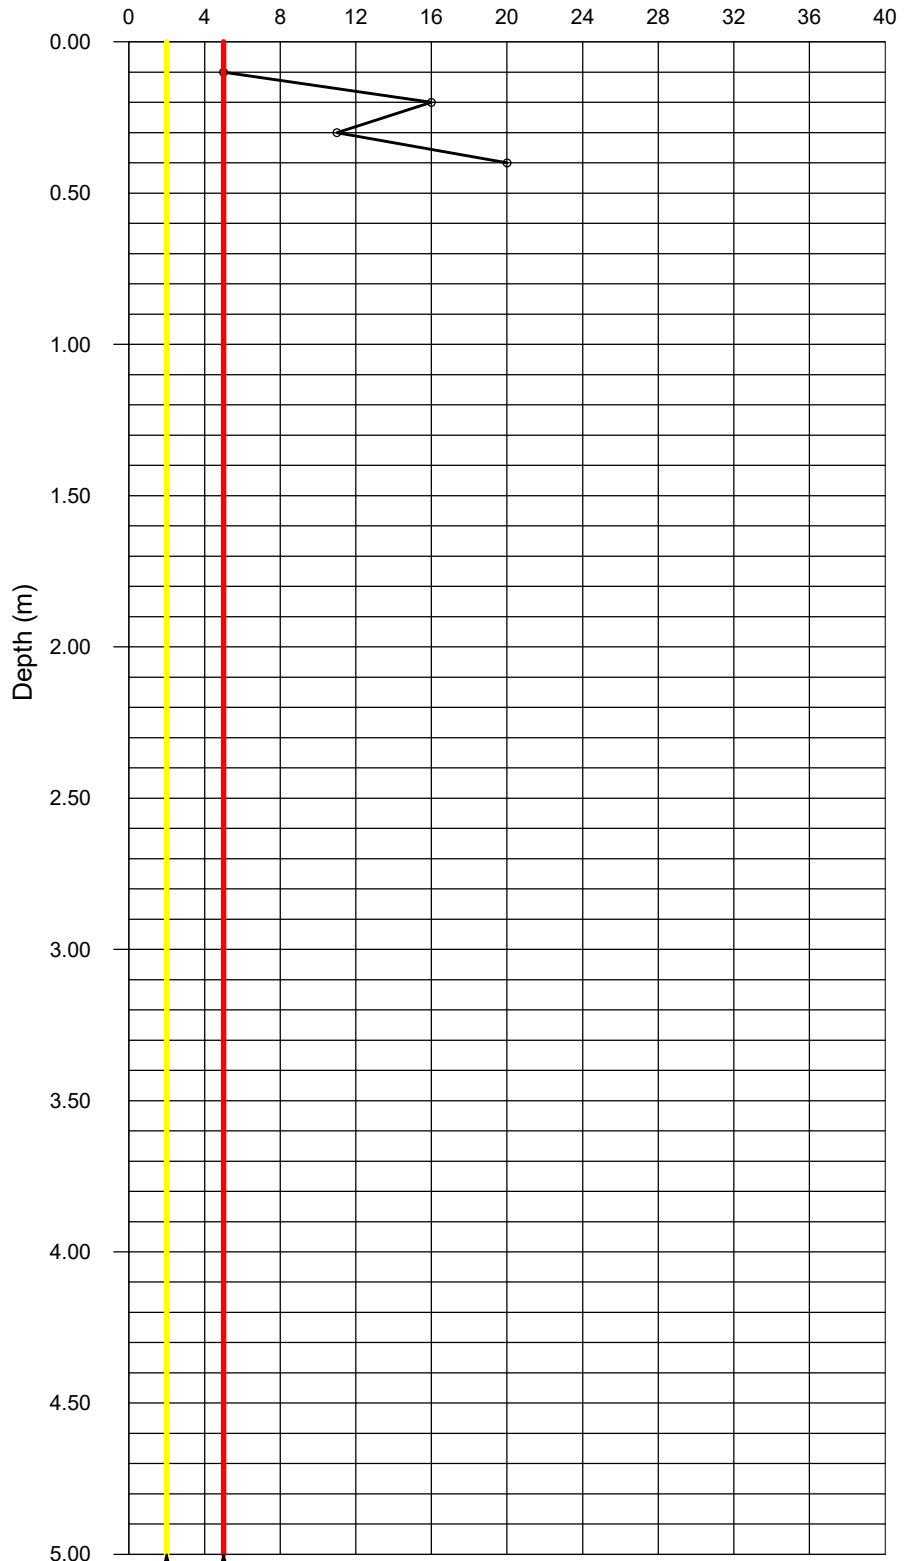
20 blows for 100mm in the last increment.
Co-ordinates recorded in the field with a mobile device (+/- 5m).
RL from data survey based on design contours (+/- 100mm) (Christchurch drainage datum).
Effective refusal, 20+ blows per 100mm
