Prestons Park Subdivision
GEOTECHNICAL REPORT FOR LOT 1013
CDL Land NZ Limited

8 December 2023
Revision: 1
Reference: 235361

| Document control | | | | | | aurecon |
|---|---|--|---|---|---|---|
| Report title | | GEOTECHNICAL REPORT FOR LOT 1013 | | | | |

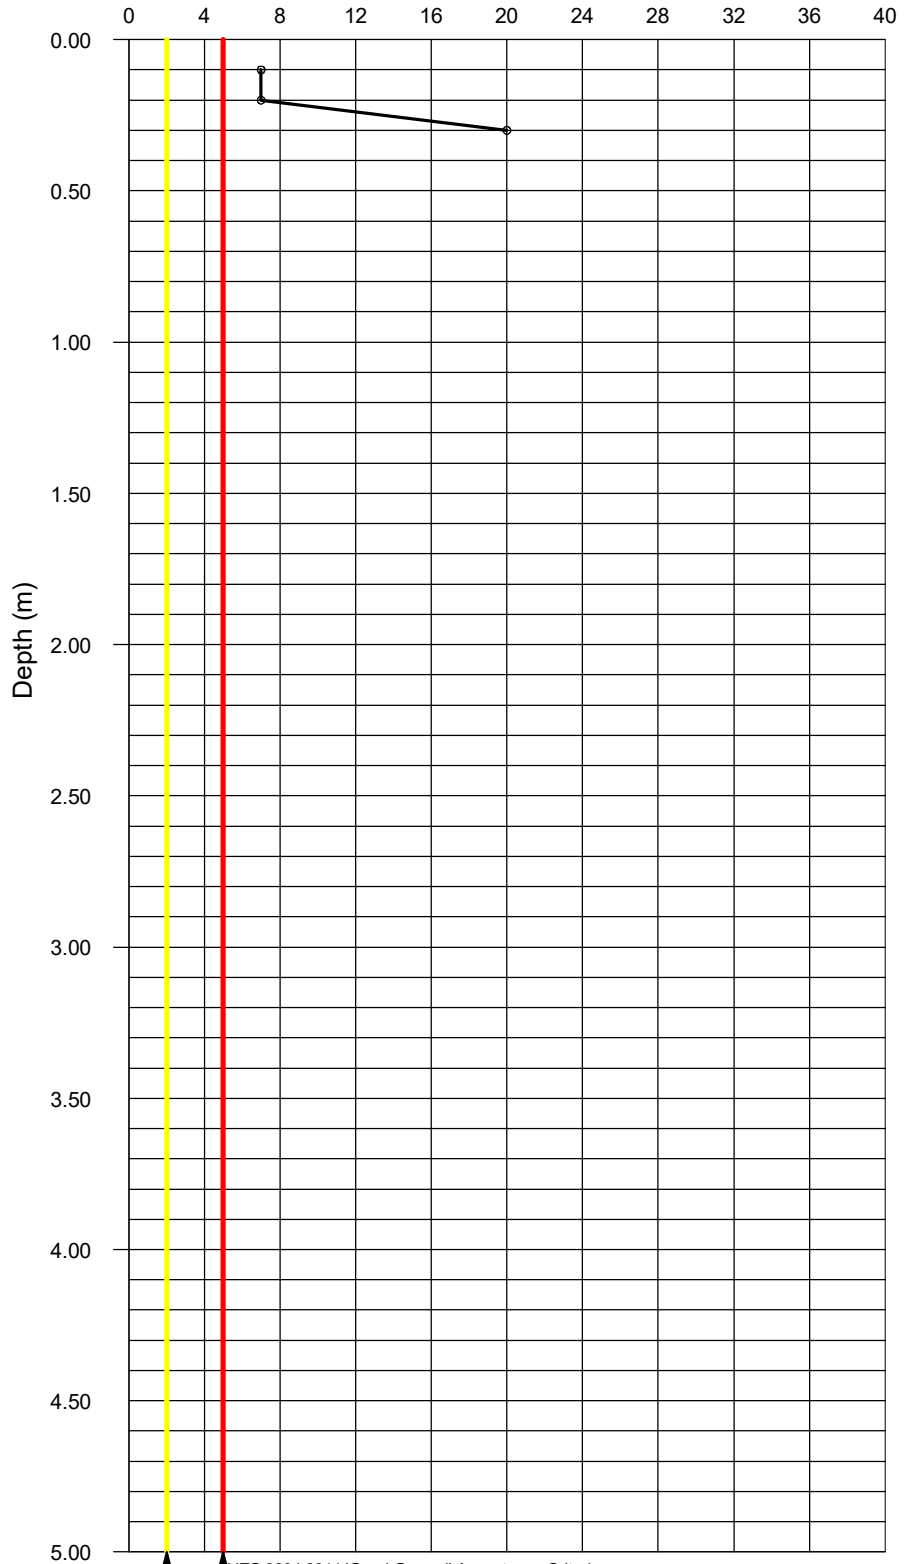
DCP logs indicate 5 blows per 100mm penetration, which is equivalent to an ultimate bearing capacity of 300kPa, was consistently encountered from shallow depths.

Remarks:

20 blows for 100mm in the last increment.
Co-ordinates recorded in the field with a mobile device.
RL from data survey based on design contours (Christchurch drainage datum).
Effective refusal, 20+ blows per 100mm

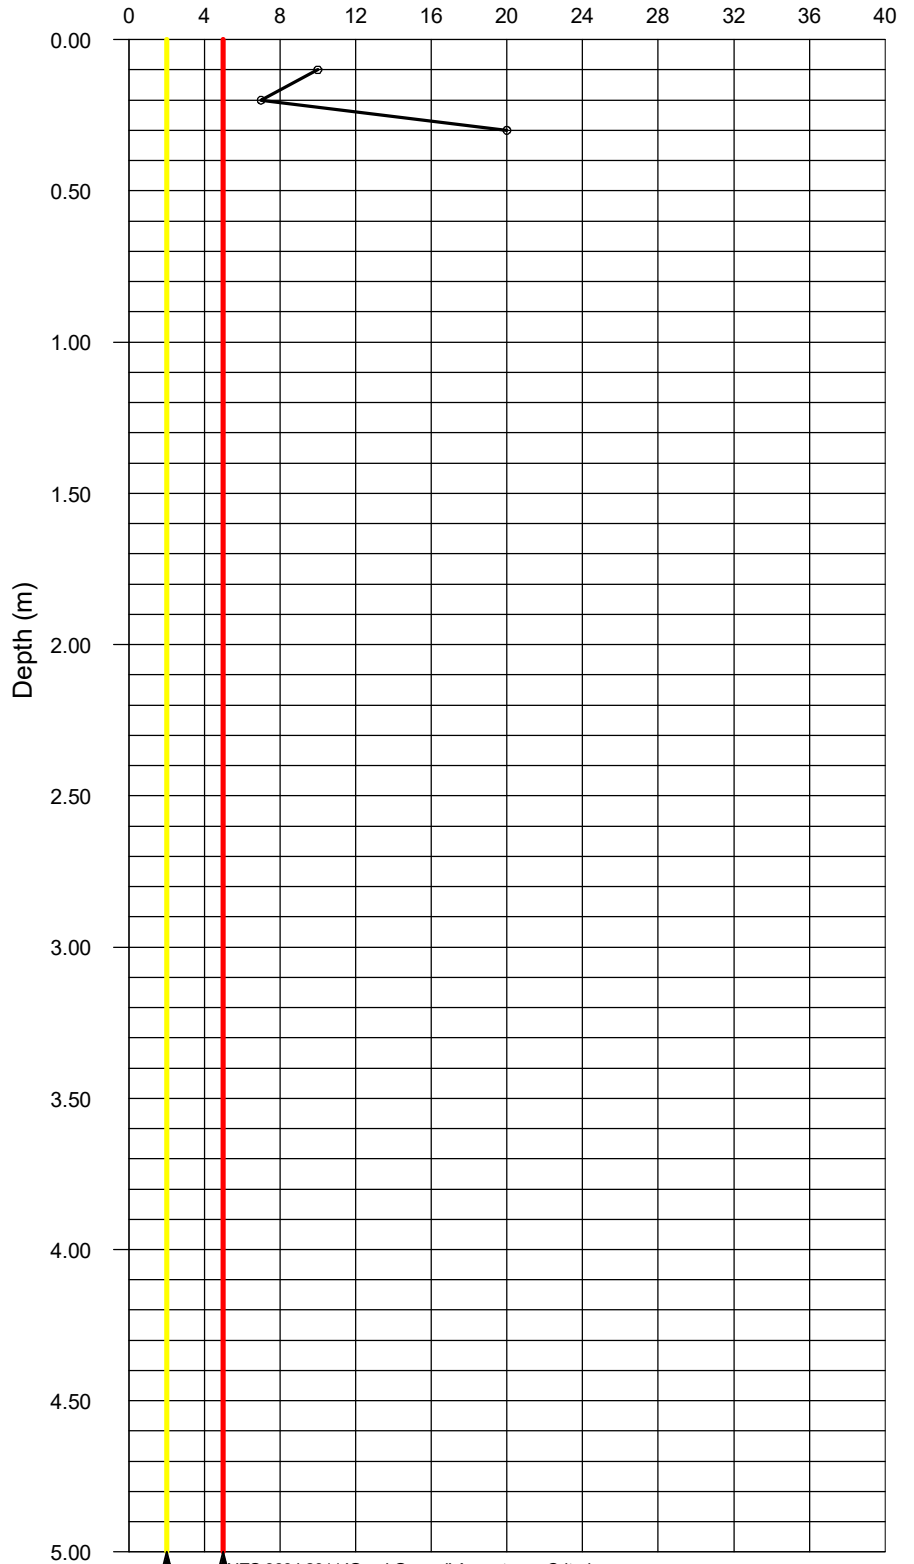
Remarks:

20 blows for 100mm in the last increment.
Co-ordinates recorded in the field with a mobile device.
RL from data survey based on design contours (Christchurch drainage datum).
Effective refusal, 20+ blows per 100mm
