**Prestons Park Subdivision**  
**GEOTECHNICAL REPORT FOR LOT 1014**  
**CDL Land NZ Limited**

**8 December 2023**  
**Revision: 1**  
**Reference: 235361**

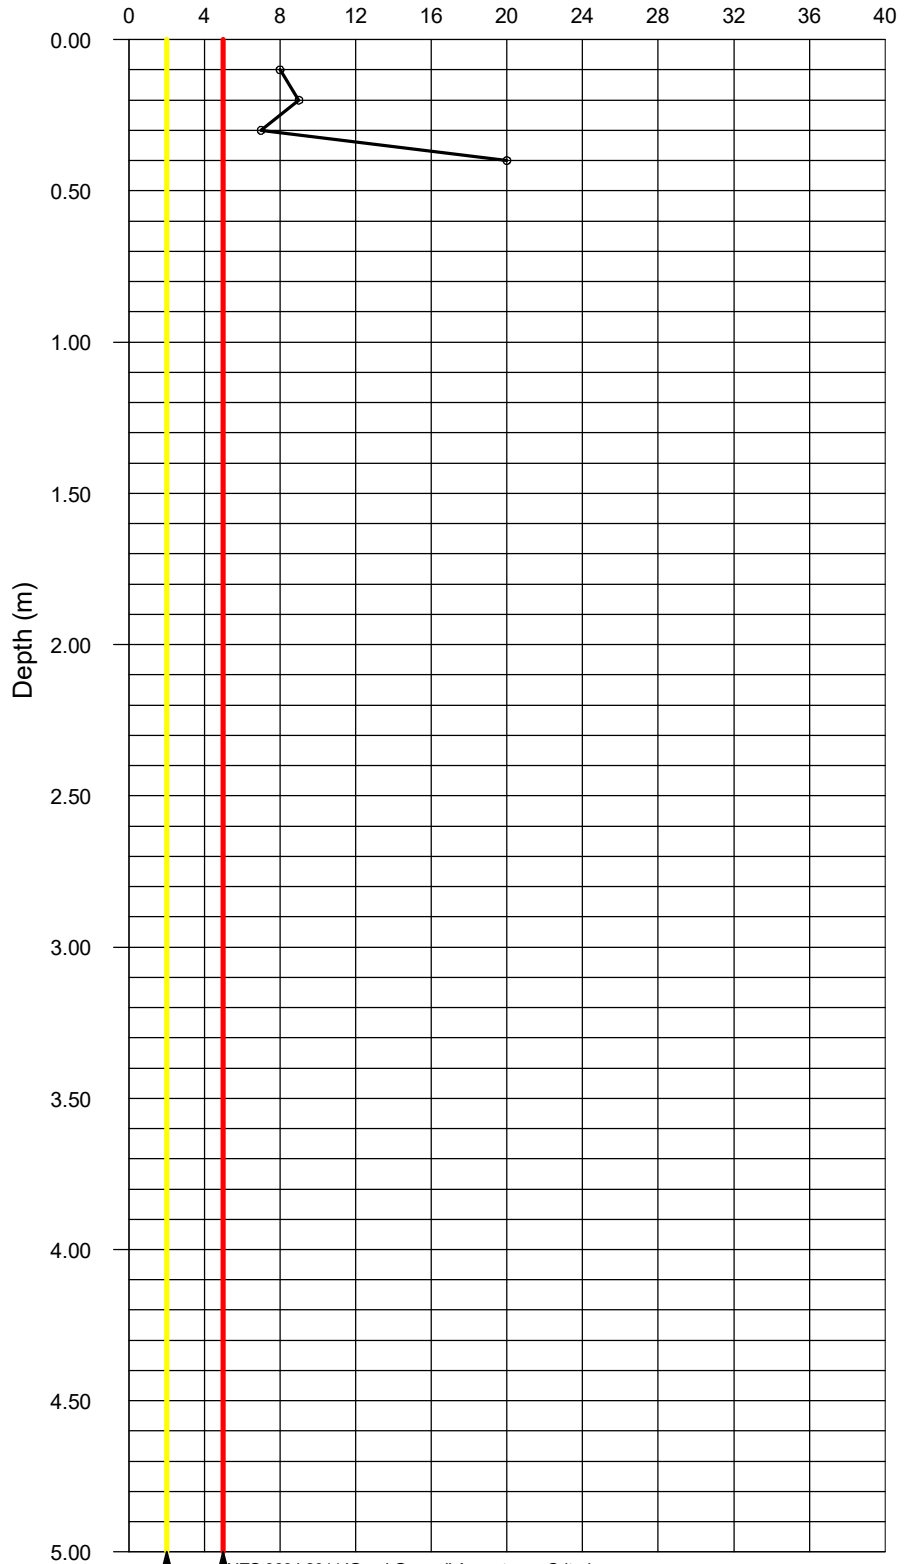
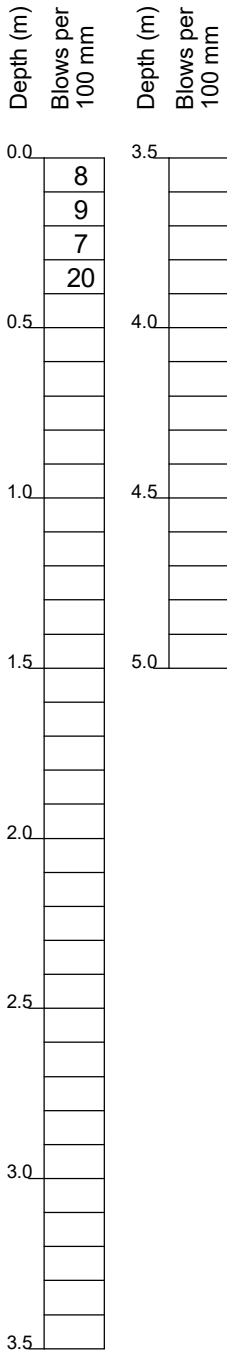
DCP logs indicate 5 blows per 100mm penetration, which is equivalent to an ultimate bearing capacity of 300kPa, was consistently encountered from shallow depths.

**Remarks:**  
20 blows for 100mm in the last increment.  
Co-ordinates recorded in the field with a mobile device.  
RL from data survey based on design contours (Christchurch drainage datum).  
Effective refusal, 20+ blows per 100mm

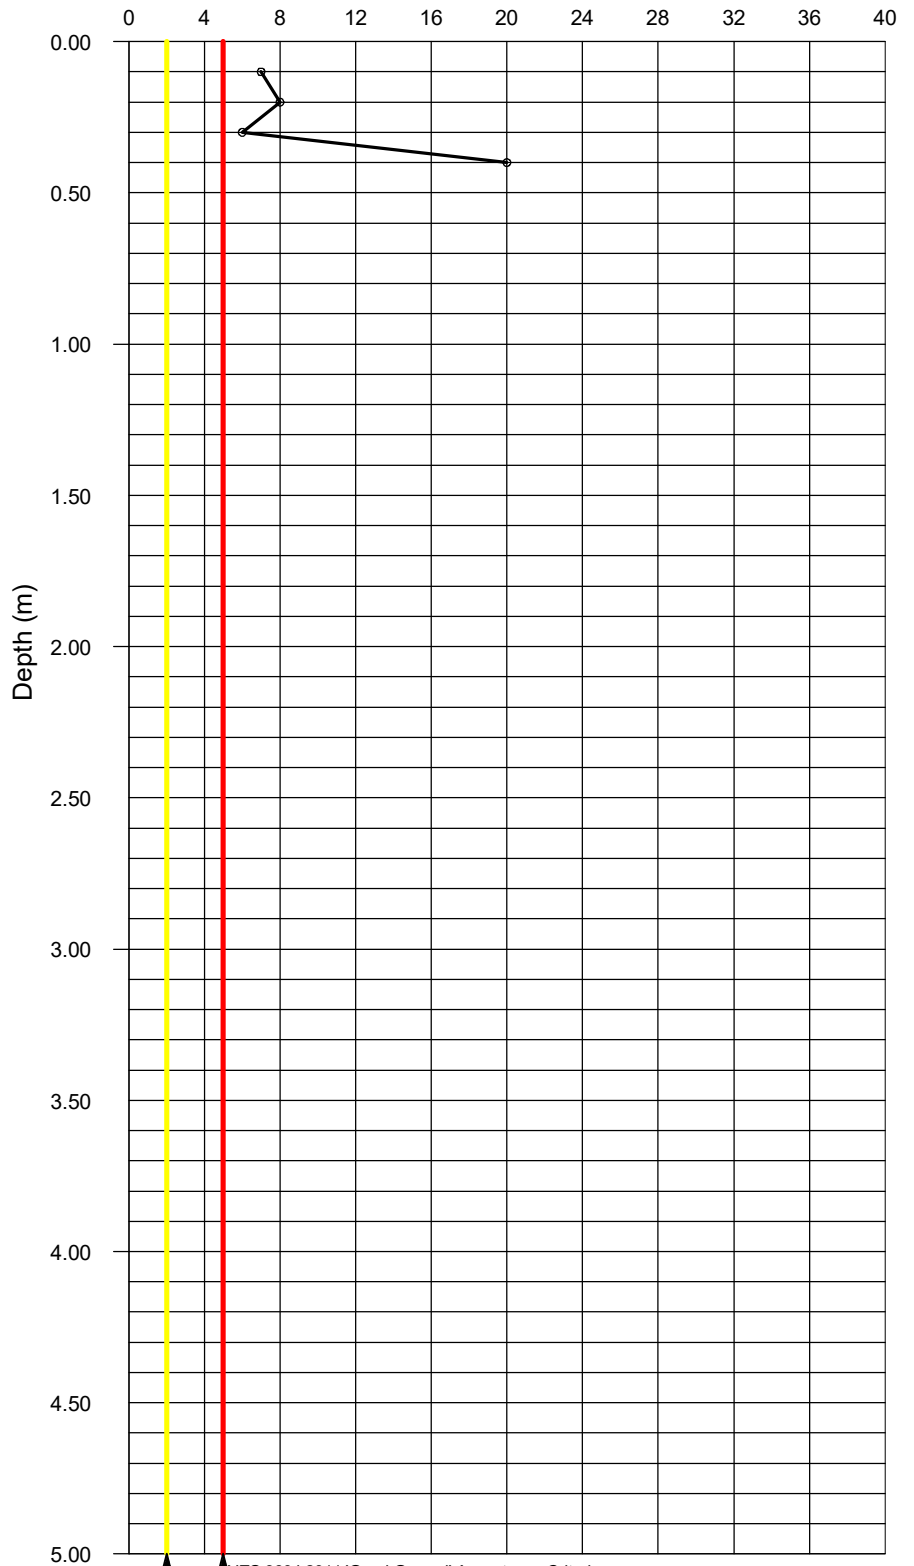
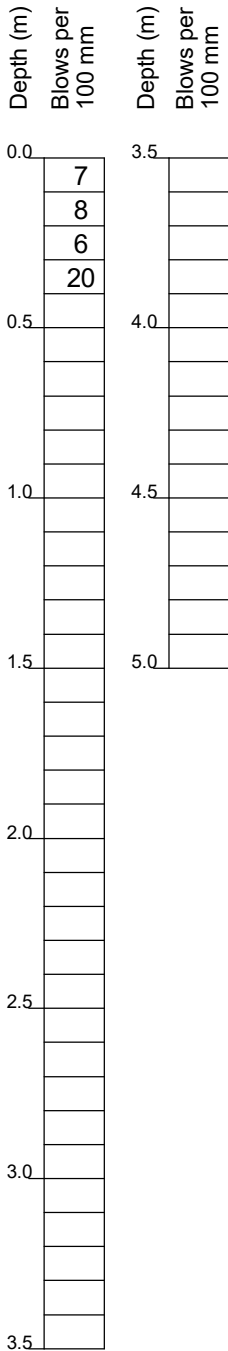
20 blows for 100mm in the last increment.  
Co-ordinates recorded in the field with a mobile device.  
RL from data survey based on design contours (Christchurch drainage datum).  
Effective refusal, 20+ blows per 100mm
