Prestons Park Subdivision
GEOTECHNICAL REPORT FOR LOT 245
CDL Land NZ Limited

8 April 2024 Revision: 0 Reference: 235361

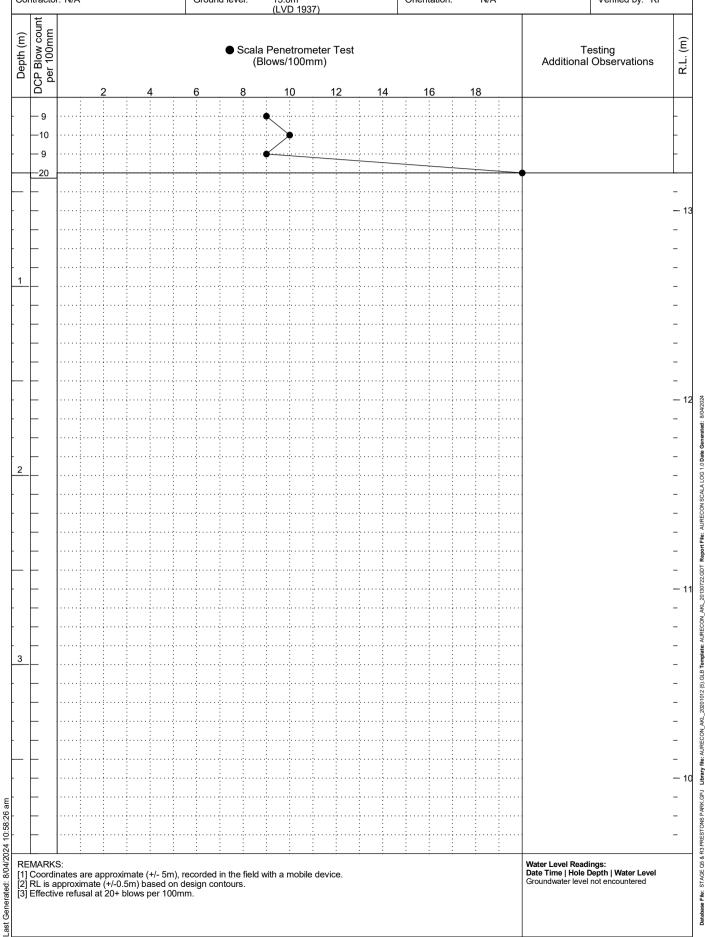
Lot 245 DCP1

DCP logs indicate 5 blows per 100mm penetration, which is equivalent to an ultimate bearing capacity of 300kPa, was consistently achieved from shallow depths.
