**Prestons Park Subdivision** GEOTECHNICAL REPORT FOR LOT 246 **CDL Land NZ Limited**

8 April 2024 Revision: 0 Reference: 235361

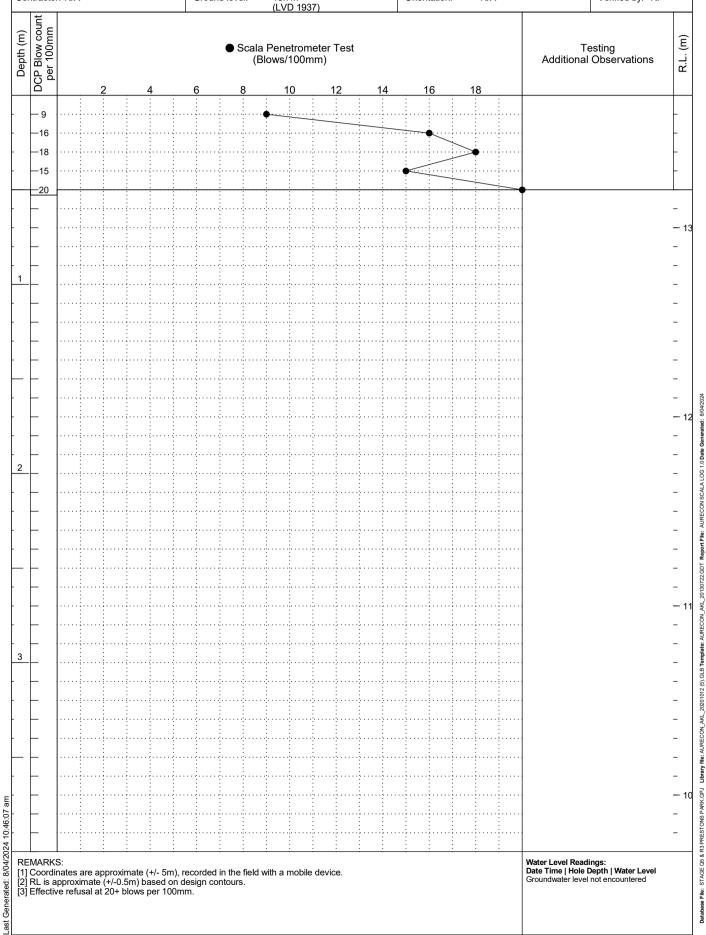
**Lot 246 DCP1**

DCP logs indicate 5 blows per 100mm penetration, which is equivalent to an ultimate bearing capacity of 300kPa, was consistently encountered from shallow depths.

Based on our understanding of the site works and the investigation results, we recommend that NZS3604:2011 compliant foundations are embedded a minimum depth of 0.35m below current ground level.
