**Prestons Park Subdivision**  
**GEOTECHNICAL REPORT FOR LOT 247**  
**CDL Land NZ Limited**

**15 April 2024**  
**Revision: 0**  
**Reference: 235361**

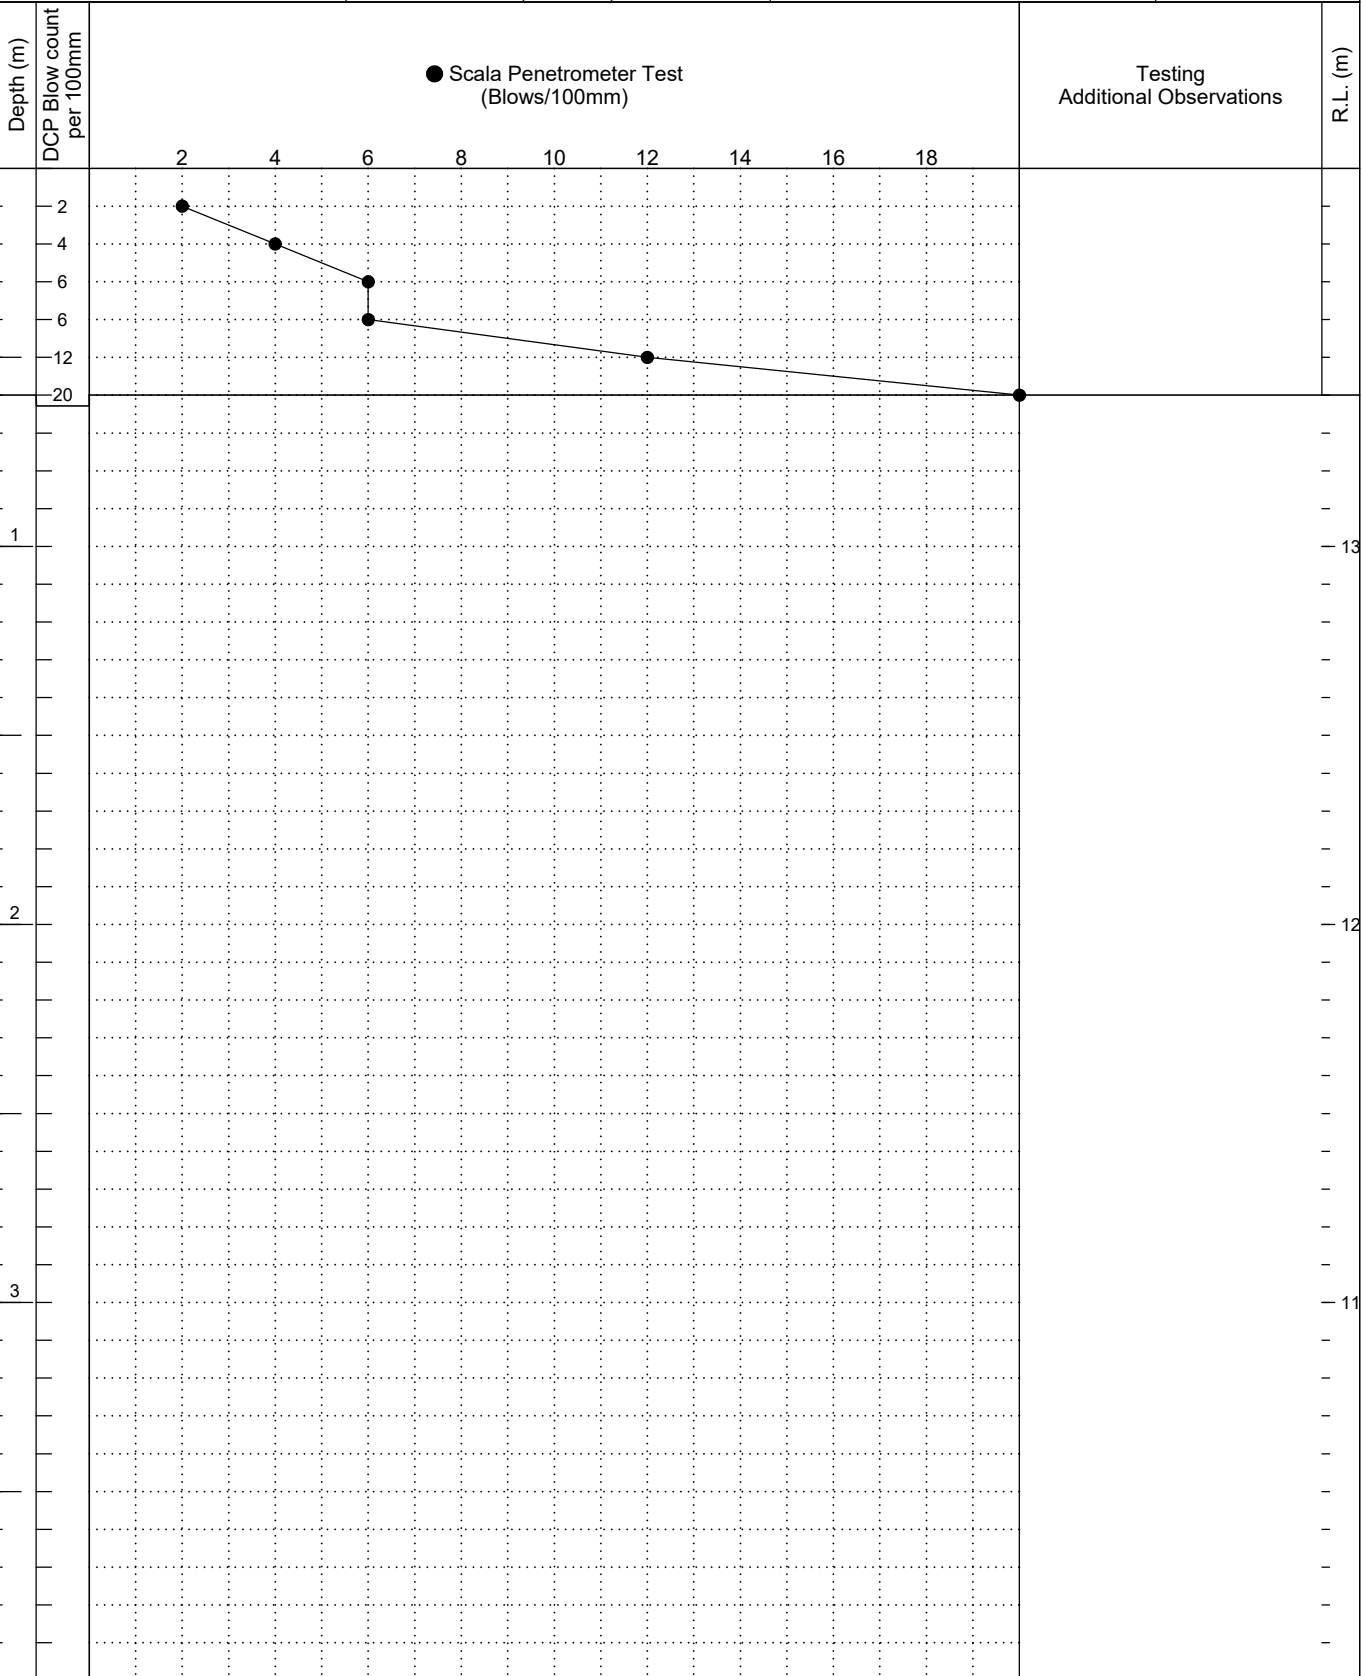
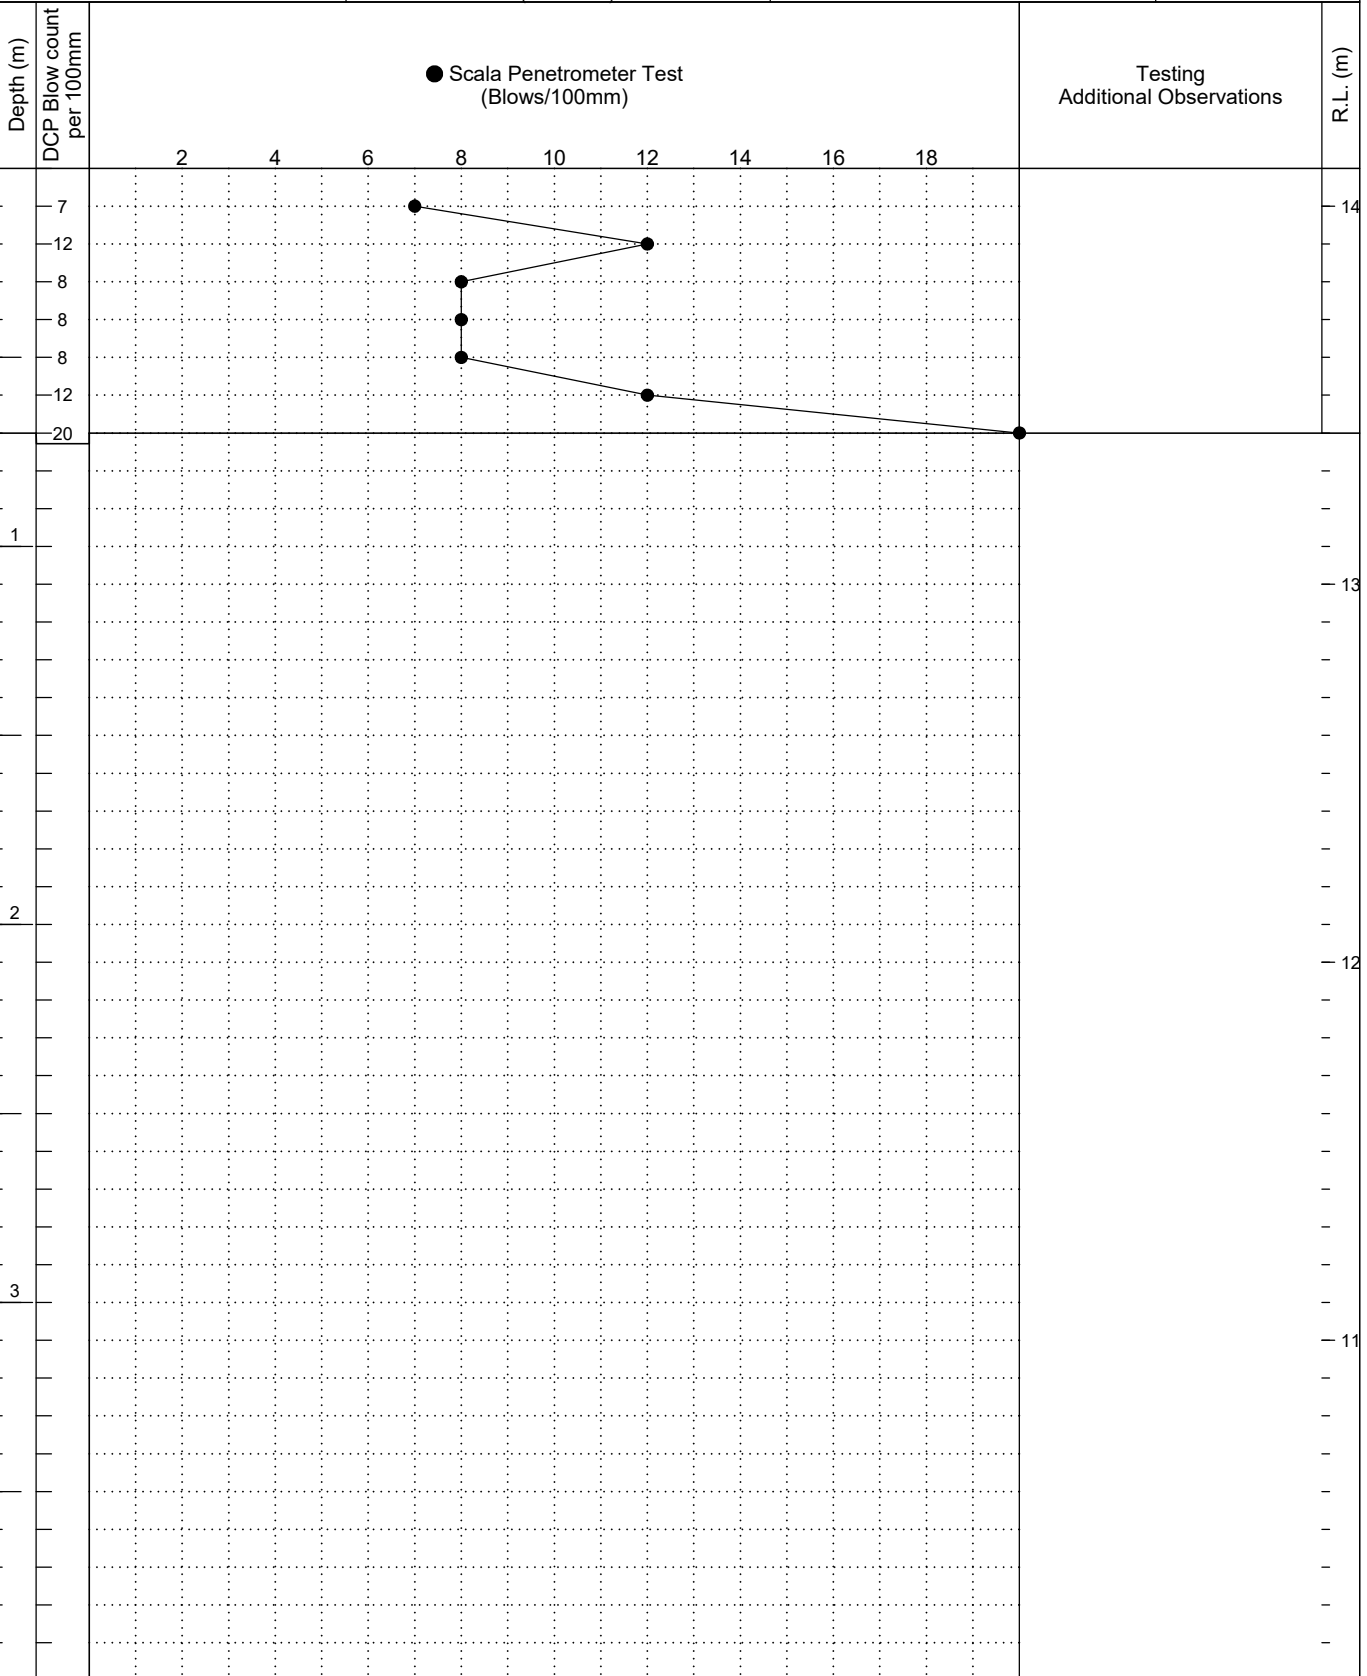
Two DCPs were carried out with the locations and results uploaded to the NZGD. The DCP test results are attached in Appendix B. One of the DCPs was located adjacent to the hand auger borehole, with the second DCP located on the opposite half of the lot.

DCP logs indicate 5 blows per 100mm penetration, which is equivalent to an ultimate bearing capacity of 300kPa, was consistently encountered from shallow depths.

It is recommended that residential structures that are built on Lot 247 are founded on standard NZS3604:2011 compliant foundations. These foundations require a minimum geotechnical ultimate bearing capacity of at least 300kPa. The site investigation results indicate that approximately 400mm of topsoil was present, which will need to be removed and the clean subgrade exposed for foundation construction.

Based on our understanding of the site works and the investigation results, we recommend that NZS3604:2011 compliant foundations are embedded a minimum depth of 0.4m below current ground level.
