Prestons Park Subdivision
GEOTECHNICAL REPORT FOR LOT 293
CDL Land NZ Limited

8 April 2024 Revision: 0 Reference: 235361

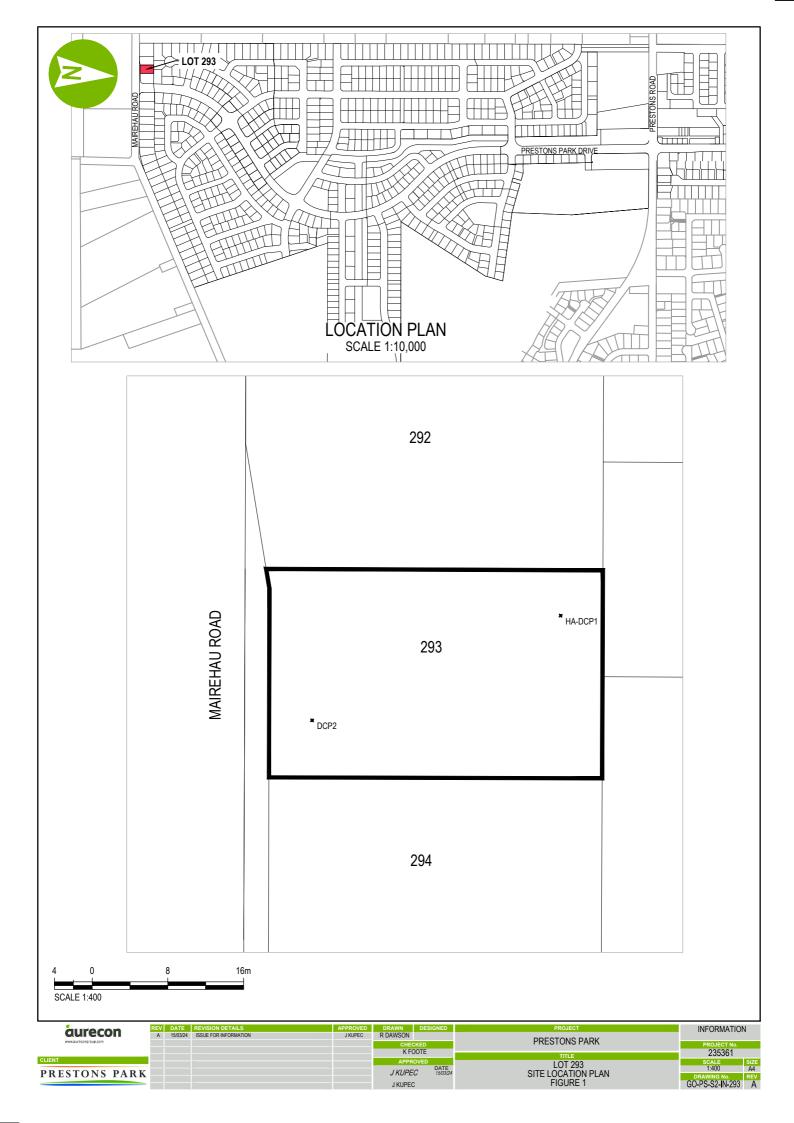
This building consent report is for Lot 293 which is located in Stage 2 of the Prestons Park Subdivision development (refer Figure 1 in Appendix A). The lot is bordered by residential lots to the north, east and Wairehau Road to the south.

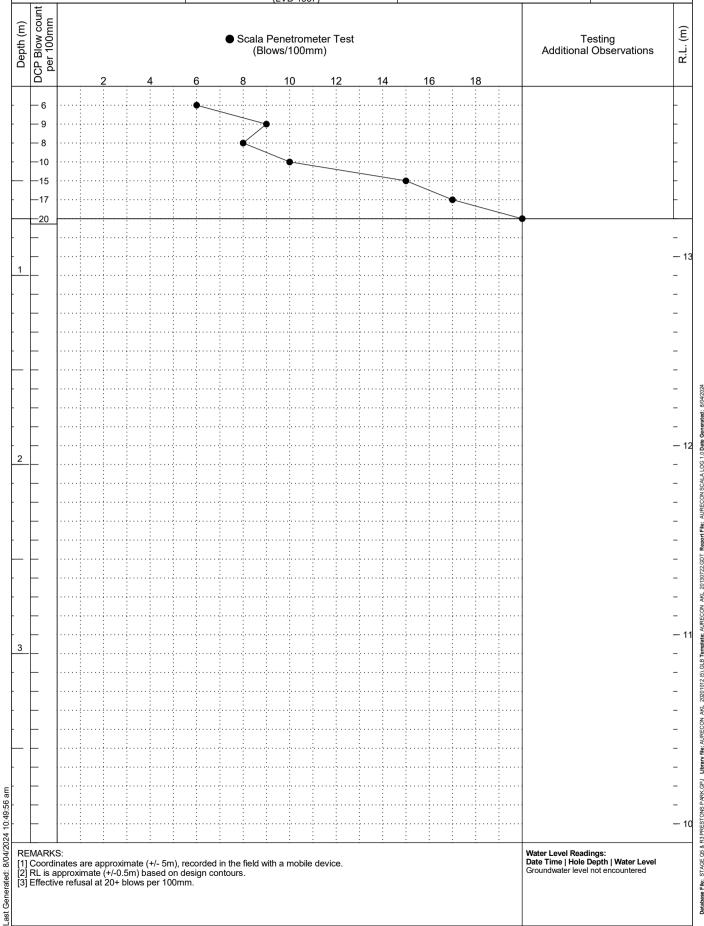
**Lot 293 DCP1**

DCP logs indicate 5 blows per 100mm penetration, which is equivalent to an ultimate bearing capacity of 300kPa, was consistently encountered from shallow depths.

[1] Coordinates are approximate (+/- 5m), recorded in the field with a mobile device.
[2] RL is approximate (+/-0.5m) based on design contours.
[3] Effective refusal at 20+ blows per 100mm.

Based on our understanding of the site works and the investigation results, we recommend that NZS3604:2011 compliant foundations are embedded a minimum depth of 0.45m below current ground level.

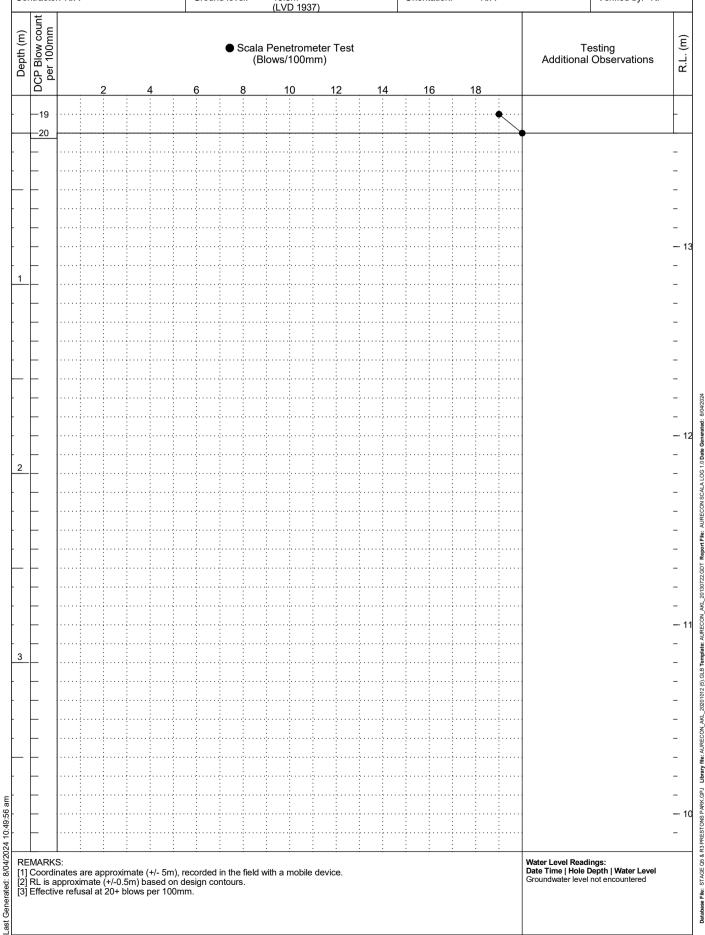
**Lot 293 DCP2**

[1] Coordinates are approximate (+/- 5m), recorded in the field with a mobile device.
[2] RL is approximate (+/-0.5m) based on design contours.
[3] Effective refusal at 20+ blows per 100mm.
