Prestons Park Subdivision
GEOTECHNICAL REPORT FOR LOT 931
CDL Land NZ Limited

8 October 2024
Revision: 0
Reference: 235361

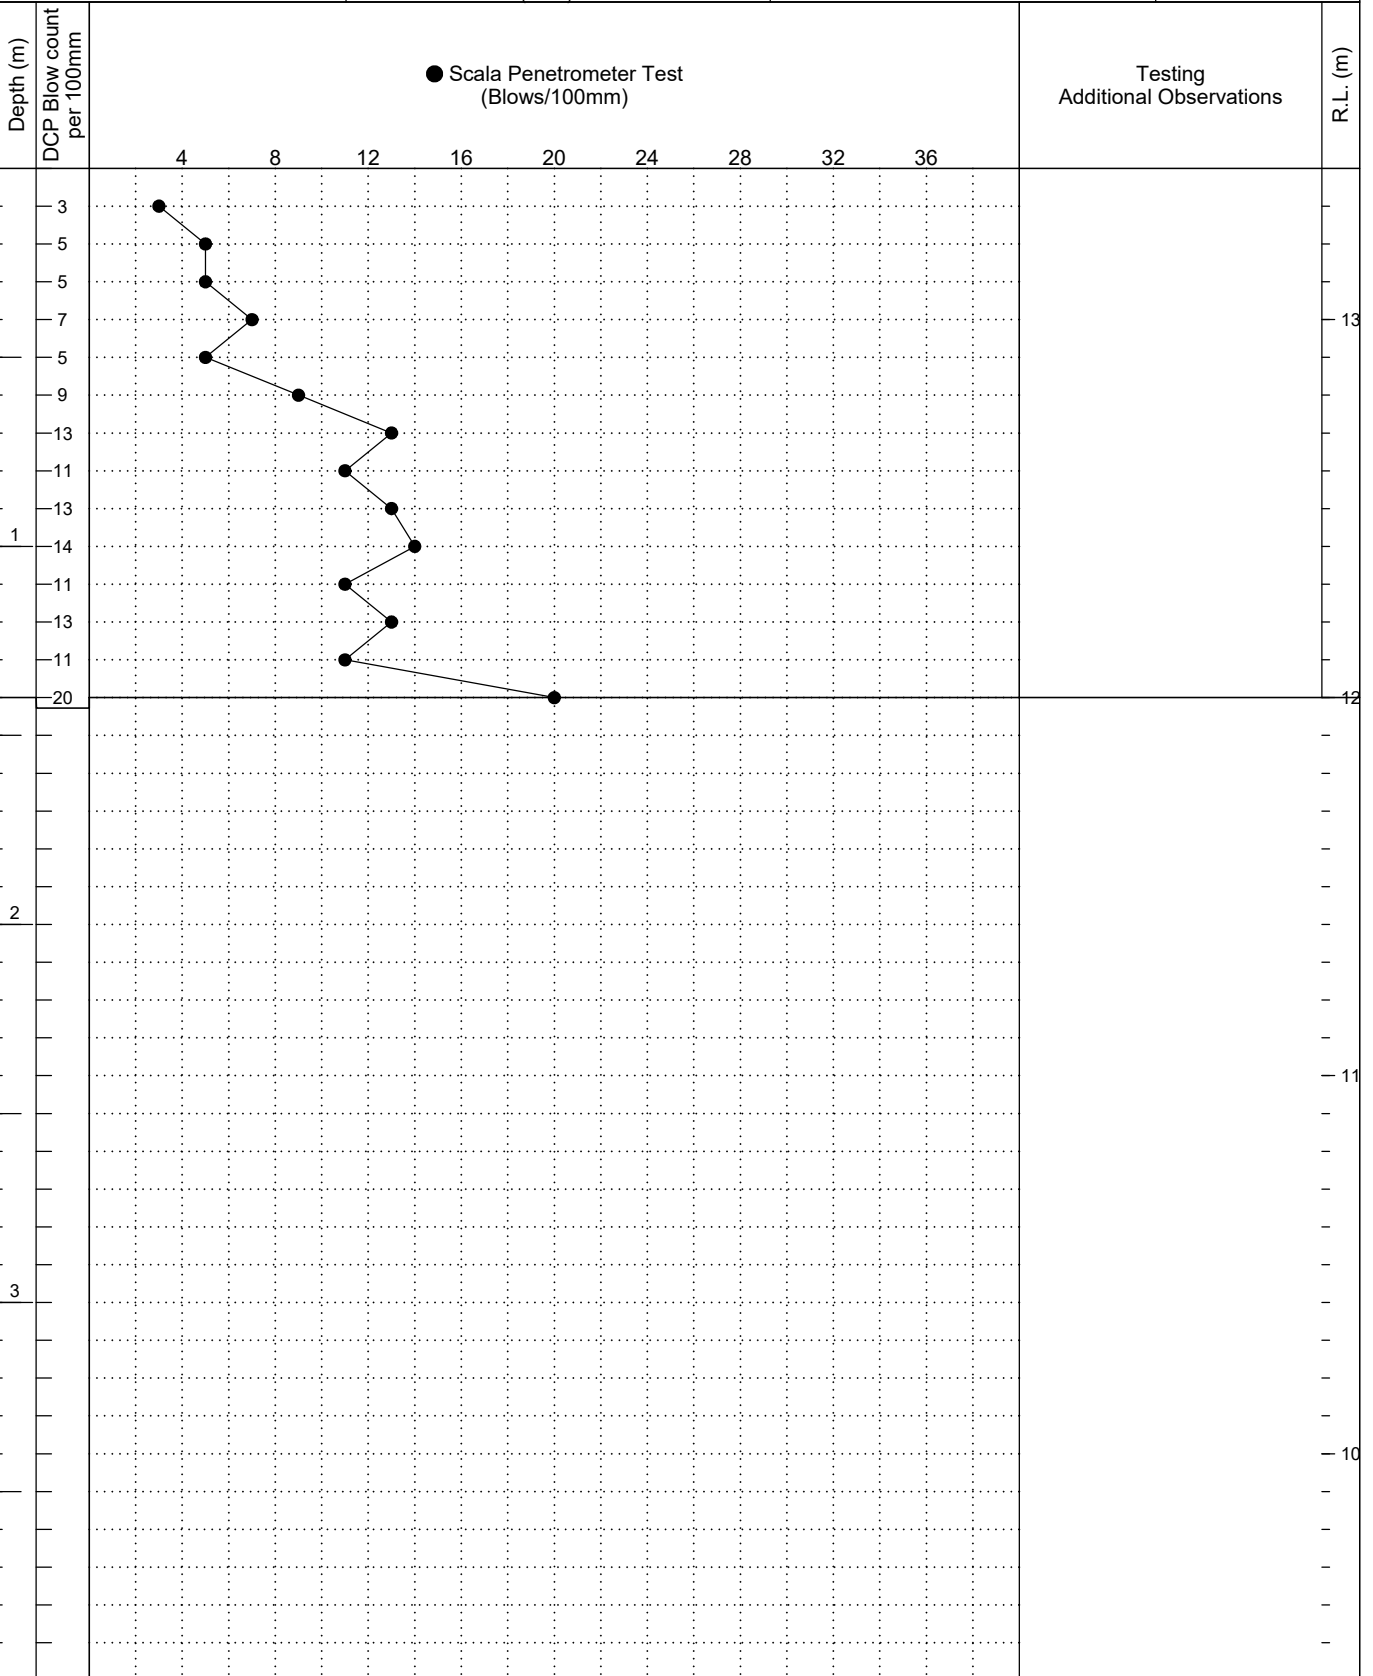
Two DCPs were carried out with the locations and results uploaded to the NZGD. The DCP test results are attached in Appendix B. One of the DCPs was located adjacent to the hand auger borehole, with the second DCP located on the opposite half of the lot.

DCP logs indicate 2 blows per 100mm penetration, which is equivalent to an ultimate bearing capacity of 200kPa, was consistently encountered from a depth of 0.1m.
