Prestons Park Subdivision
GEOTECHNICAL REPORT FOR LOT 935
CDL Land NZ Limited

8 October 2024
Revision: 0
Reference: 235361

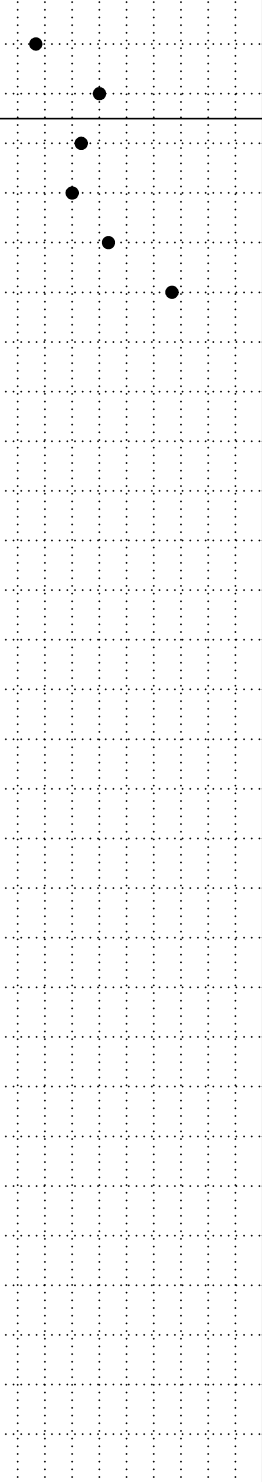
The hand auger borehole was terminated when soil samples became too dense to auger. The hand auger borehole indicates ground conditions comprise topsoil underlain by gravel.

0m: Sandy SILT with minor gravel and rootlets; dark brown. Moist; sand, fine to coarse; gravel, fine to coarse, subrounded to subangular. [TOPSOIL]

Terminated at 0.25m (Effective refusal)				
1						12
2						11
						10

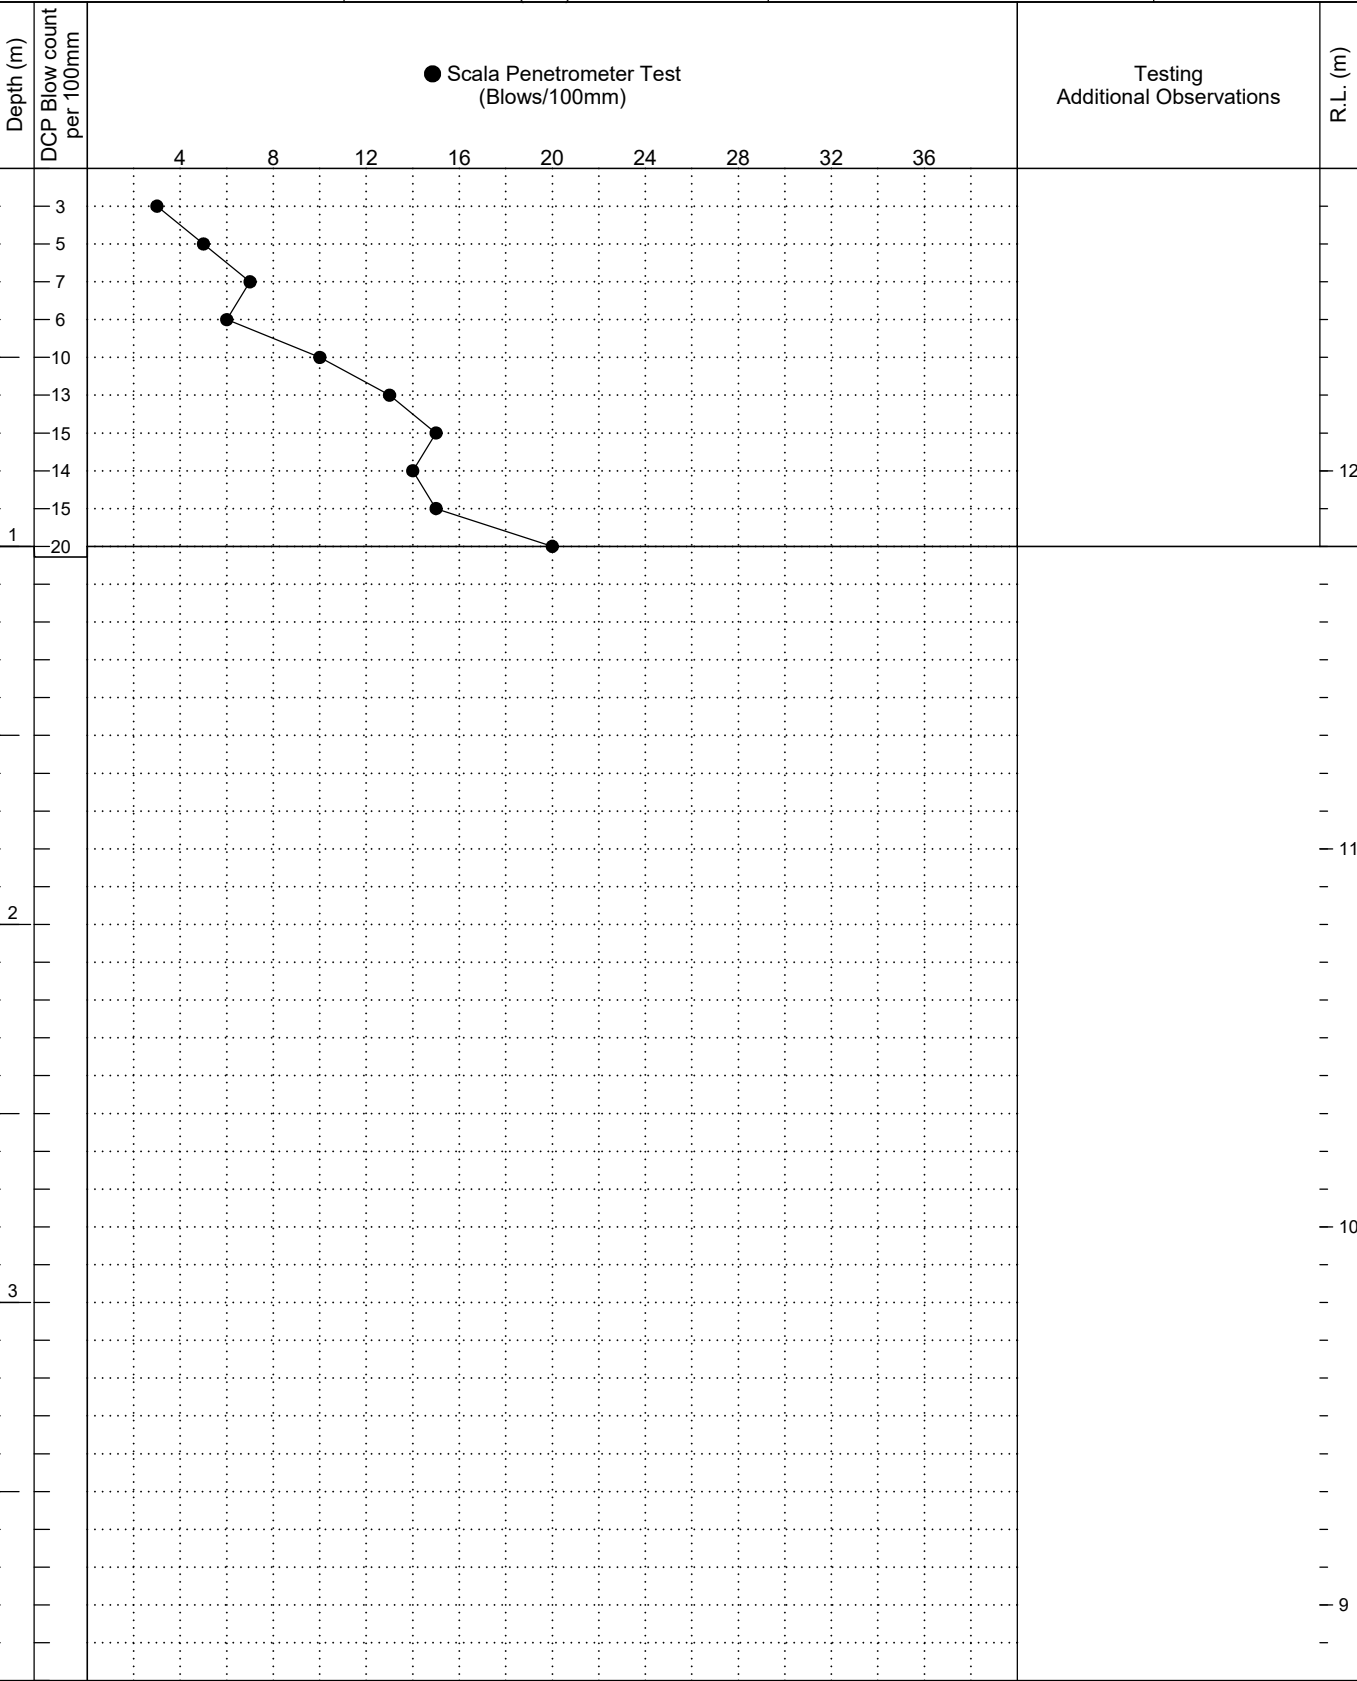
Lot 935 DCP2

DCP logs indicate 2 blows per 100mm penetration, which is equivalent to an ultimate bearing capacity of 200kPa, was consistently encountered from a depth of 0.1m.
