Prestons Park Subdivision
GEOTECHNICAL REPORT FOR LOT 313
CDL Land NZ Limited

26 July 2024 Revision: 0 Reference: 235361

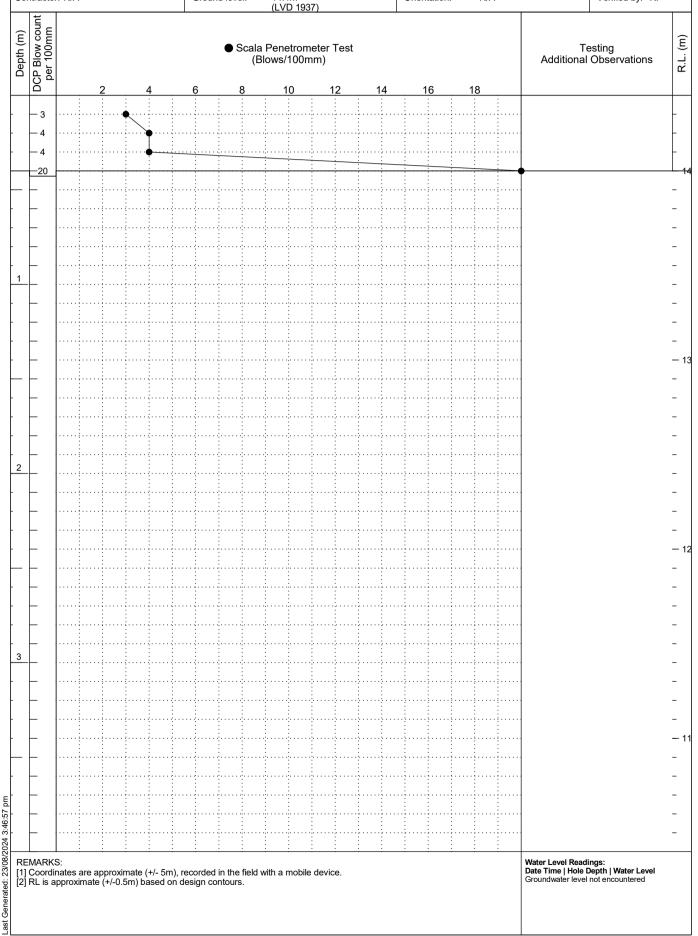
Lot 313 DCP2

DCP logs indicate 5 blows per 100mm penetration, which is equivalent to an ultimate bearing capacity of 300kPa, was consistently encountered from a depth of 0.4m.

Water Level Readings: Date Time | Hole Depth | Water Level Groundwater level not encountered
