Prestons Park Subdivision
GEOTECHNICAL REPORT FOR LOT 318
CDL Land NZ Limited

26 July 2024
Revision: 0
Reference: 235361

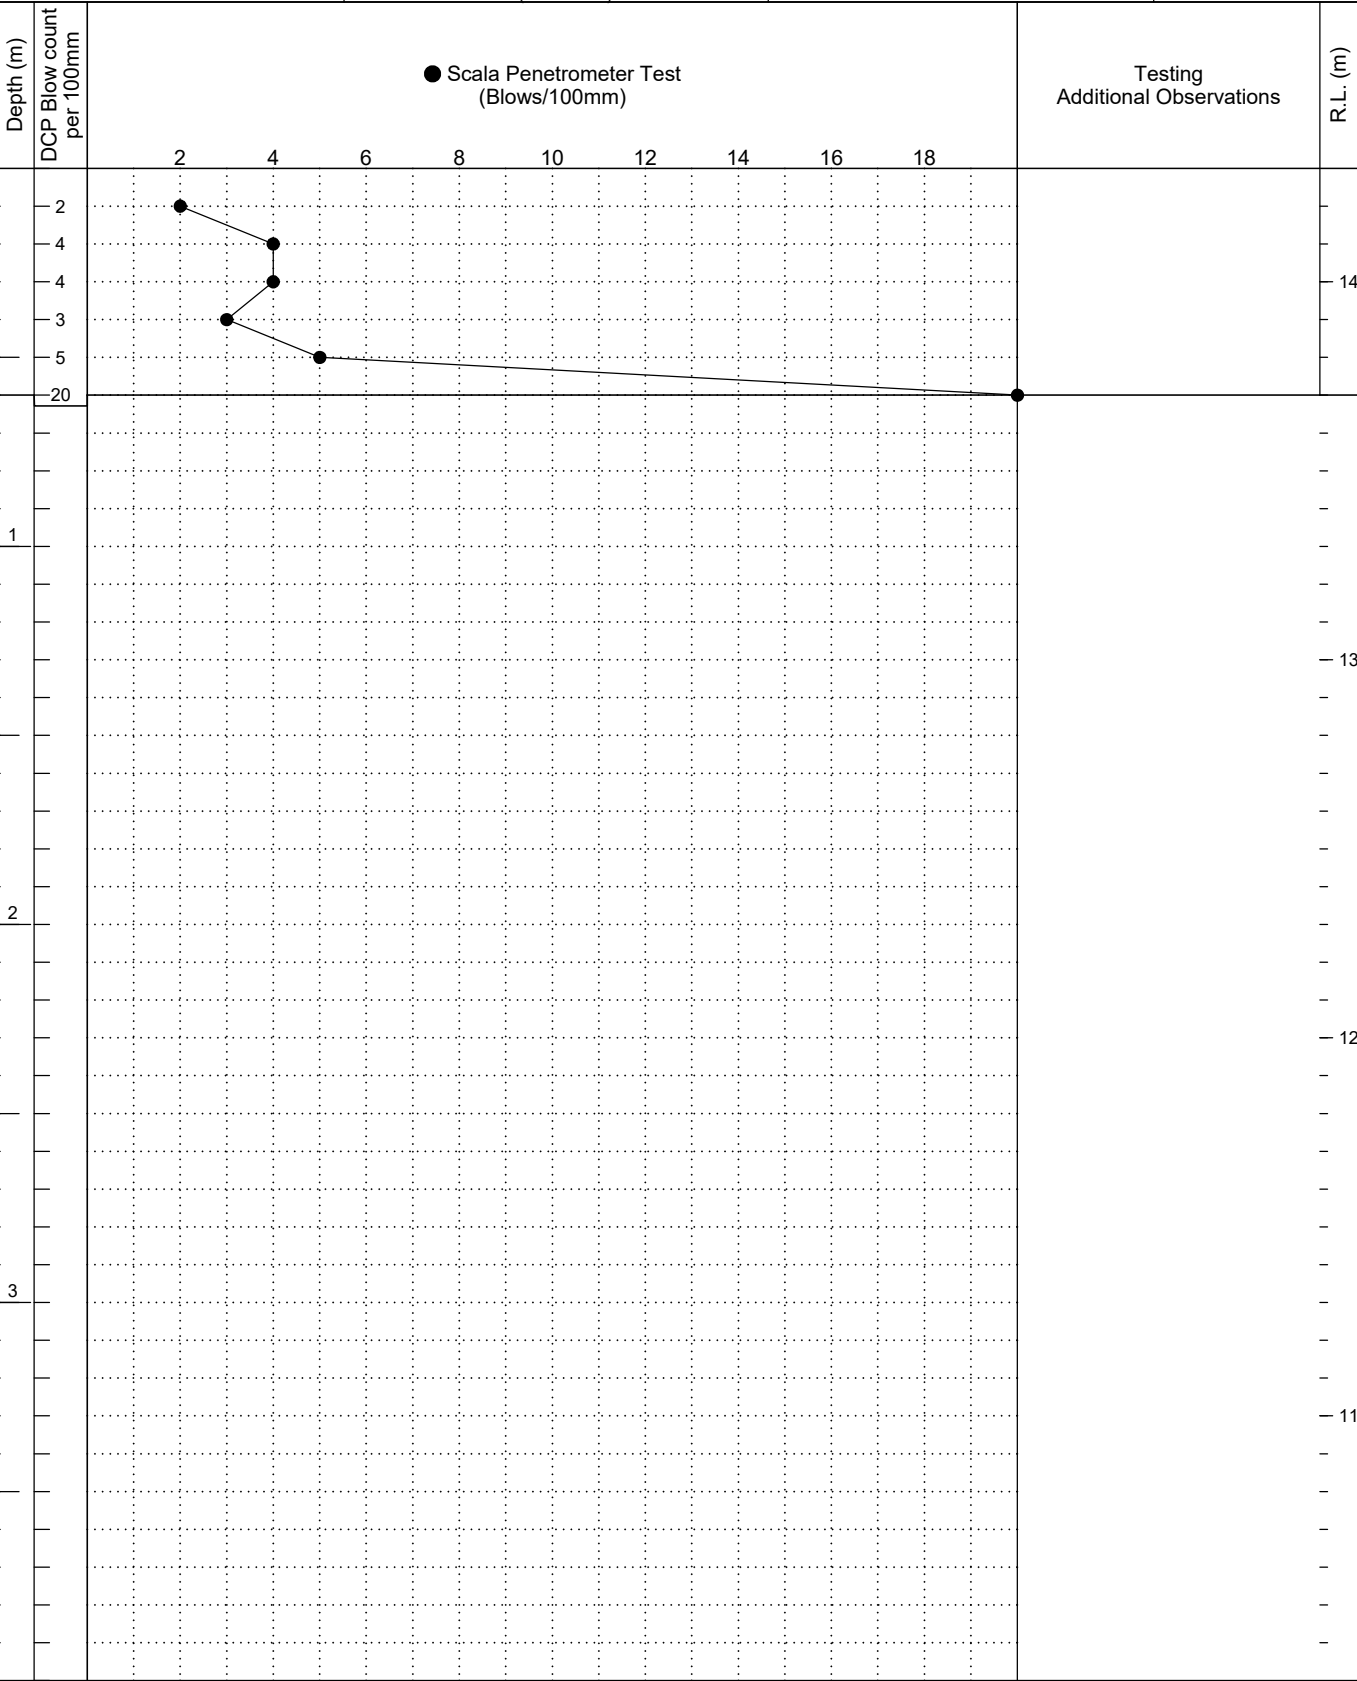
Lot 318 DCP2

DCP logs indicate 5 blows per 100mm penetration, which is equivalent to an ultimate bearing capacity of 300kPa, was consistently encountered from a depth of 0.5m.

Based on our understanding of the site works and the investigation results, we recommend that NZS3604:2011 compliant foundations are embedded a minimum depth of 0.5m below current ground level.
