Prestons Park Subdivision
GEOTECHNICAL REPORT FOR LOT 782
CDL Land NZ Limited

5 August 2024 Revision: 0 Reference: 235361

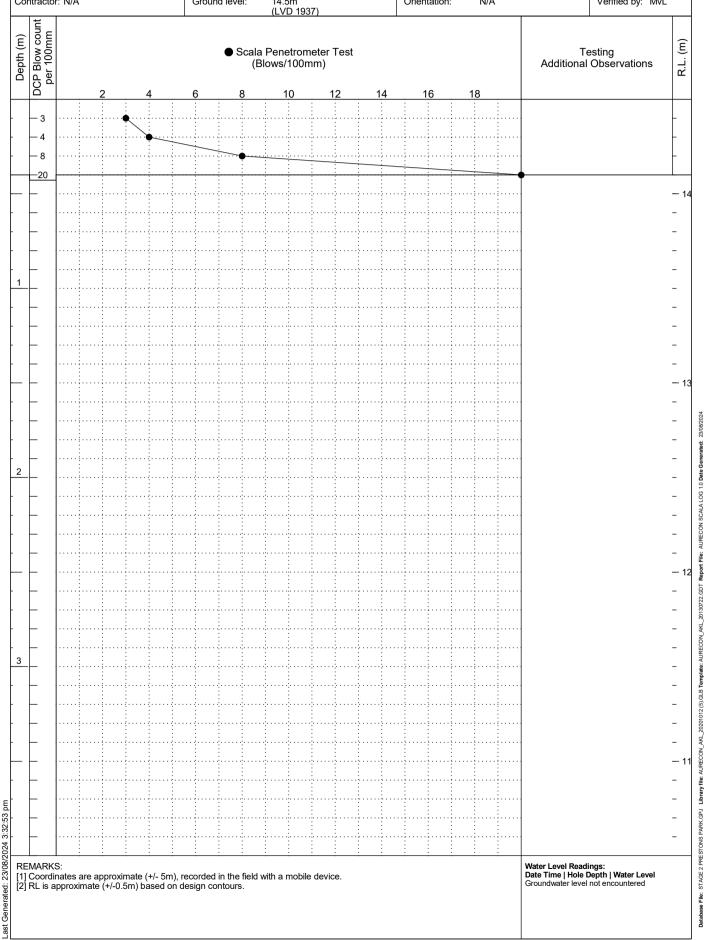
Project: Prestons Park Subdivision Location: Prestons Park, Christchurch **Lot 782 DCP2**

DCP logs indicate 5 blows per 100mm penetration, which is equivalent to an ultimate bearing capacity of 300kPa, was consistently encountered from a depth of 0.3m.

Water Level Readings: Date Time | Hole Depth | Water Level Groundwater level not encountered
