**Prestons Park Subdivision**  
**GEOTECHNICAL REPORT FOR LOT 380**  
**CDL Land NZ Limited**

**25 September 2024**  
**Revision: 0**  
**Reference: 235361**

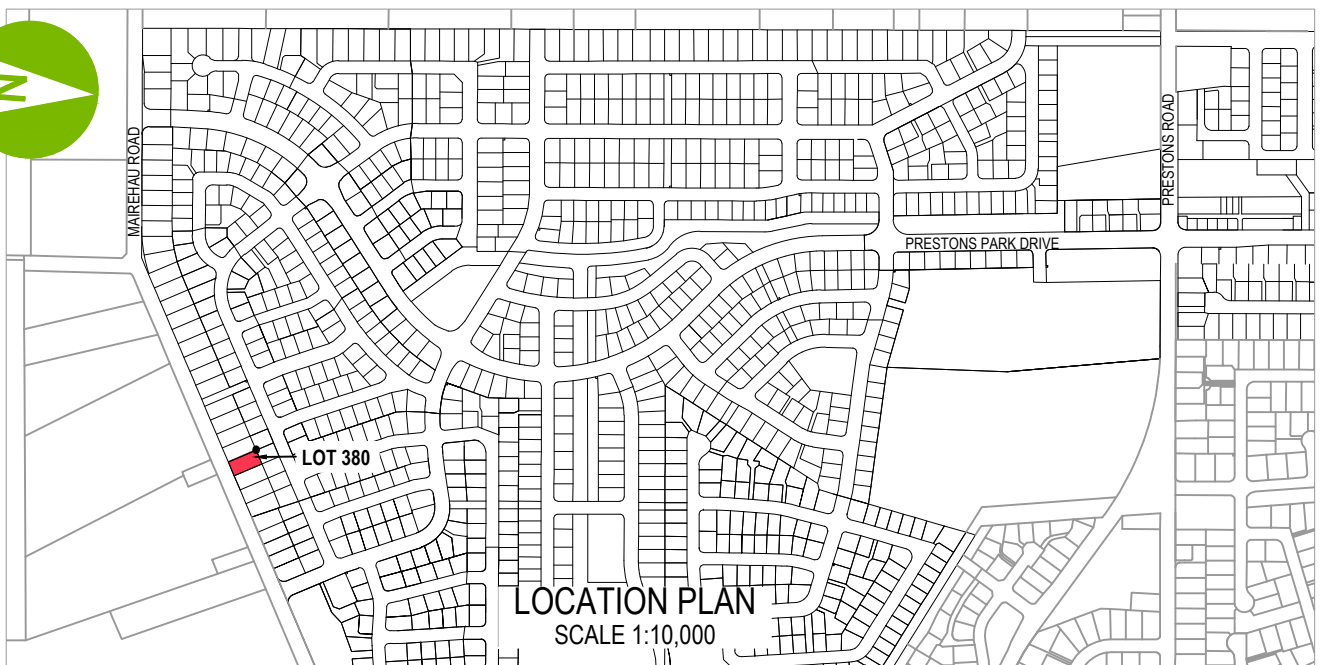
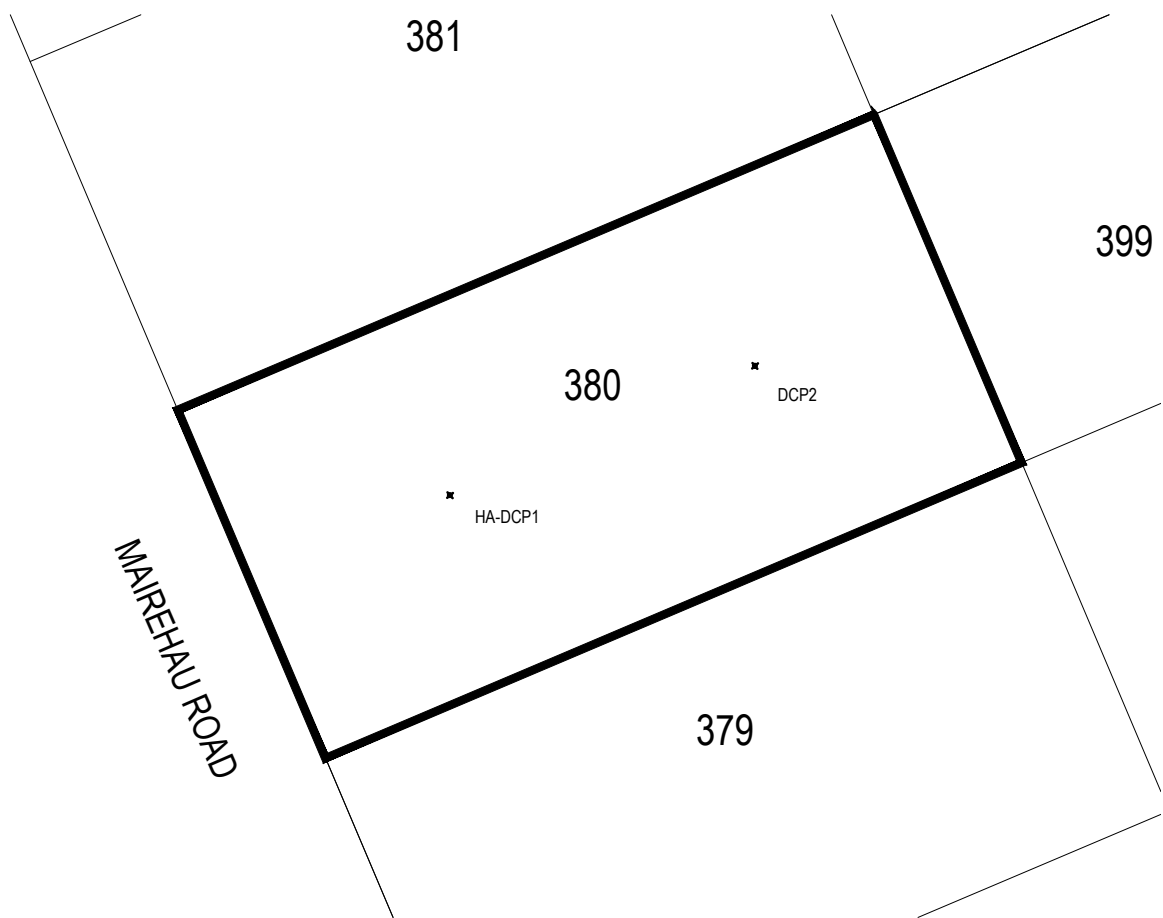
PROJECT	
PRESTONS PARK	
TITLE	
LOT 380	
SITE LOCATION PLAN	
FIGURE 1

This building consent report is for Lot 380 which is located in Stage 2 of the Prestons Park Subdivision development (refer Figure 1 in Appendix A). The lot is bordered by residential lots to the north, west and east and Mairehau Road to the south.

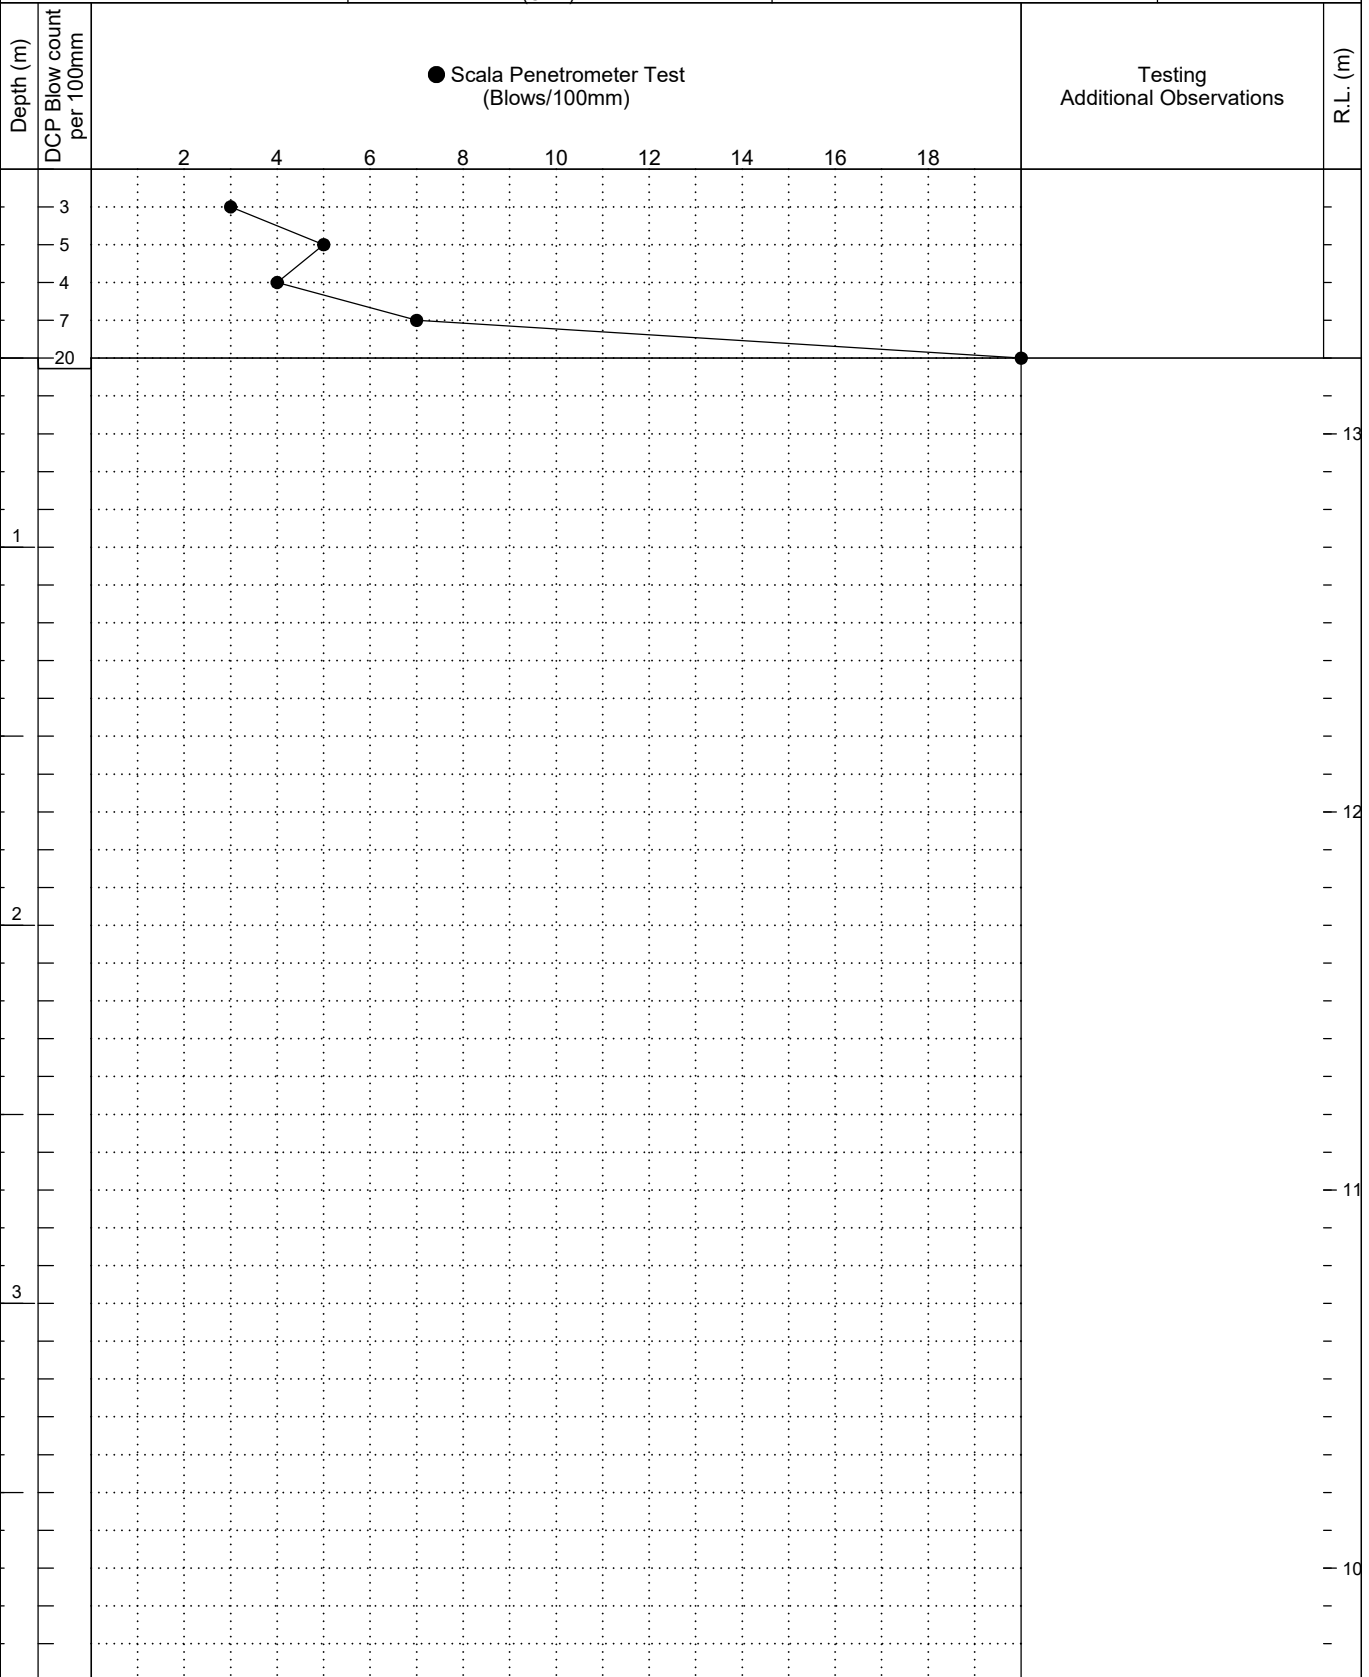
Two DCPs were carried out with the locations and results uploaded to the NZGD. The DCP test results are attached in Appendix B. One of the DCPs was located adjacent to the hand auger borehole, with the second DCP located on the opposite half of the lot.

DCP logs indicate 5 blows per 100mm penetration, which is equivalent to an ultimate bearing capacity of 300kPa, was consistently encountered from a depth of 0.2m.

Based on our understanding of the site works and the investigation results, we recommend that NZS3604:2011 compliant foundations are embedded a minimum depth of 0.4m below current ground level.
