Prestons Park Subdivision
GEOTECHNICAL REPORT FOR LOT 385
CDL Land NZ Limited

26 August 2024 Revision: 0 Reference: 235361

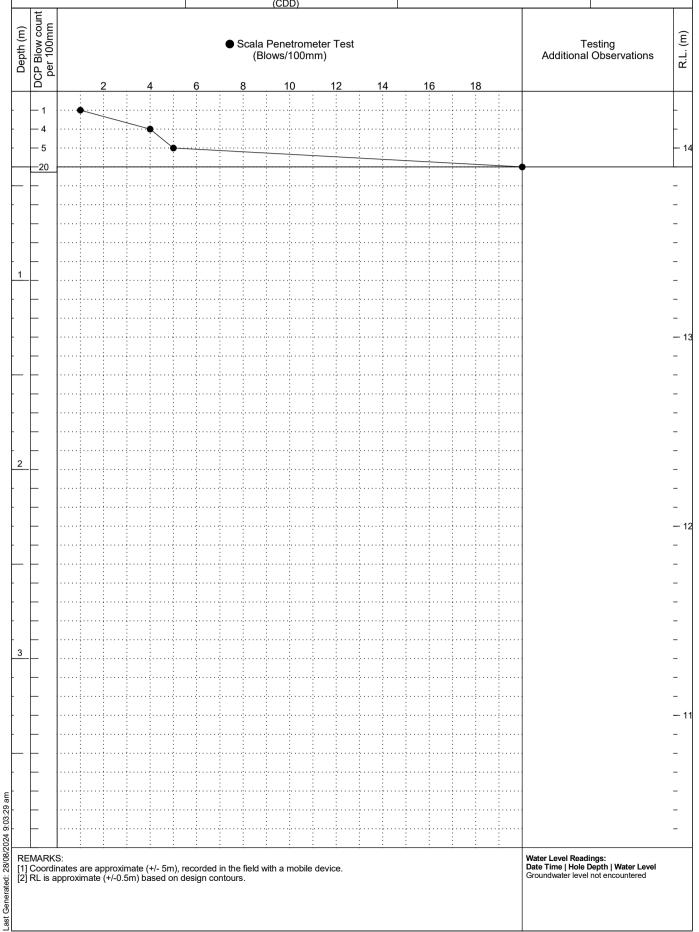
**Lot 385 DCP2**

DCP logs indicate 5 blows per 100mm penetration, which is equivalent to an ultimate bearing capacity of 300kPa, was consistently encountered from a depth of 0.4m.

Water Level Readings: Date Time | Hole Depth | Water Level Groundwater level not encountered

Based on our understanding of the site works and the investigation results, we recommend that NZS3604:2011 compliant foundations are embedded a minimum depth of 0.4m below current ground level.
