Prestons Park Subdivision
GEOTECHNICAL REPORT FOR LOT 388
CDL Land NZ Limited

26 August 2024
Revision: 0
Reference: 235361

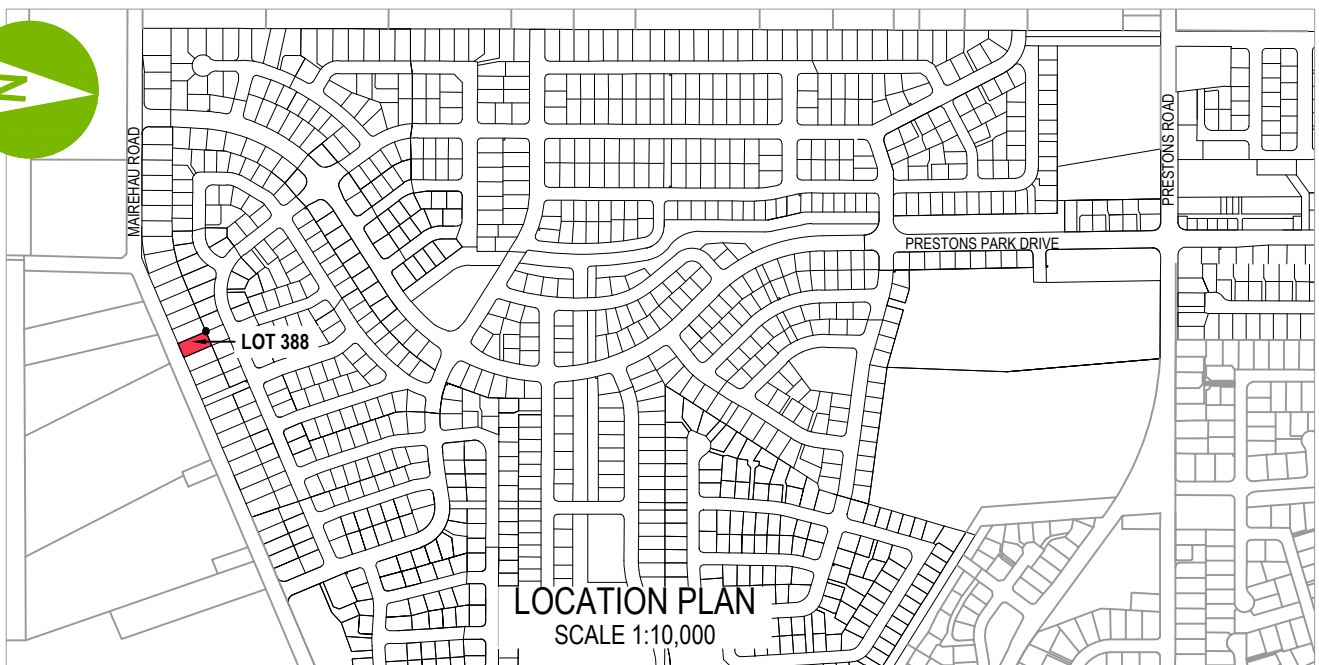
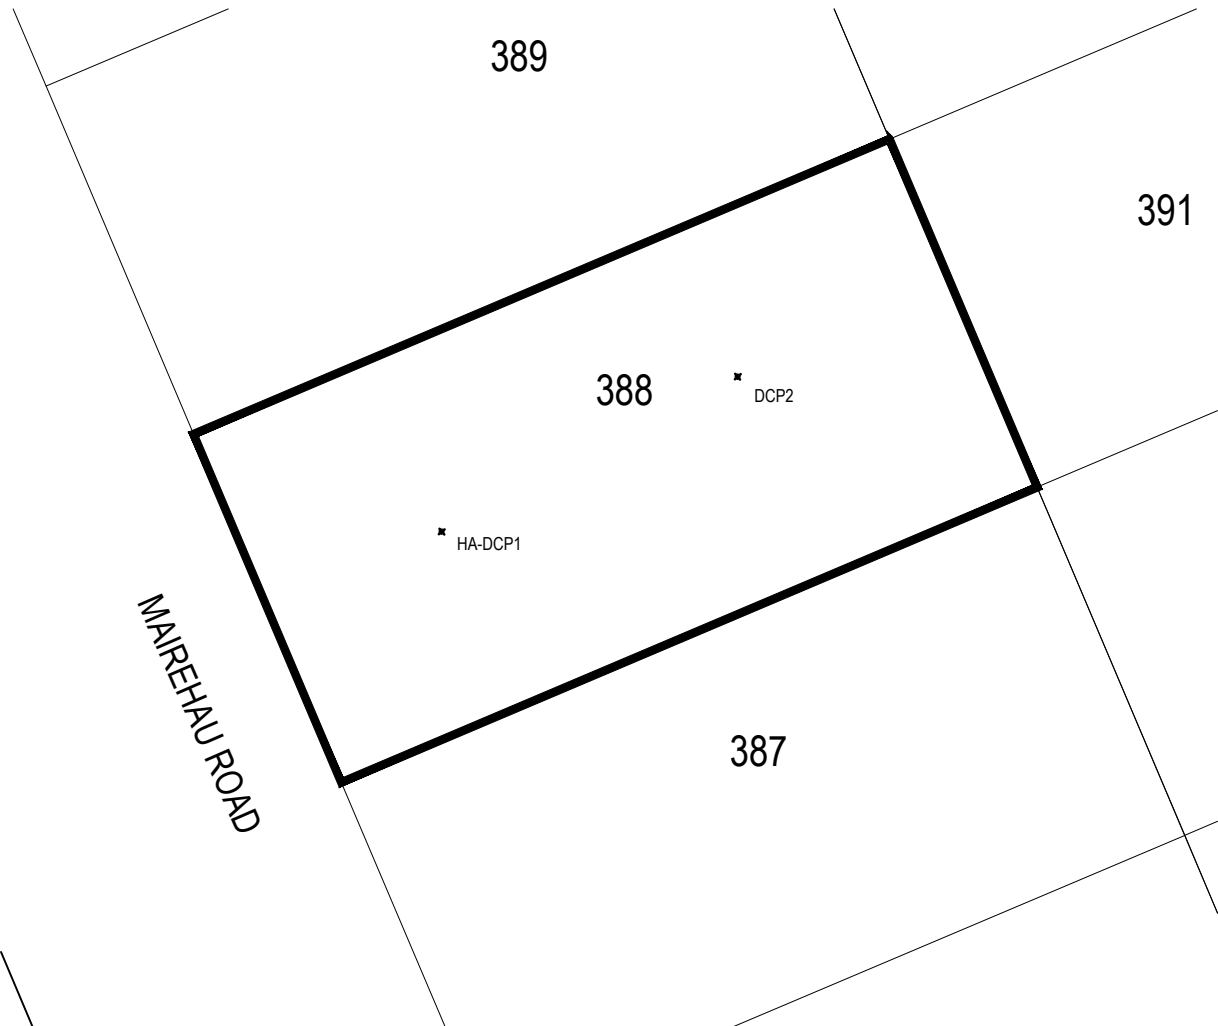
TITLE
**LOT 388
SITE LOCATION PLAN
FIGURE 1**

This building consent report is for Lot 388 which is located in Stage 2 of the Prestons Park Subdivision development (refer Figure 1 in Appendix A). The lot is bordered by residential lots to the north, west and east and Mairehau Road to the south.

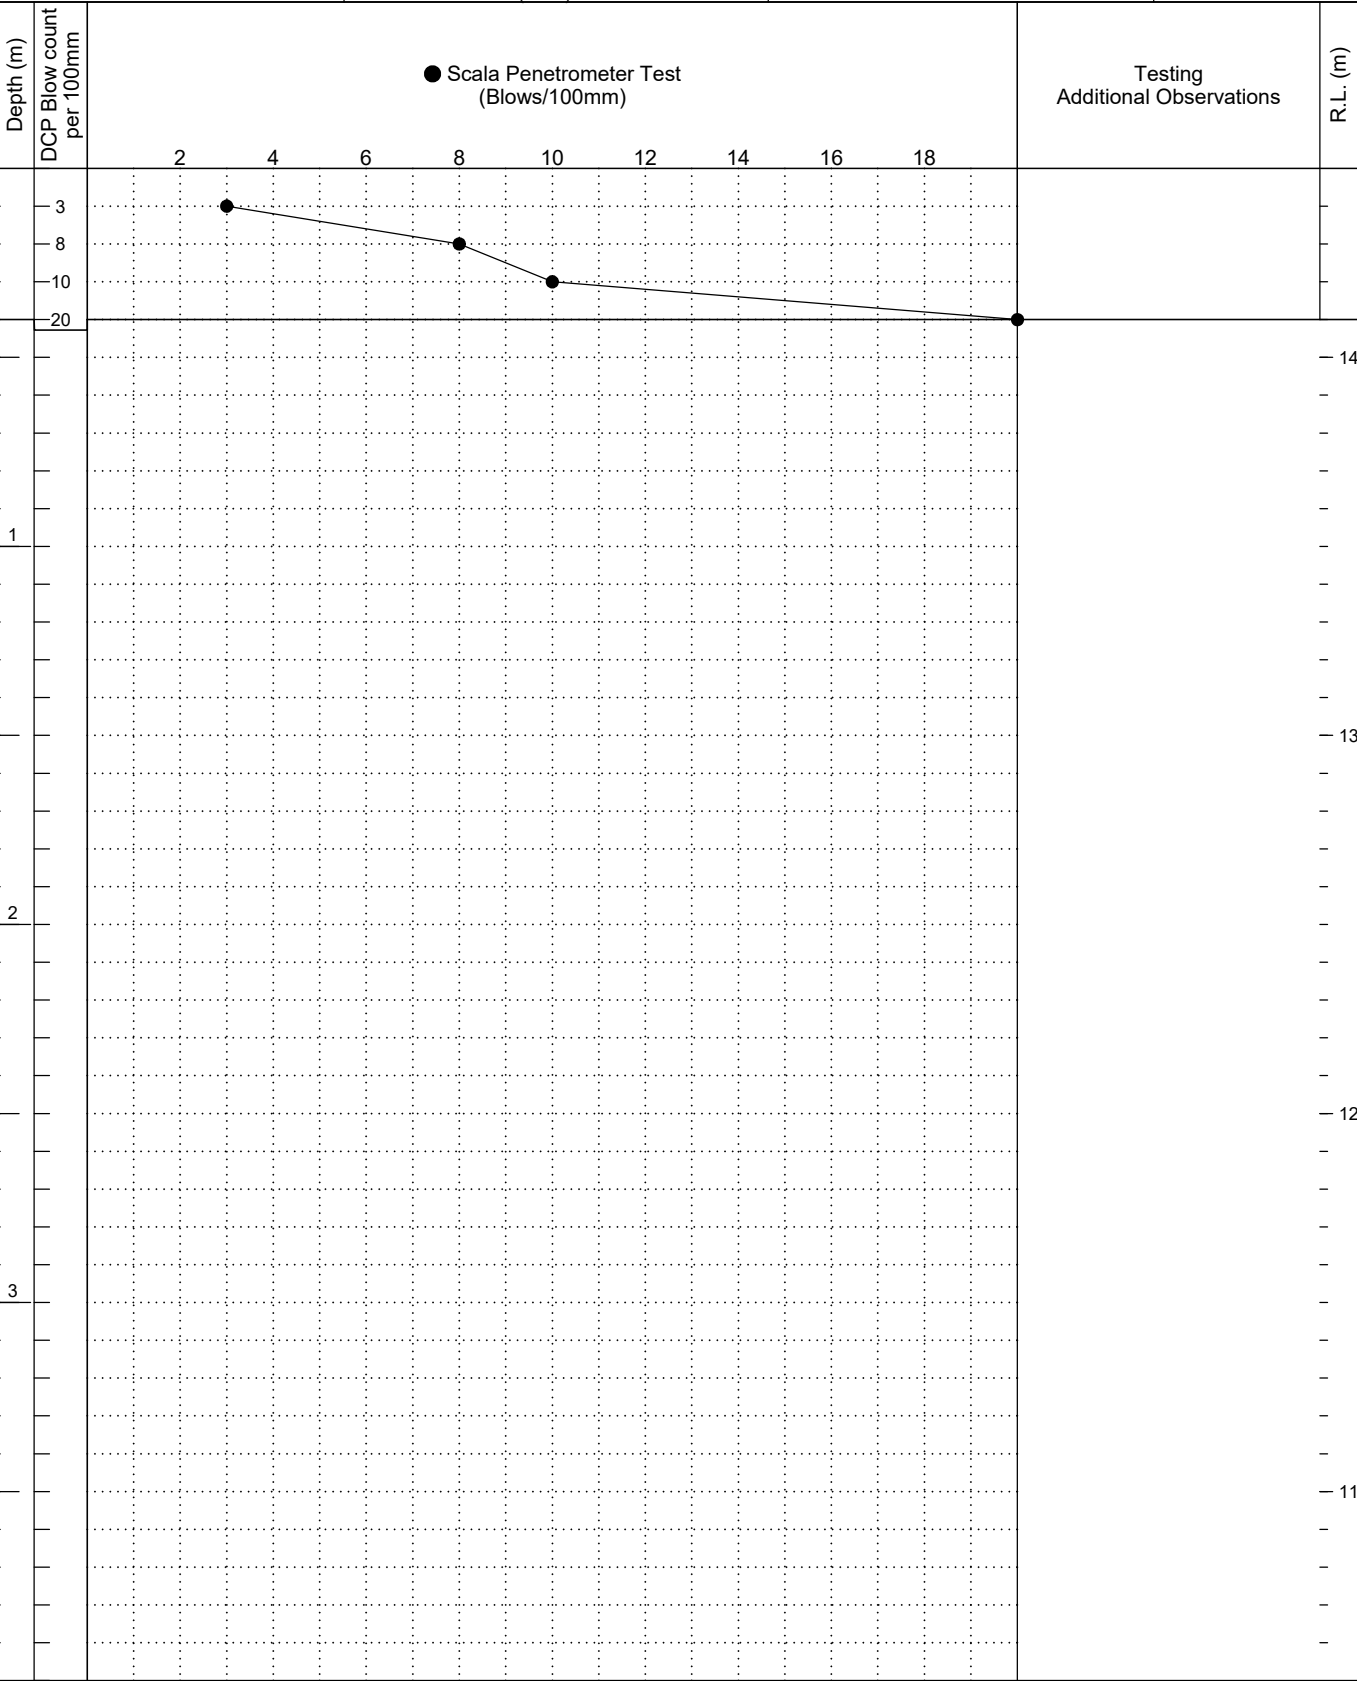
Lot 388 DCP2

DCP logs indicate 5 blows per 100mm penetration, which is equivalent to an ultimate bearing capacity of 300kPa, was consistently encountered from a depth of 0.2m.

Based on our understanding of the site works and the investigation results, we recommend that NZS3604:2011 compliant foundations are embedded a minimum depth of 0.25m below current ground level.
