Prestons Park Subdivision
GEOTECHNICAL REPORT FOR LOT 389
CDL Land NZ Limited

26 August 2024
Revision: 0
Reference: 235361

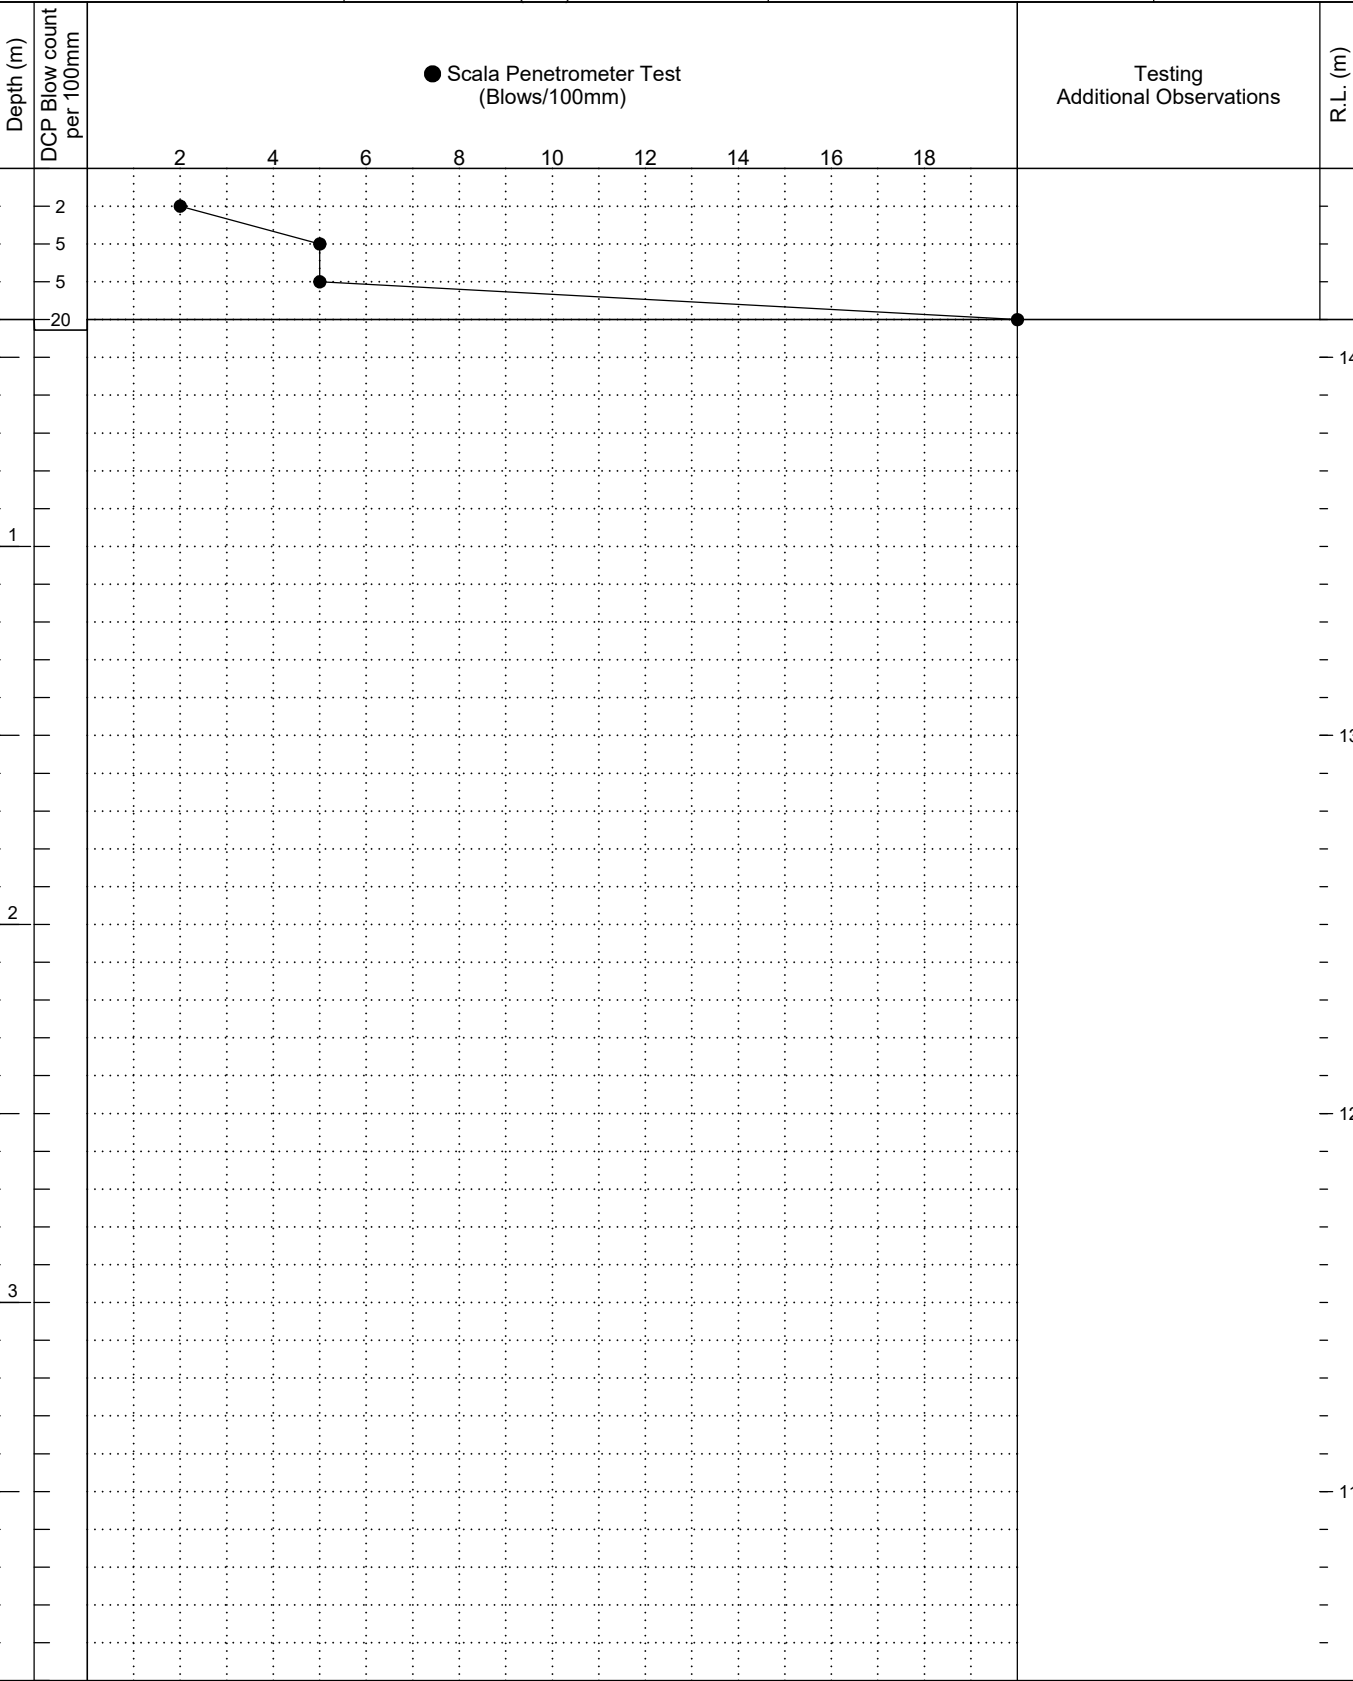
Lot 389 DCP2

DCP logs indicate 5 blows per 100mm penetration, which is equivalent to an ultimate bearing capacity of 300kPa, was consistently encountered from a depth of 0.2m.

Based on our understanding of the site works and the investigation results, we recommend that NZS3604:2011 compliant foundations are embedded a minimum depth of 0.3m below current ground level.
