**Prestons Park Subdivision**  
**GEOTECHNICAL REPORT FOR LOT 1089**  
**CDL Land NZ Limited**

**16 September 2021**  
**Revision: 1**  
**Reference: 235361**

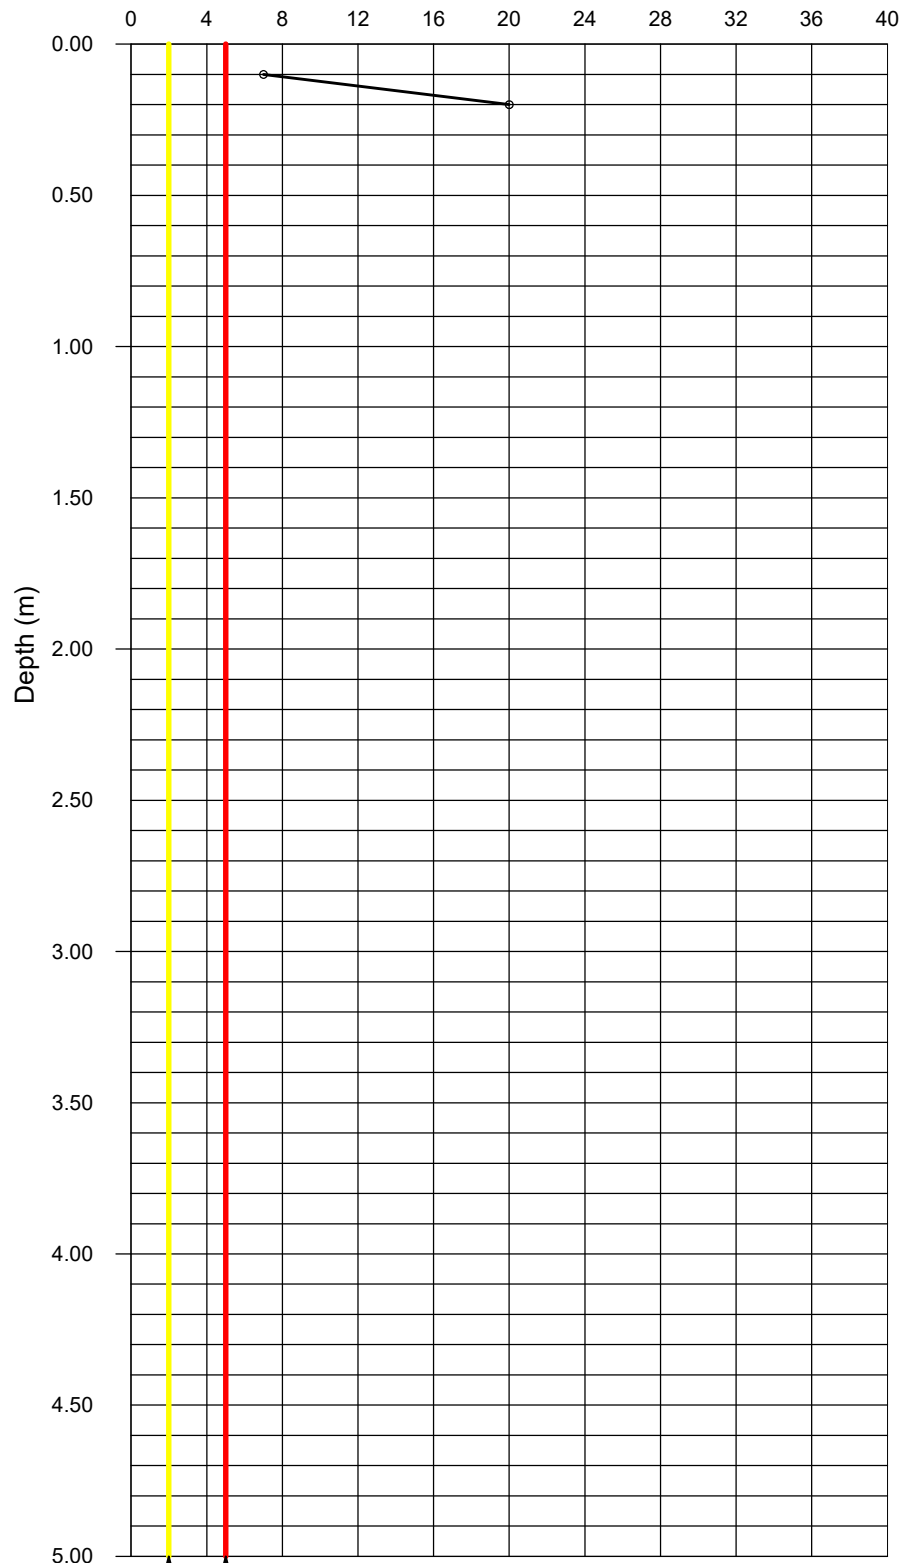
DCP logs indicate 5 blows per 100mm penetration, which is equivalent to an ultimate bearing capacity of 300kPa, was encountered from a shallow depth.

20 blows for 100mm in the last increment.  
Co-ordinates and elevation data from site survey.  
Elevation based on Christchurch Drainage Datum.  
Effective refusal, 20+ blows per 100mm

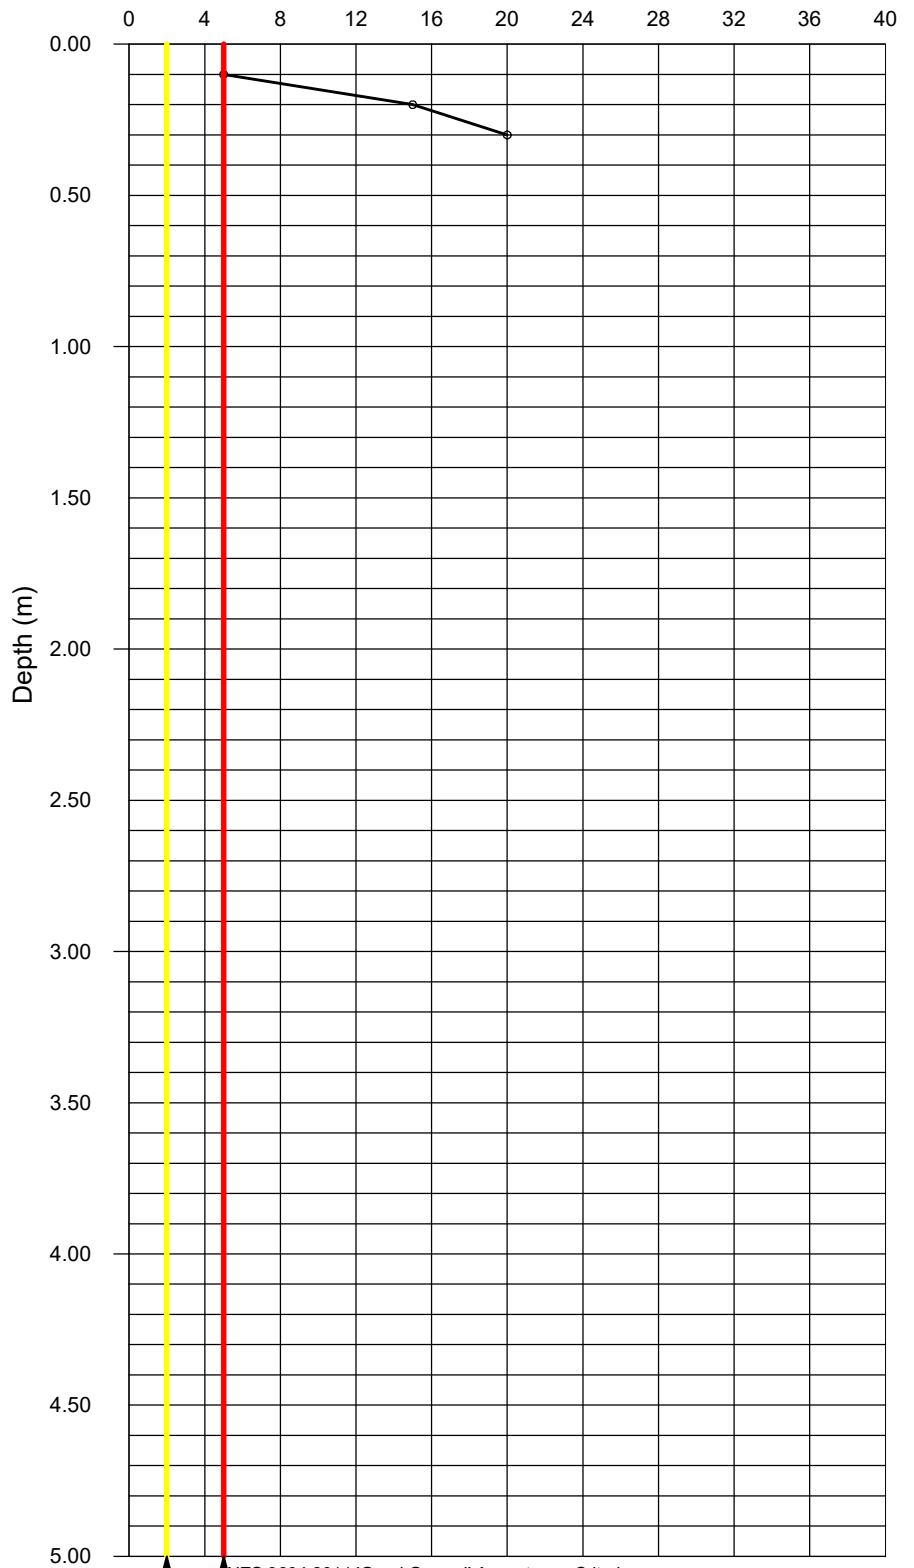
20 blows for 100mm in the last increment.  
Co-ordinates and elevation data from site survey.  
Elevation based on Christchurch Drainage Datum.  
Effective refusal, 20+ blows per 100mm
