Prestons Park Subdivision GEOTECHNICAL REPORT FOR LOT 1035 **CDL Land NZ Limited**

21 November 2022 Revision: 1 Reference: 235361

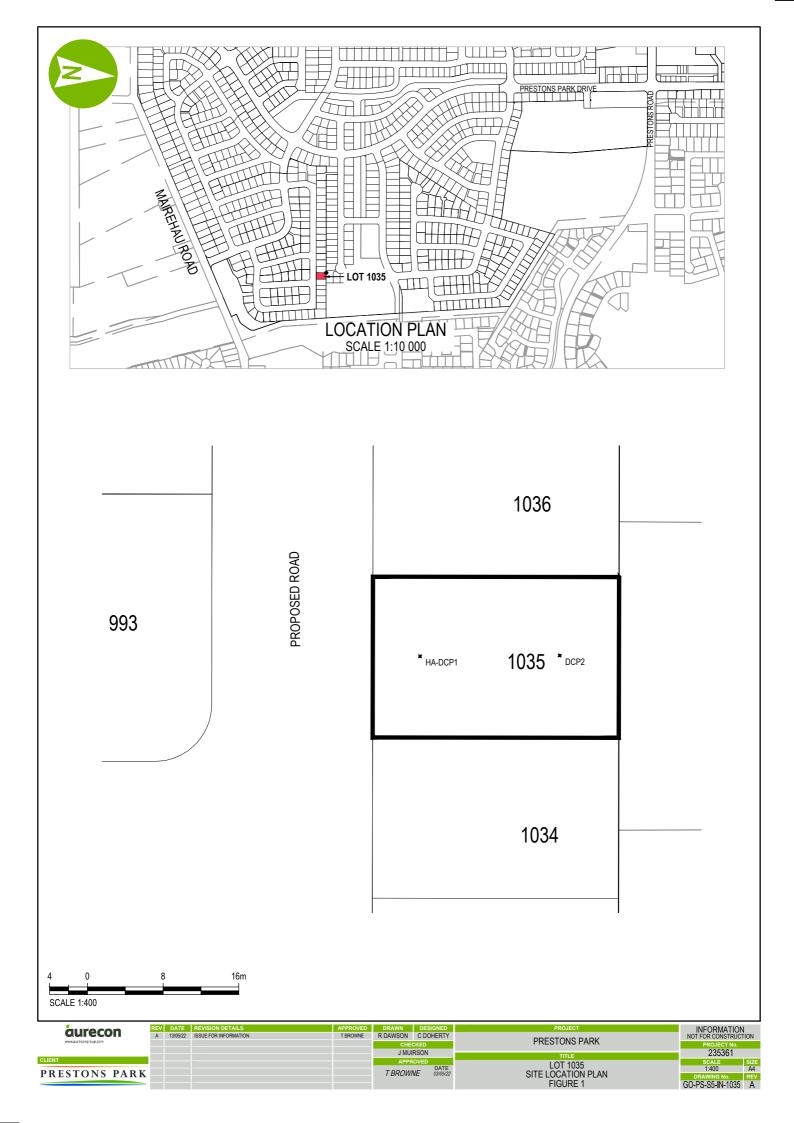
Appendix A Figures

This building consent report is for Lot 1035 which is located in Stage 5 of the Prestons Park Subdivision development (refer Figure 1 in Appendix A). The lot is bordered by residential lots to the north, east and west, with an access road to the south.

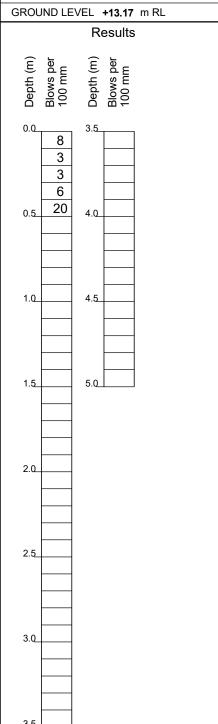
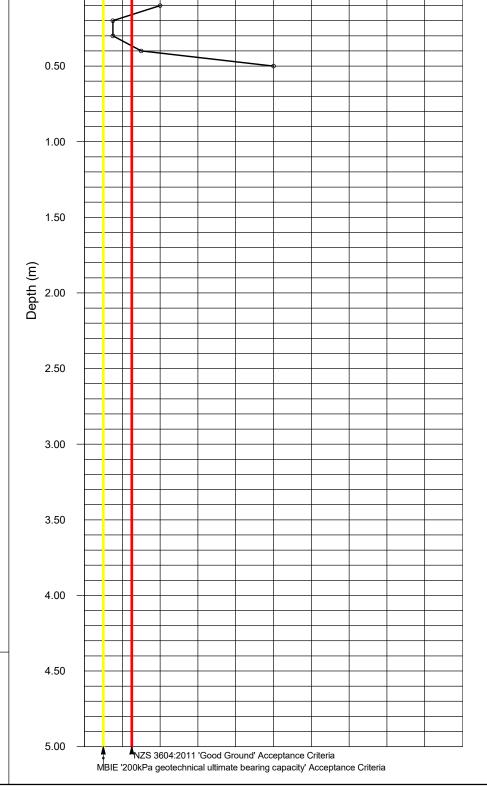
Lot 1035 - DCP1

DCP logs indicate two blows per 100mm penetration, which is equivalent to an ultimate bearing capacity of 200kPa, was consistently encountered from a shallow depth.

20 blows for 100mm in the last increment.

Effective refusal, 20+ blows per 100mm

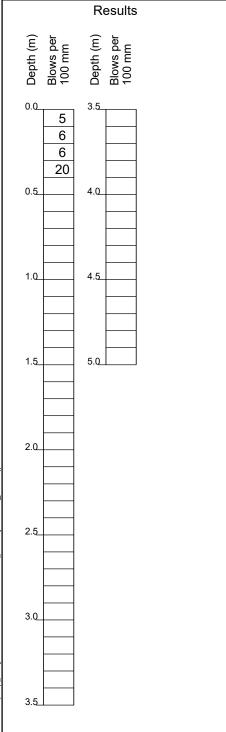
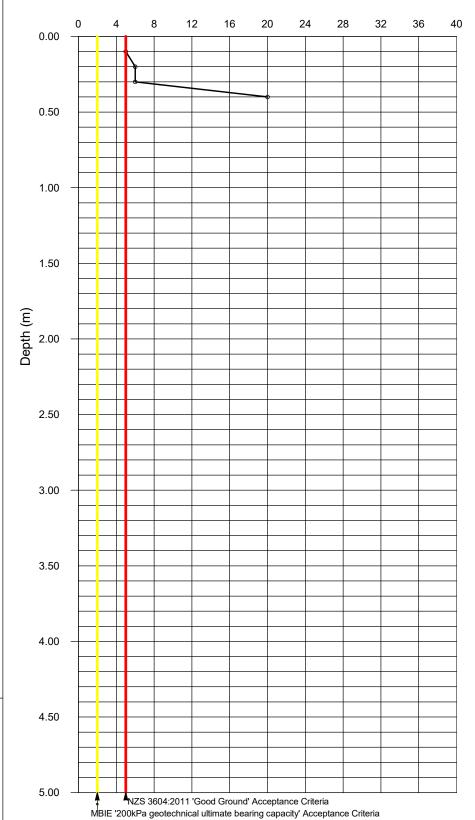
Lot 1035 - DCP2

20 blows for 100mm in the last increment.

Effective refusal, 20+ blows per 100mm
