**Prestons Park Subdivision**  
**GEOTECHNICAL REPORT FOR LOT 892**  
**CDL Land NZ Limited**

**23 April 2021**  
**Revision: 1**  
**Reference: 235361**

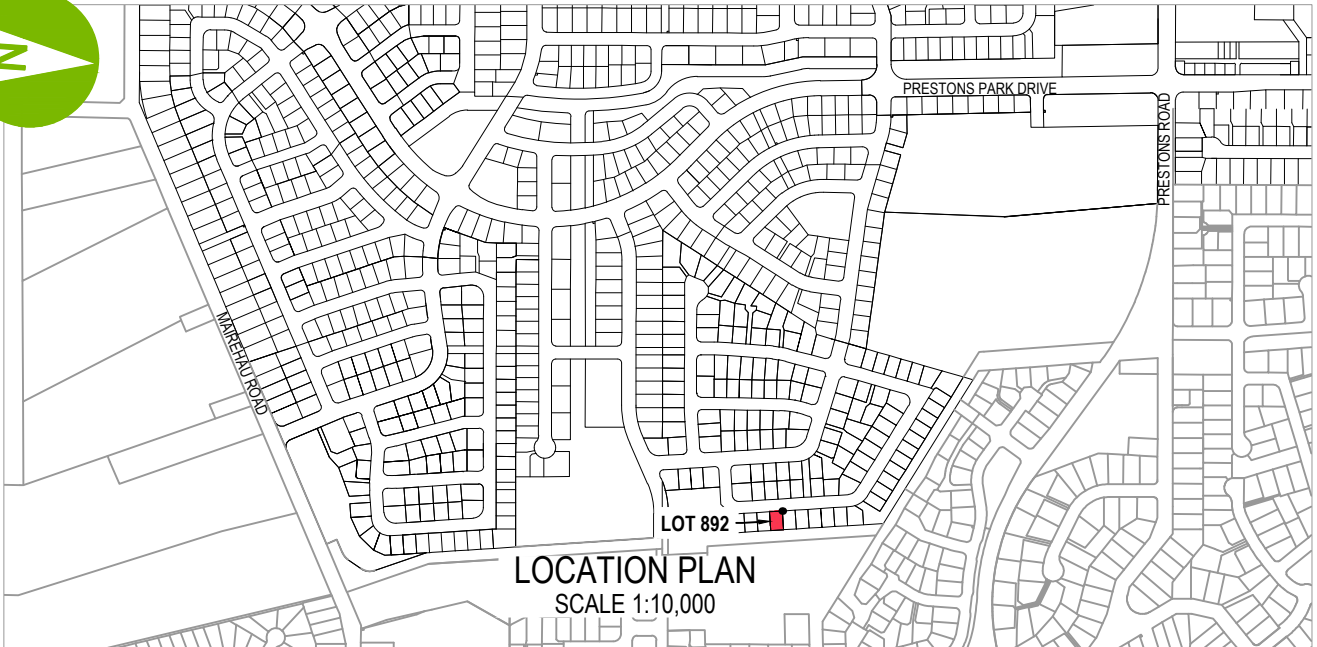
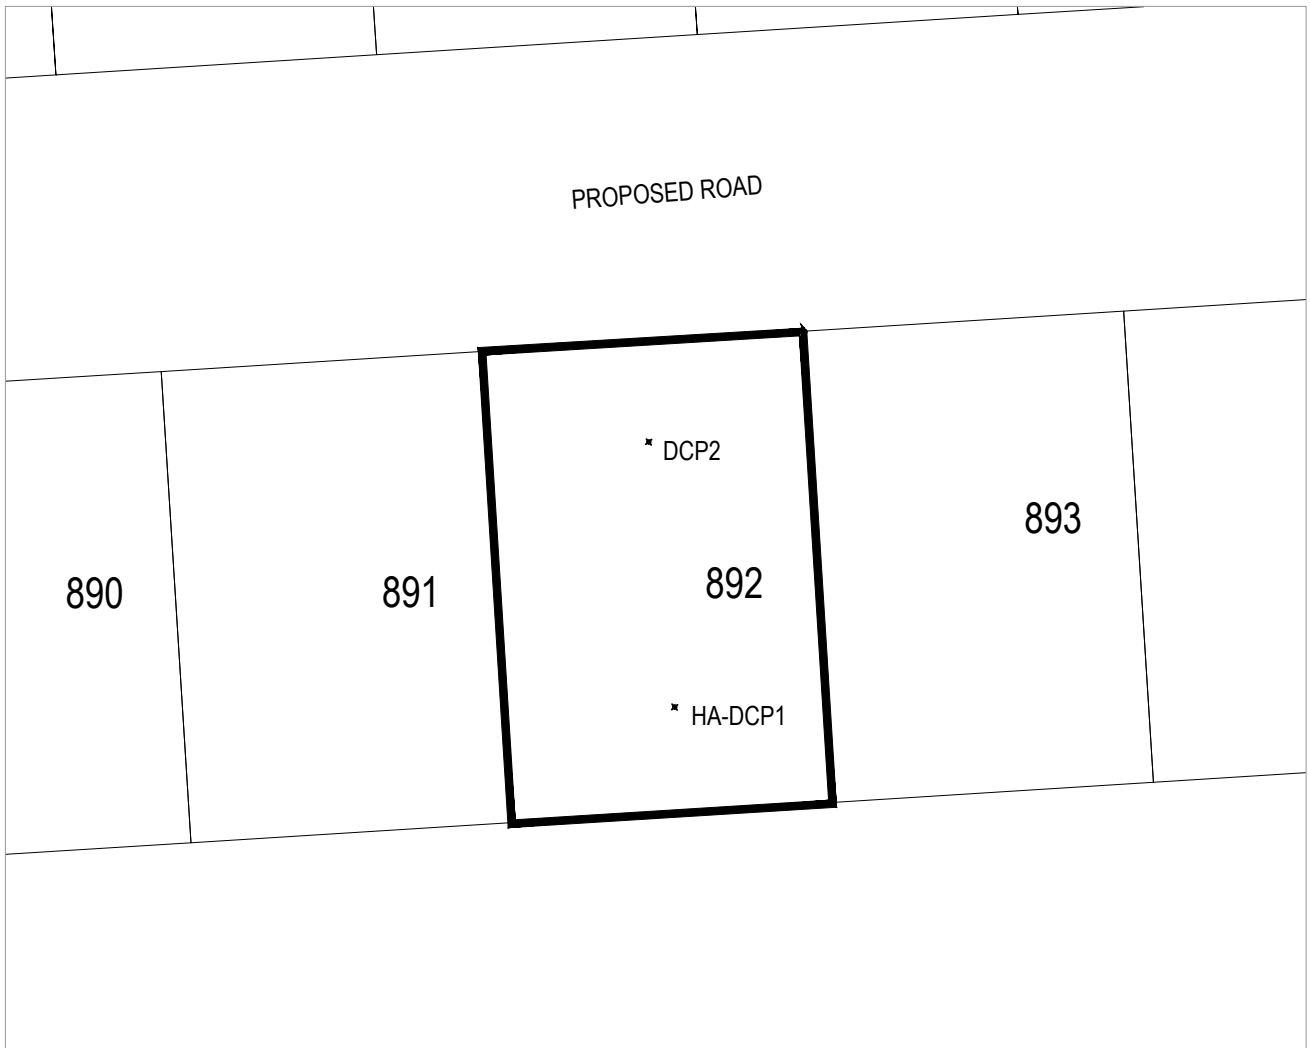
PROJECT
PRESTONS PARK
TITLE
LOT 892 SITE LOCATION PLAN FIGURE 1

This building consent report is for Lot 892 which is located in Stage 4 of the Prestons South Subdivision development (refer Figure 1 in Appendix A). The lot is bordered by residential lots to the north and south, an access road to the west and a storm water channel to the east.

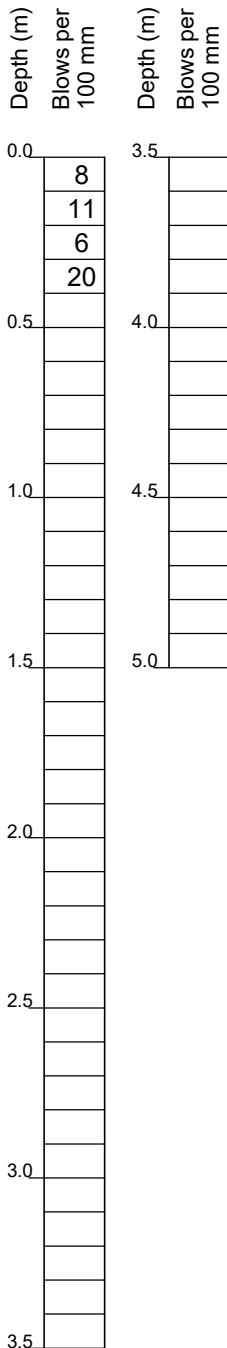
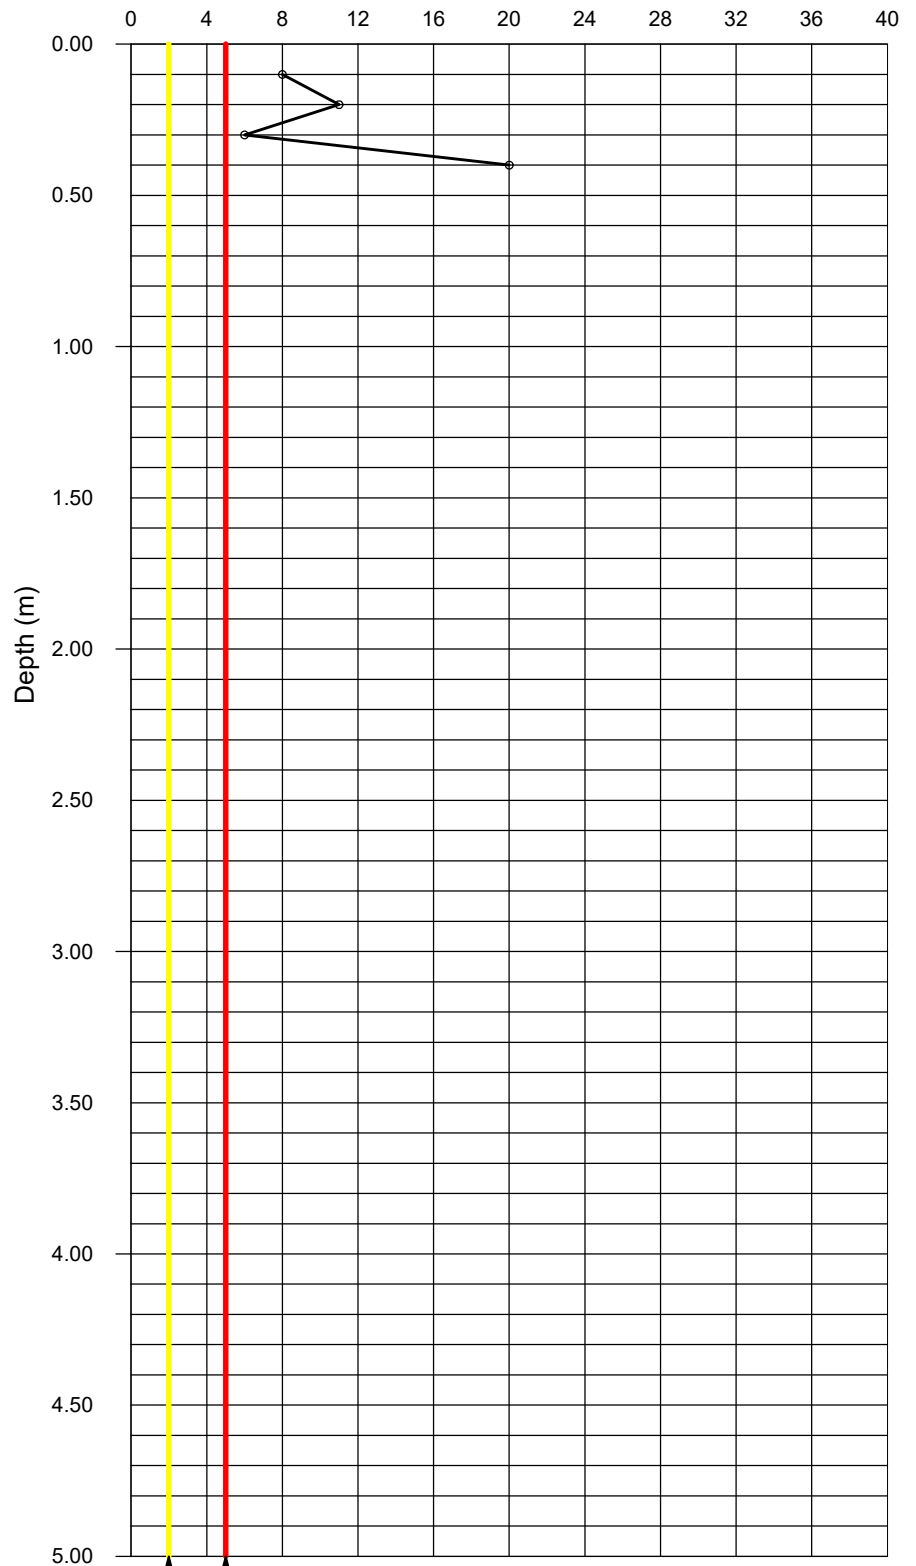
DCP logs indicate two blows per 100mm penetration, which is equivalent to an ultimate bearing capacity of 200kPa, was consistently encountered from a shallow depth.

20 blows for 100mm in the last increment.  
Co-ordinates and elevation data from site survey.  
Elevation based on Christchurch Drainage Datum.  
Effective refusal on gravel, 20+ blows per 100mm

Based on our understanding of the site works and the investigation results, we recommend that MBIE Guidelines (2012) Section 5.3.1 compliant foundations are embedded a minimum depth of 0.3m below current ground level.

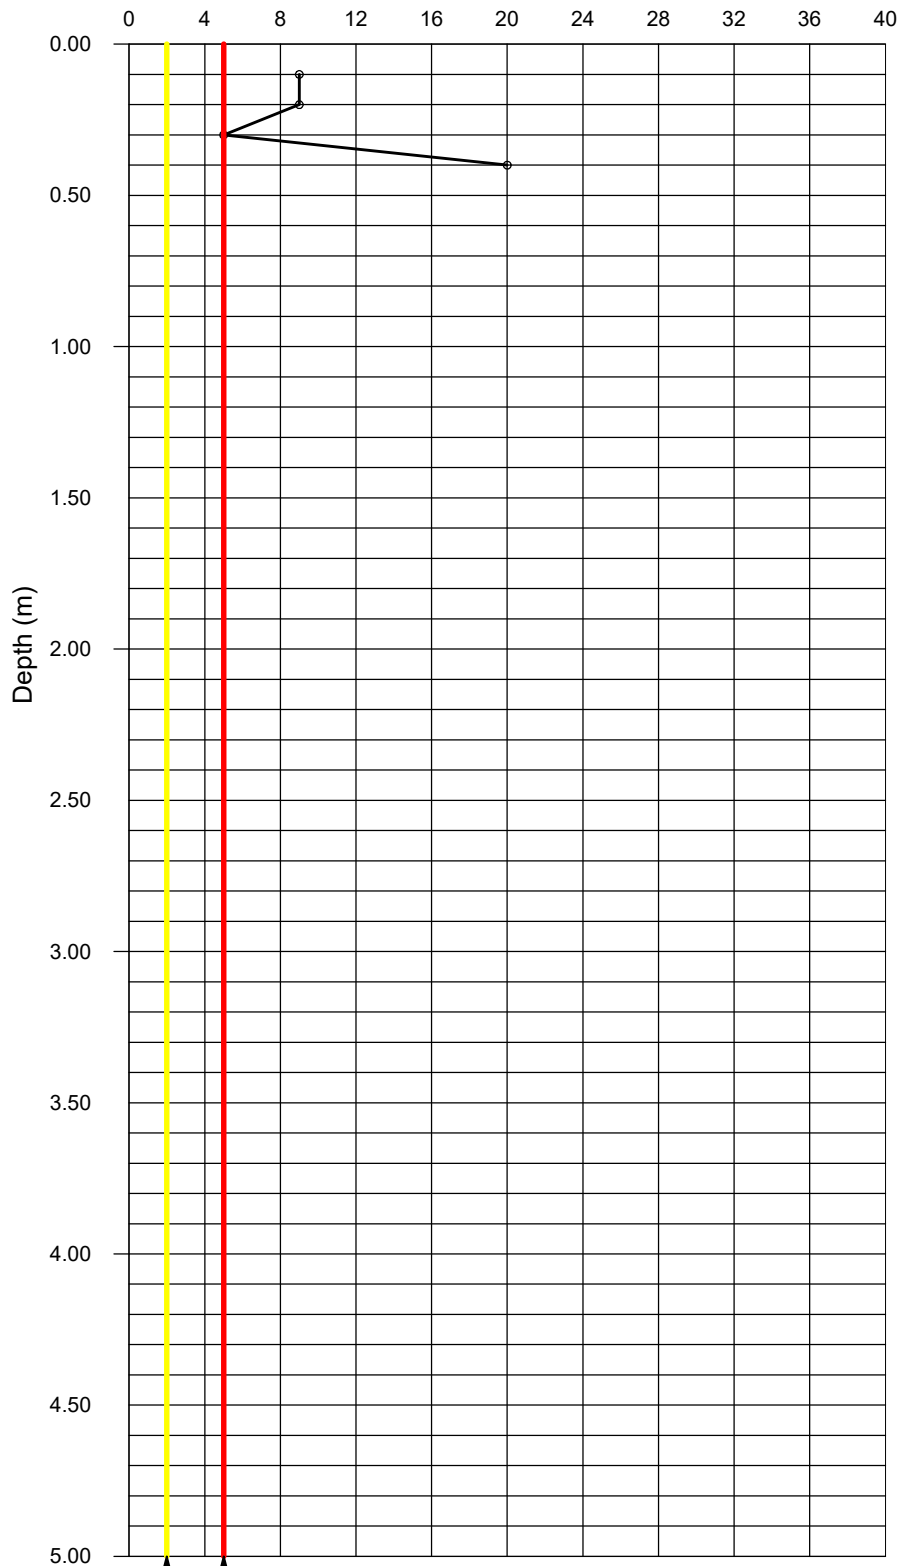
Depth (m)	Blows per 100 mm	Depth (m)	Blows per 100 mm
0.0	9	3.5	
0.1	9		
0.2	5		
0.3	20		
0.4		4.0	
0.5			
1.0		4.5	
1.5		5.0	
2.0			
2.5			
3.0			
3.5

20 blows for 100mm in the last increment.  
Co-ordinates and elevation data from site survey.  
Elevation based on Christchurch Drainage Datum.  
Effective refusal on gravel, 20+ blows per 100mm
