Prestons Park Subdivision
GEOTECHNICAL REPORT FOR LOT 897
CDL Land NZ Limited

23 April 2021
Revision: 1
Reference: 235361

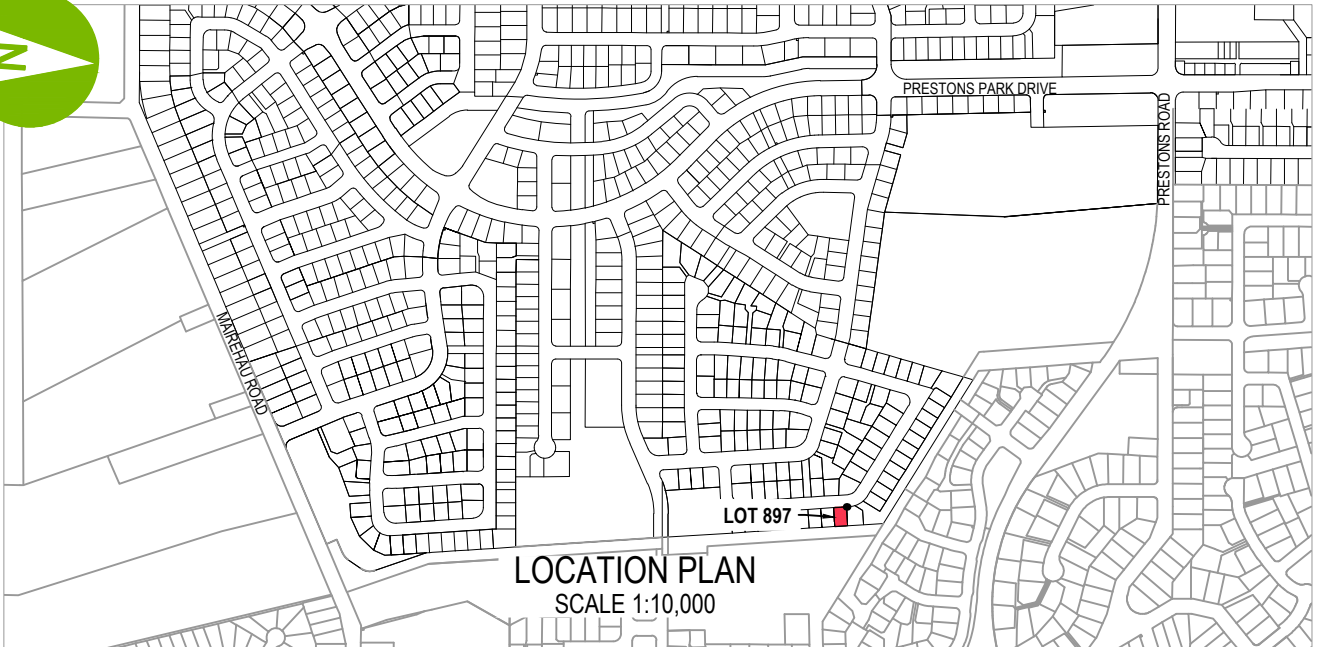
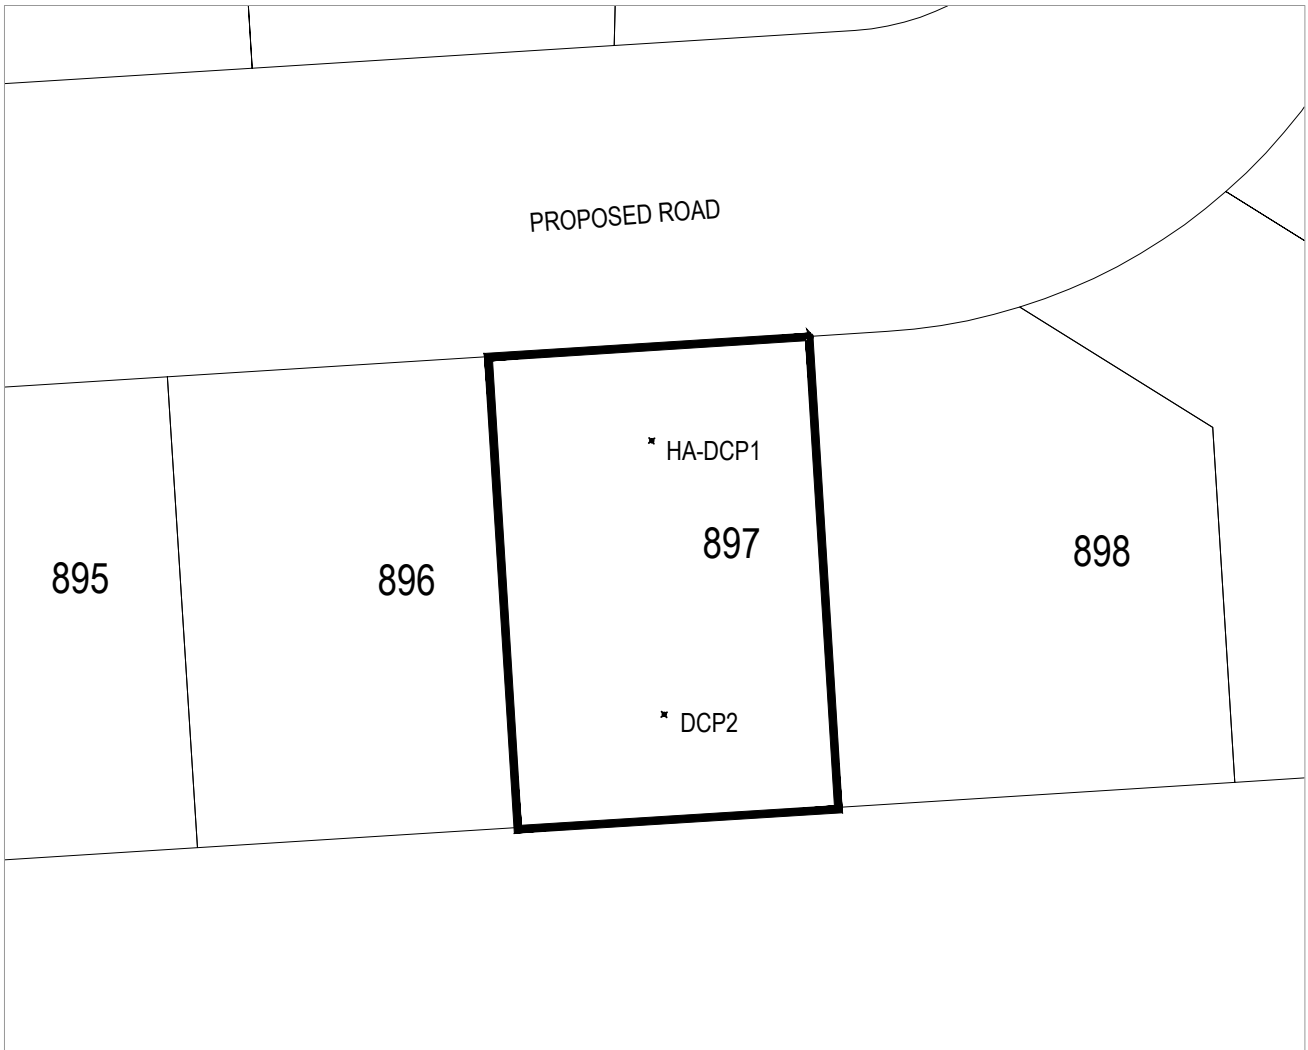
PROJECT	
PRESTONS PARK	
TITLE	
LOT 897 SITE LOCATION PLAN FIGURE 1

This building consent report is for Lot 897 which is located in Stage 4 of the Prestons South Subdivision development (refer Figure 1 in Appendix A). The lot is bordered by residential lots to the north and south, an access road to the west and a storm water channel to the east.

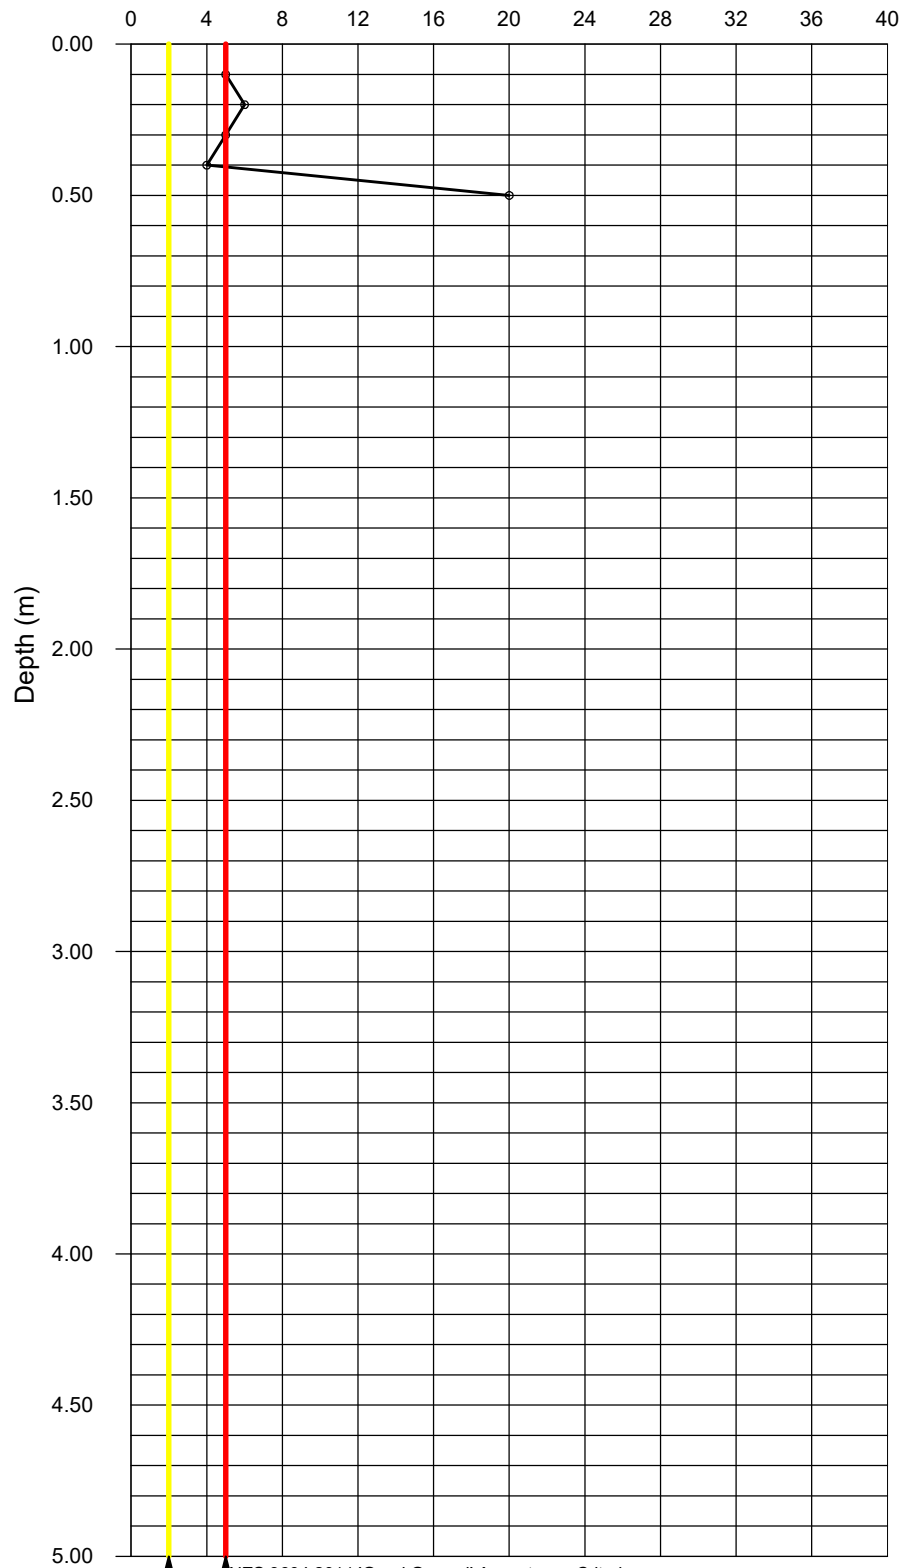
DCP logs indicate two blows per 100mm penetration, which is equivalent to an ultimate bearing capacity of 200kPa, was consistently encountered from a shallow depth.

Depth (m)	Blows per 100 mm	Depth (m)	Blows per 100 mm
0.0	5	3.5	
0.1	6		
0.2	5		
0.3	4		
0.4	20	4.0	
0.5			
1.0		4.5	
1.5		5.0	
2.0			
2.5			
3.0			
3.5

20 blows for 100mm in the last increment.
Co-ordinates and elevation data from site survey.
Elevation based on Christchurch Drainage Datum.
Effective refusal on gravel, 20+ blows per 100mm

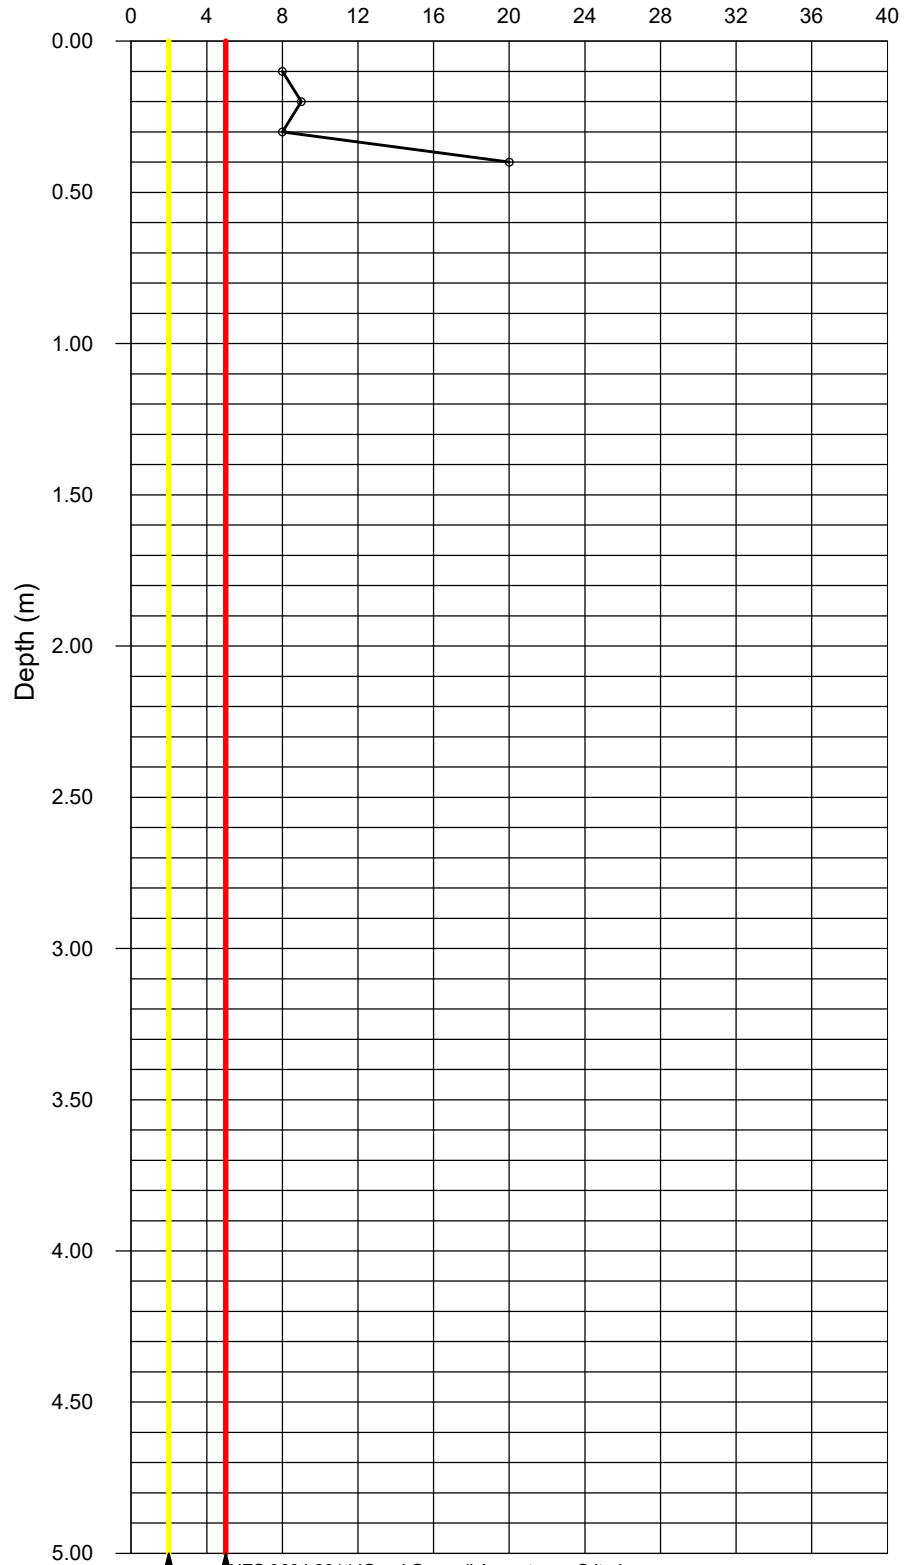
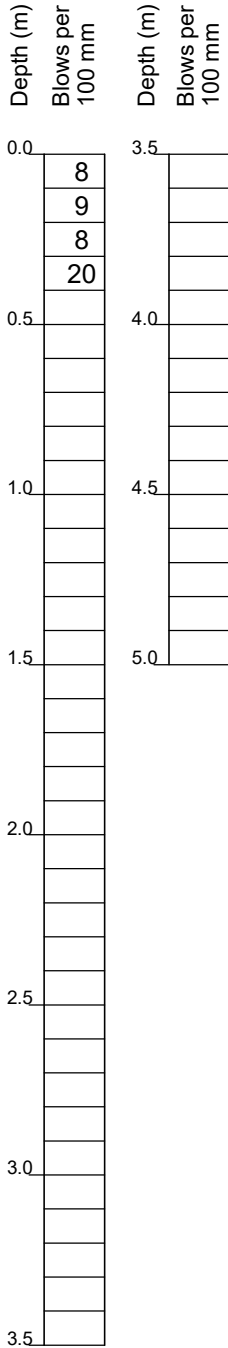
20 blows for 100mm in the last increment.
Co-ordinates and elevation data from site survey.
Elevation based on Christchurch Drainage Datum.
Effective refusal on gravel, 20+ blows per 100mm
