Prestons Subdivision
GEOTECHNICAL REPORT FOR LOT 1051
CDL Land NZ Limited

24 August 2021
Revision: 1
Reference: 235361

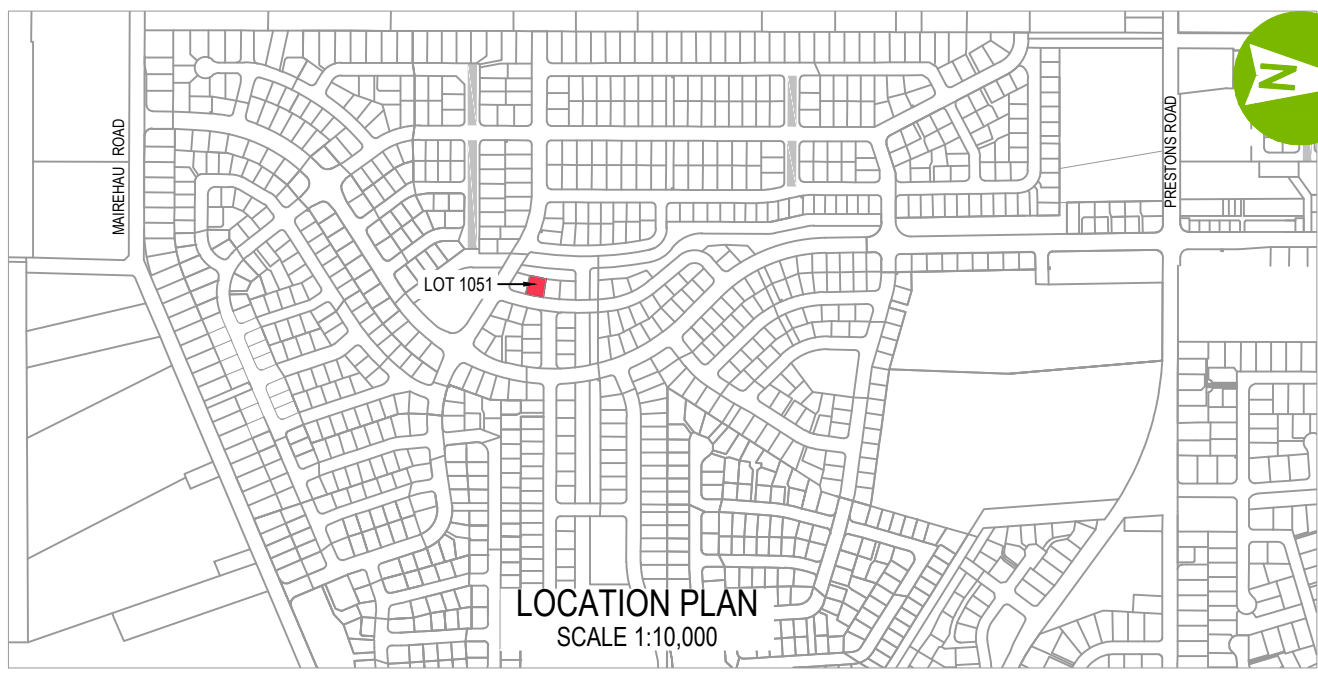
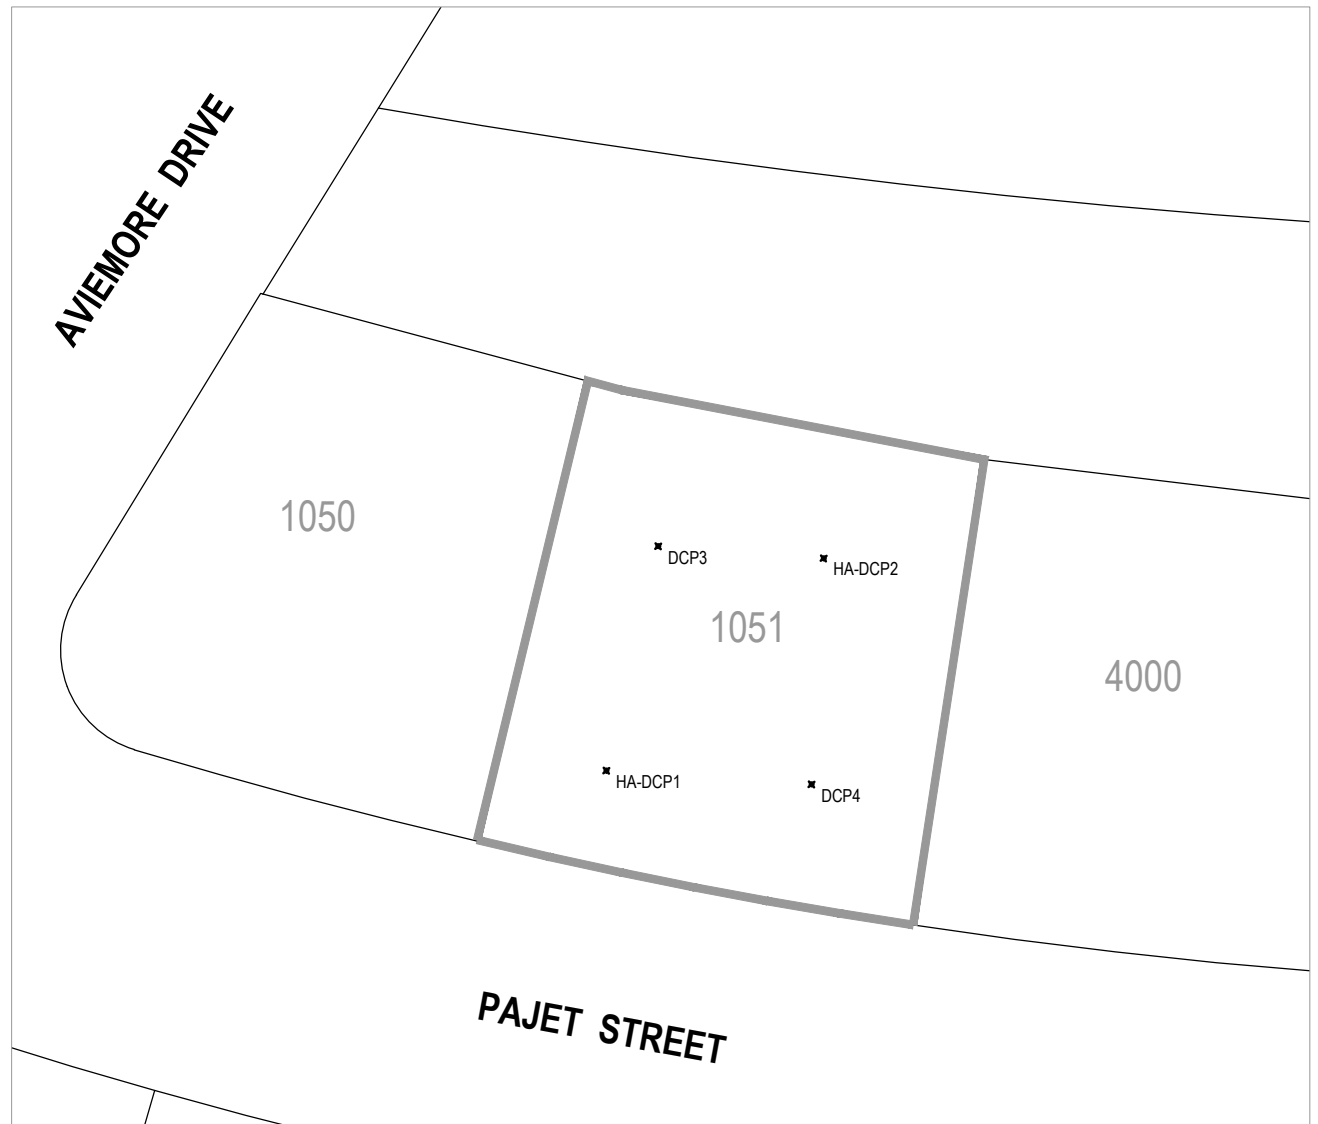
This building consent report is for Lot 1051 which is located in Stage 2 of the Prestons South Subdivision development (refer Figure 1 in Appendix A). The lot is bordered by residential lots to the north and south, an access road to the east and an open storm water channel to the west.

Two hand auger boreholes were undertaken on the lot as part of the geotechnical investigation to assess the upper soil profile and the groundwater level. The test location and the borehole log have been uploaded to the New Zealand Geotechnical Database (NZGD). The borehole log is attached in Appendix B. The hand held testing was undertaken at an earlier date, however it is still considered suitable for the purposes of building consent as no further earthworks or site modifications have been undertaken.

Four DCPs were carried out with the locations and results uploaded to the NZGD. The DCP test results are attached in Appendix B. Two of the DCPs were located adjacent to the hand auger boreholes, with the other DCPs being located on the opposite half of the lot. The DCPs were undertaken at an earlier date, however they are still considered suitable for the purposes of building consent as no further earthworks or site modifications have been undertaken.

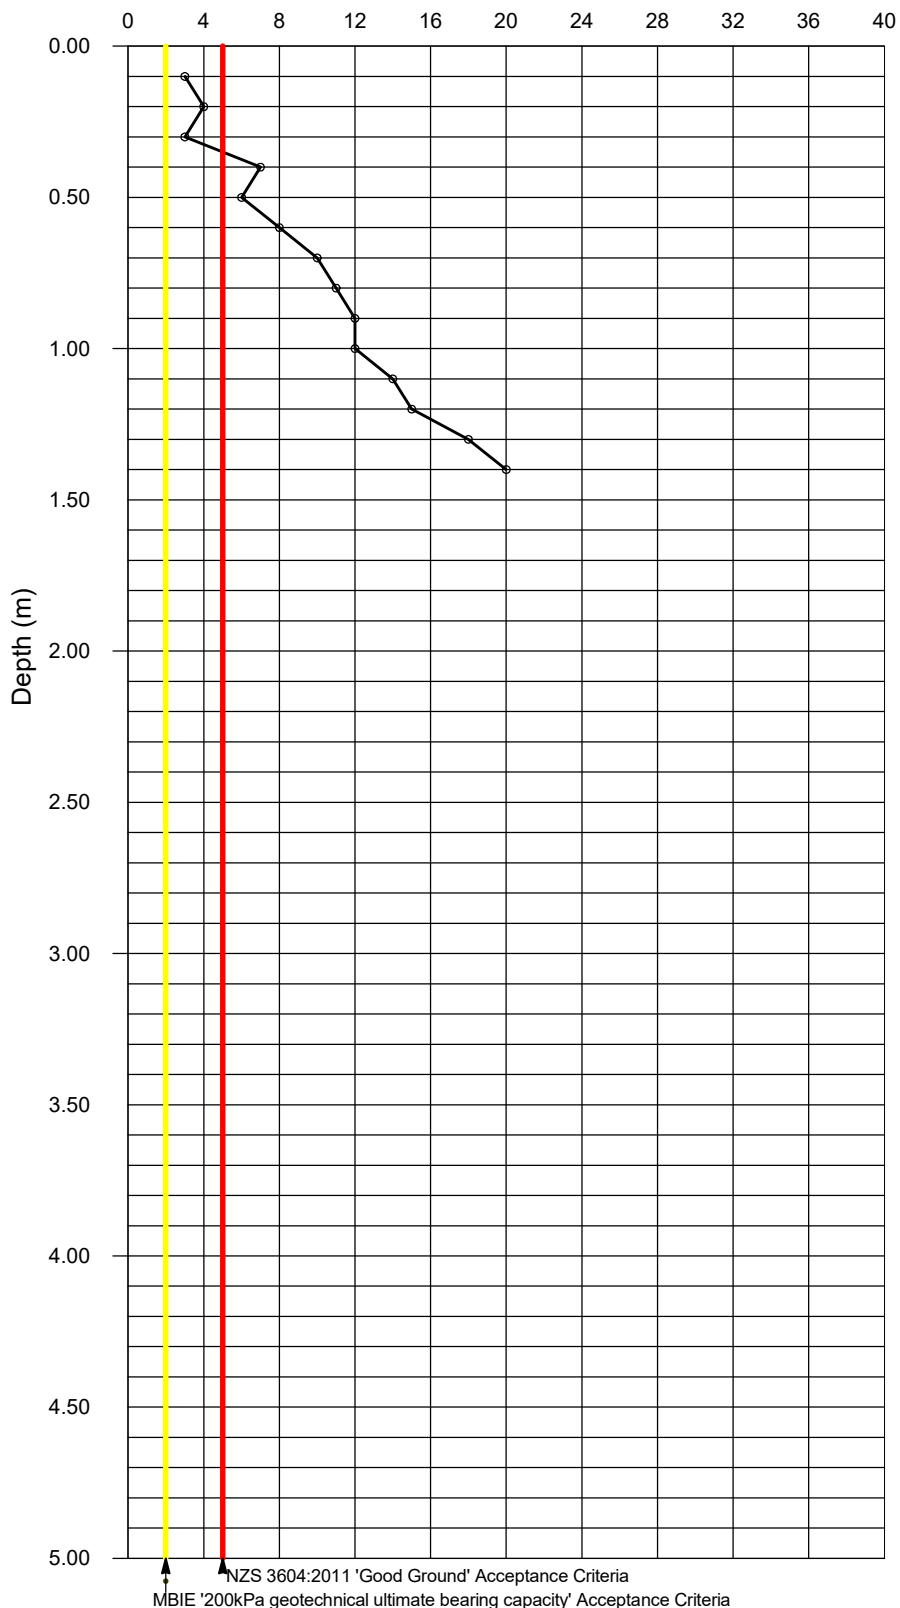
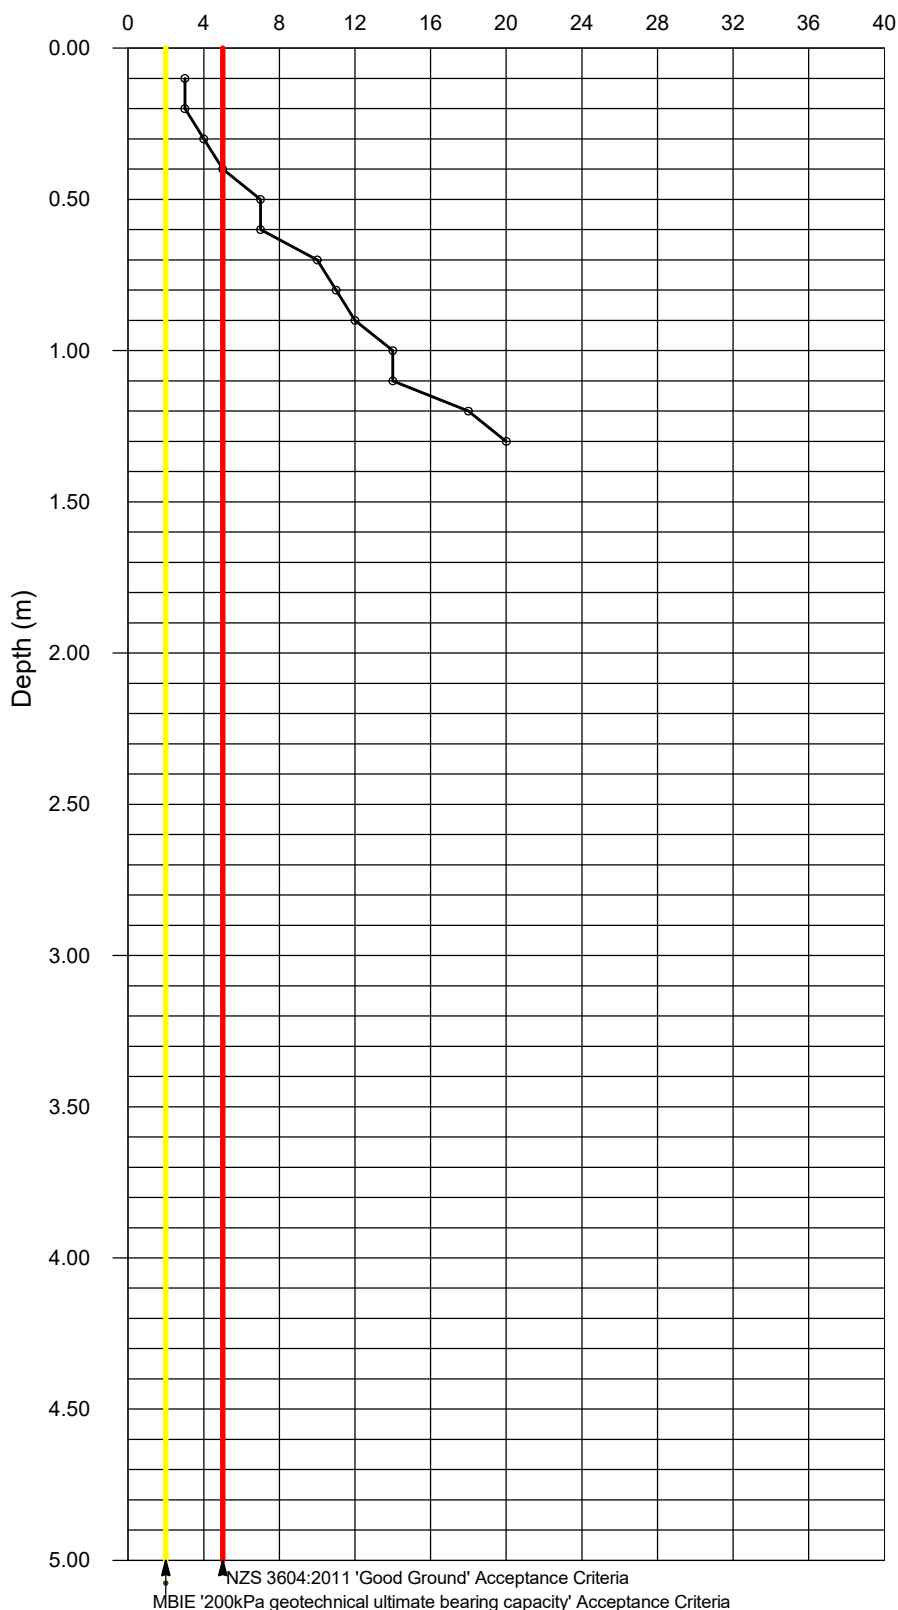
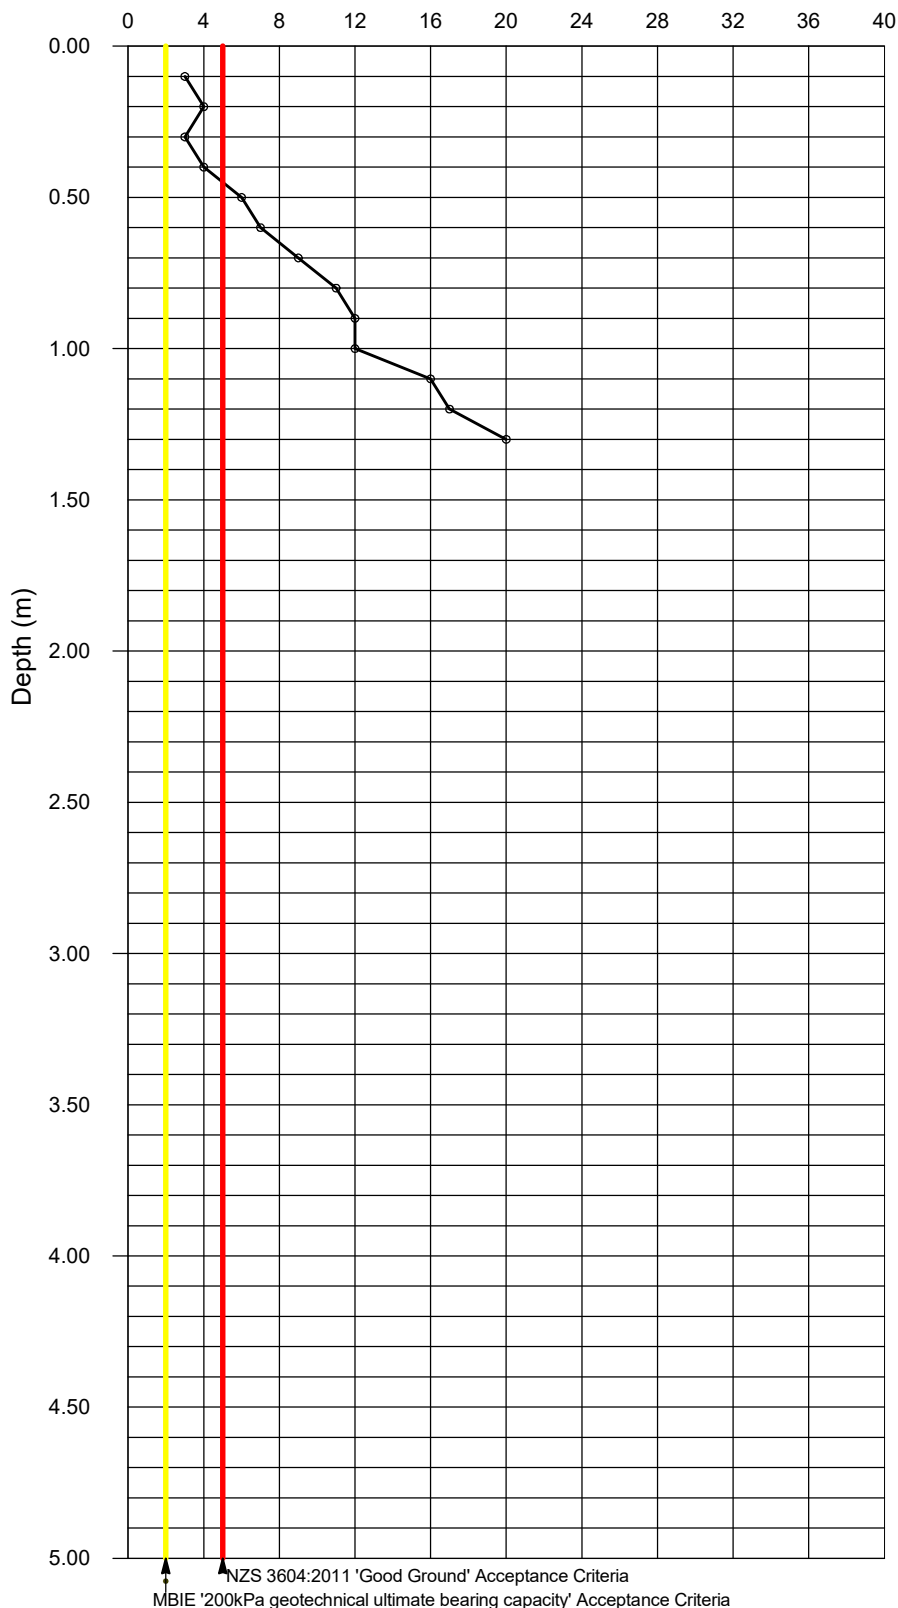
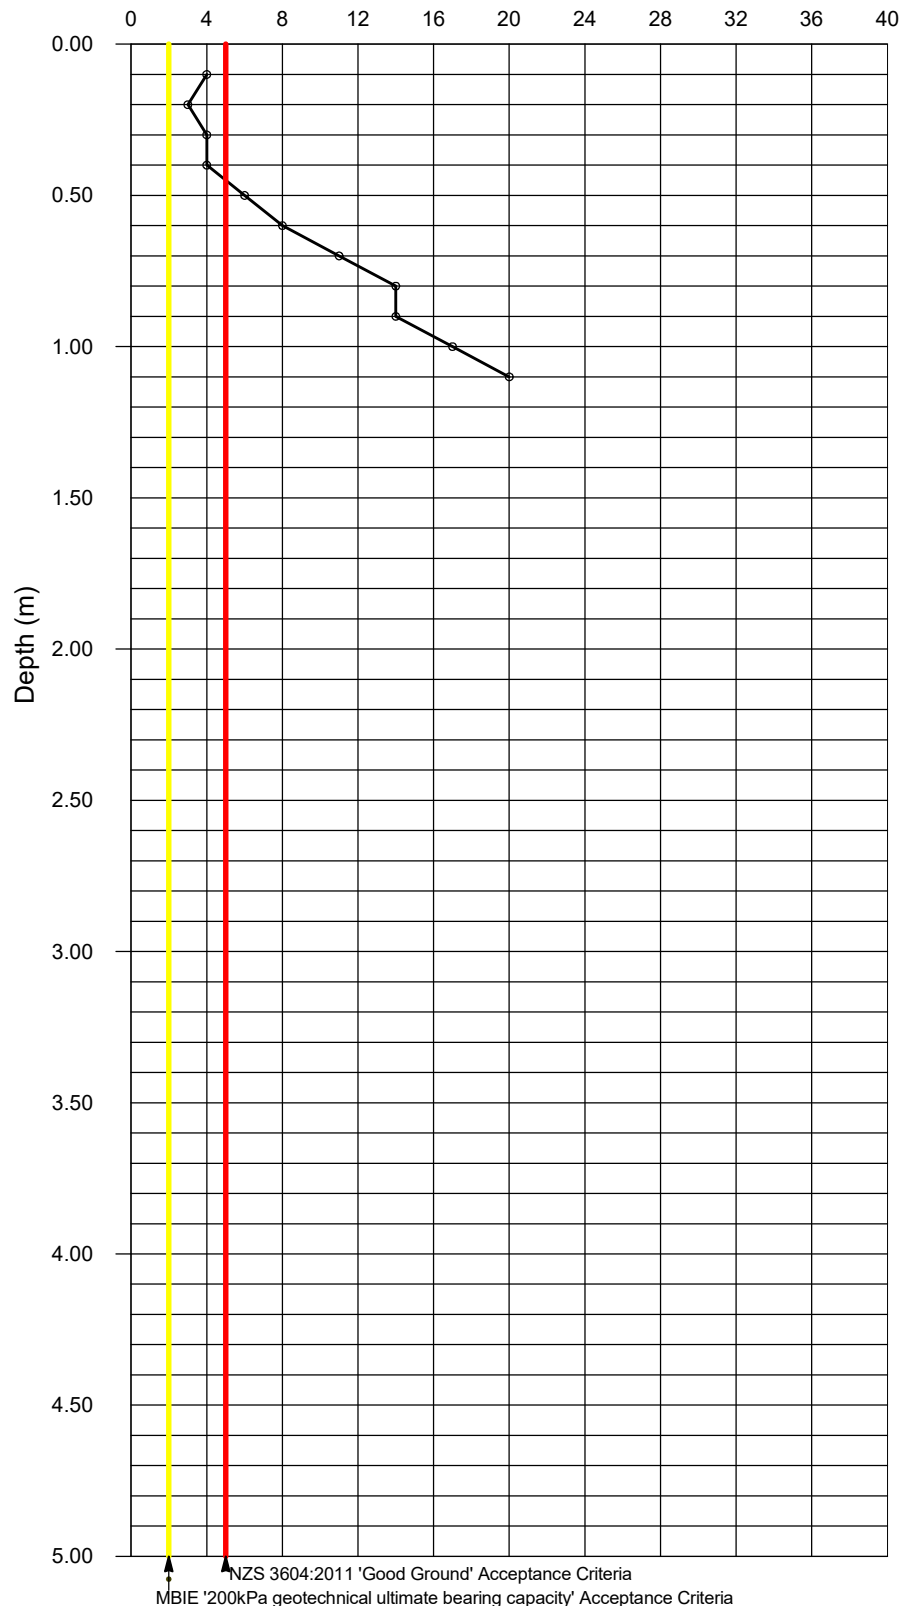
DCP logs indicate 5 blows per 100mm penetration, which is equivalent to an ultimate bearing capacity of 300kPa, was consistently encountered from a depth of 0.4m to 0.5m.

Based on our understanding of the site works and the investigation results, we recommend that NZS3604:2011 compliant foundations are embedded a minimum depth of 0.5m below current ground level.
