Prestons Subdivision GEOTECHNICAL REPORT FOR LOT 1054 **CDL Land NZ Limited**

25 August 2021 Revision: 1 Reference: 235361

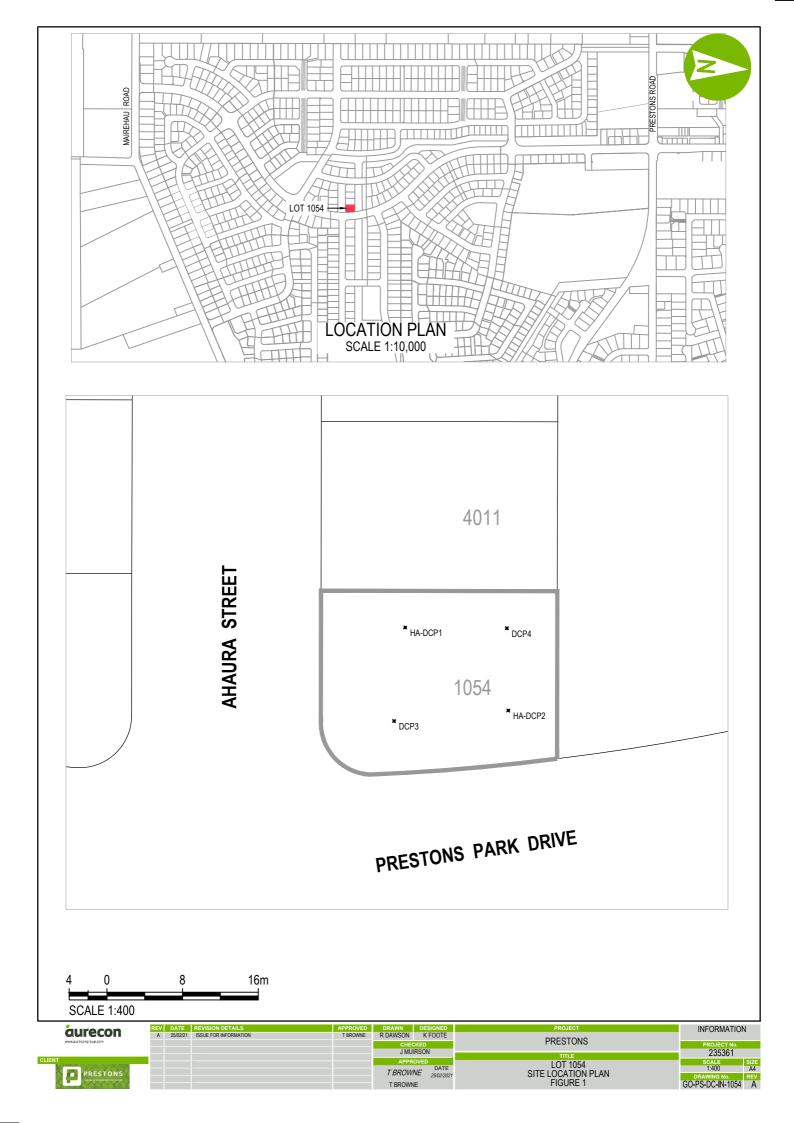
This building consent report is for Lot 1054 which is located in Stage 2 of the Prestons South Subdivision development (refer Figure 1 in Appendix A). The lot is bordered by a residential lot to the west, access roads to the south and east, and an open storm water channel to the north.

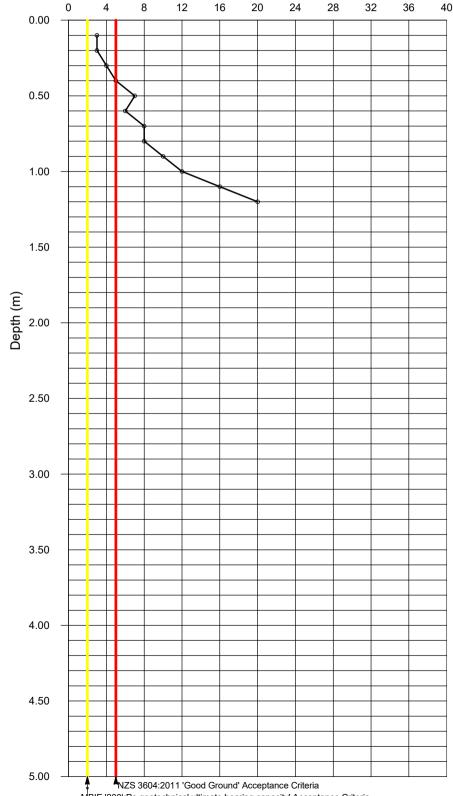
Lot 1054 - DCP1

DCP logs indicate 5 blows per 100mm penetration, which is equivalent to an ultimate bearing capacity of 300kPa, was consistently encountered from a depth of 0.4m.

Effective refusal, 20+ blows per 100mm penetration.

Based on our understanding of the site works and the investigation results, we recommend that NZS3604:2011 compliant foundations are embedded a minimum depth of 0.4m below current ground level.

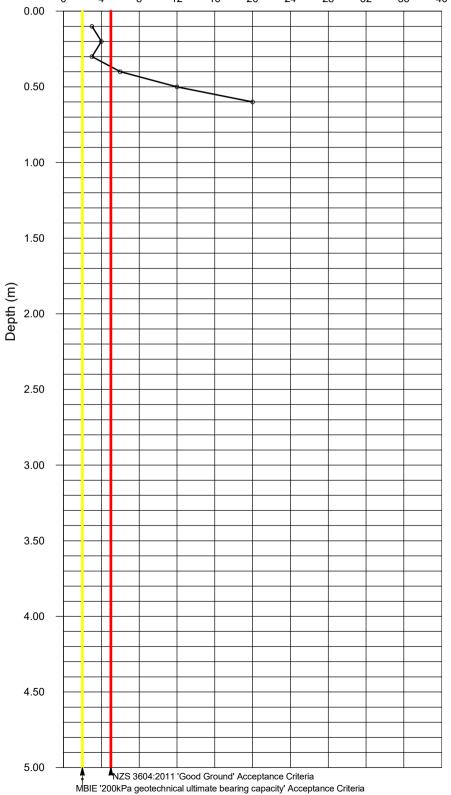
20 blows for 100mm in the last increment.

Effective refusal, 20+ blows per 100mm penetration.

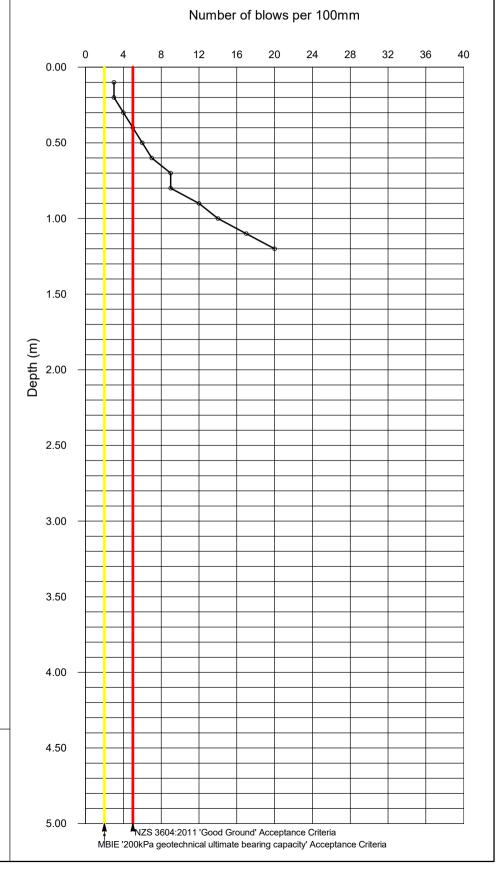
Lot 1054 - DCP3

20 blows for 100mm in the last increment.

Effective refusal, 20+ blows per 100mm penetration.
