**Prestons Park Subdivision**  
**GEOTECHNICAL REPORT FOR LOT 969**  
**CDL Land NZ Limited**

**28 June 2023**  
**Revision: 1**  
**Reference: 235361**

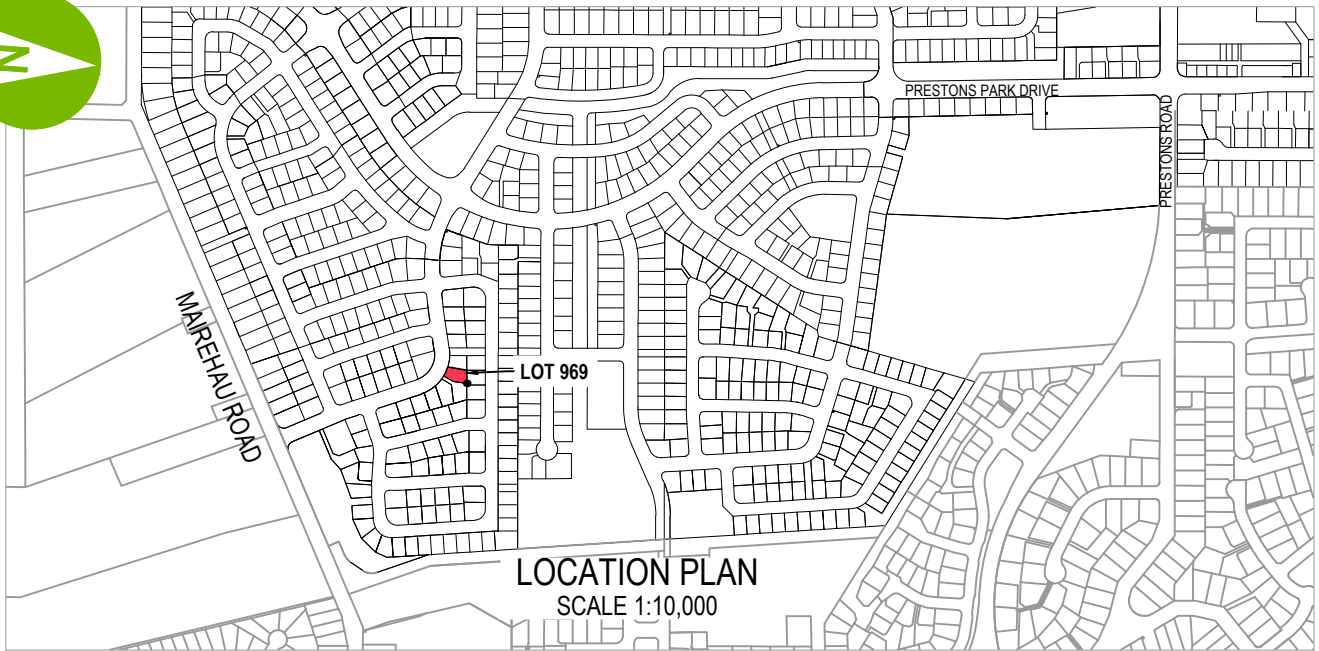
PROJECT
PRESTONS PARK
TITLE
LOT 969 SITE LOCATION PLAN FIGURE 1

This building consent report is for Lot 969 which is located in Stage 5 of the Prestons Park Subdivision development (refer Figure 1 in Appendix A). The lot is bordered by residential lots to the north, east and west, with road access to the south.

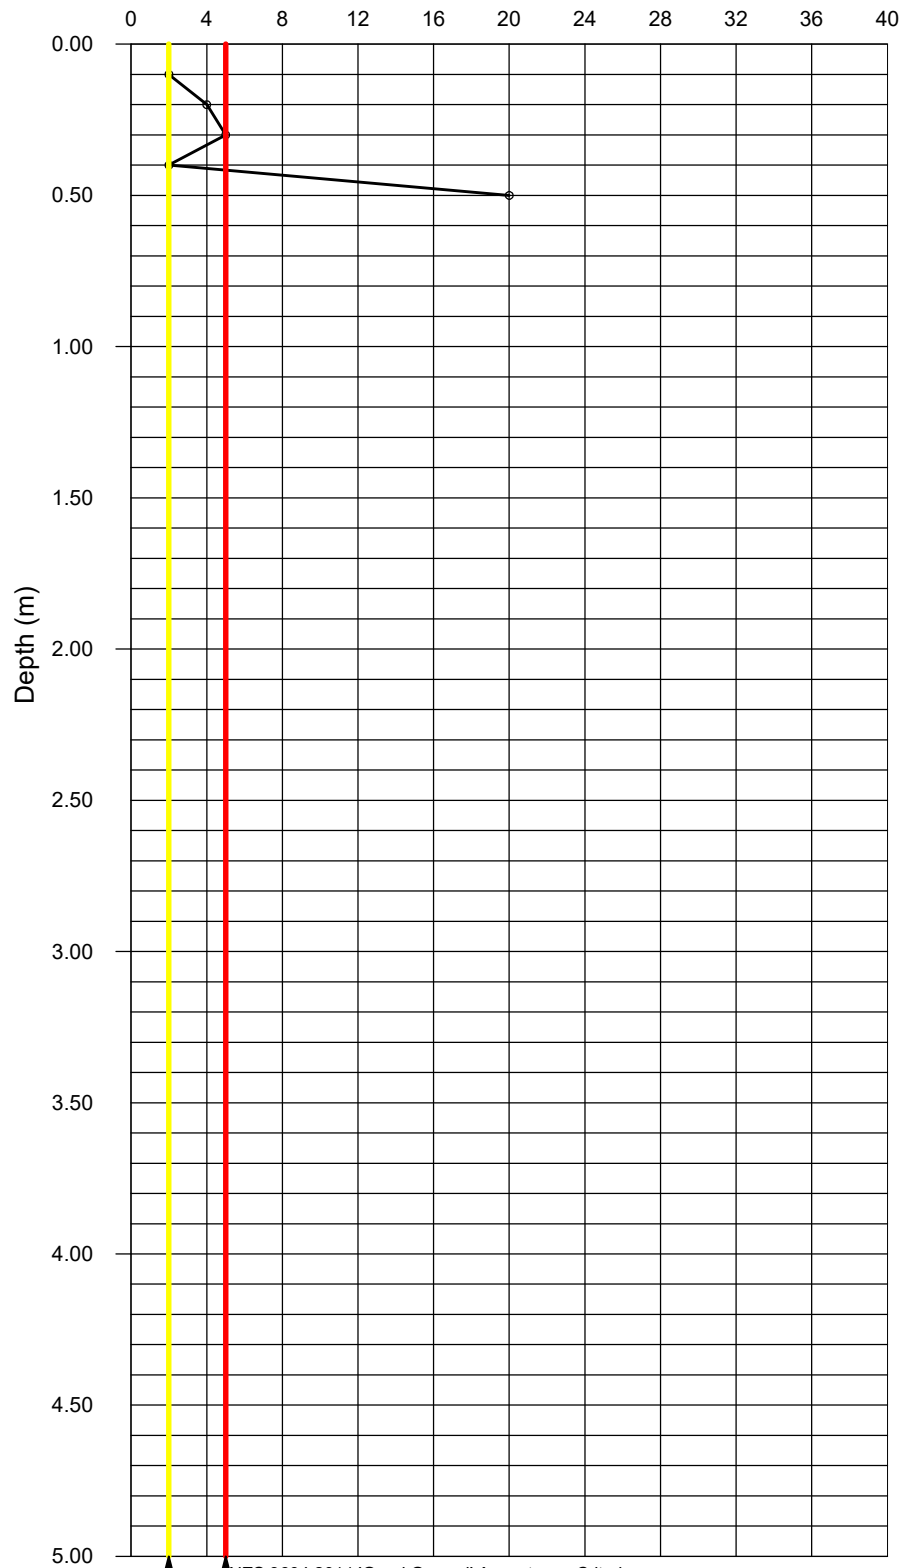
DCP logs indicate 5 blows per 100mm penetration, which is equivalent to an ultimate bearing capacity of 300kPa, was consistently encountered from a depth of 0.4m.

20 blows for 100mm in the last increment.  
Co-ordinates and elevation data from site survey.  
Elevation based on Christchurch Drainage Datum.  
Effective refusal, 20+ blows per 100mm.

Based on our understanding of the site works and the investigation results, we recommend that NZS3604:2011 compliant foundations are embedded a minimum depth of 0.45m below current ground level.

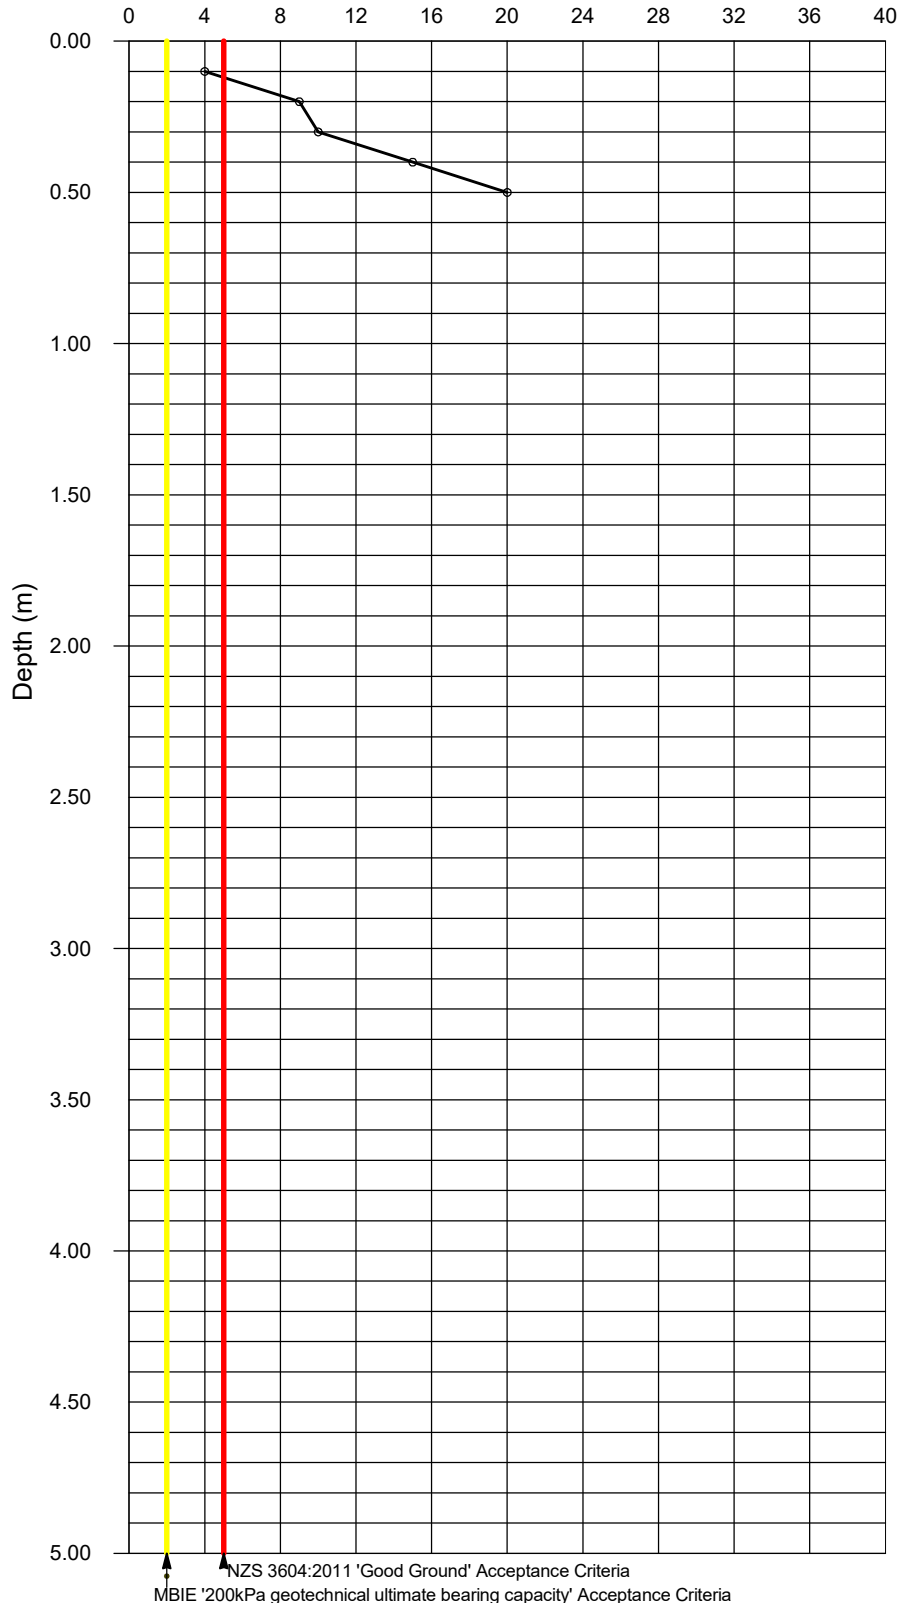
20 blows for 100mm in the last increment.  
Co-ordinates and elevation data from site survey.  
Elevation based on Christchurch Drainage Datum.  
Effective refusal, 20+ blows per 100mm.
