**Prestons Park Subdivision**  
**GEOTECHNICAL REPORT FOR LOT 949**  
**CDL Land NZ Limited**

**28 June 2023**  
**Revision: 1**  
**Reference: 235361**

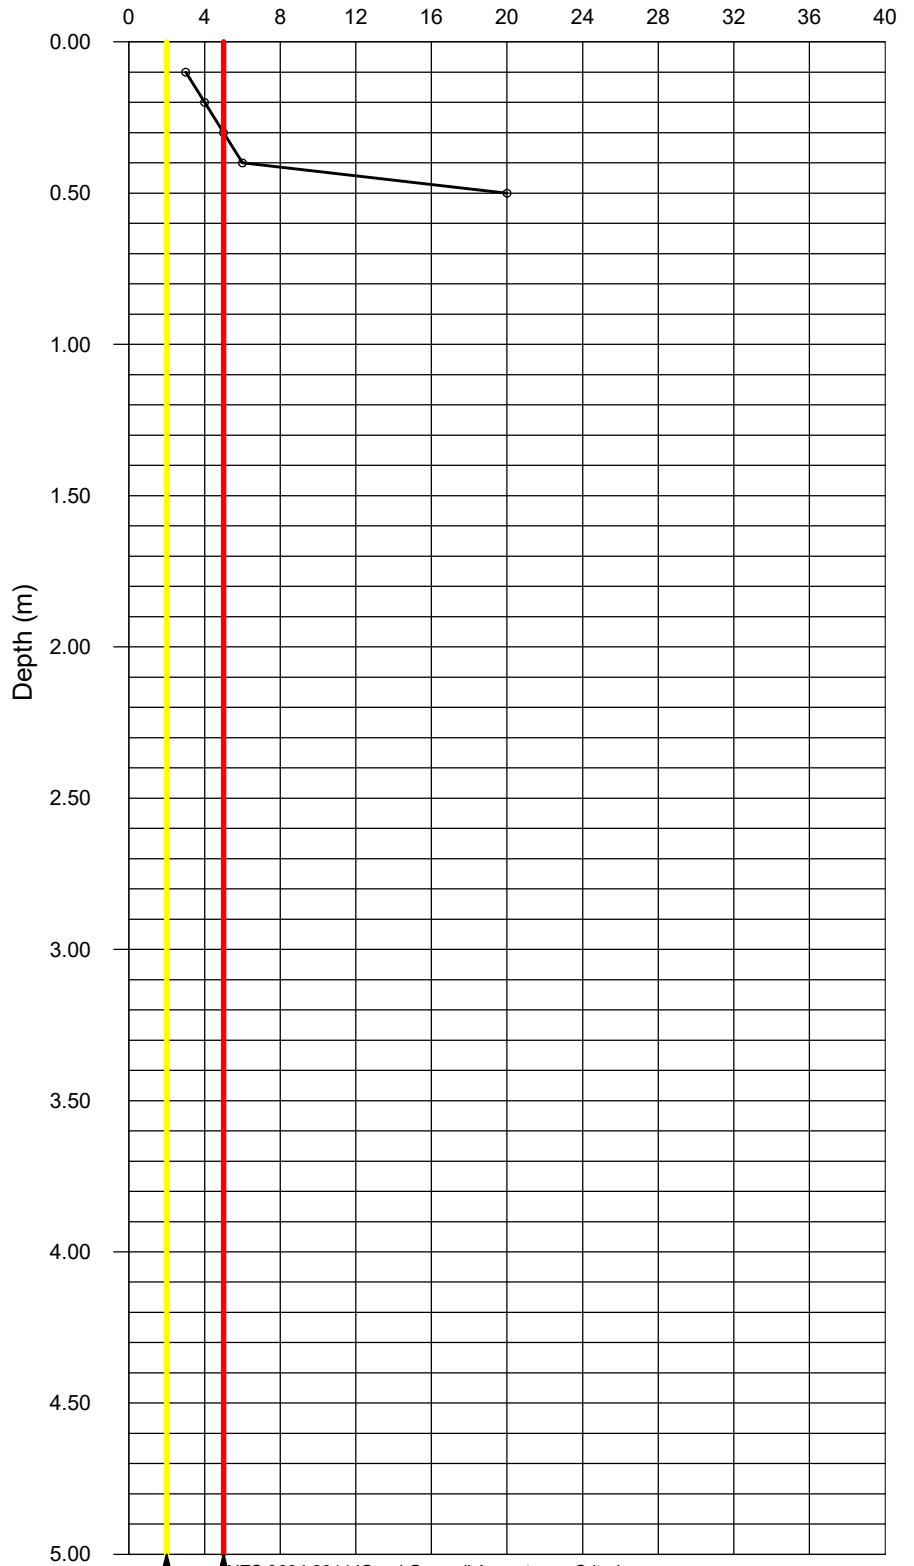
DCP logs indicate 5 blows per 100mm penetration, which is equivalent to an ultimate bearing capacity of 300kPa, was consistently encountered from a shallow depth.

20 blows for 100mm in the last increment.  
Co-ordinates and elevation data from site survey.  
Elevation based on Christchurch Drainage Datum.  
Effective refusal, 20+ blows per 100mm

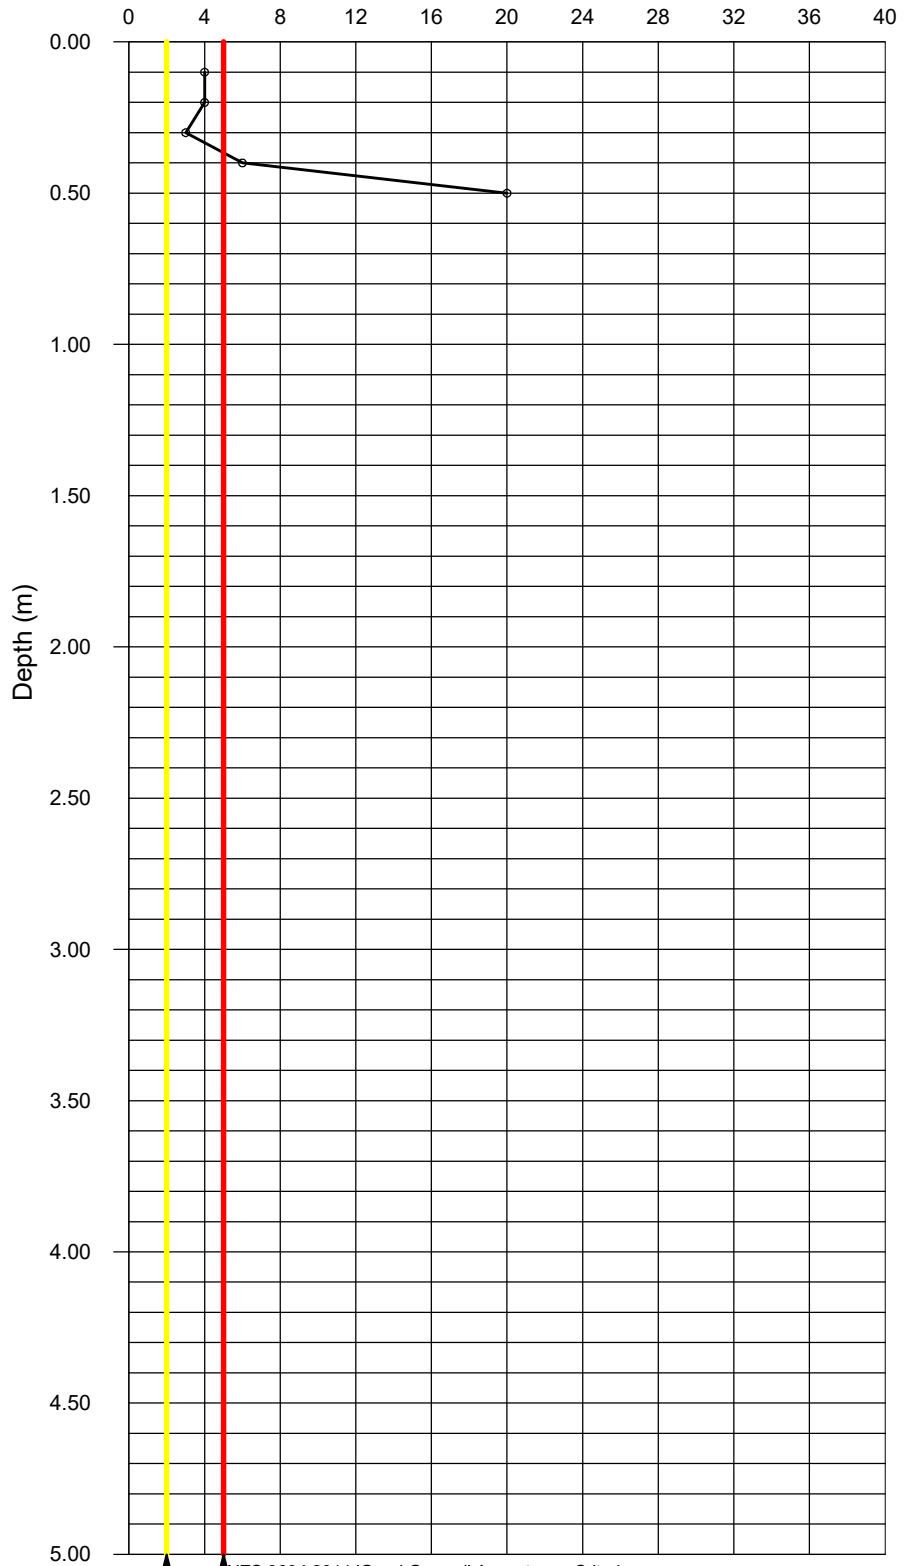
20 blows for 100mm in the last increment.  
Co-ordinates and elevation data from site survey.  
Elevation based on Christchurch Drainage Datum.  
Effective refusal, 20+ blows per 100mm
