**Prestons Park Subdivision**  
**GEOTECHNICAL REPORT FOR LOT 1003**  
**CDL Land NZ Limited**

**10 January 2024**  
**Revision: 1**  
**Reference: 235361**

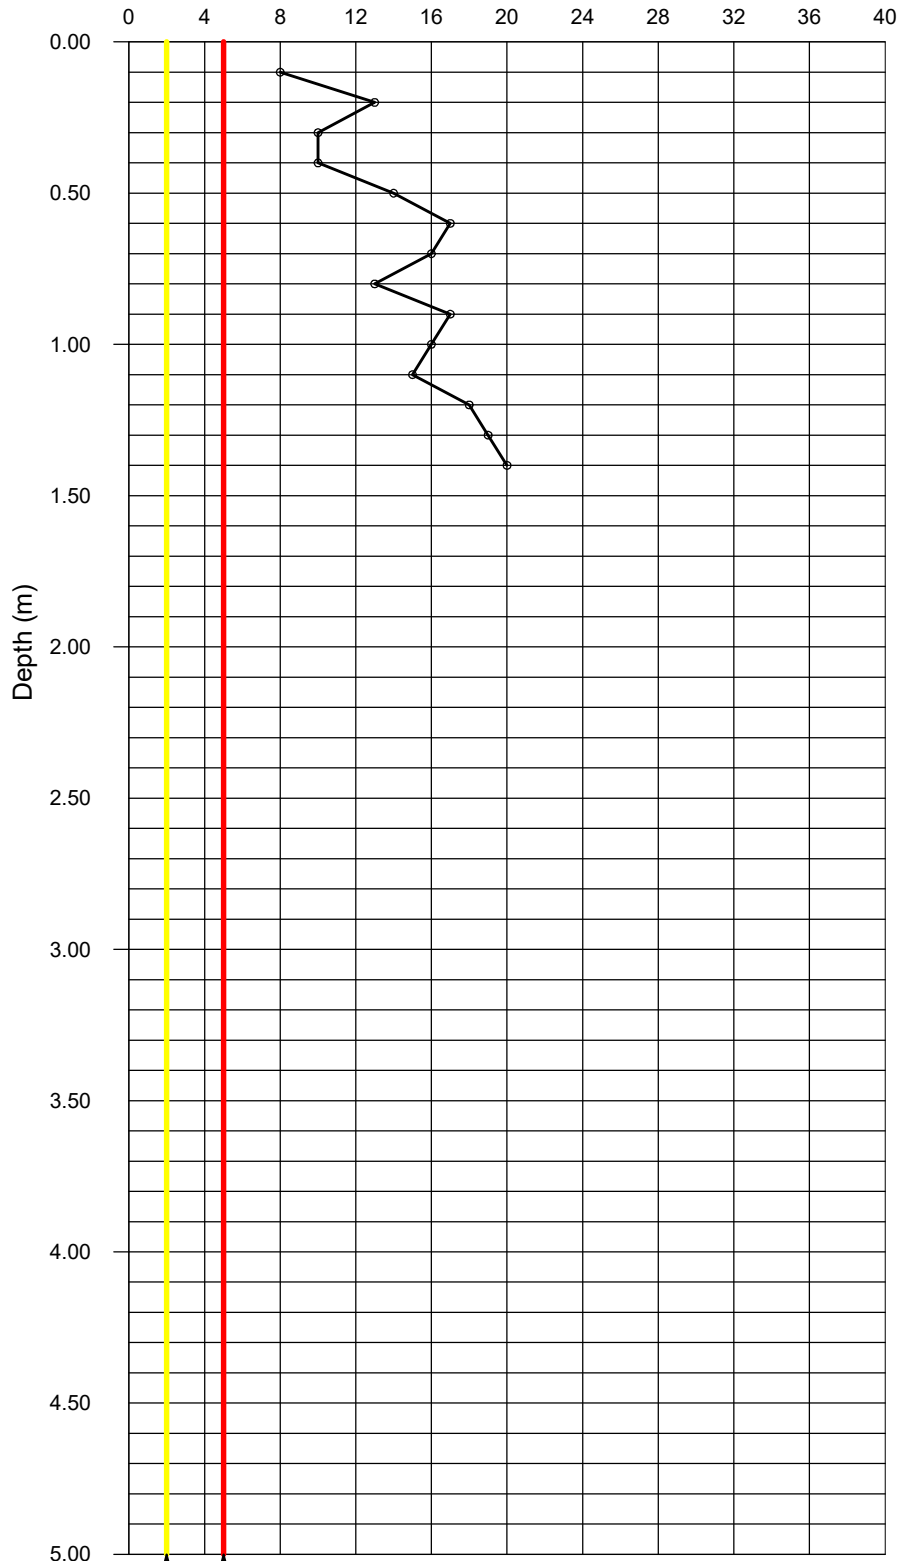
DCP logs indicate two blows per 100mm penetration, which is equivalent to an ultimate bearing capacity of 200kPa, was consistently encountered from shallow depths.

20 blows for 100mm in the last increment.  
Co-ordinates recorded in the field with a mobile device.  
RL from data survey based on design contours (+/- 10cm) (Christchurch Drainage Datum).  
Effective refusal, 20+ blows per 100mm

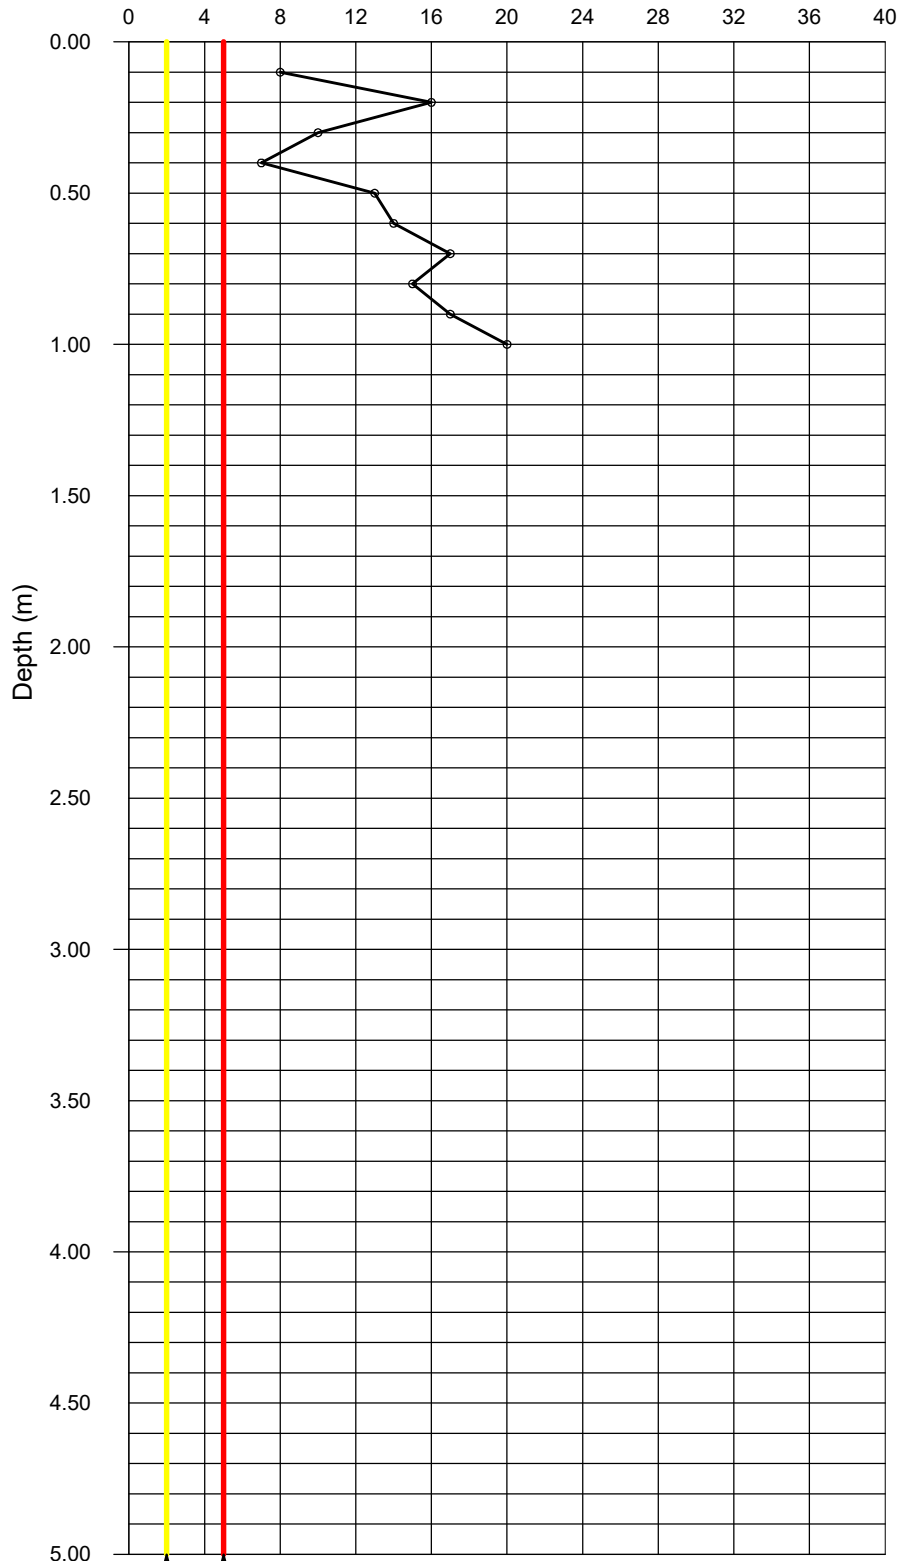
20 blows for 100mm in the last increment.  
Co-ordinates recorded in the field with a mobile device.  
RL from data survey based on design contours (+/- 10cm) (Christchurch Drainage Datum).  
Effective refusal, 20+ blows per 100mm
