**Prestons Park Subdivision**  
**GEOTECHNICAL REPORT FOR LOT 377**  
**CDL Land NZ Limited**

**25 September 2024**  
**Revision: 0**  
**Reference: 235361**

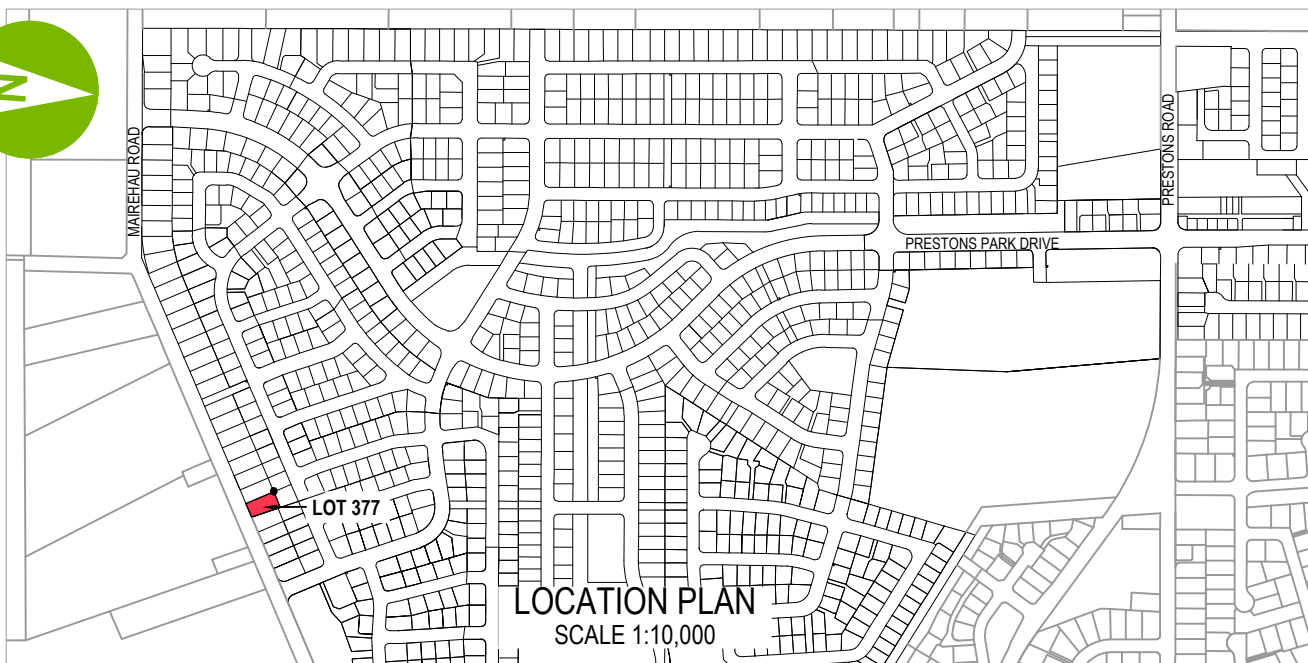
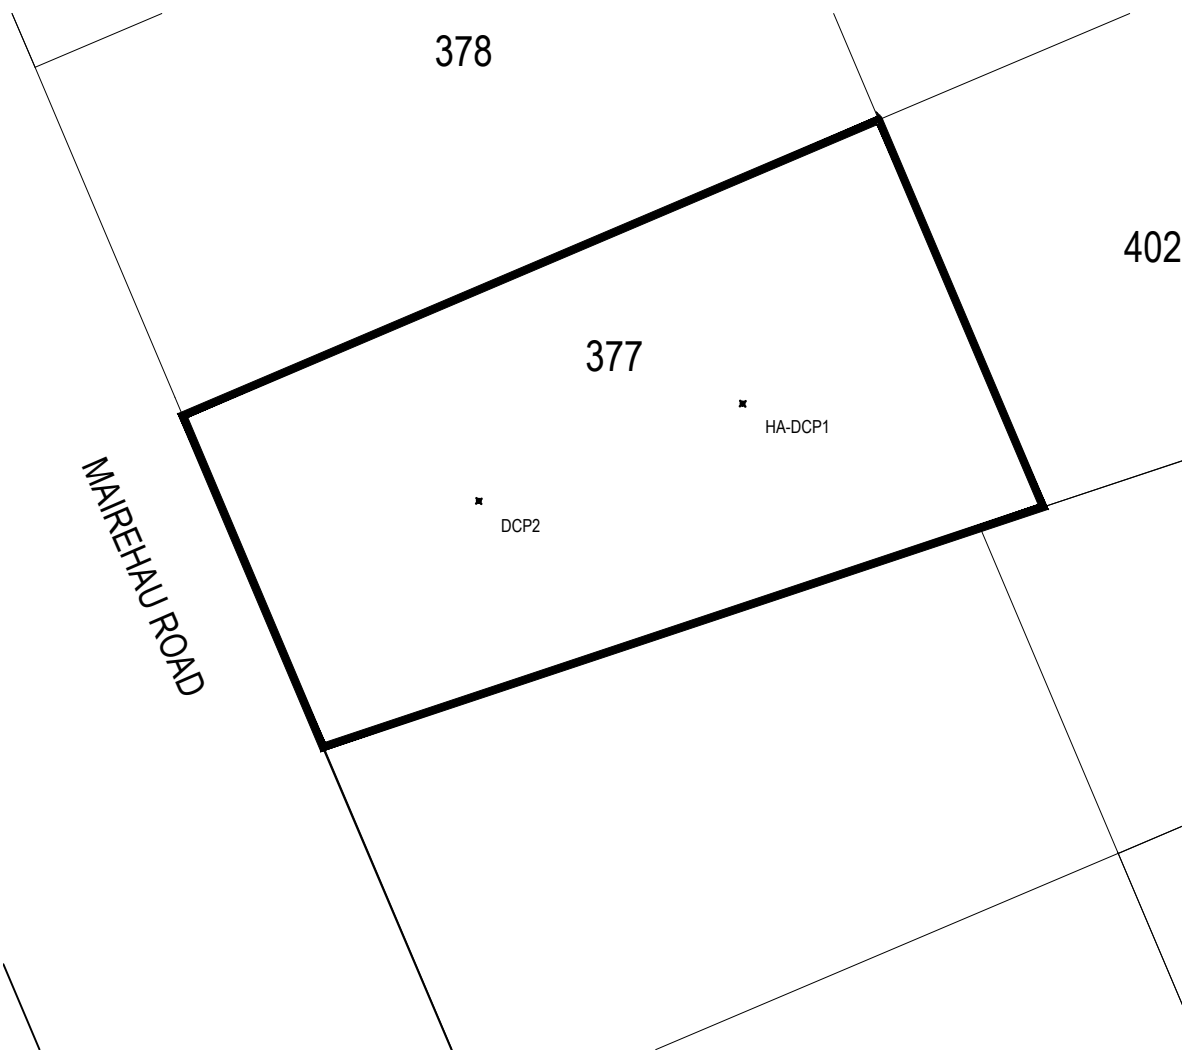
PROJECT	TITLE
PRESTONS PARK	LOT 377
	SITE LOCATION PLAN
	FIGURE 1

This building consent report is for Lot 377 which is located in Stage 2 of the Prestons Park Subdivision development (refer Figure 1 in Appendix A). The lot is bordered by residential lots to the north, west and east and Mairehau Road to the south.

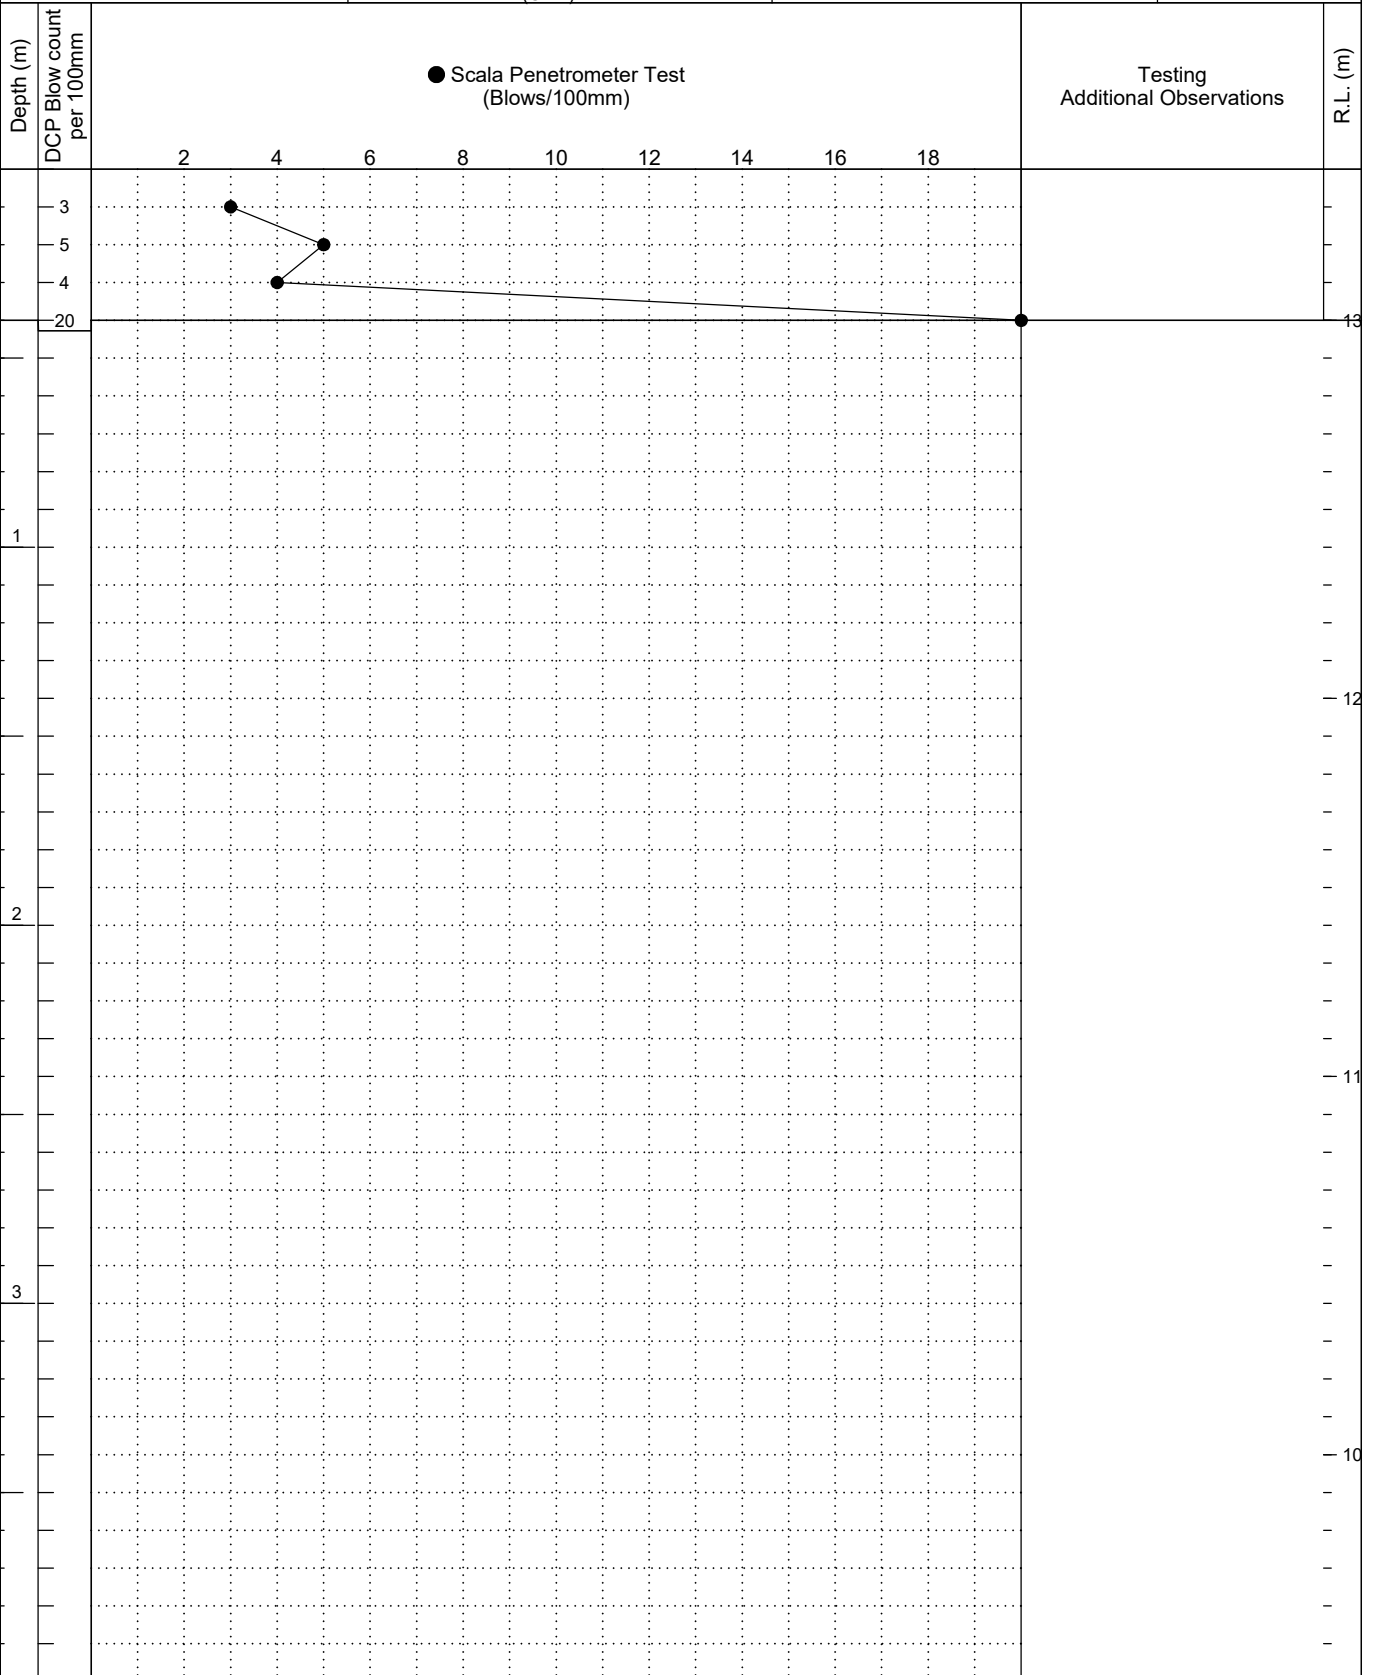
DCP logs indicate 5 blows per 100mm penetration, which is equivalent to an ultimate bearing capacity of 300kPa, was consistently encountered from a depth of 0.3m.
