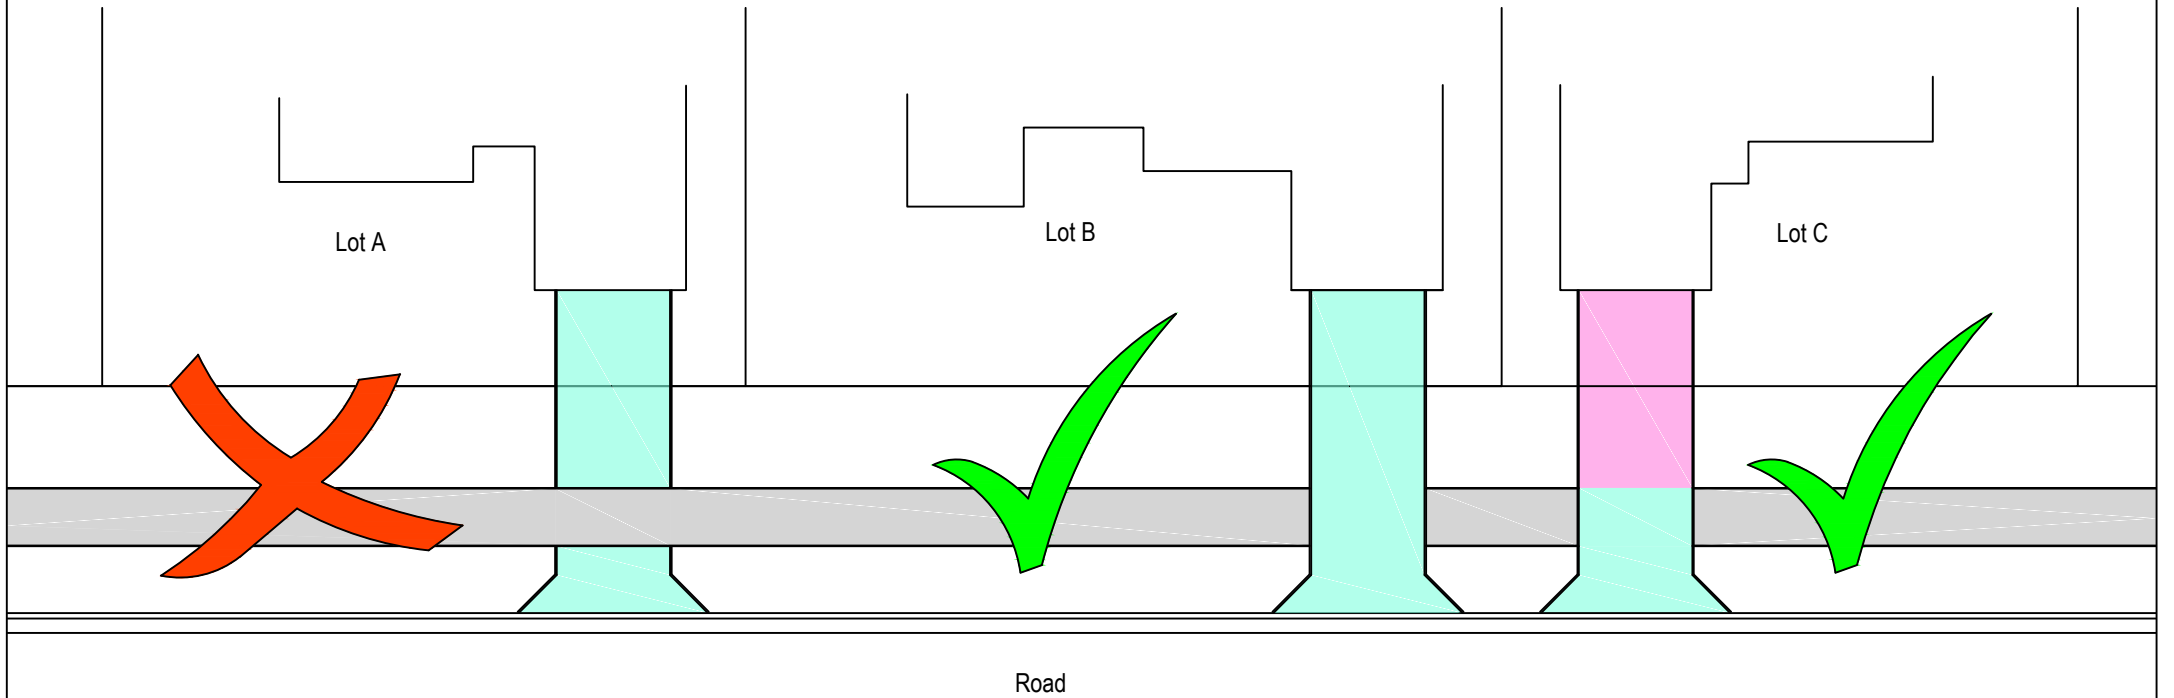
Key

- Existing footpath (Asphalt or Concrete) not built for vehicle loading
- Newly constructed driveway (matching existing footpath Asphalt or Concrete) and built to vehicle loading requirements
- Newly constructed driveway built to vehicle loading requirements matching surface material at garage

Lot A Drive is **incorrect** and does not meet council standards. The footpath battens and surface (Asphalt or Concrete) have not been cut out. The surface has not been replaced to match footpath either side

Lot B Drive is **correct** and meets council standards. The footpath surface (Asphalt or Concrete) and batten has been removed and the entire drive way from road to boundary has been constructed with the same surface material (Asphalt or Concrete) of the footpath either side.

Lot C Drive is **correct** and meets council standards. The footpath surface (Asphalt or Concrete) and batten has been removed and reconstructed from the road to back of footpath using the same surface material (Asphalt or Concrete) as the footpath either side. From the back of footpath to the boundary the drive way has been constructed to match the driveway material outside their garage
