**Project:** Stonebrook Subdivision Geotechnical Completion Report Stages 9, 10 and 11

Reference: 224926
Prepared for: CDL Land
New Zealand Ltd.

Revision: 1 13 November 2014

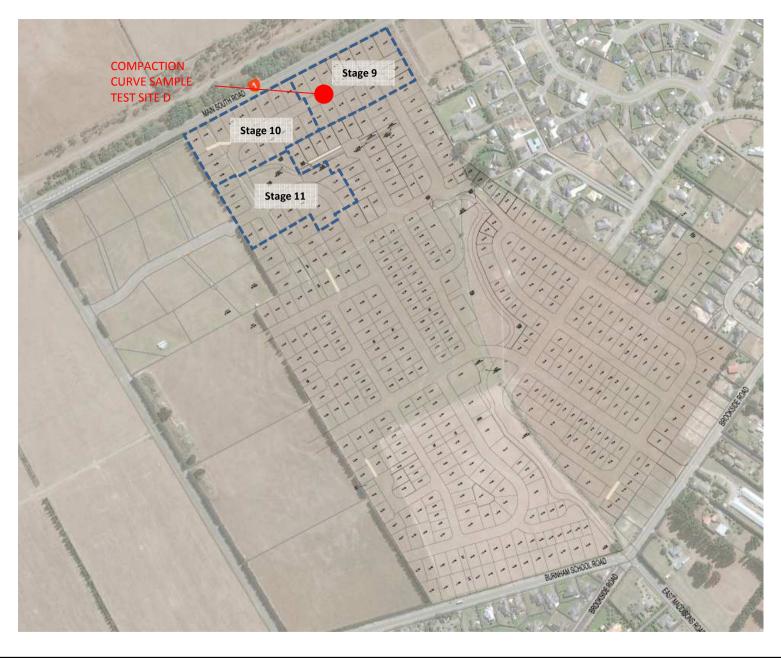
FIGURE FIGURE 2

The location of the soil samples obtained for laboratory compaction testing (Test Site D) is shown on Figure 2. The results of the nuclear density tests were compared to the compaction tests to confirm the adequacy of the site compaction.

STONEBROOK SUBDIVISION LAYOUT

This report has been prepared for CDL Land New Zealand Limited and Selwyn District Council. It describes earthworks within Stages 9, 10 and 11 of the Stonebrook Subdivision (See Figure 2 in Appendix A).

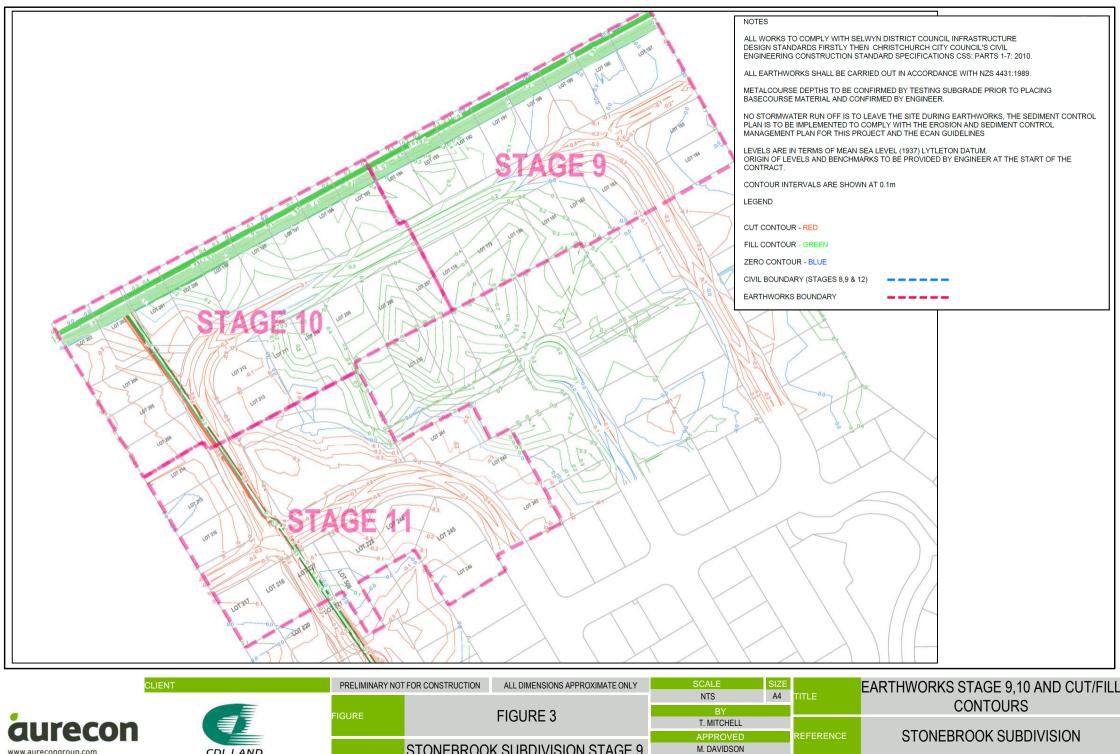
FIGURE No. PROJECT WBS TYPE DISC NUMBER REFERENCE
224926 003 FIG TRA 03

The maximum depth of filling was 2.0m along the northern boundary of the subdivision where a noise barrier bund has been constructed. The maximum depth of cut was 0.7m depth. The gravel fill was sourced from areas of cut close to each of the lots to minimise transportation. The extent of cutting and filling for each stage is shown on Figure 3 in Appendix A.

The extent of earthfill on Lots within Stages 9, 10 and 11 is shown on Figure 3 in Appendix A.

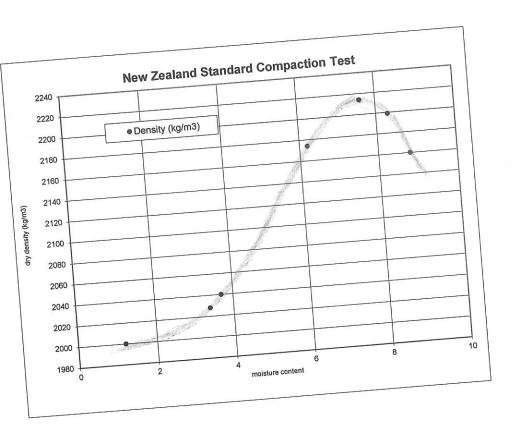
Maximum Dry Density = 2220 kg/m3 Optimum Water Content = 8 %

e: urce: Sand and aggregate Rolleston CDL, Test Site D

The compaction test results and the compaction curve for Test Site D is presented in Appendix B.

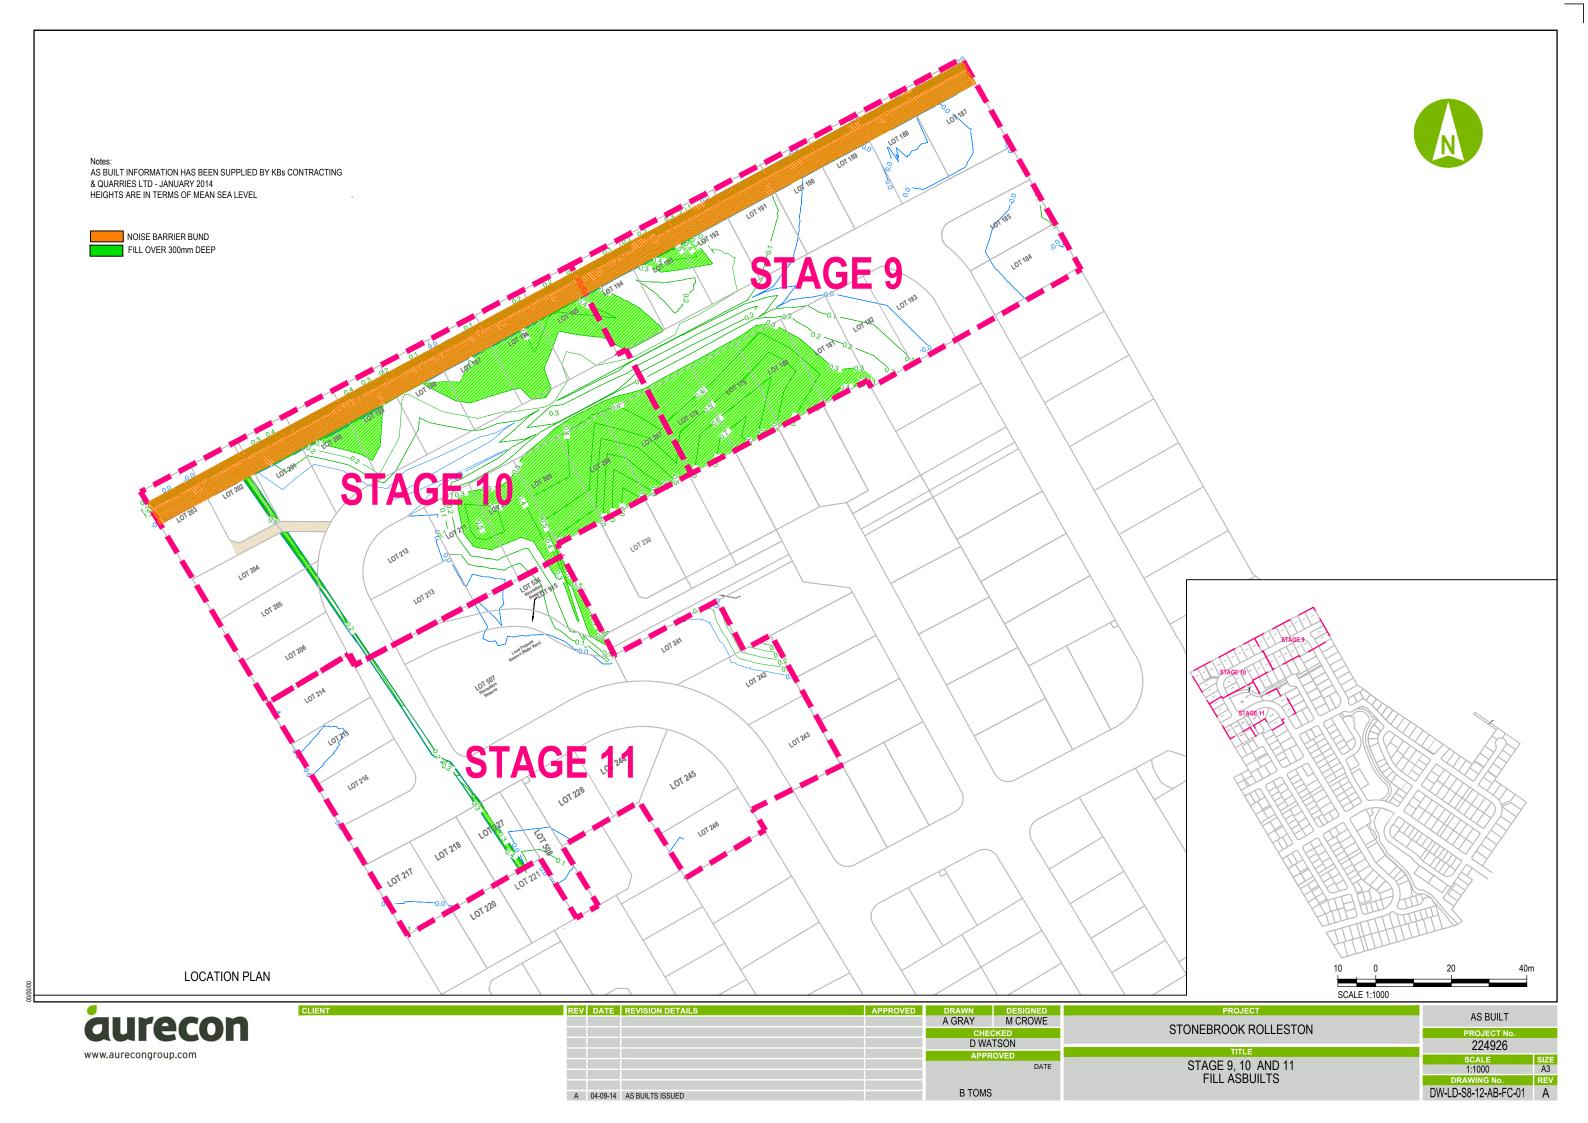
The earth filling, with depths of fill are shown on the attached plan 224926-DW-LD-S8-12-AB-FC-01 [A], have been place in compliance with the terms of NZS 4431:1989.

The attached plan, 224926-DW-LD-S8-12-AB-FC-01 [A], shows those lots affected by filling and the extent of the fill as part of the development works.
