Prestons Park Subdivision
GEOTECHNICAL REPORT FOR LOT 941
CDL Land NZ Limited

26 June 2023
Revision: 1
Reference: 235361

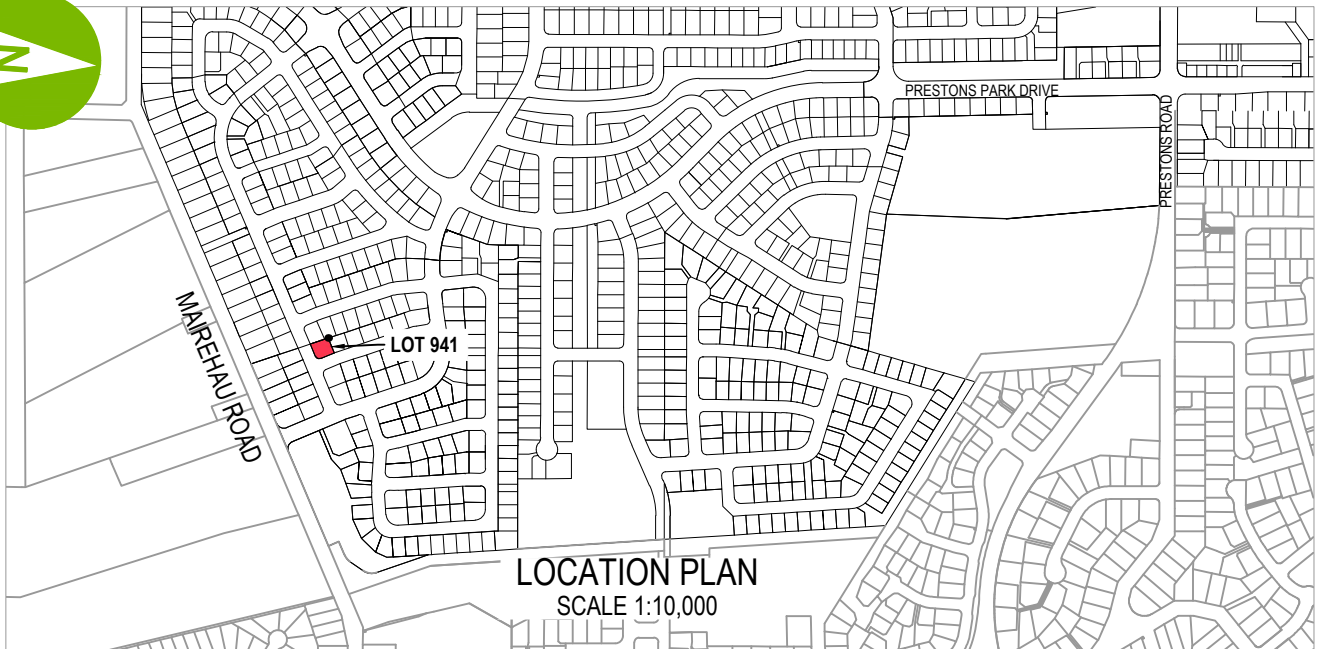
TITLE
**LOT 941
SITE LOCATION PLAN
FIGURE 1**

This building consent report is for Lot 941 which is located in Stage 5-H1 of the Prestons Park Subdivision development (refer Figure 1 in Appendix A). The lot is bordered by residential lots to the west and north, with access road to the east and south.

There are no natural sources of surface water on the subdivision. There is a storm water channel and pond to the east of Lot 941.
