Prestons Park Subdivision  
GEOTECHNICAL REPORT FOR LOT 953  
CDL Land NZ Limited

28 June 2023  
Revision: 1  
Reference: 235361

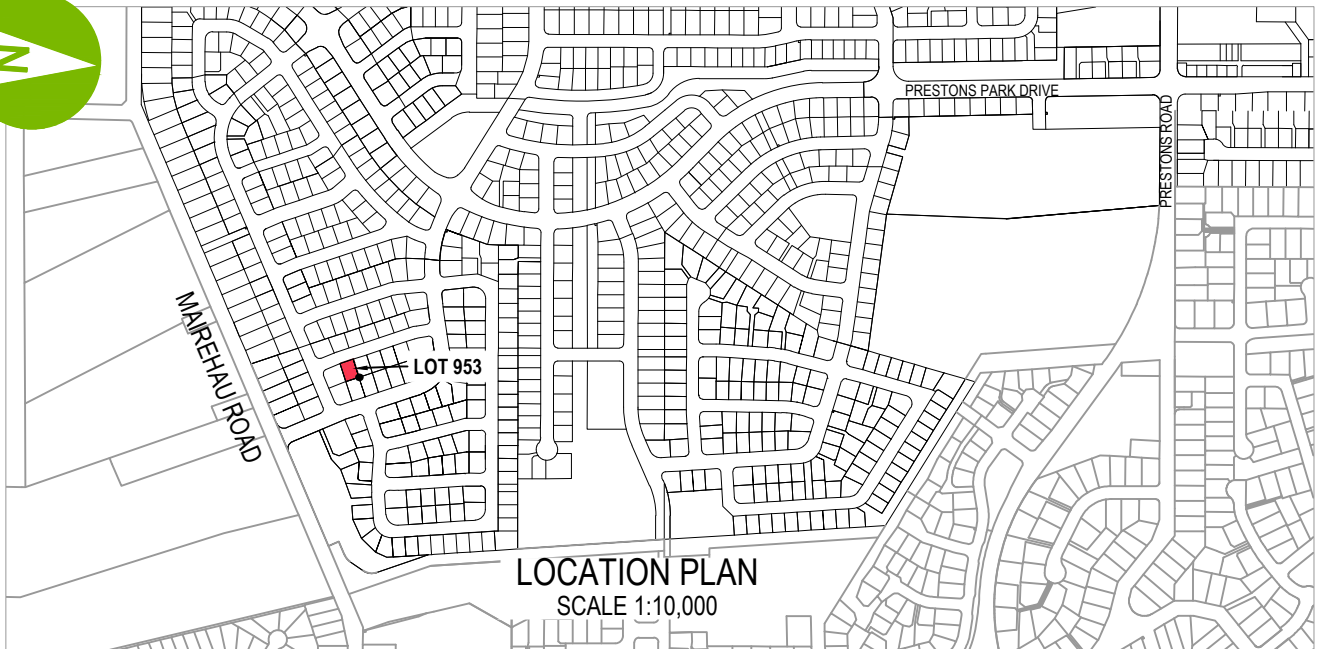
PROJECT
PRESTONS PARK
TITLE
LOT 953 SITE LOCATION PLAN FIGURE 1

This building consent report is for Lot 953 which is located in Stage 5 of the Prestons Park Subdivision development (refer Figure 1 in Appendix A). The lot is bordered by residential lots to the north, south and east, with access roads to the west.
