Appendix D

2012 CPT Logs

PIEZOCONE PENETROMETER TEST (CPTU) INTERPRETIVE REPORT

Location: Prestons Subdivision, Christchurch

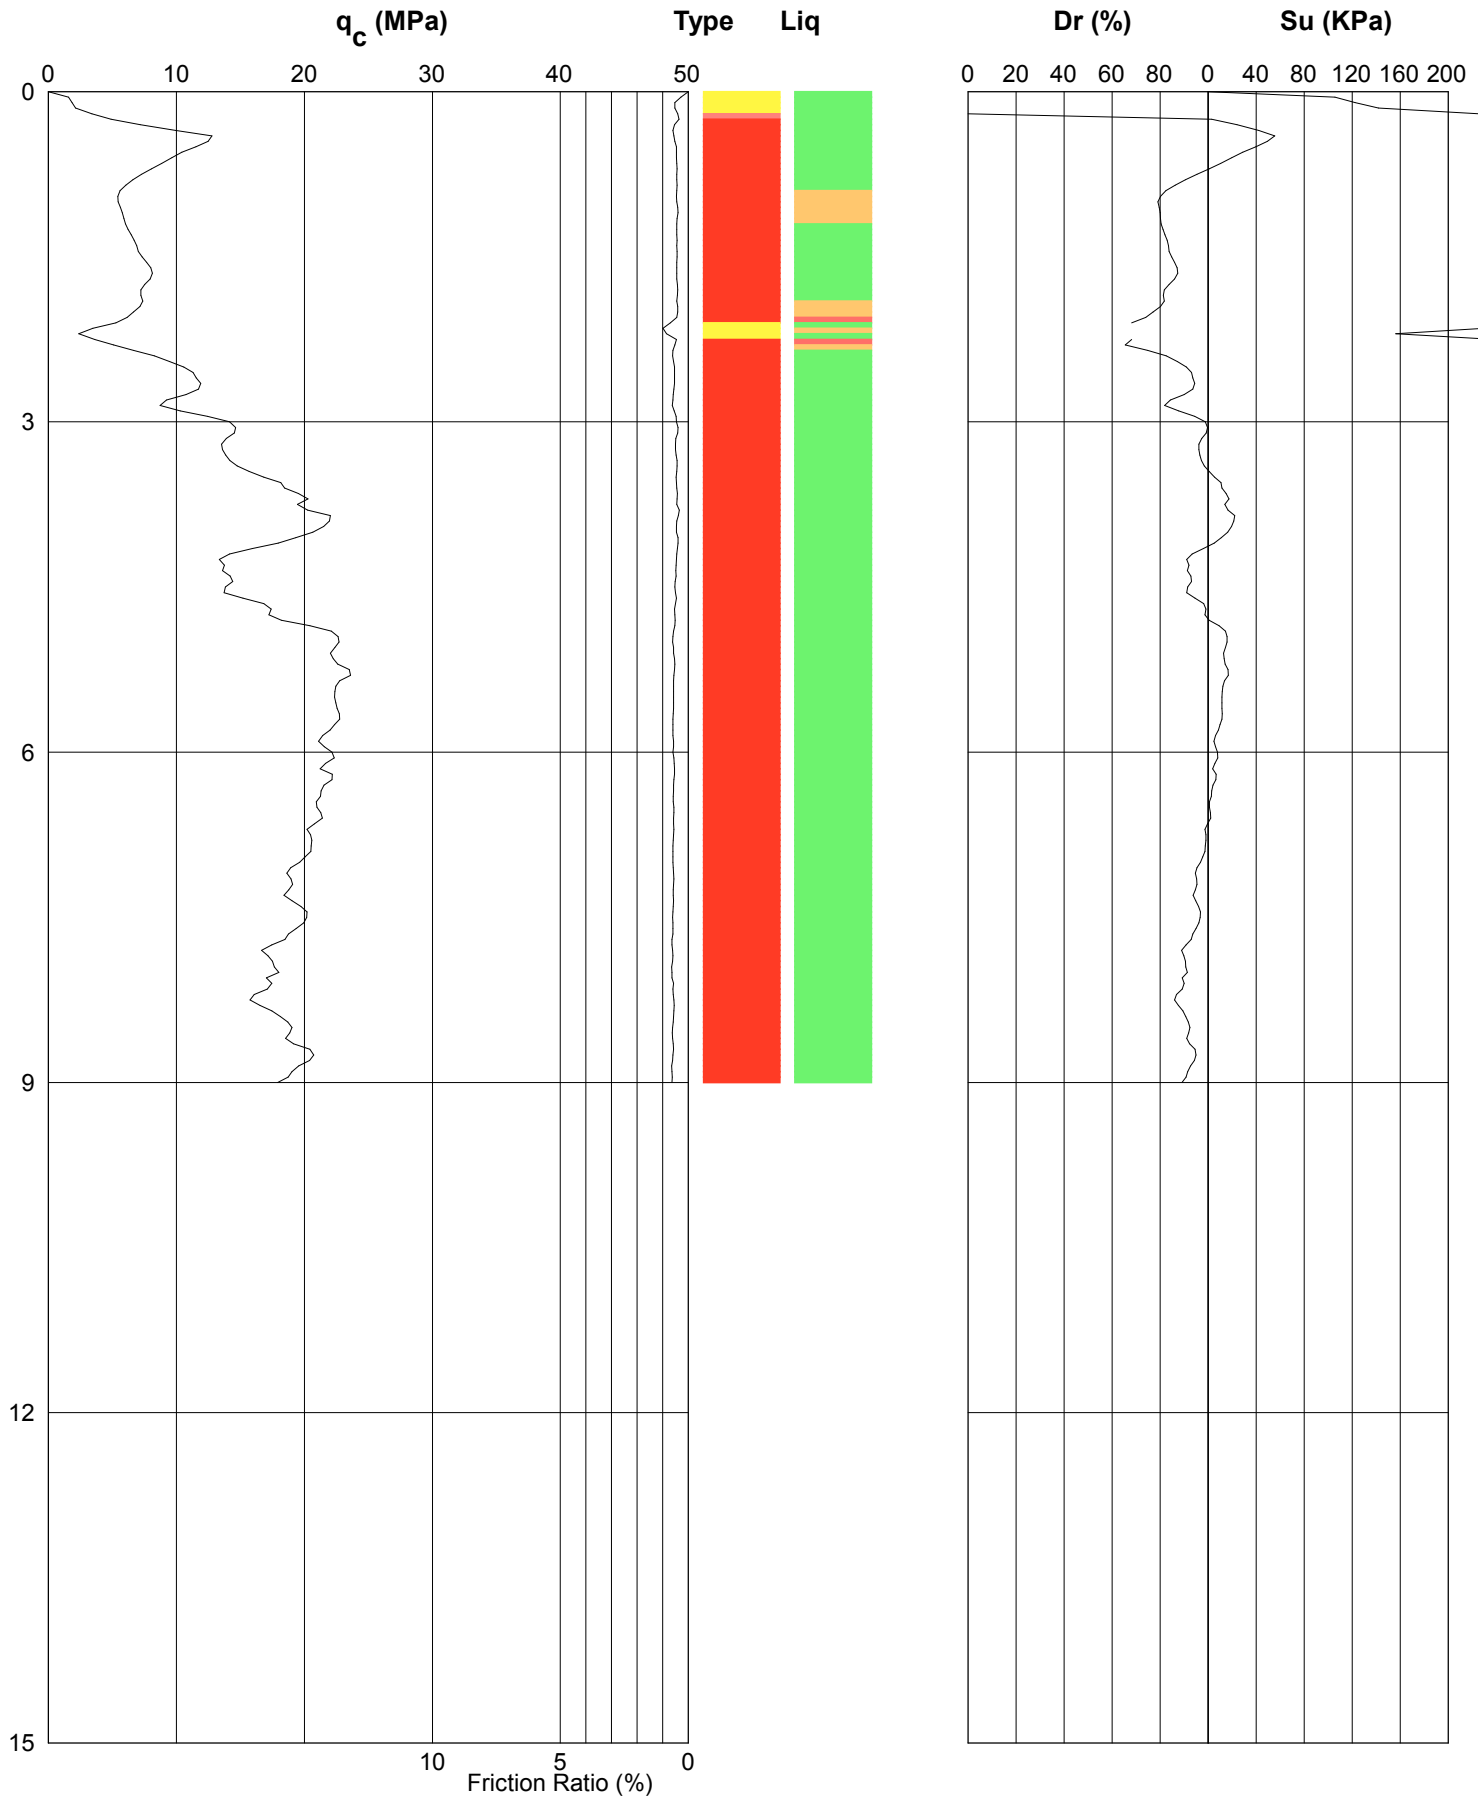
CPT No: CPT101

Remark: Effective Refusal

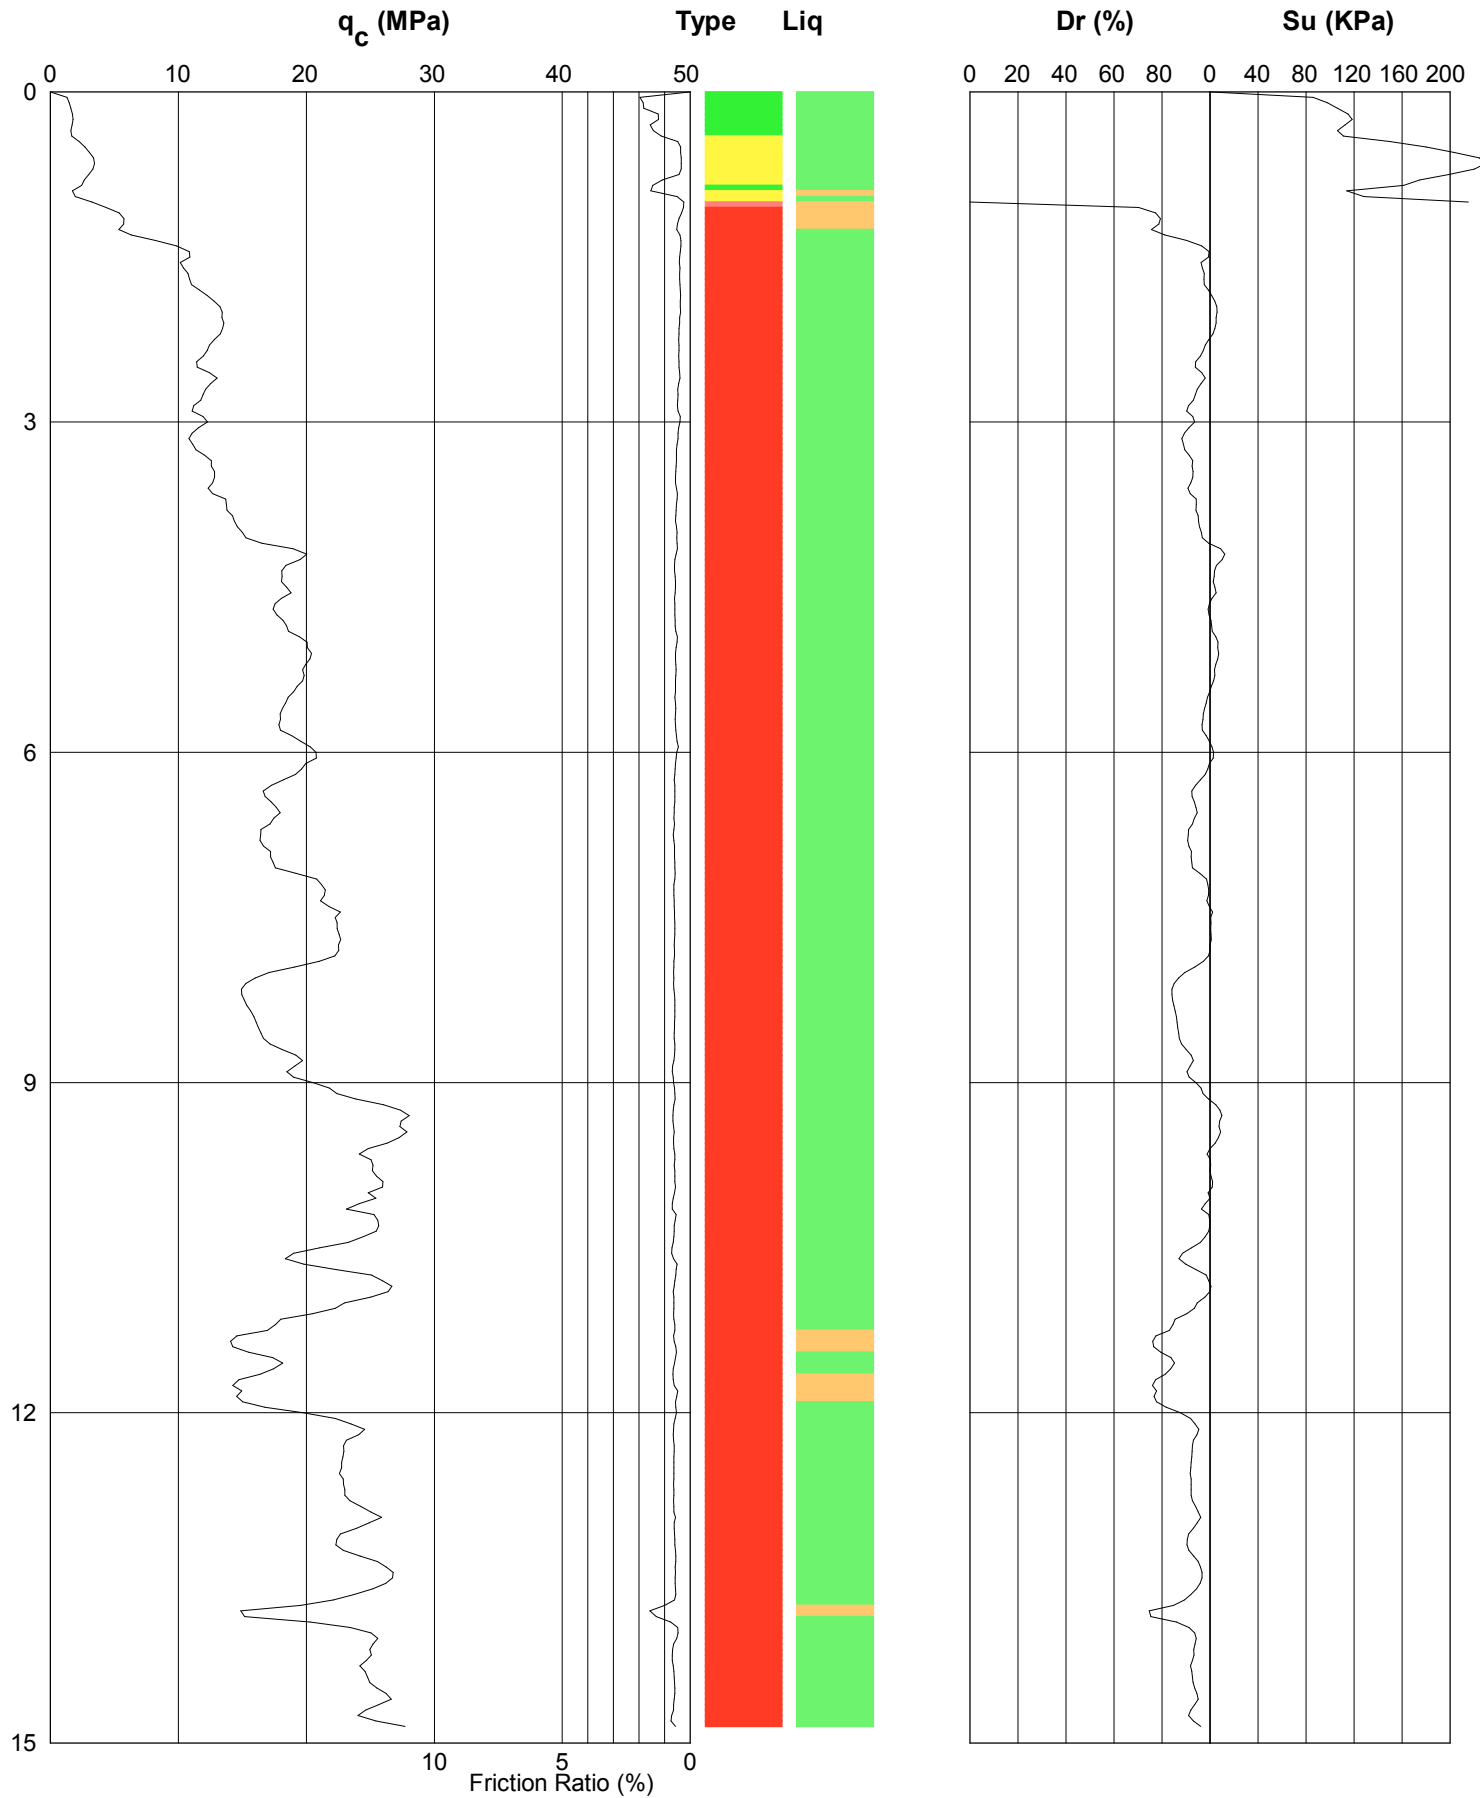
CPT No: CPT102

Remark: Target Depth

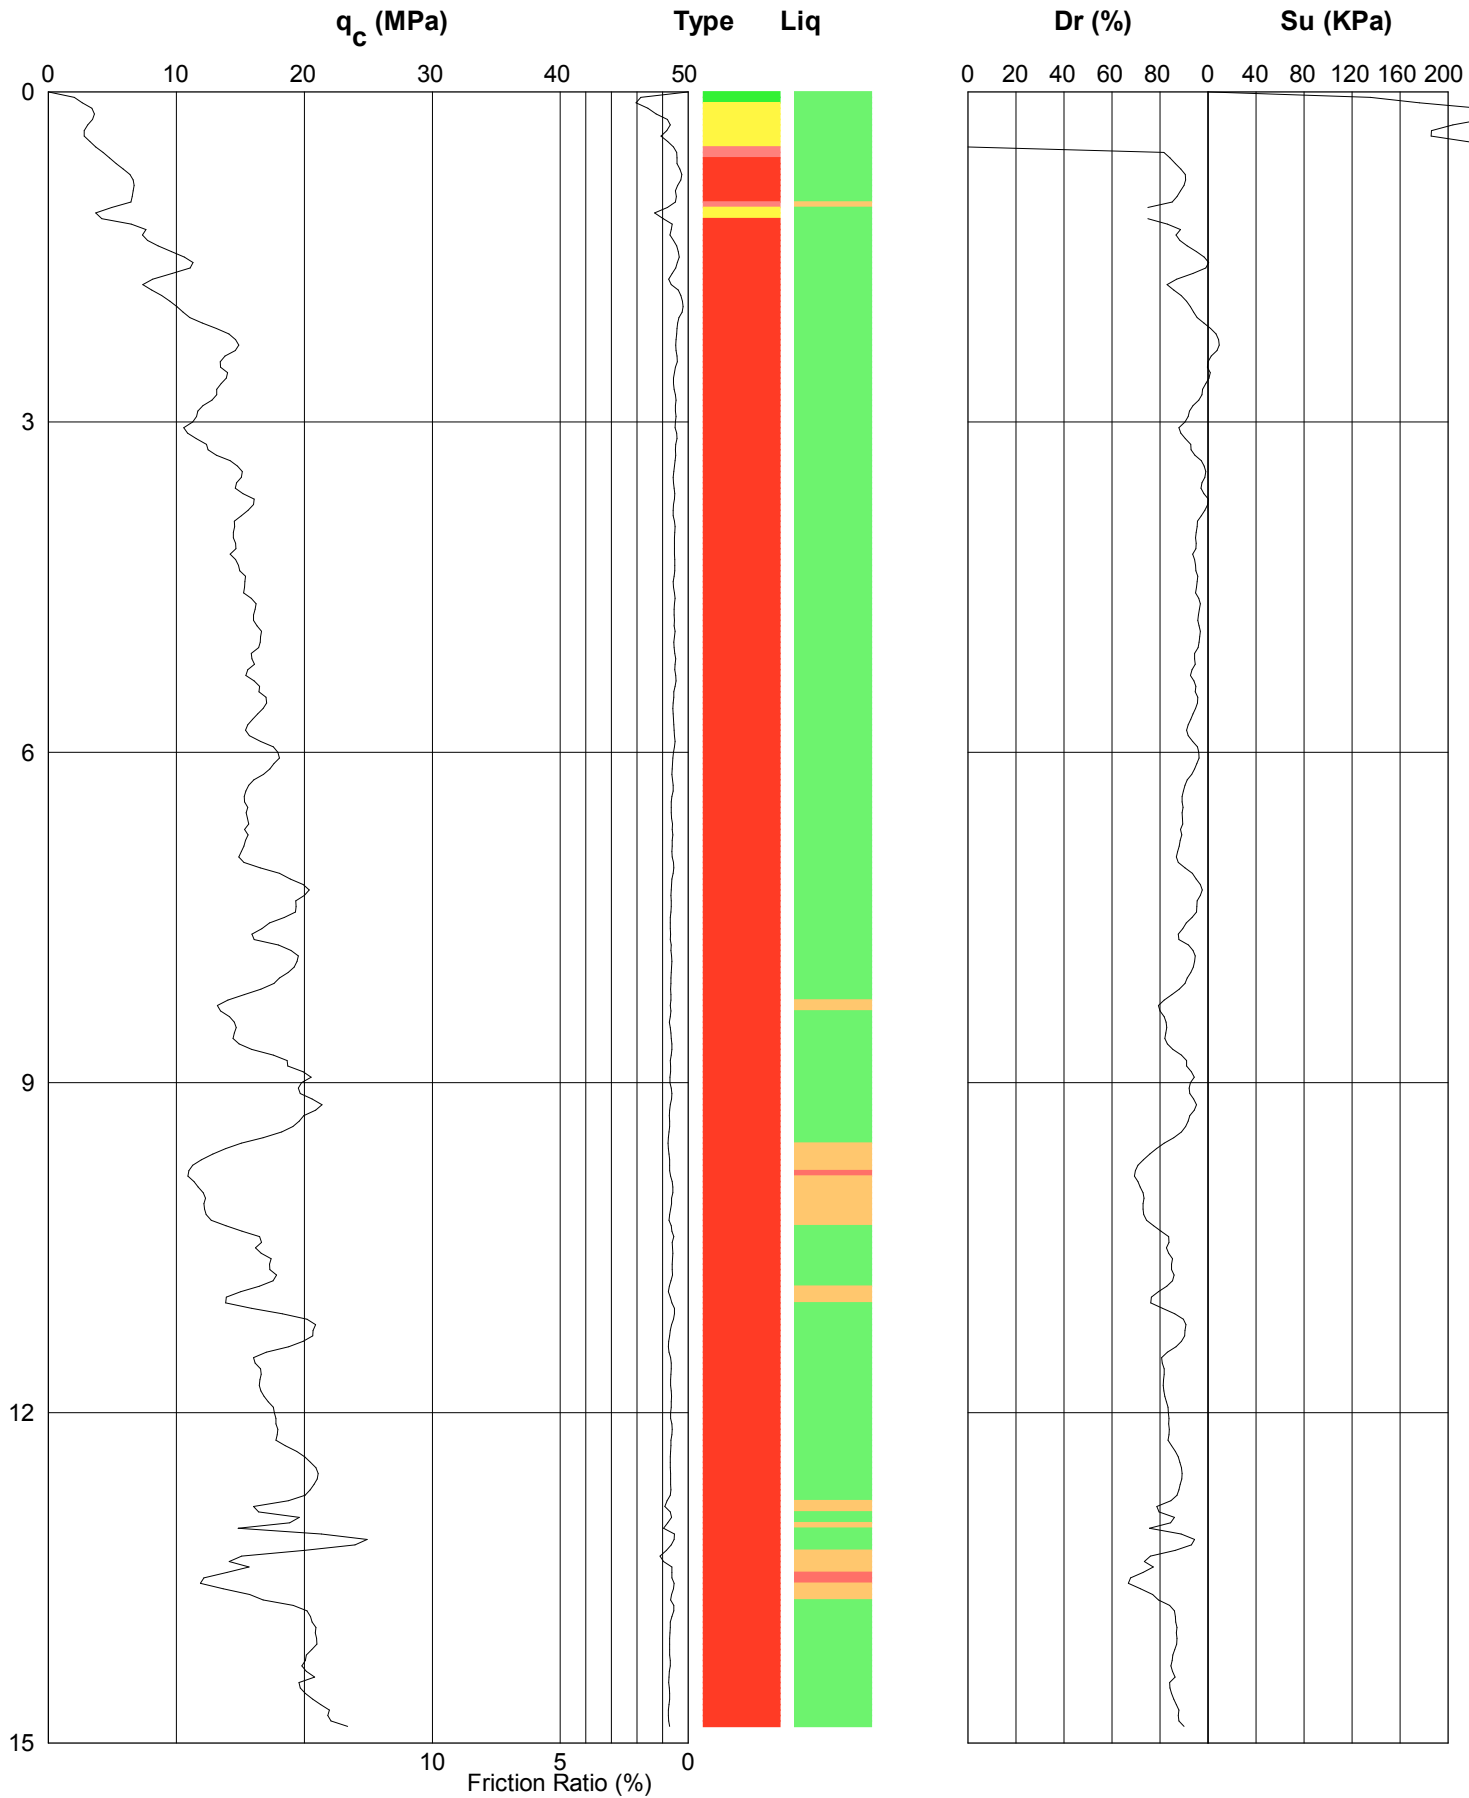
CPT No: CPT103

Remark: Target Depth

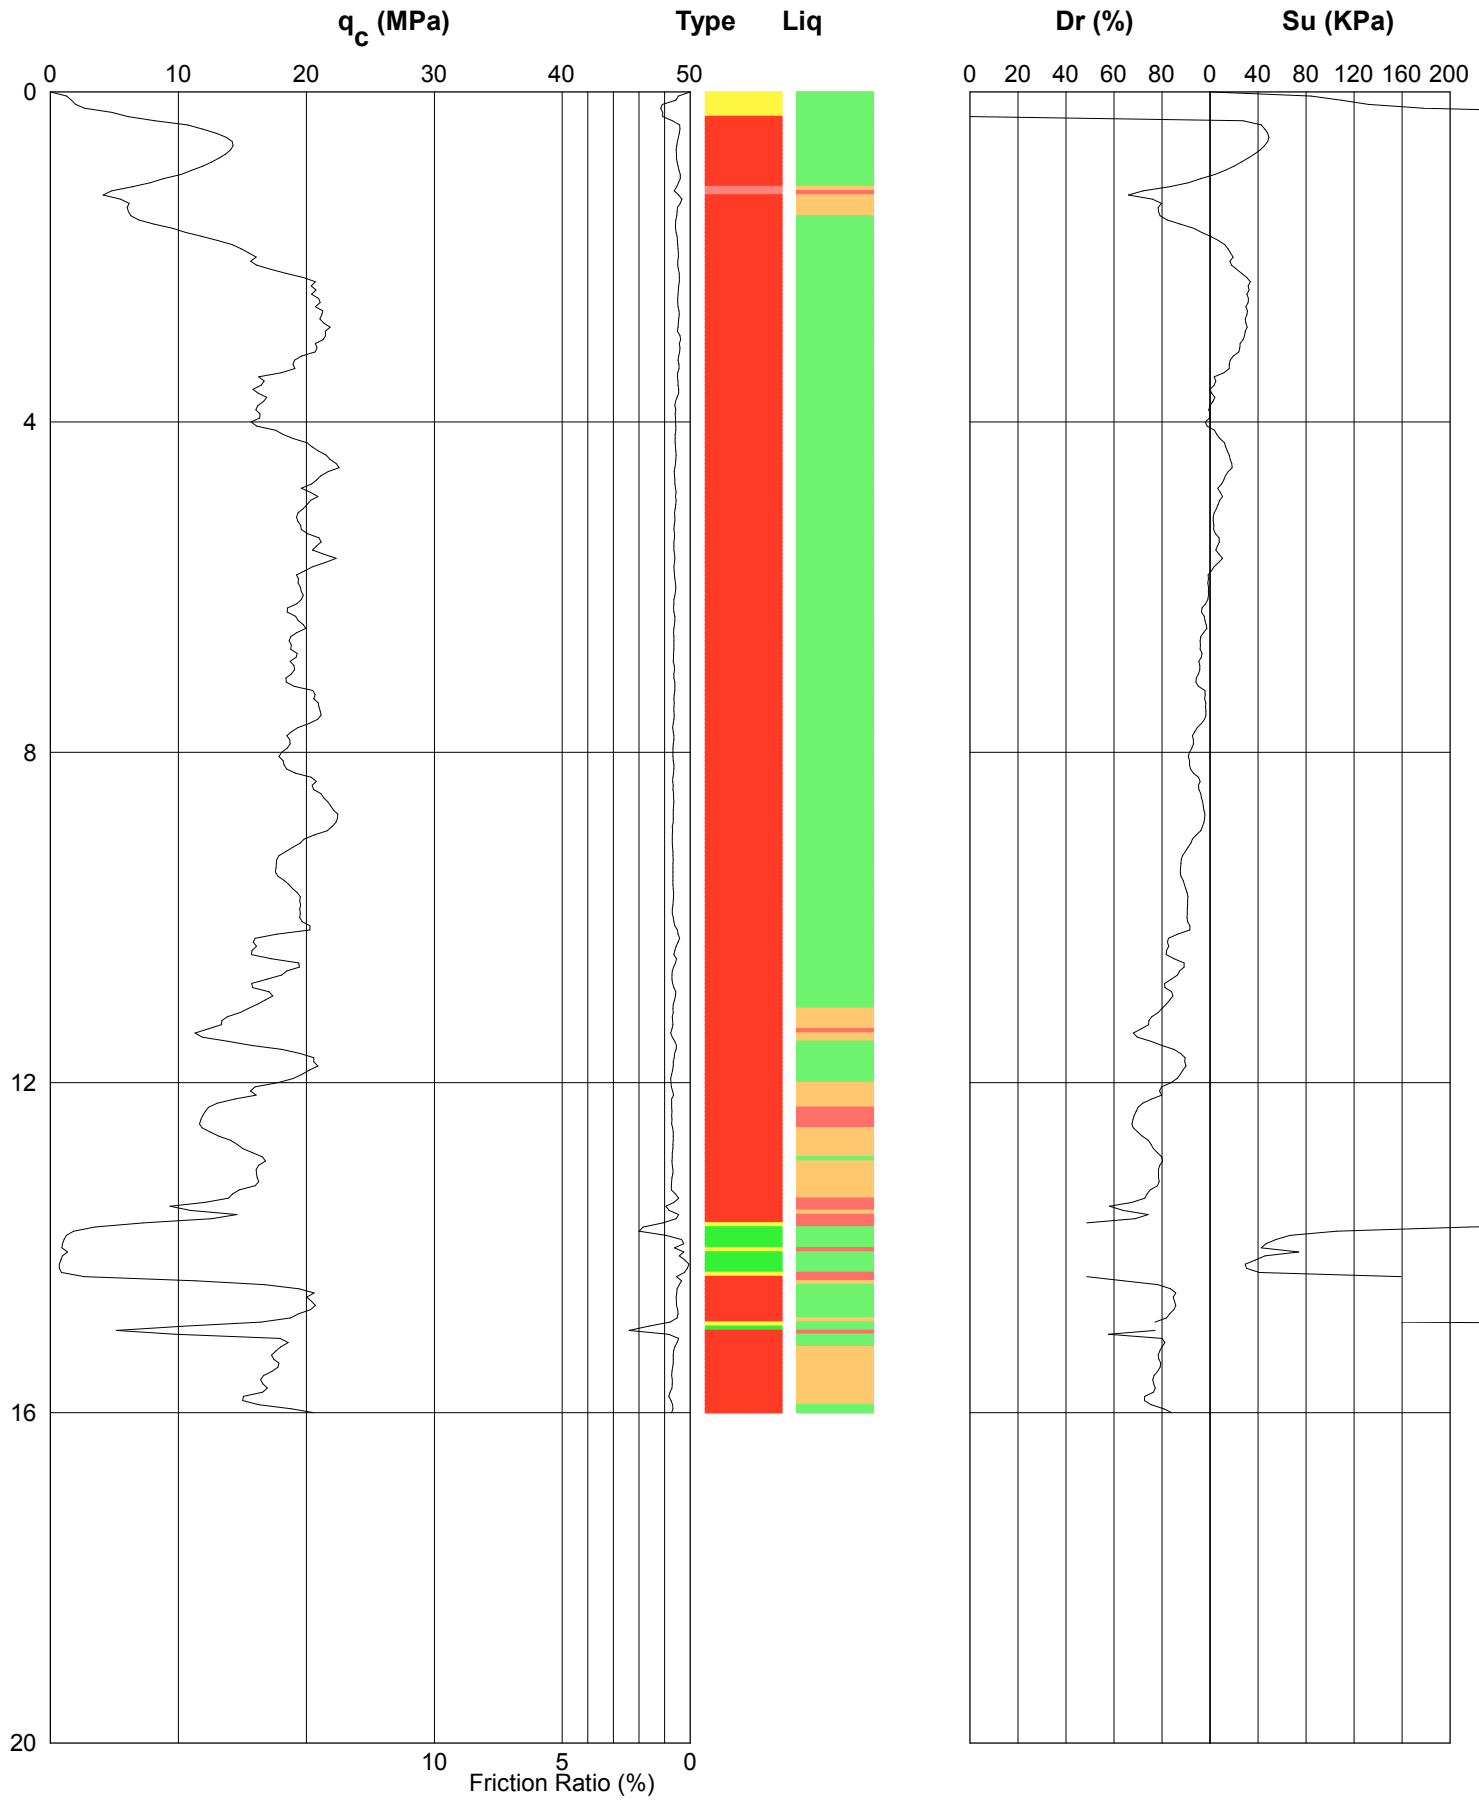
CPT No: CPT104

Remark: Effective Refusal

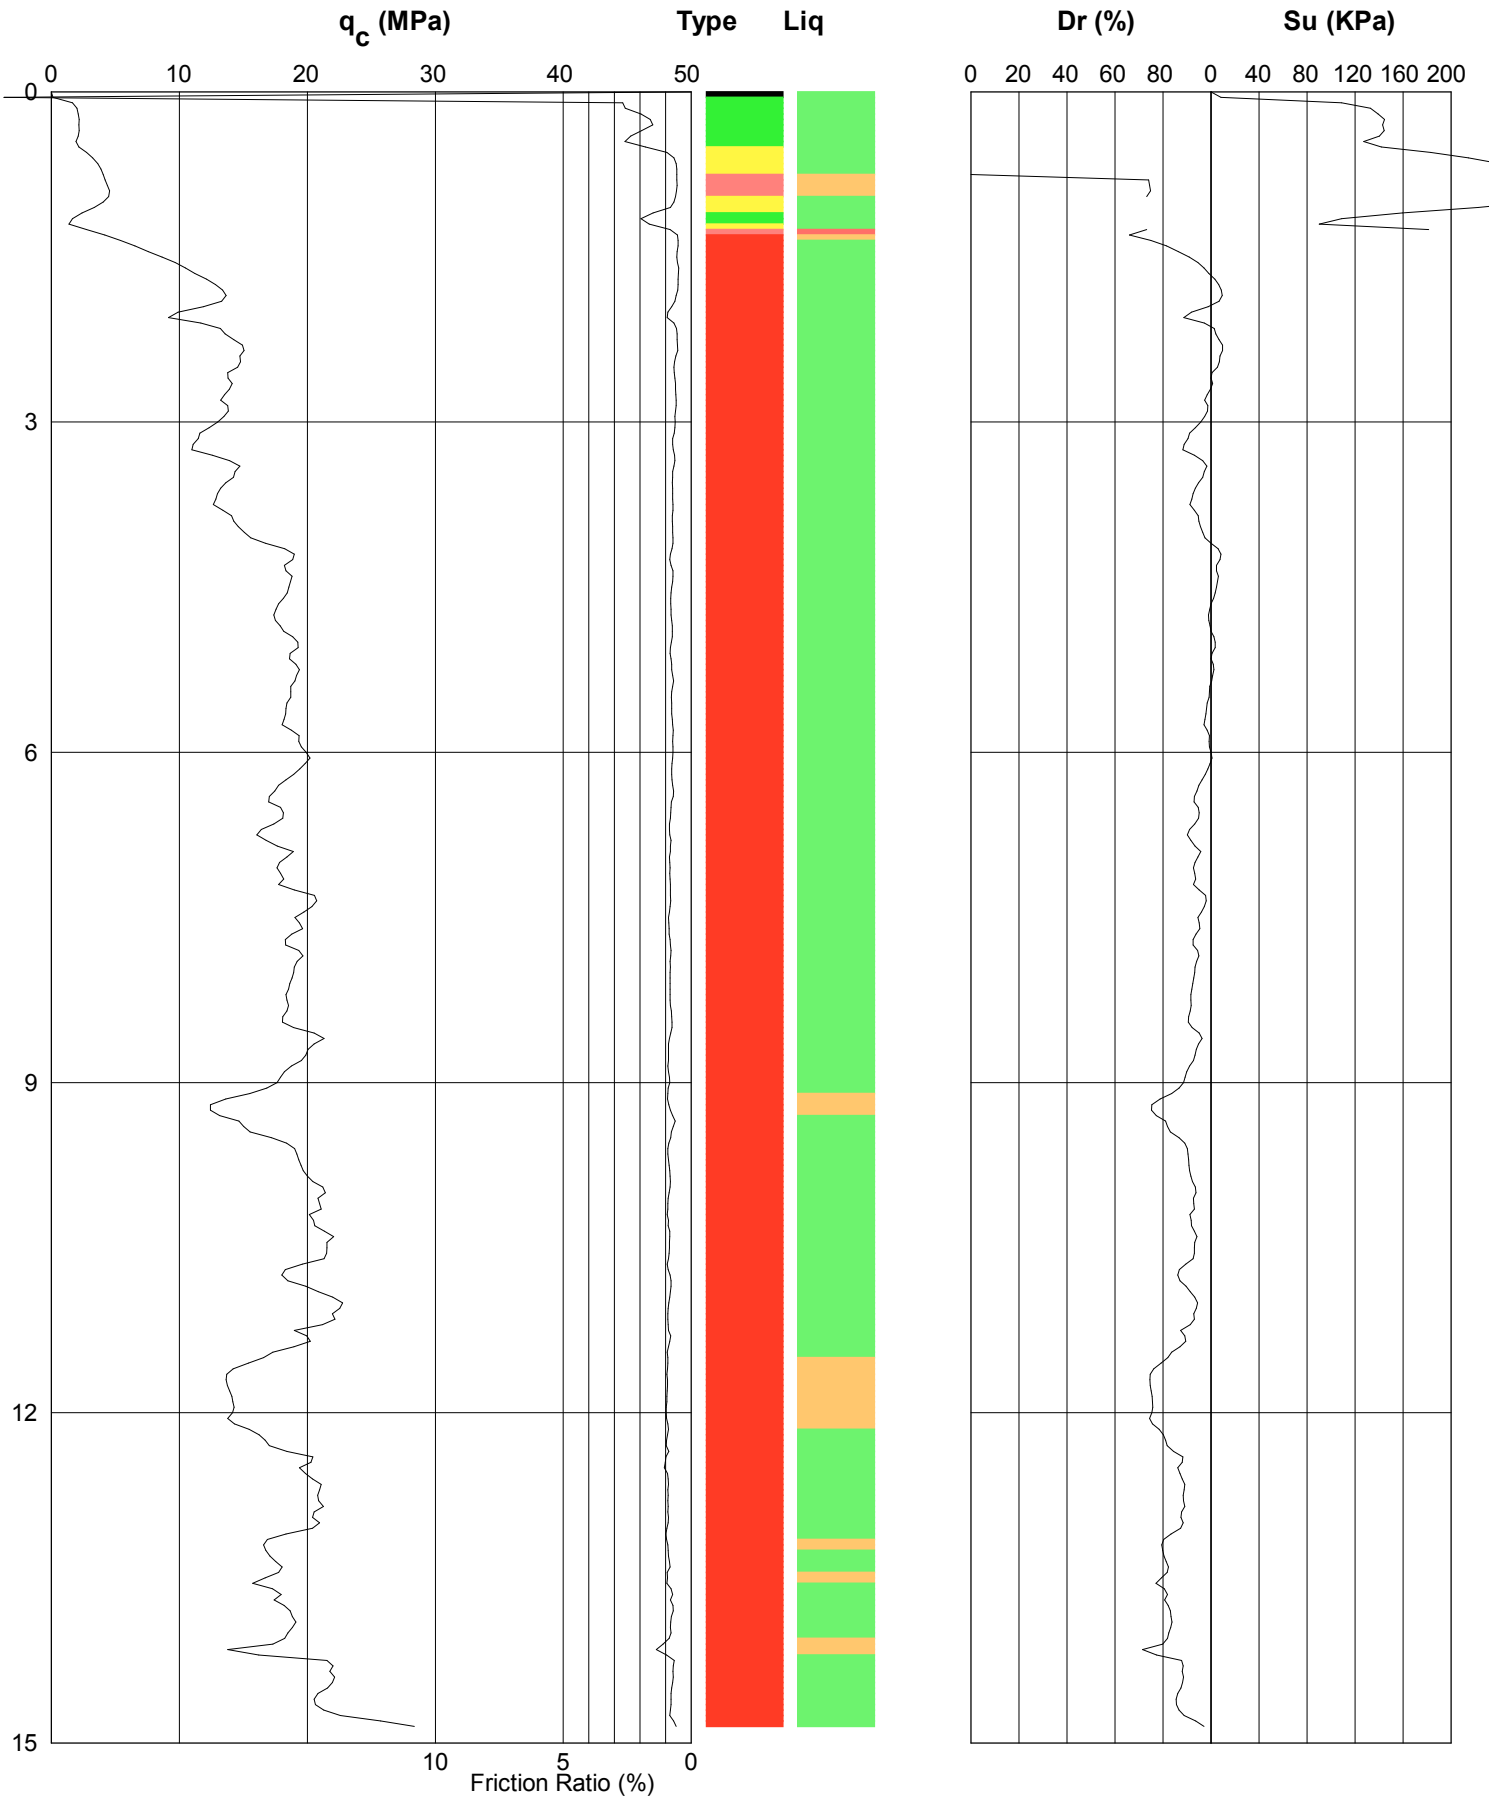
CPT No: CPT105

Remark: Target Depth

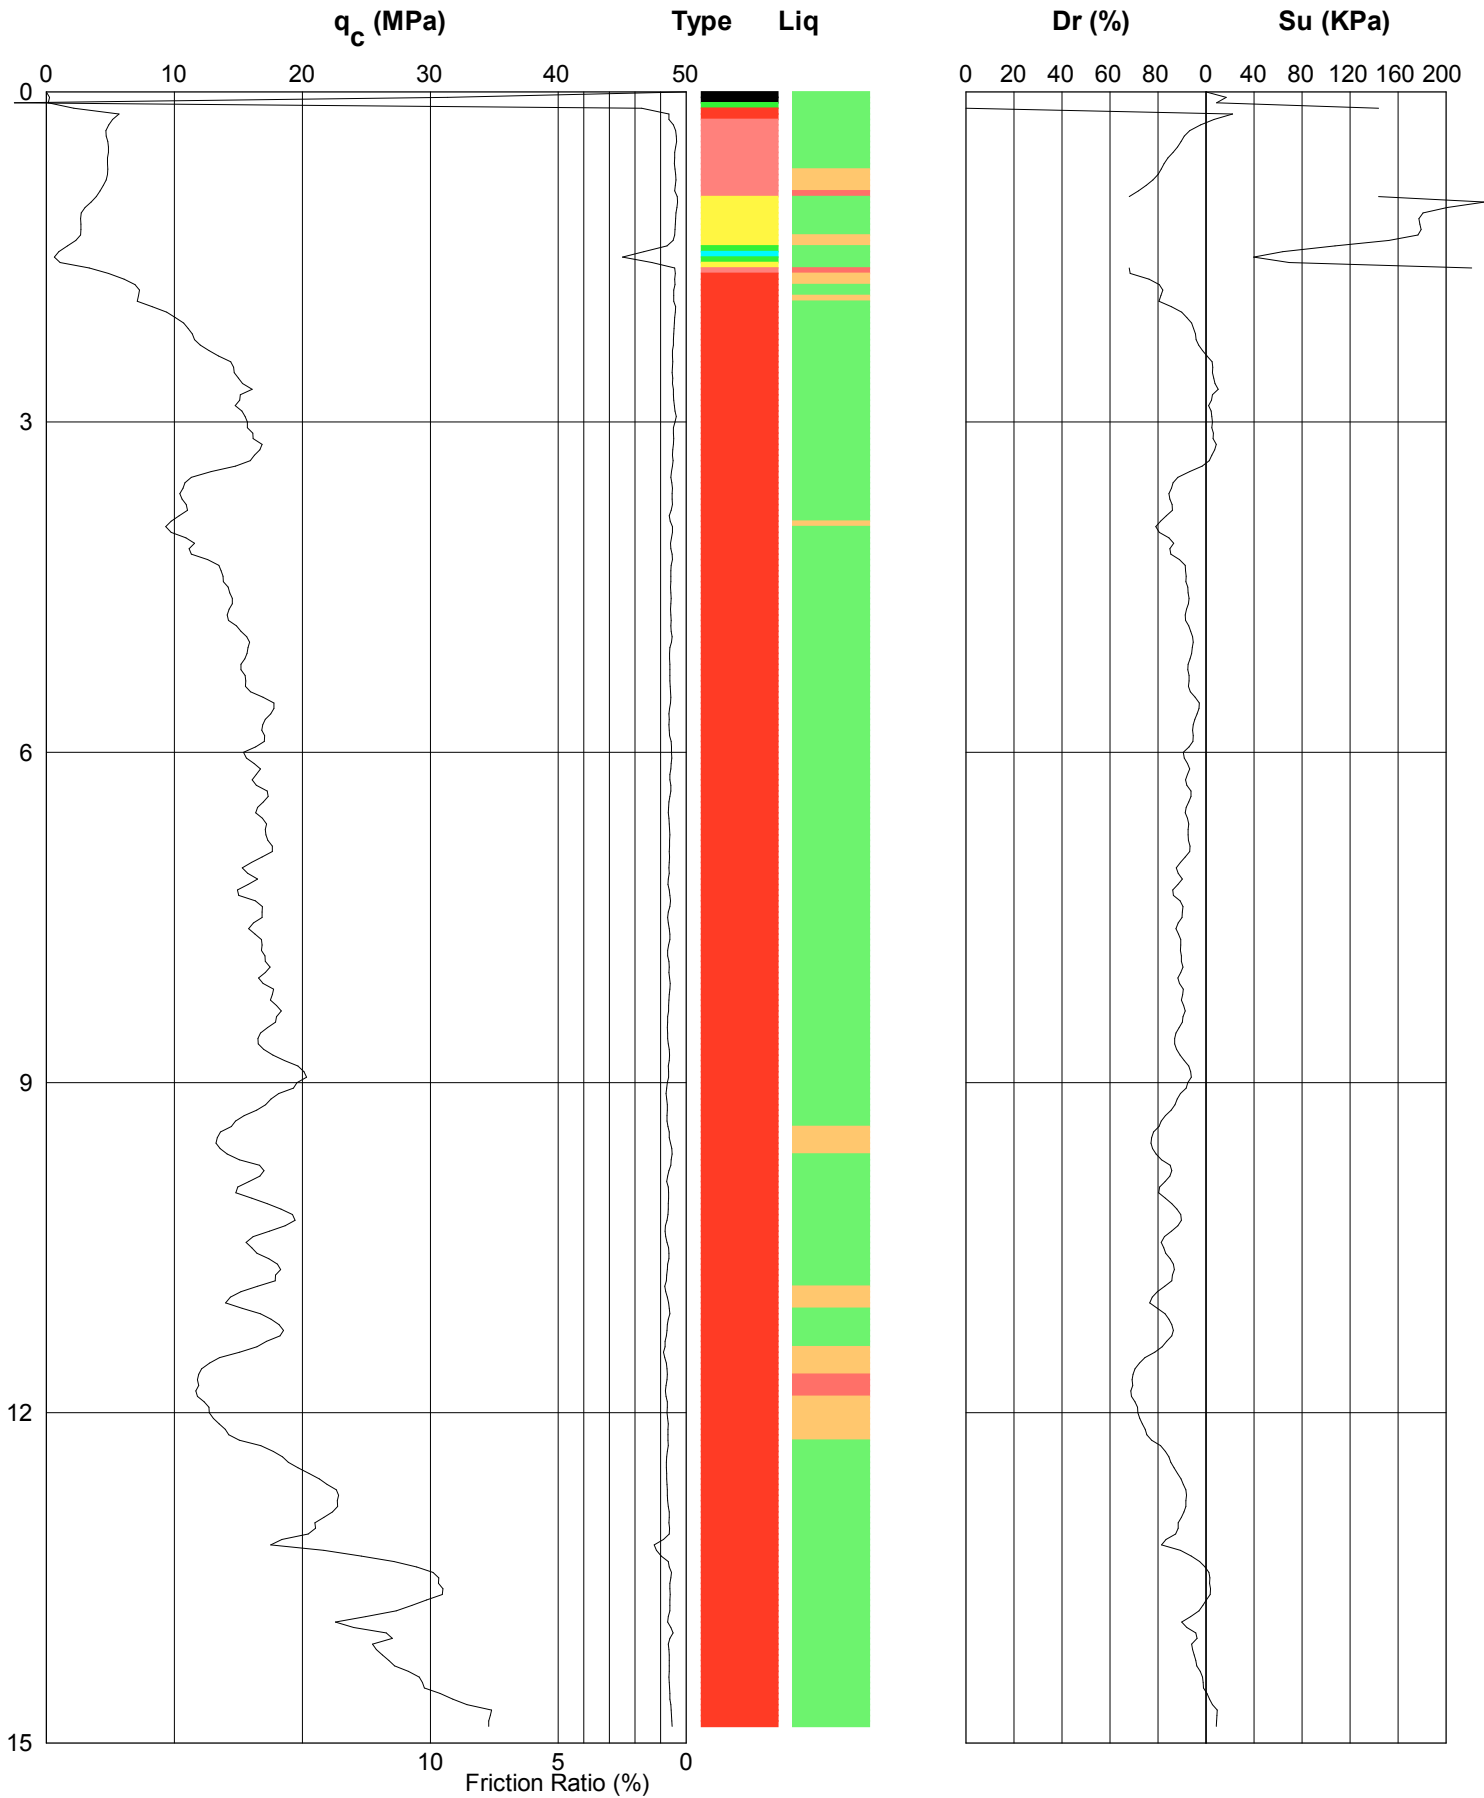
CPT No: CPT106

Remark: Target Depth

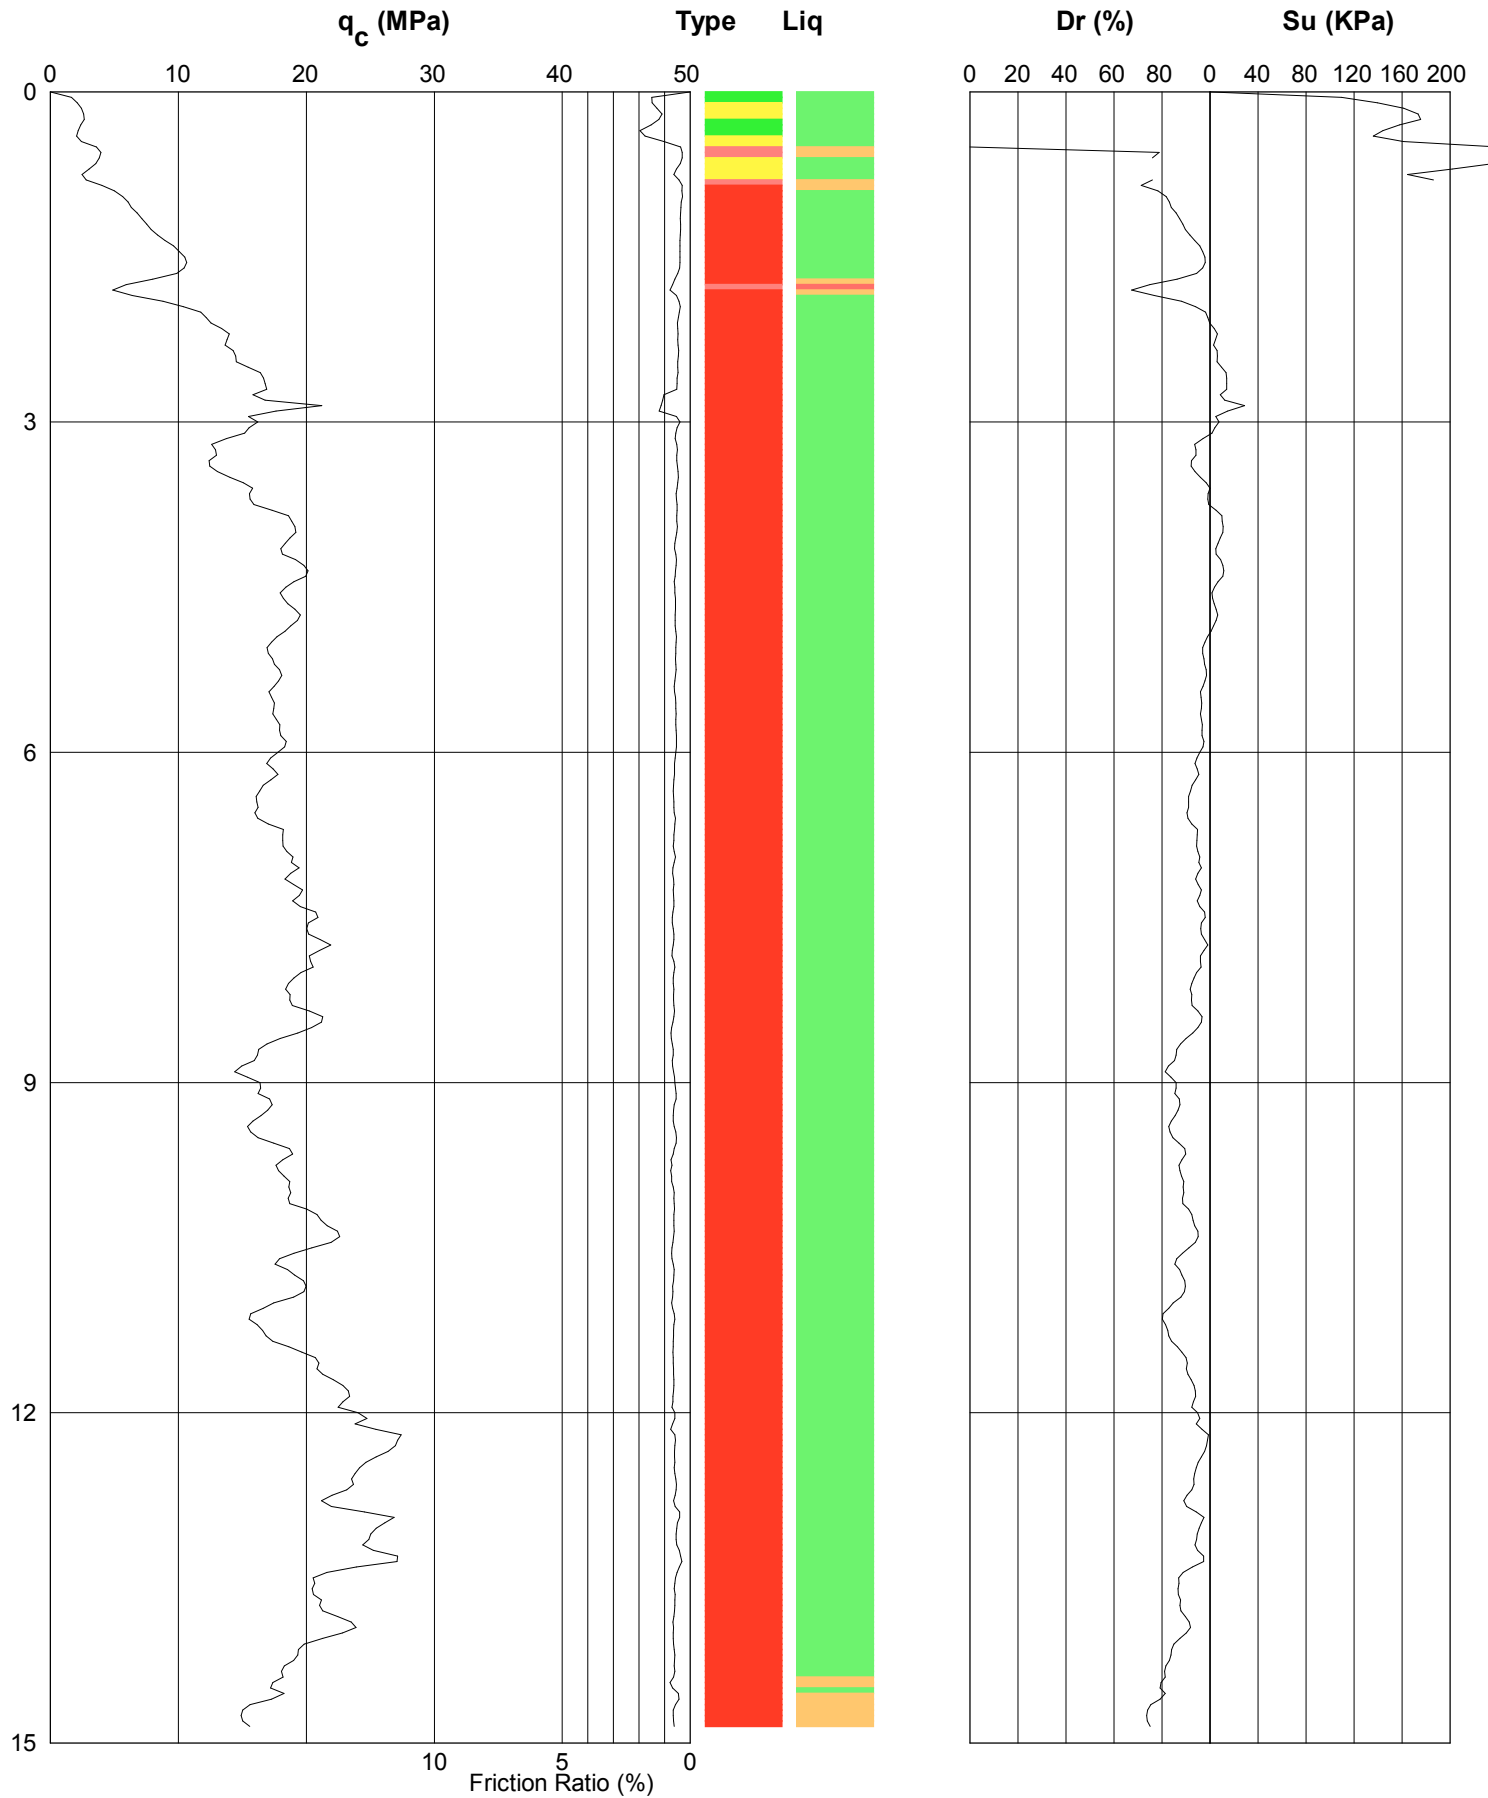
CPT No: CPT107

Remark: Target Depth

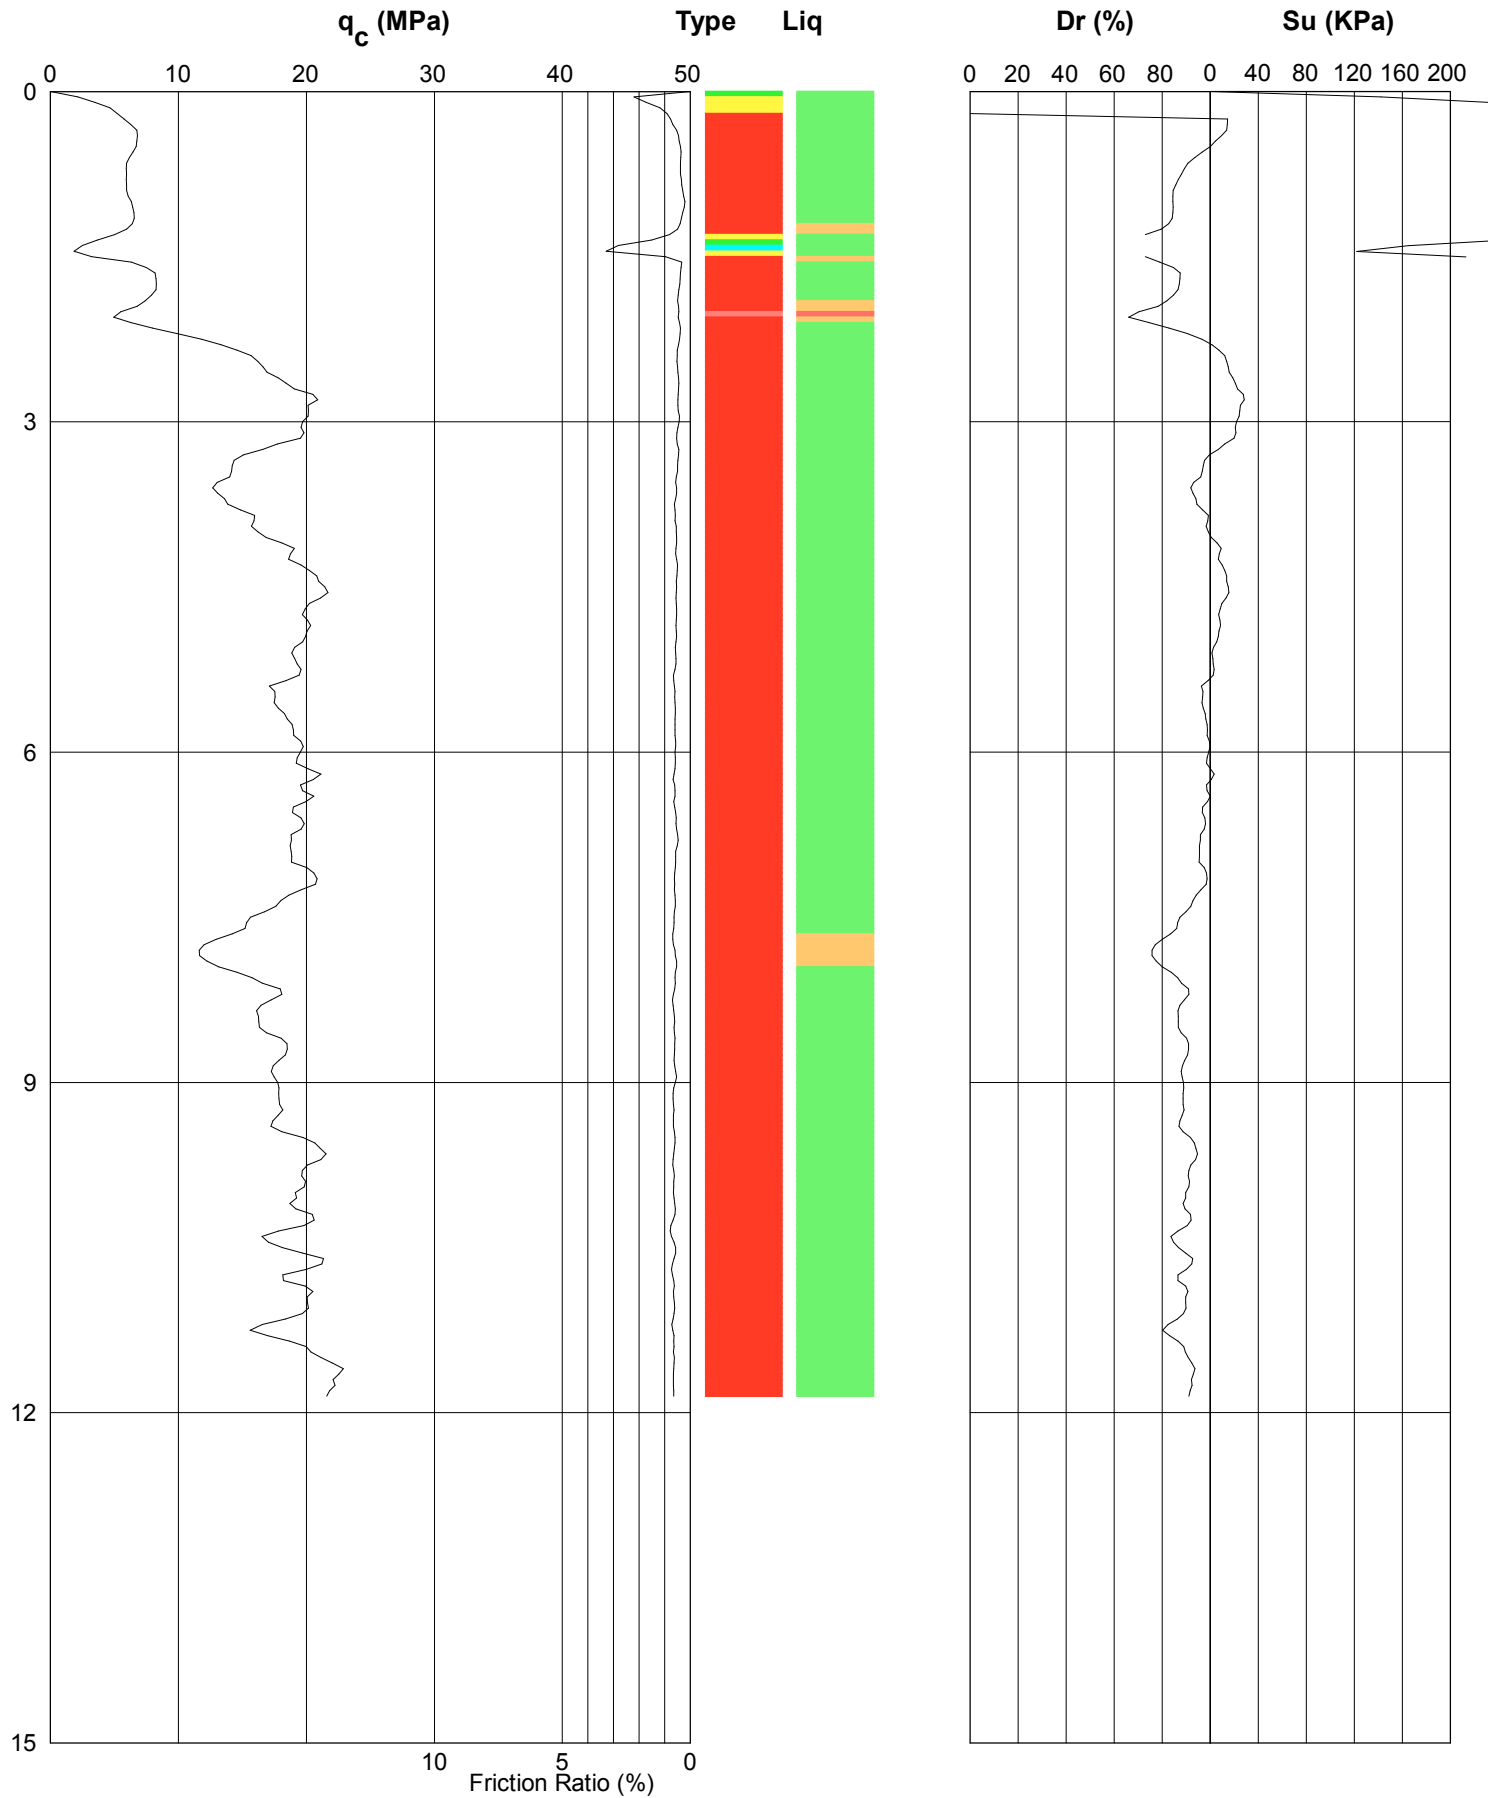
CPT No: CPT108

Remark: Effective Refusal
