Appendix D

2012 CPT Logs

PIEZOCONE PENETROMETER TEST (CPTU) INTERPRETIVE REPORT

Location: Prestons Subdivision, Christchurch

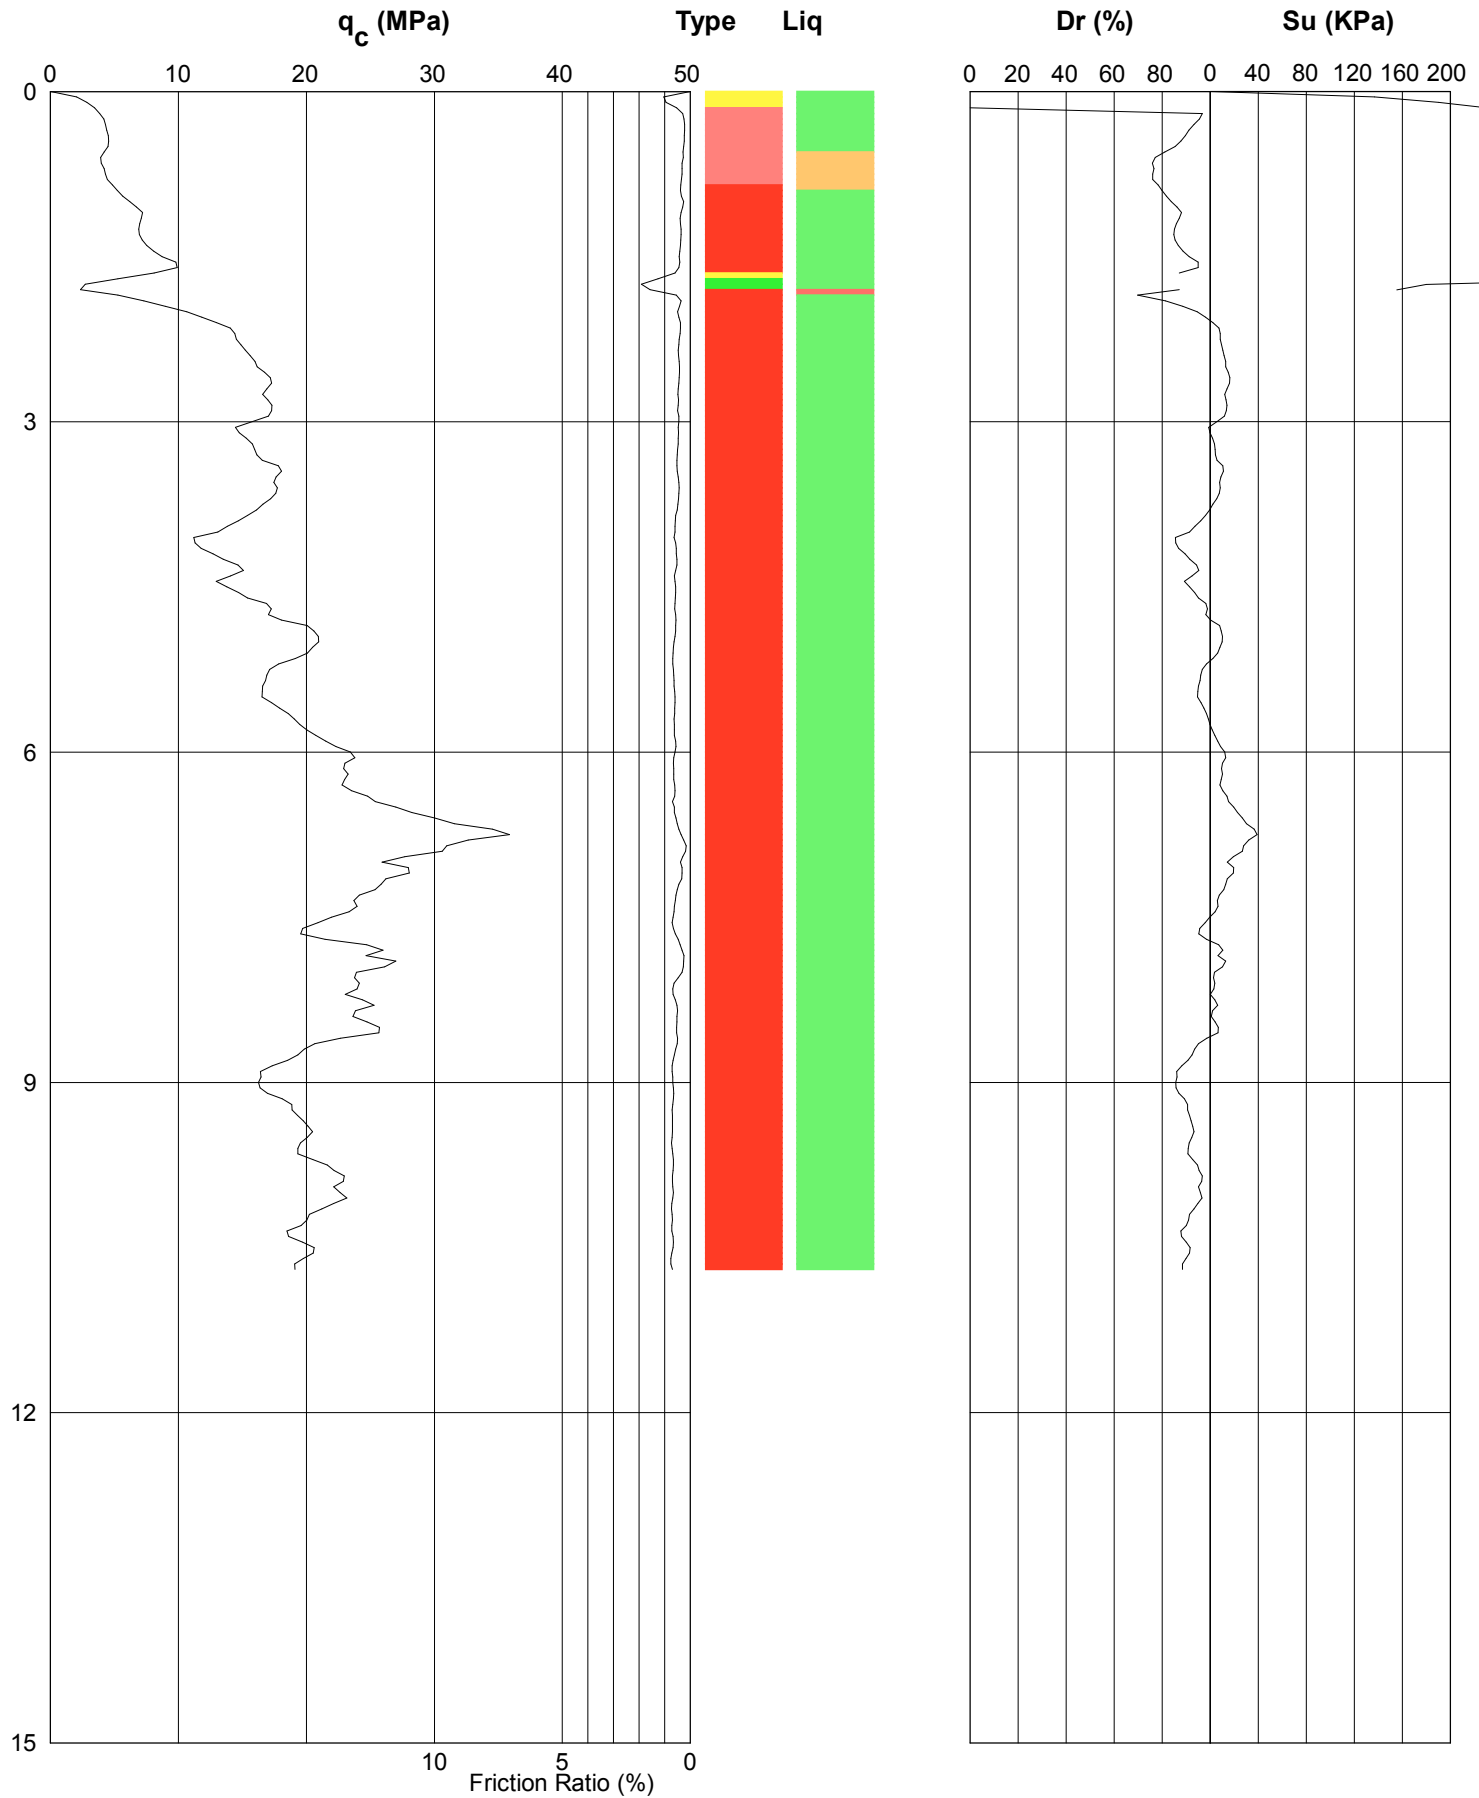
CPT No: CPT109

Remark: Effective Refusal

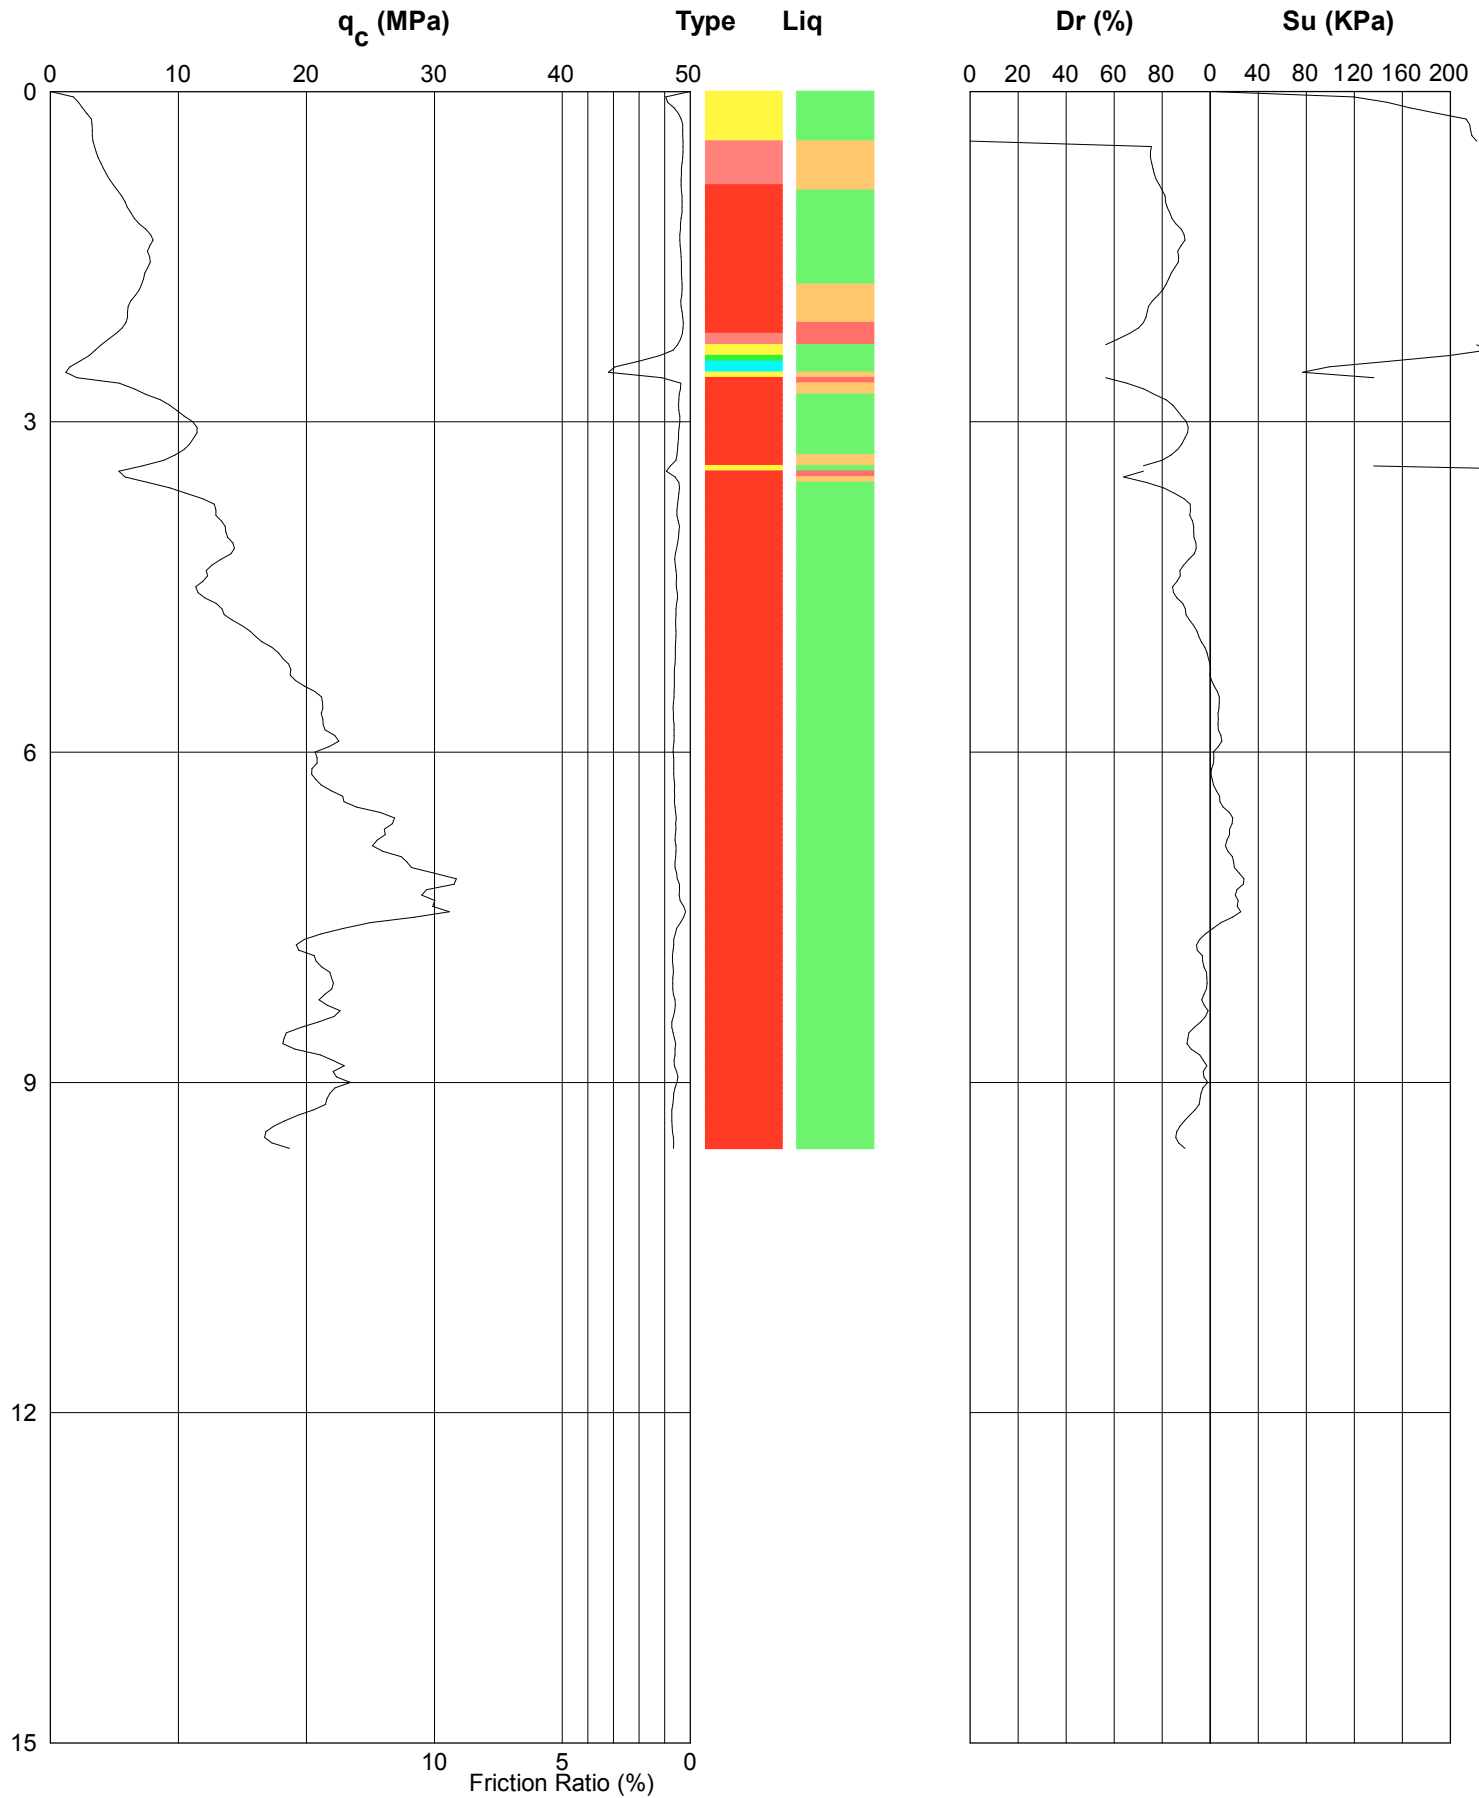
CPT No: CPT110

Remark: Effective Refusal

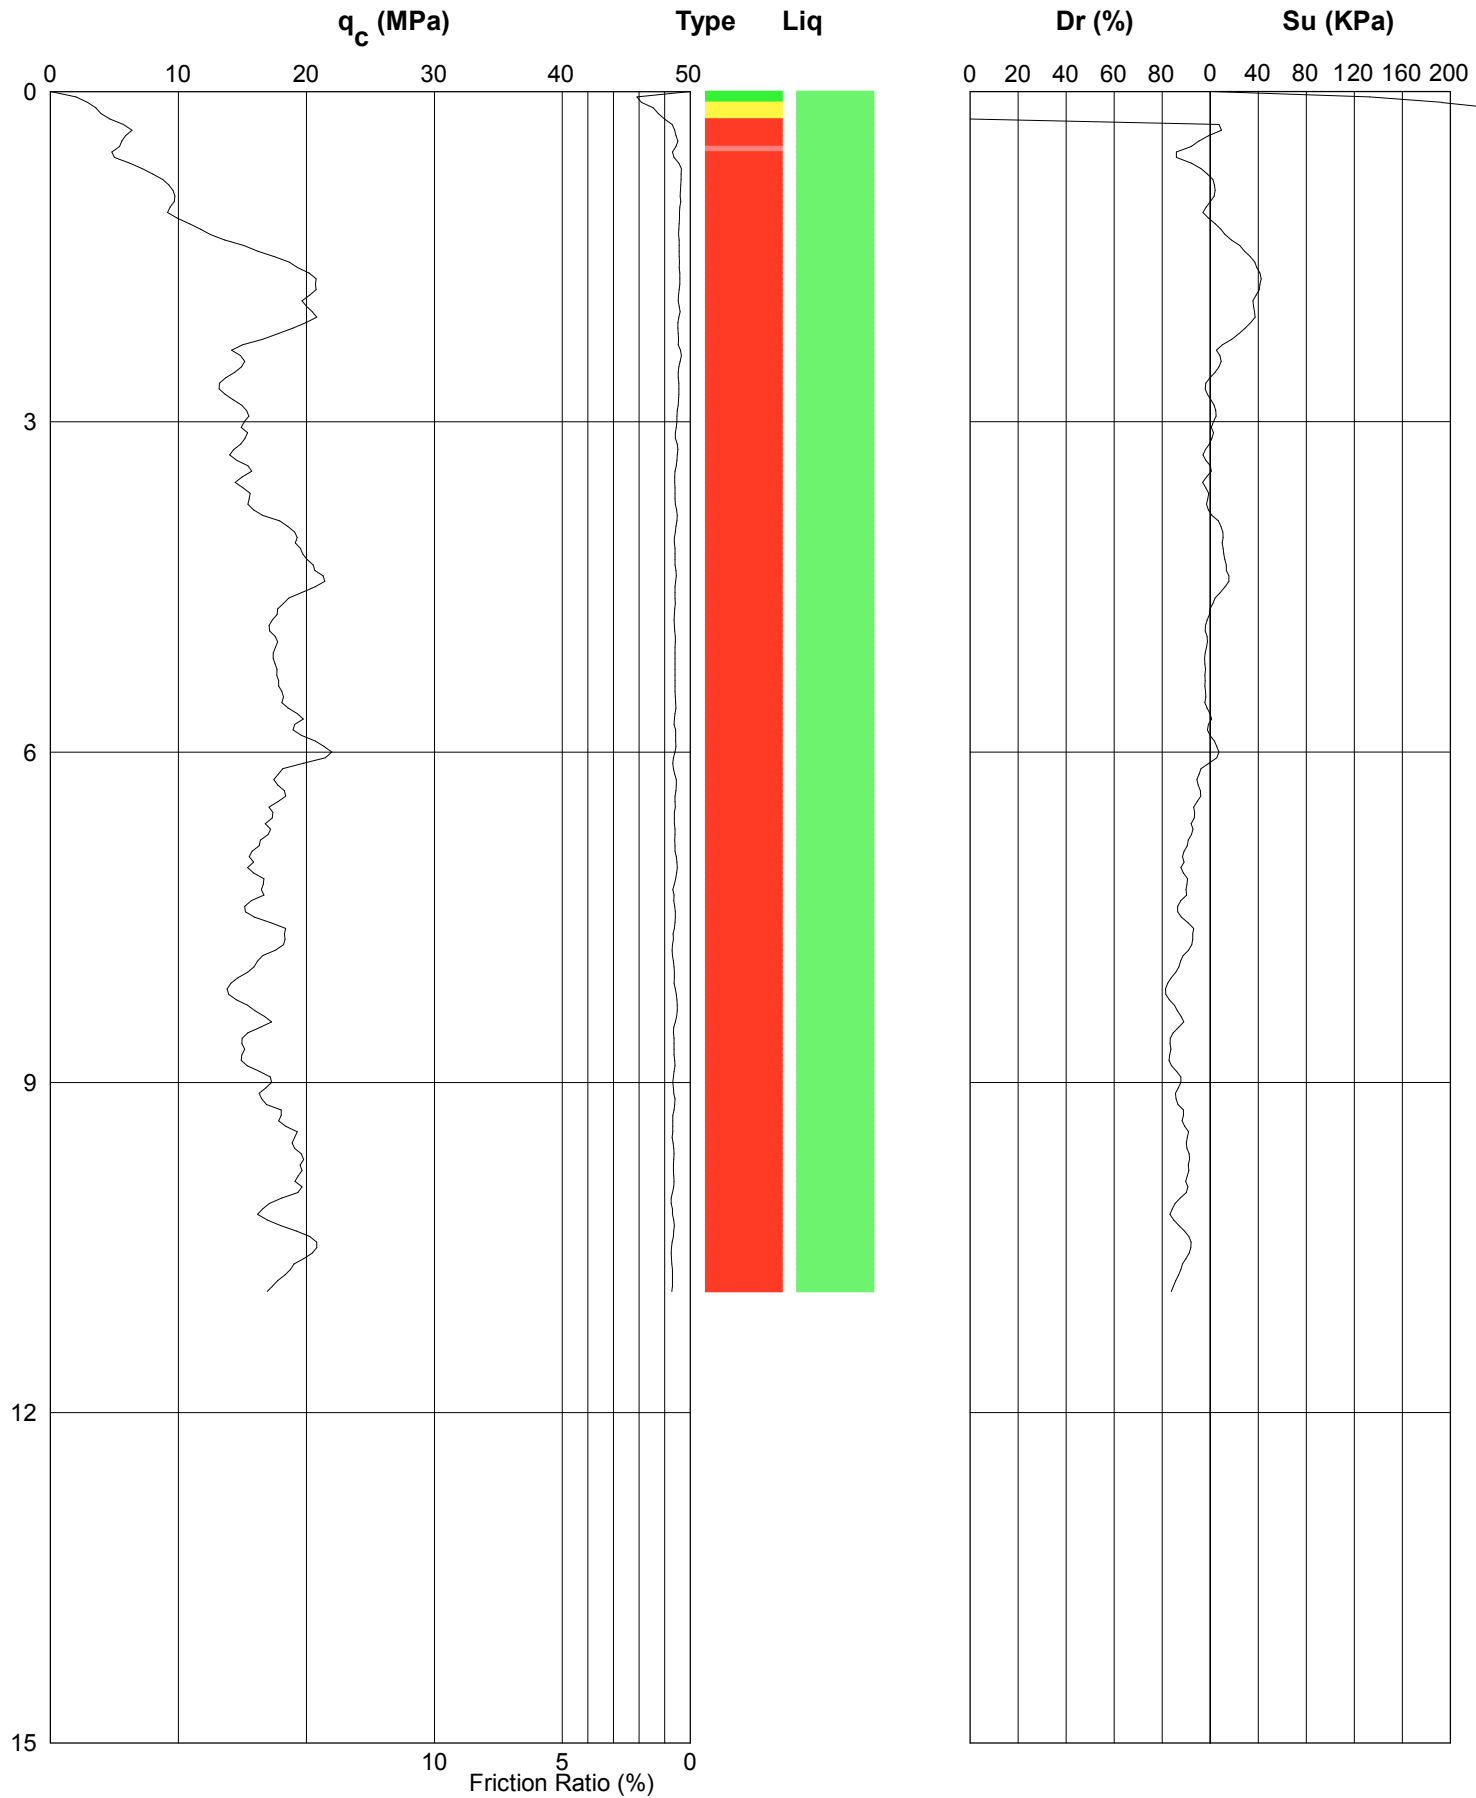
CPT No: CPT111

Remark: Effective Refusal

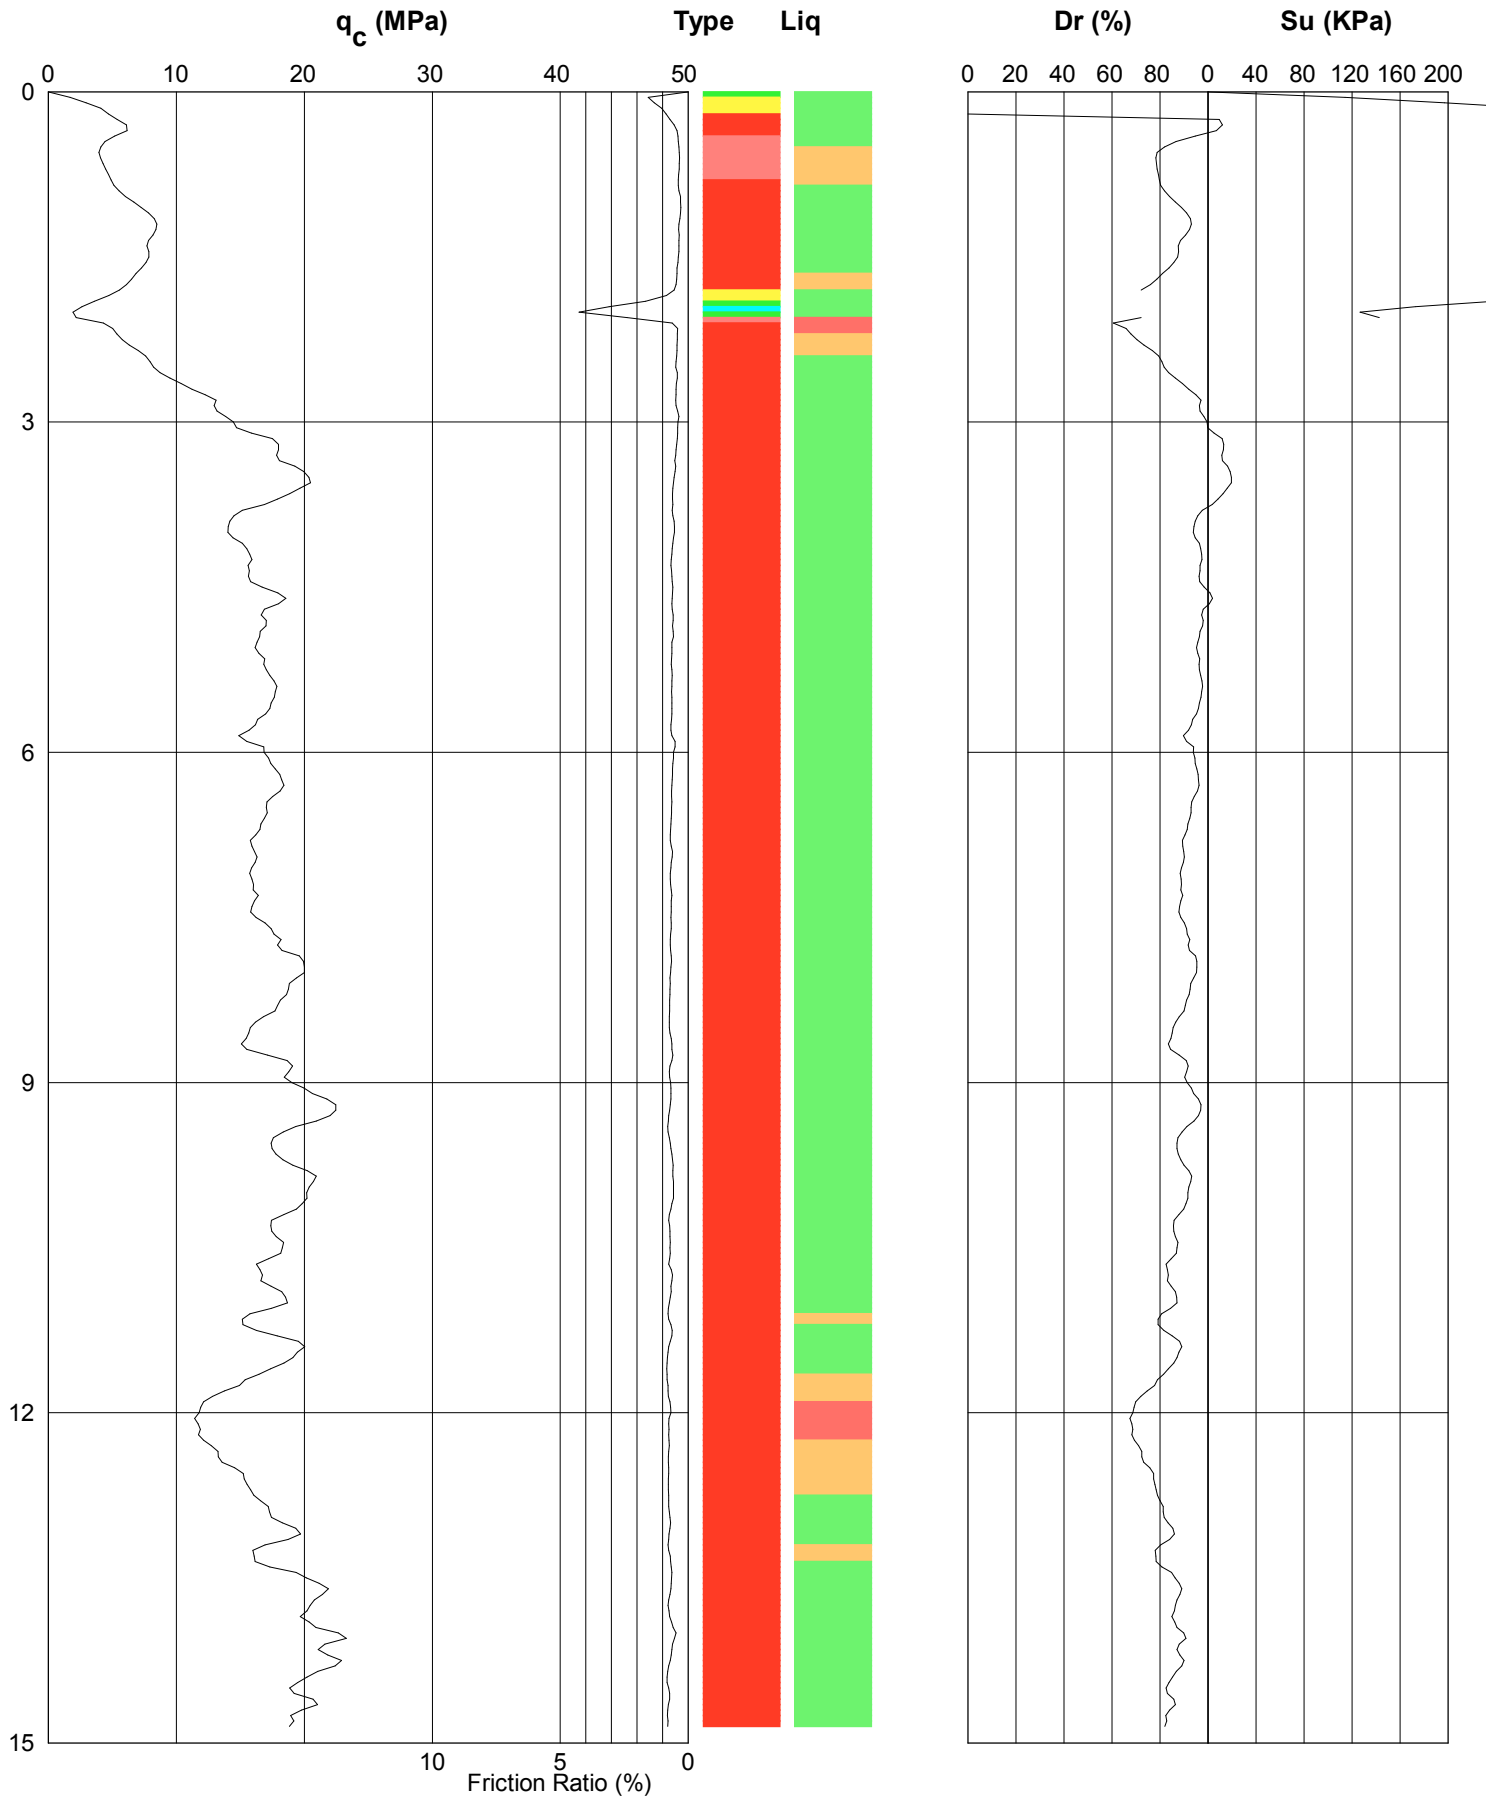
CPT No: CPT112

Remark: Target Depth

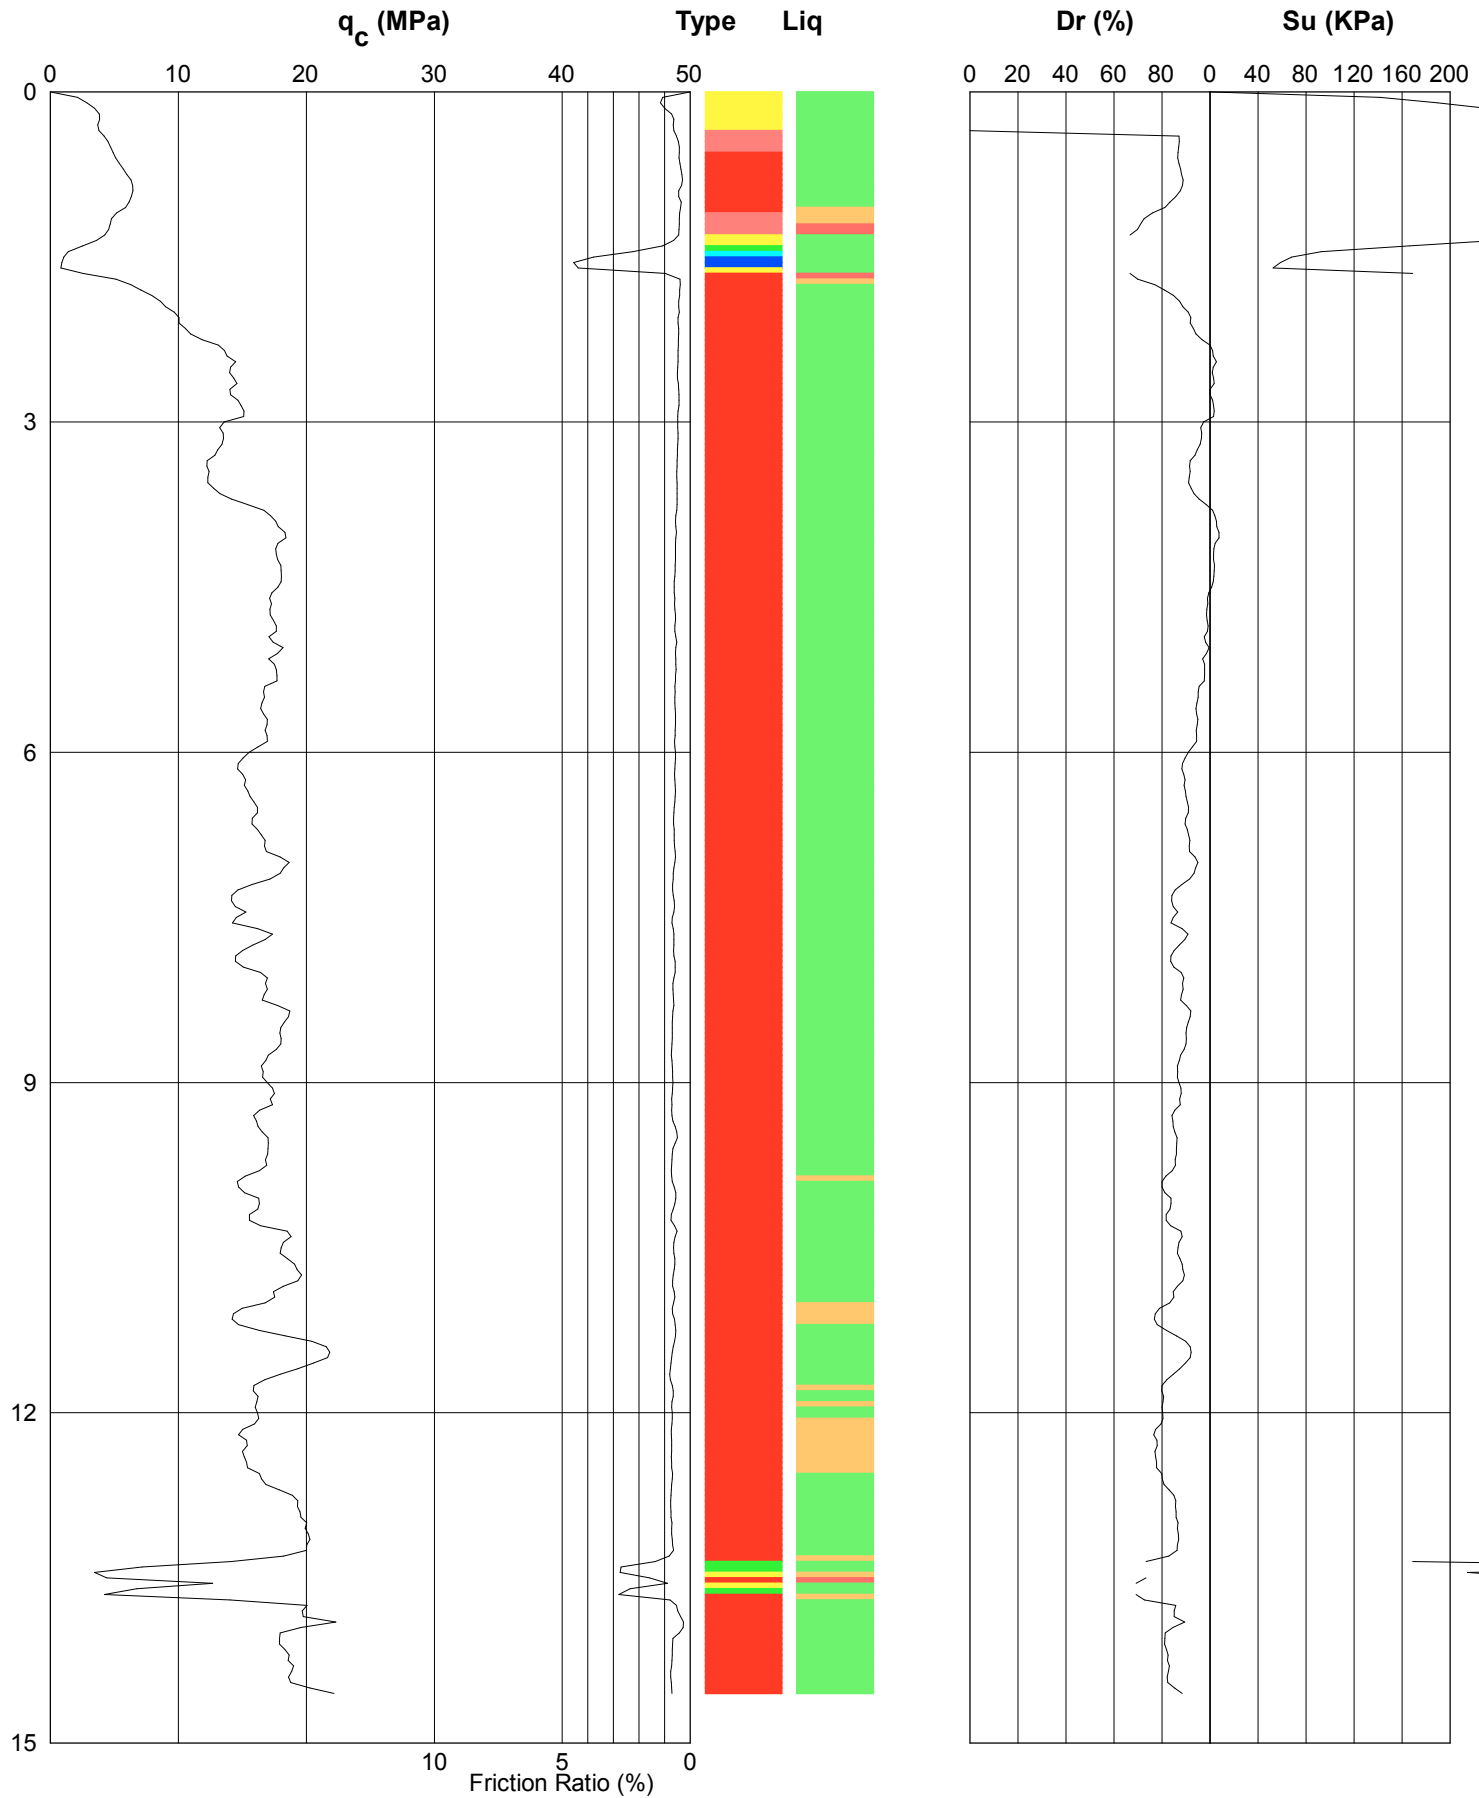
CPT No: CPT113

Remark: Effective Refusal

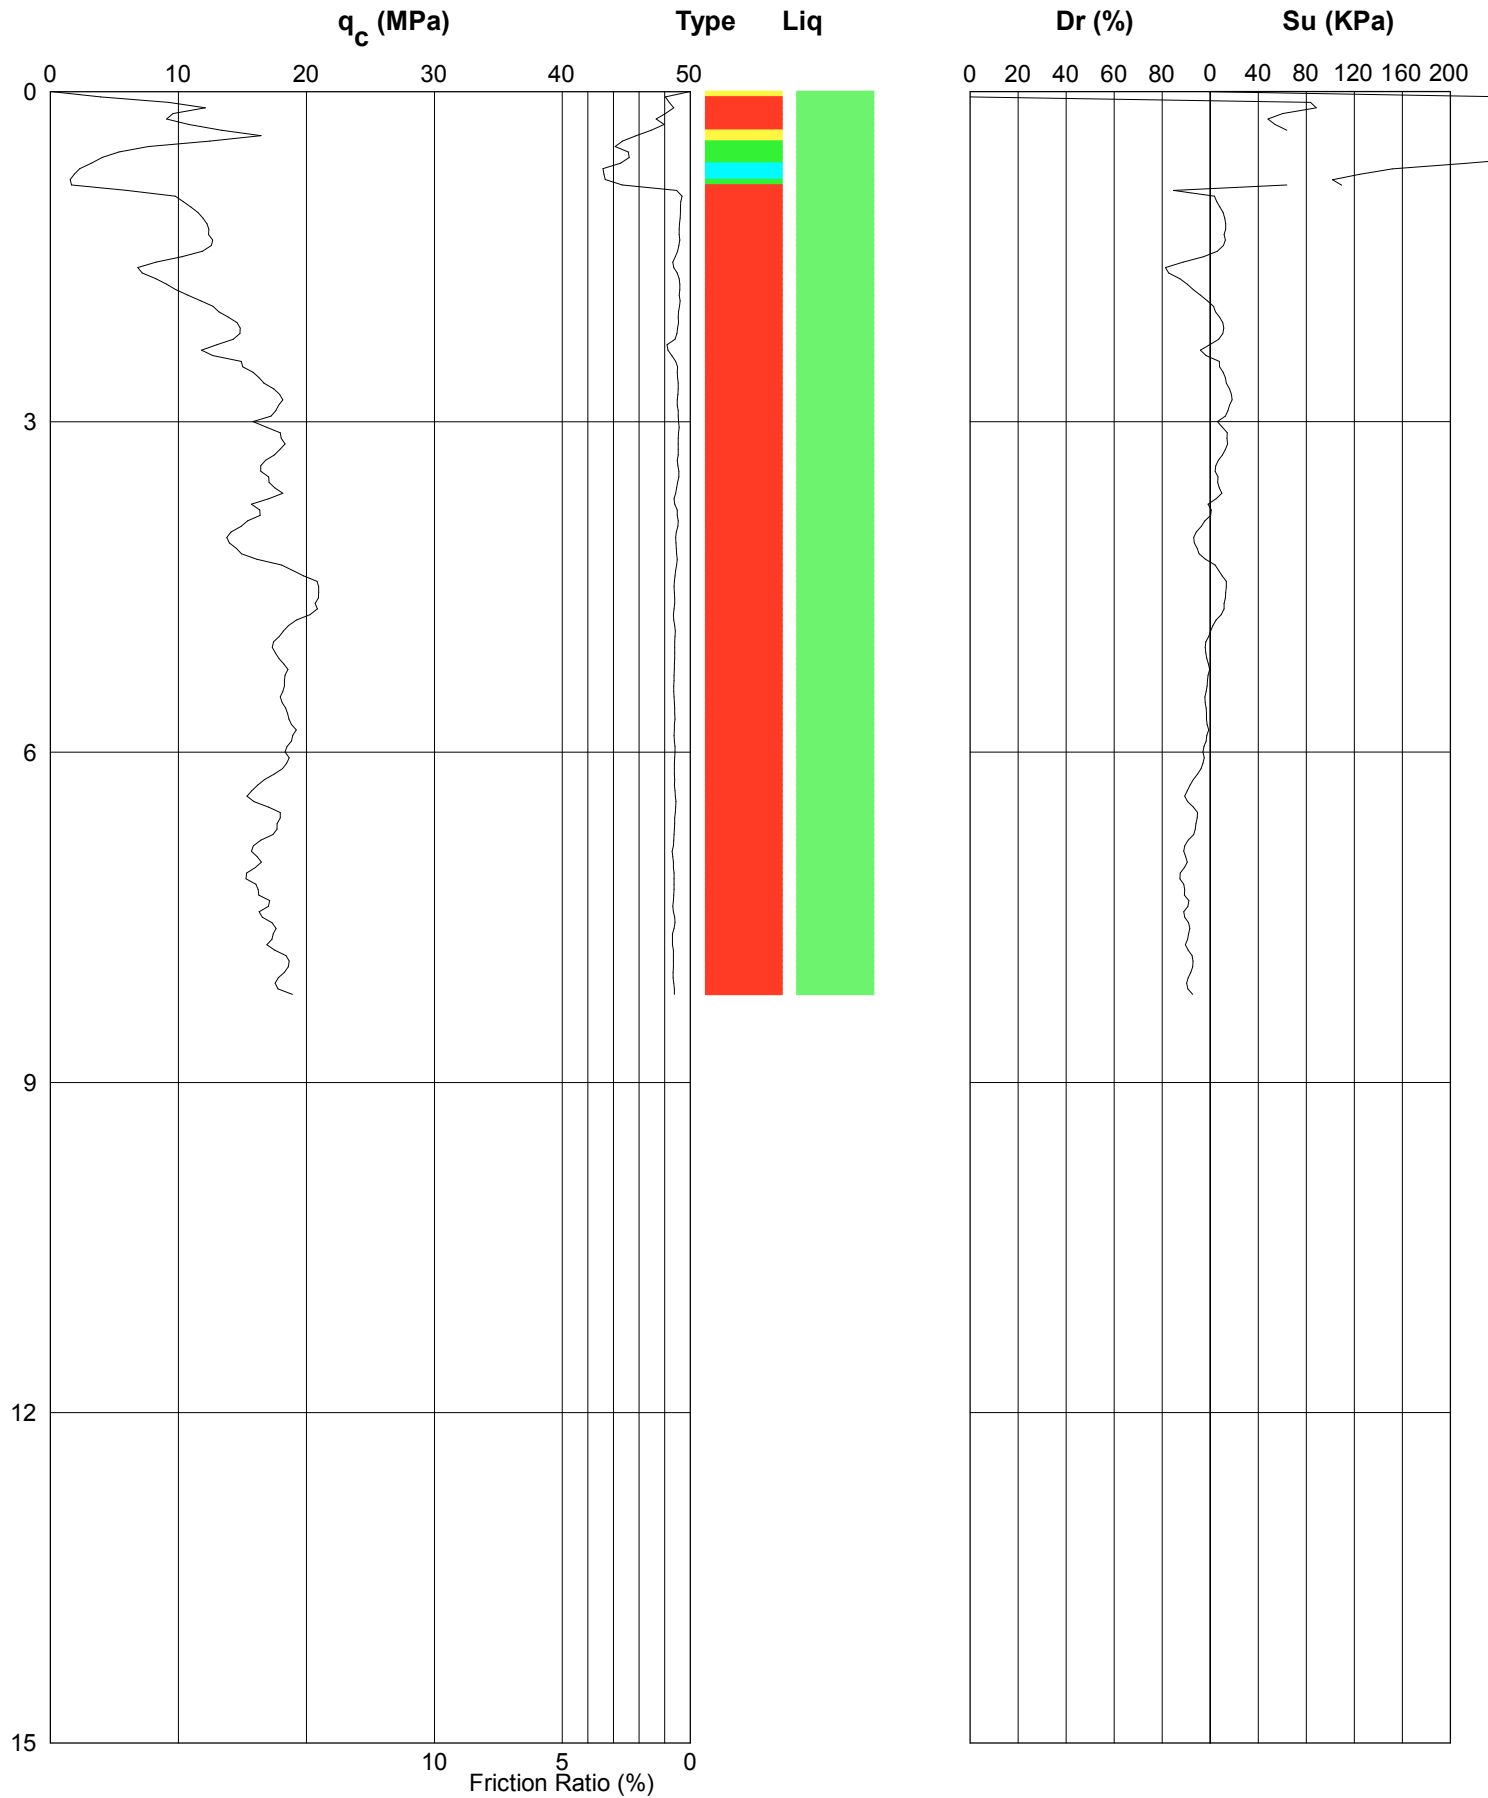
CPT No: CPT114

Remark: Effective Refusal

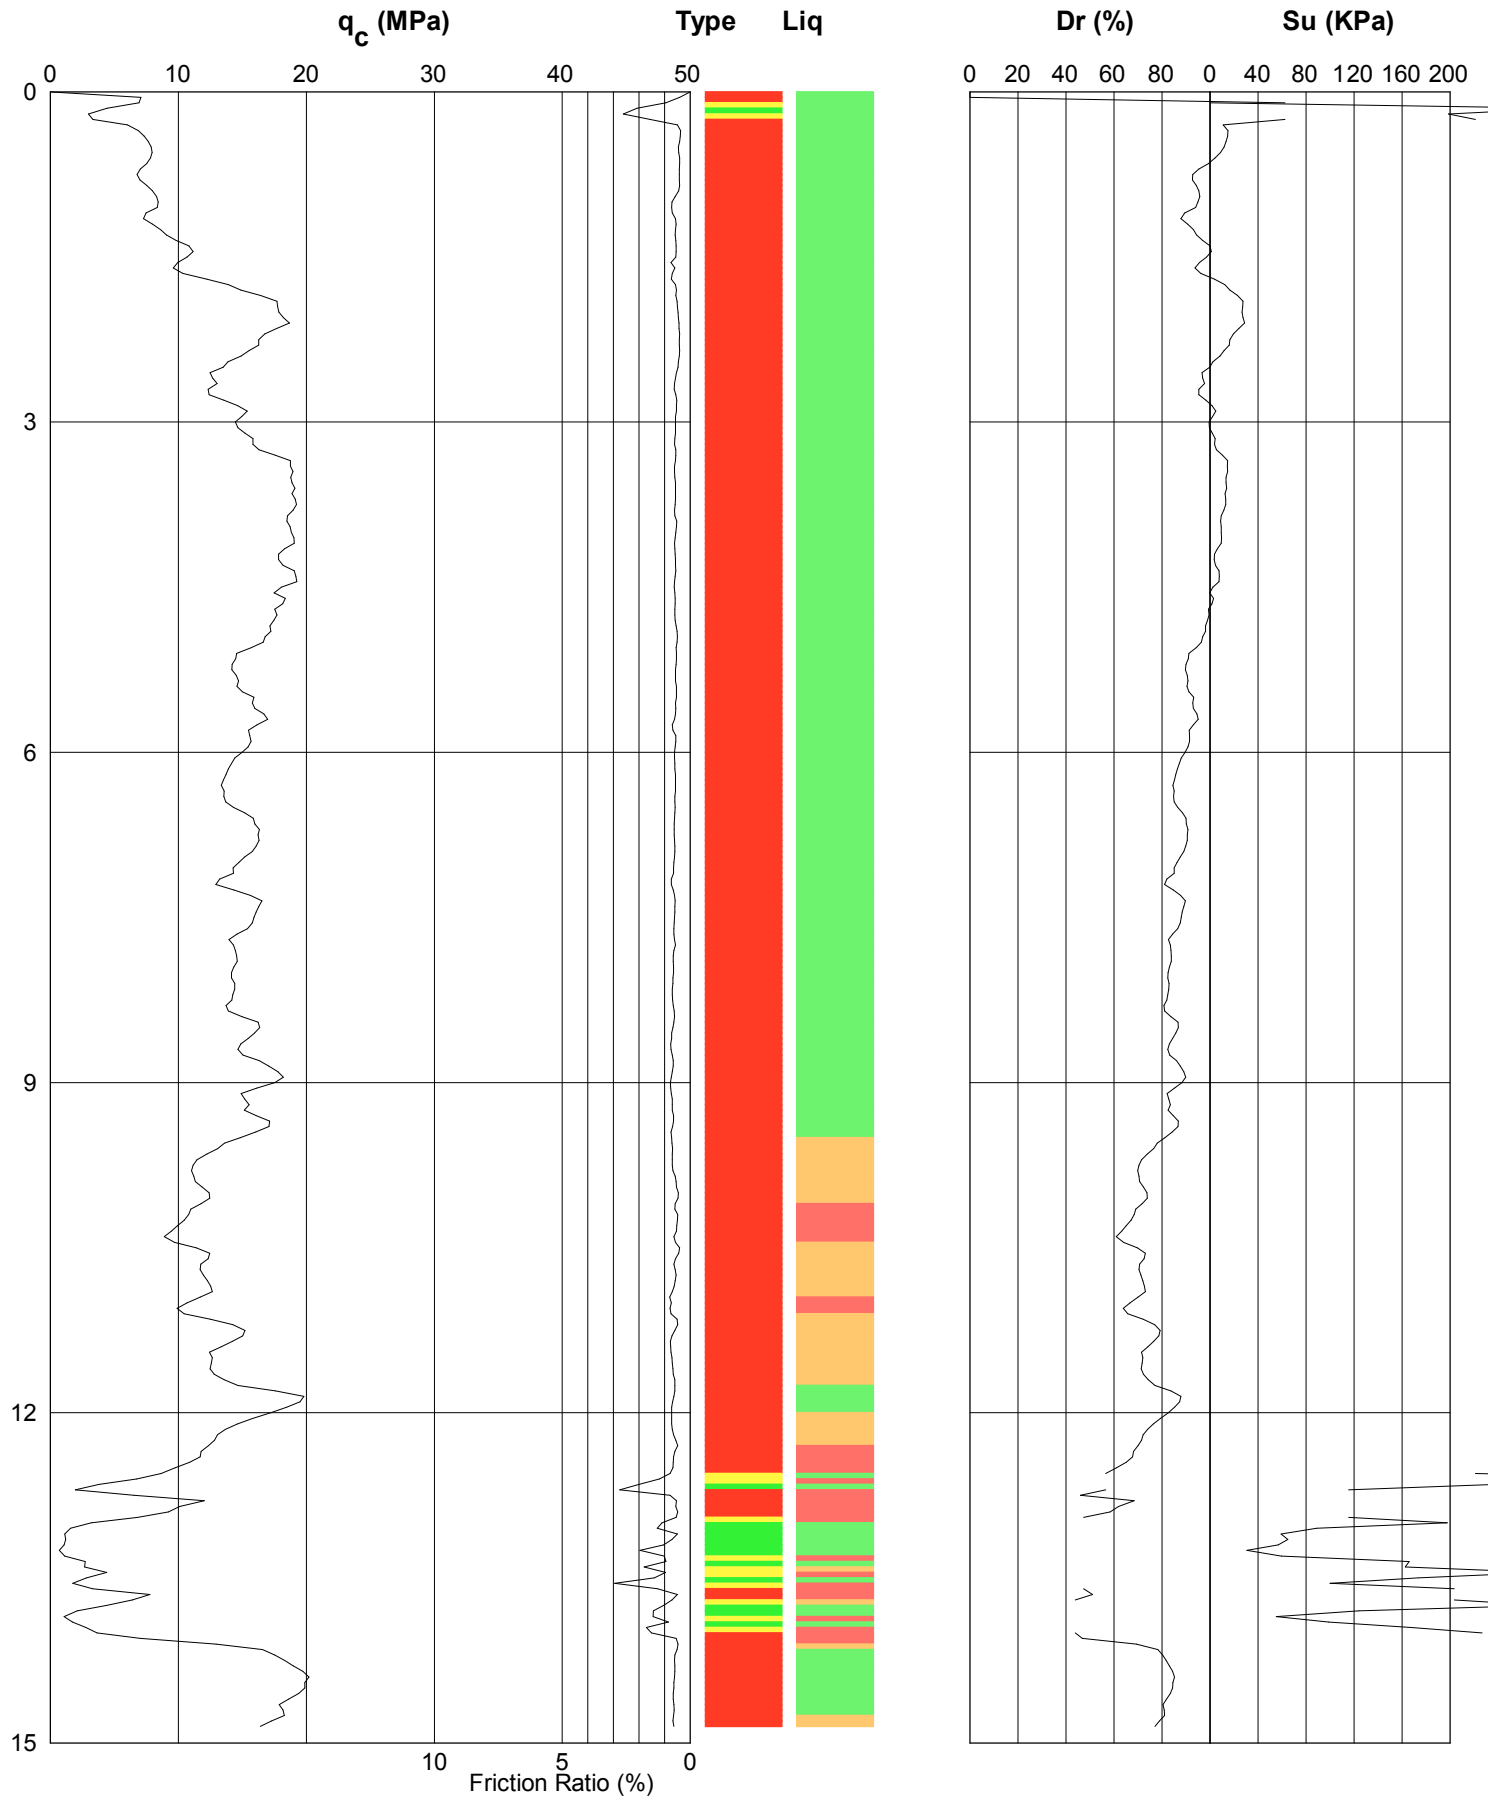
CPT No: CPT115

Remark: Target Depth

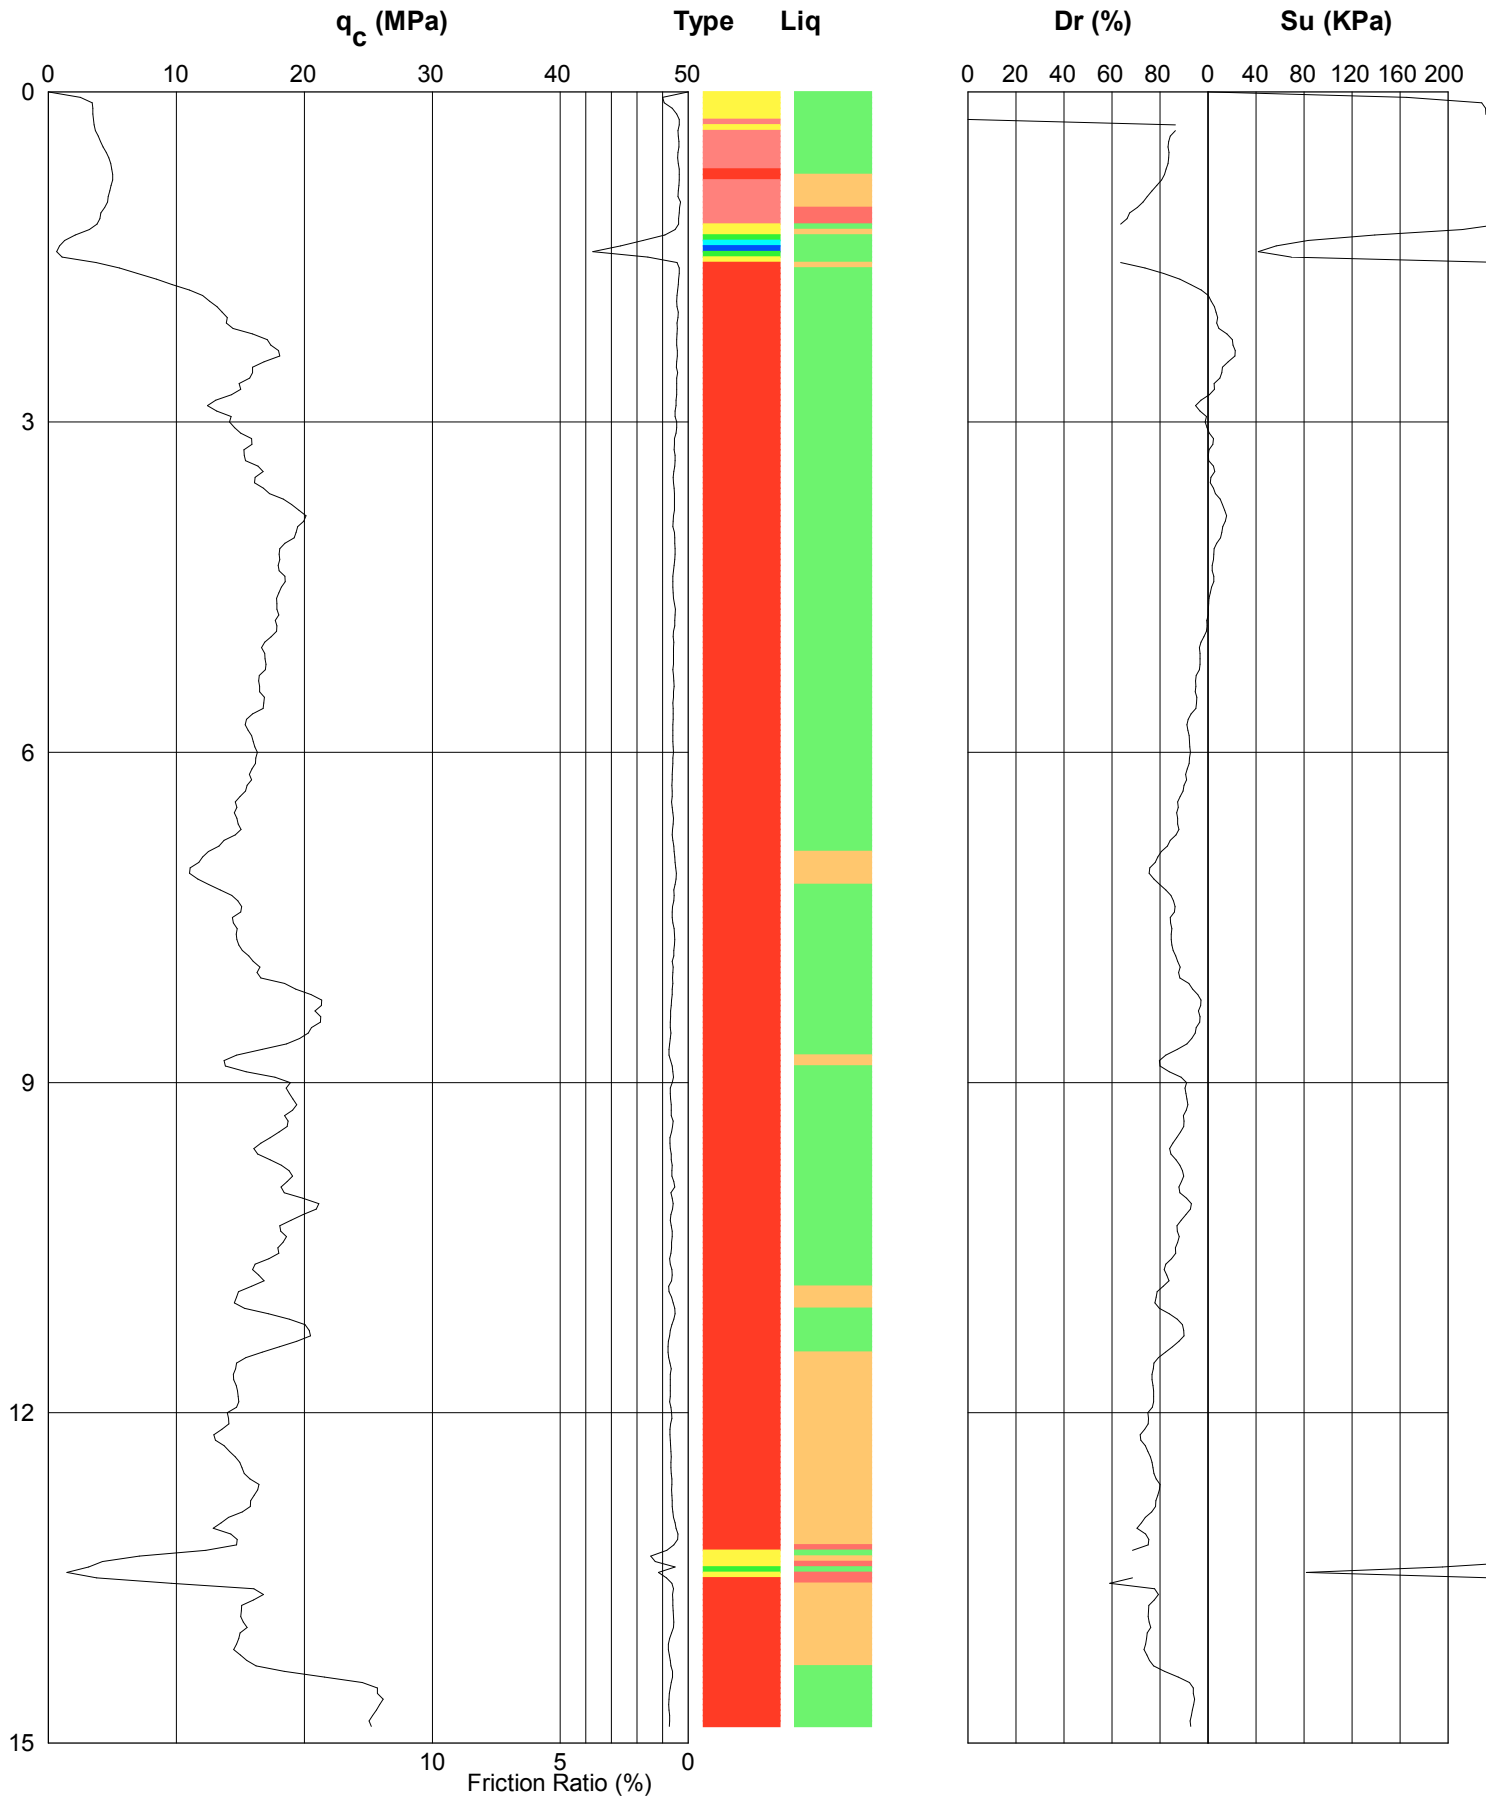
CPT No: CPT116

Remark: Target Depth
