Appendix D

2012 CPT Logs

PIEZOCONE PENETROMETER TEST (CPTU) INTERPRETIVE REPORT

Location: Prestons Subdivision, Christchurch

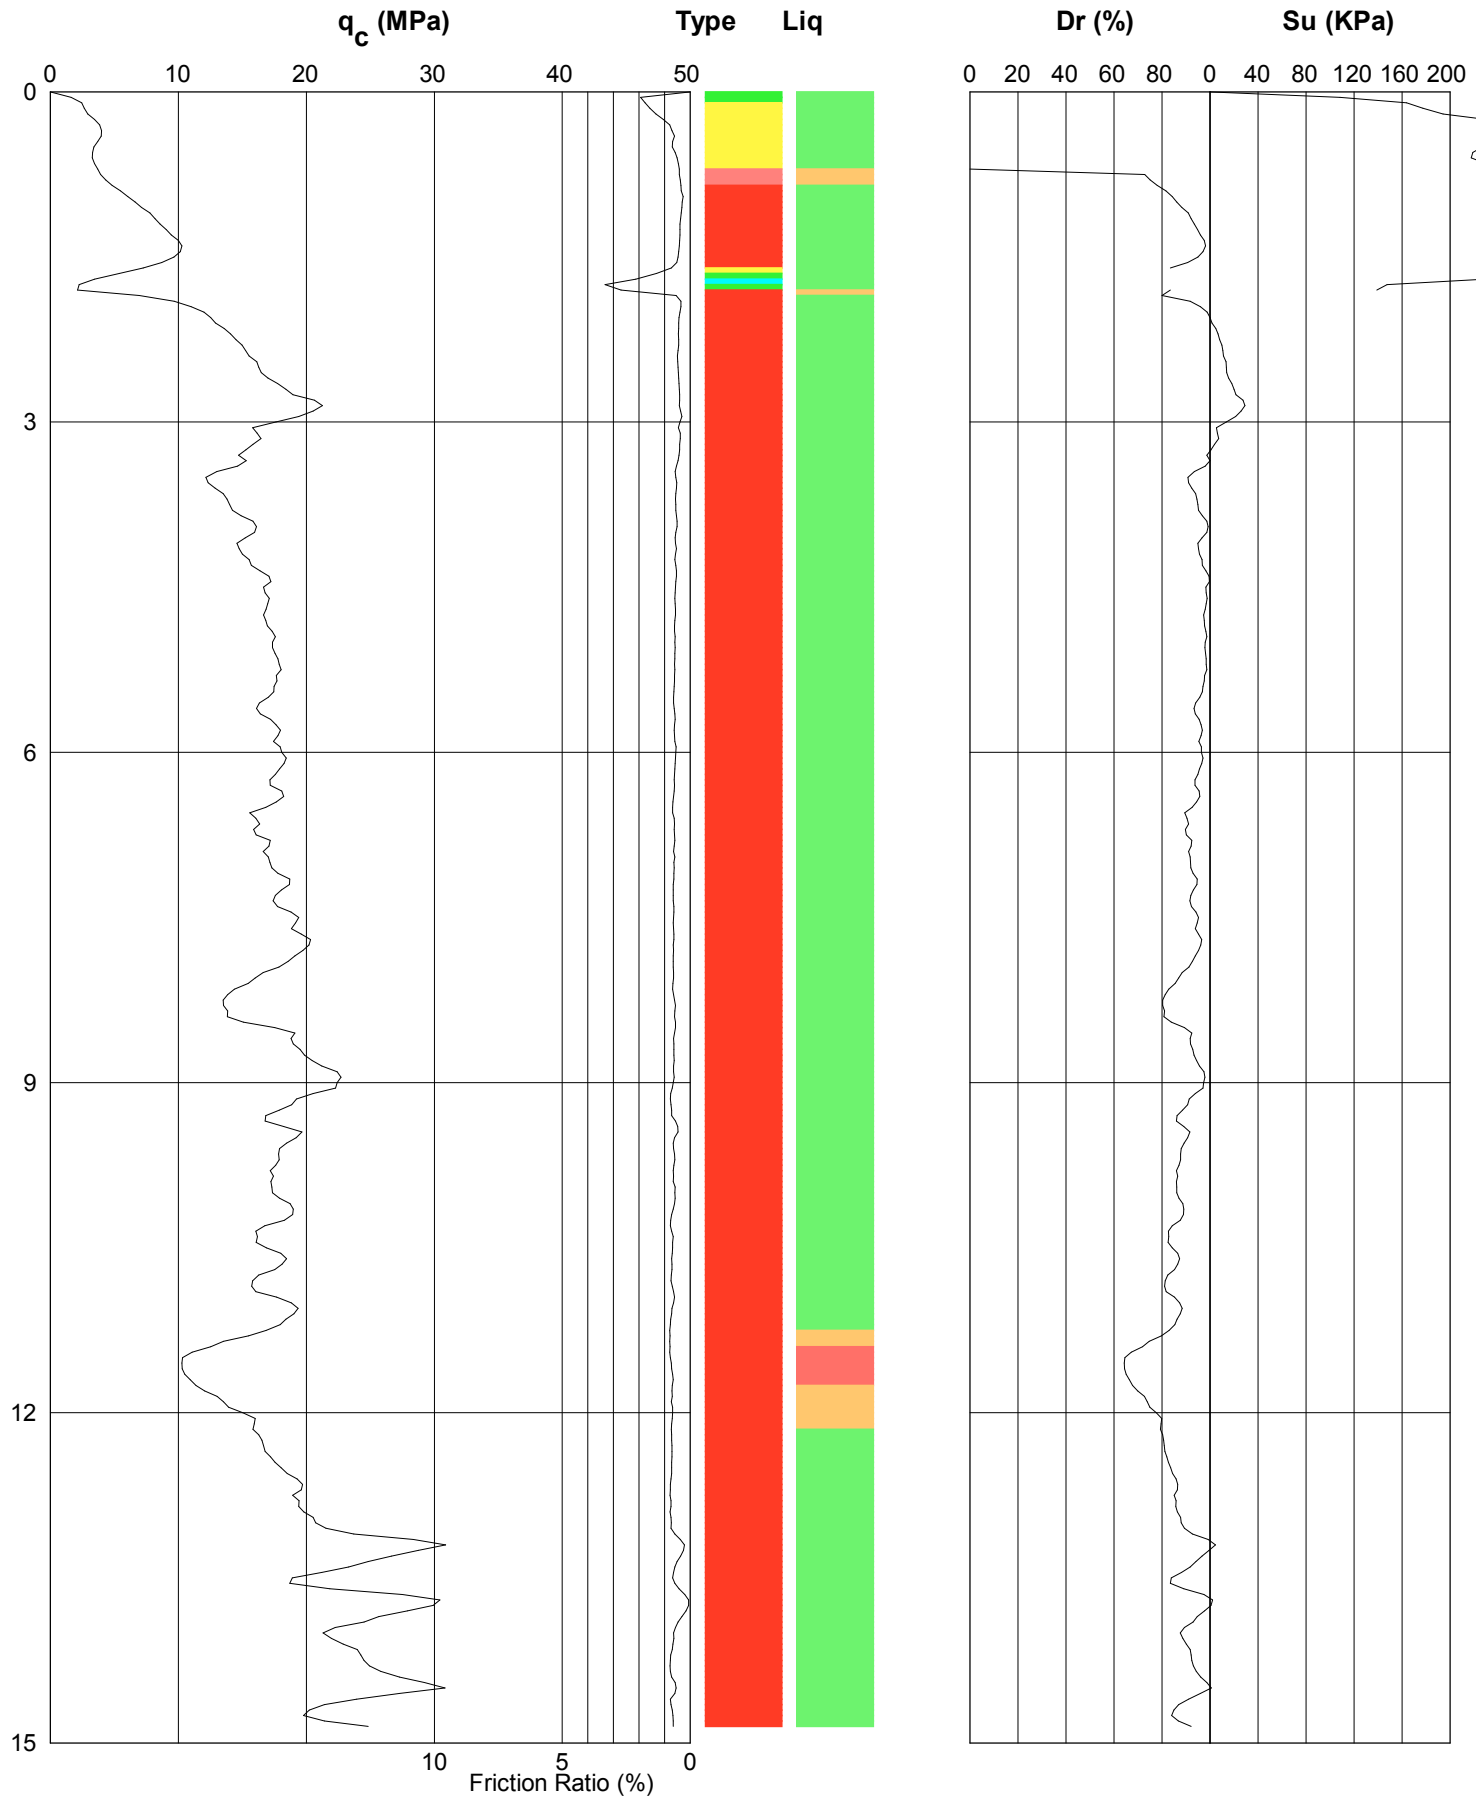
CPT No: CPT117

Remark: Target Depth

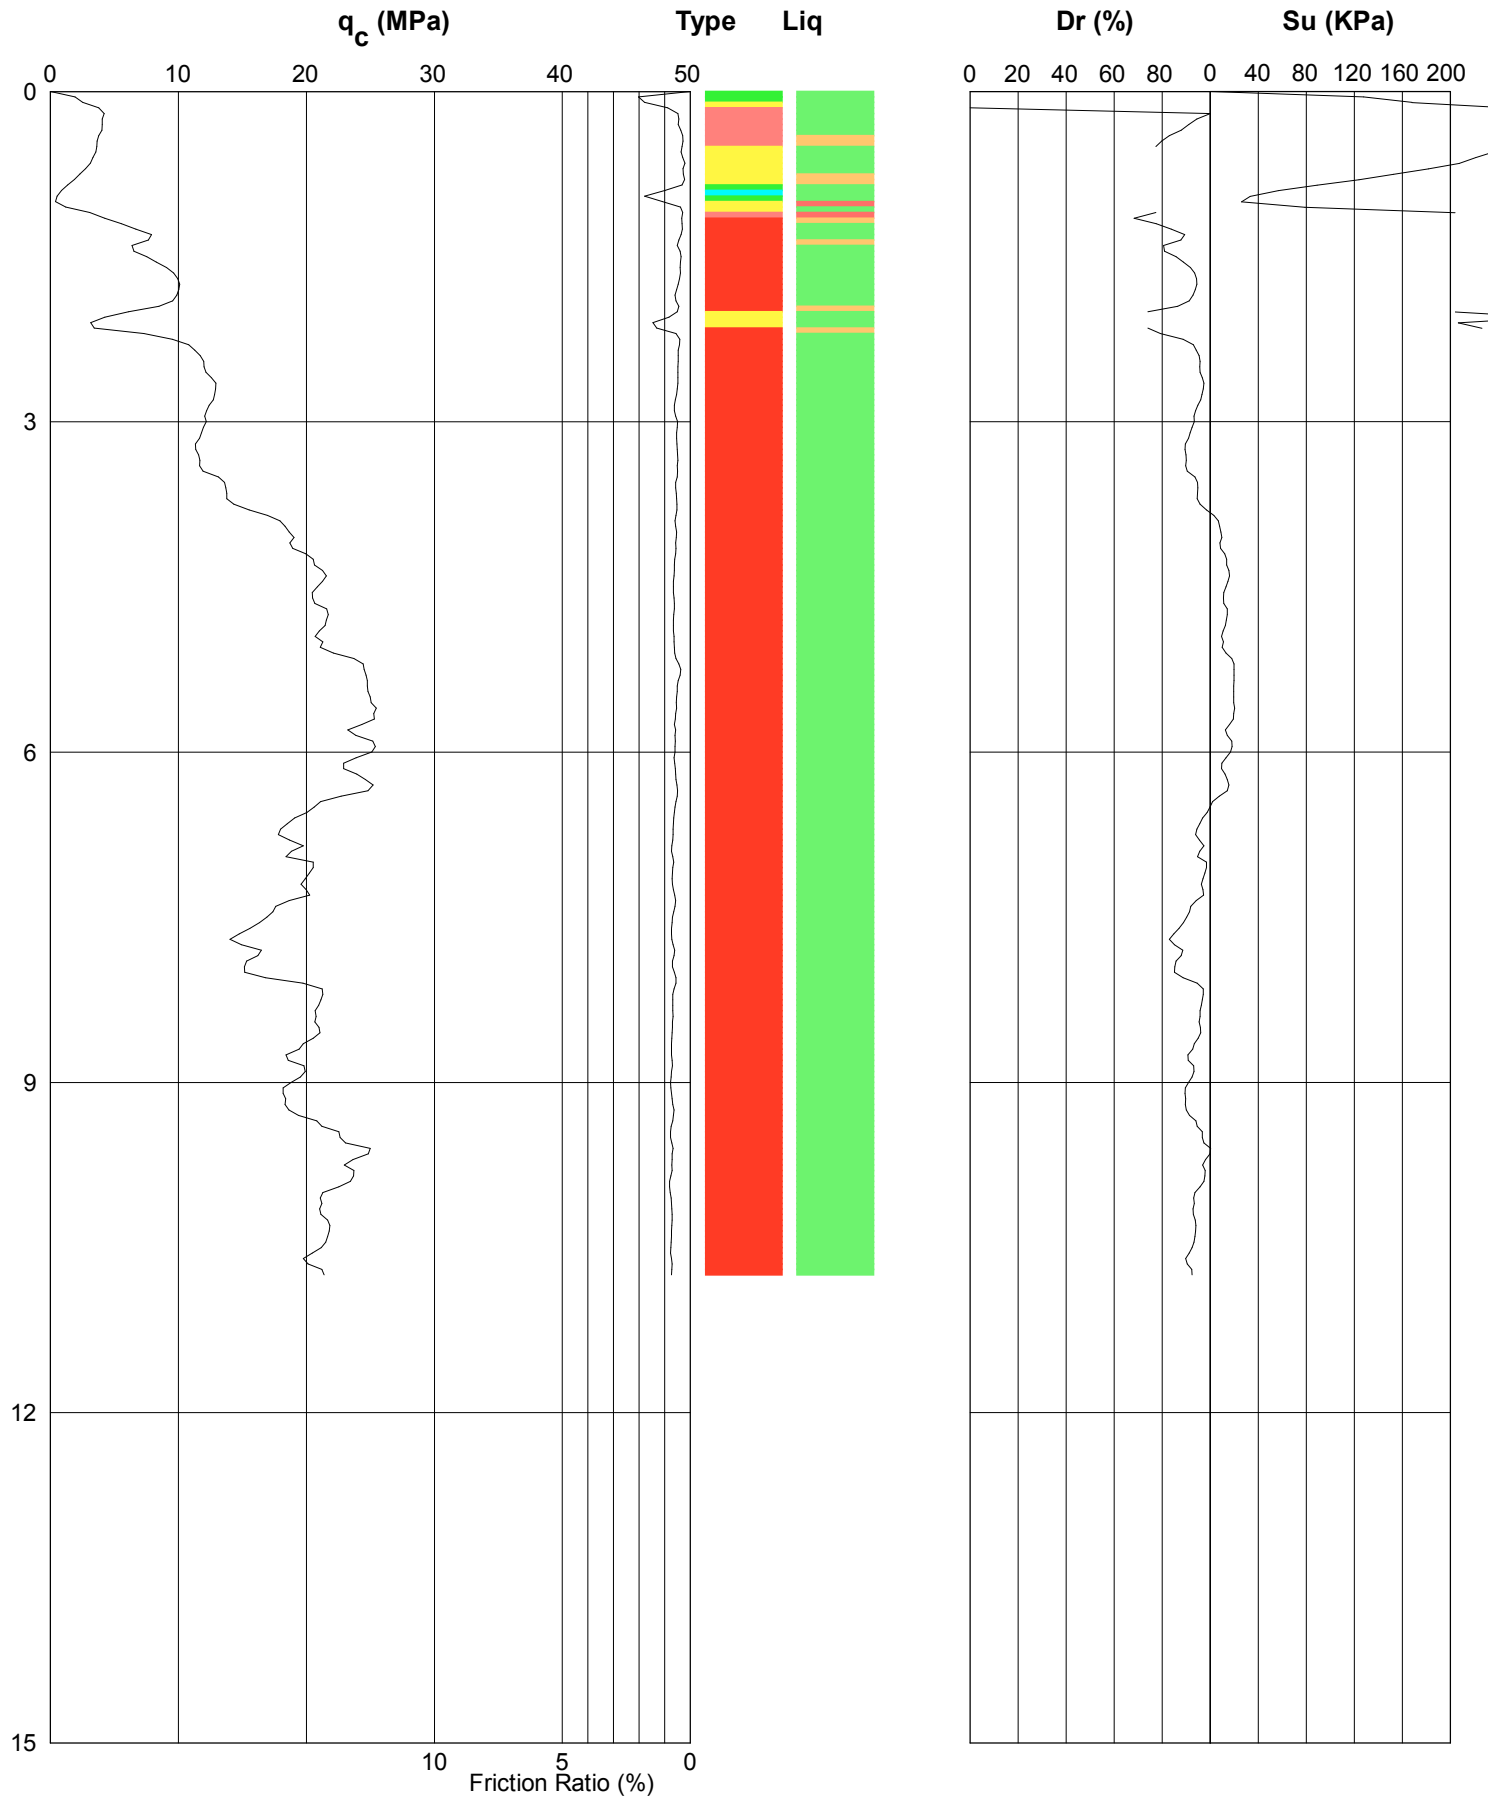
CPT No: CPT118

Remark: Effective Refusal

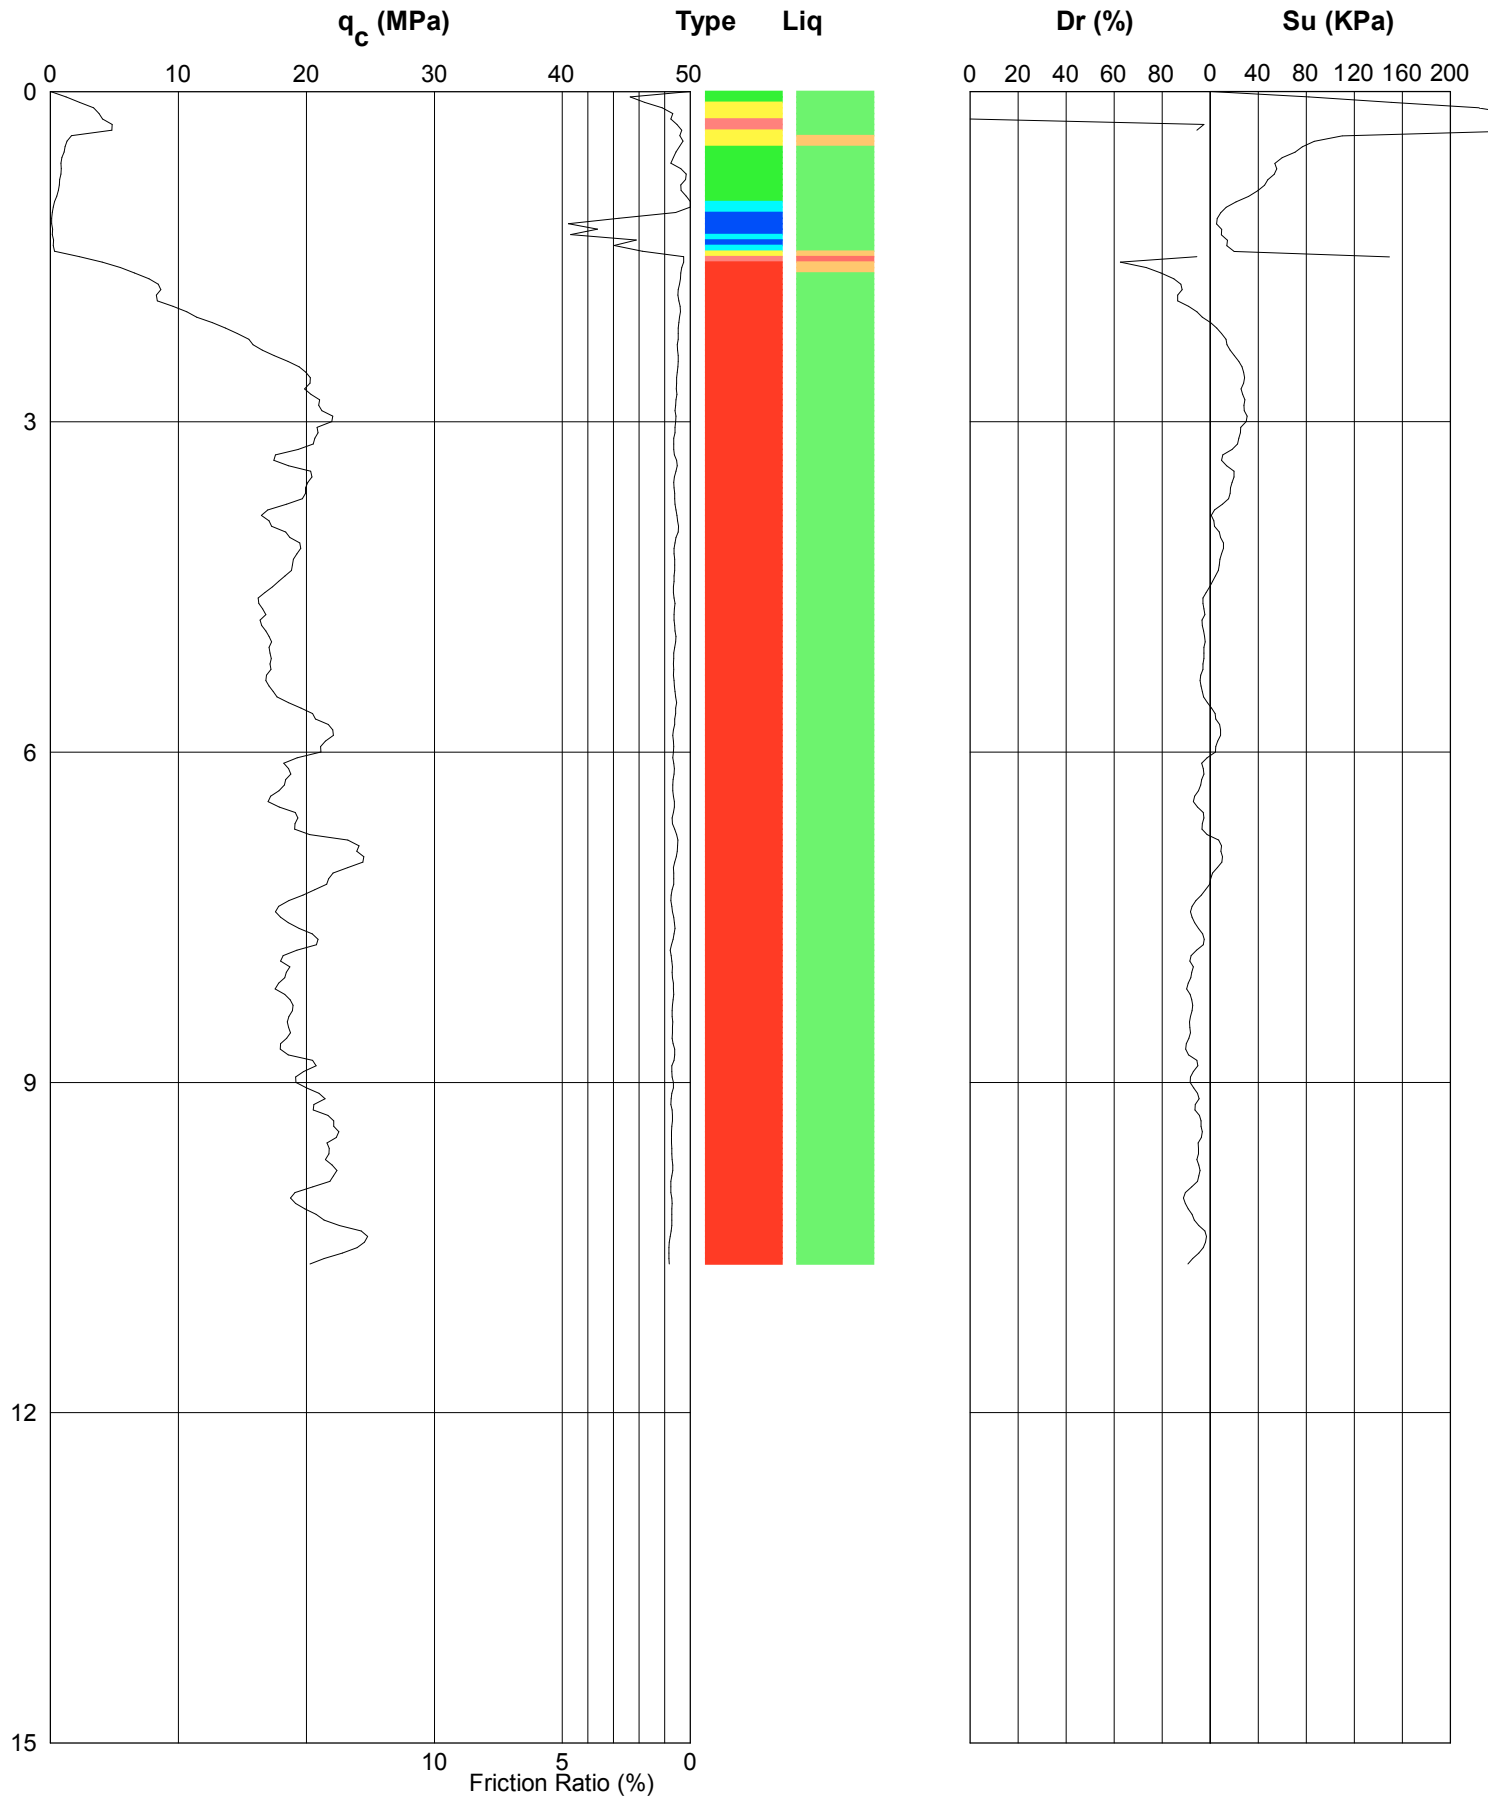
CPT No: CPT119

Remark: Effective Refusal

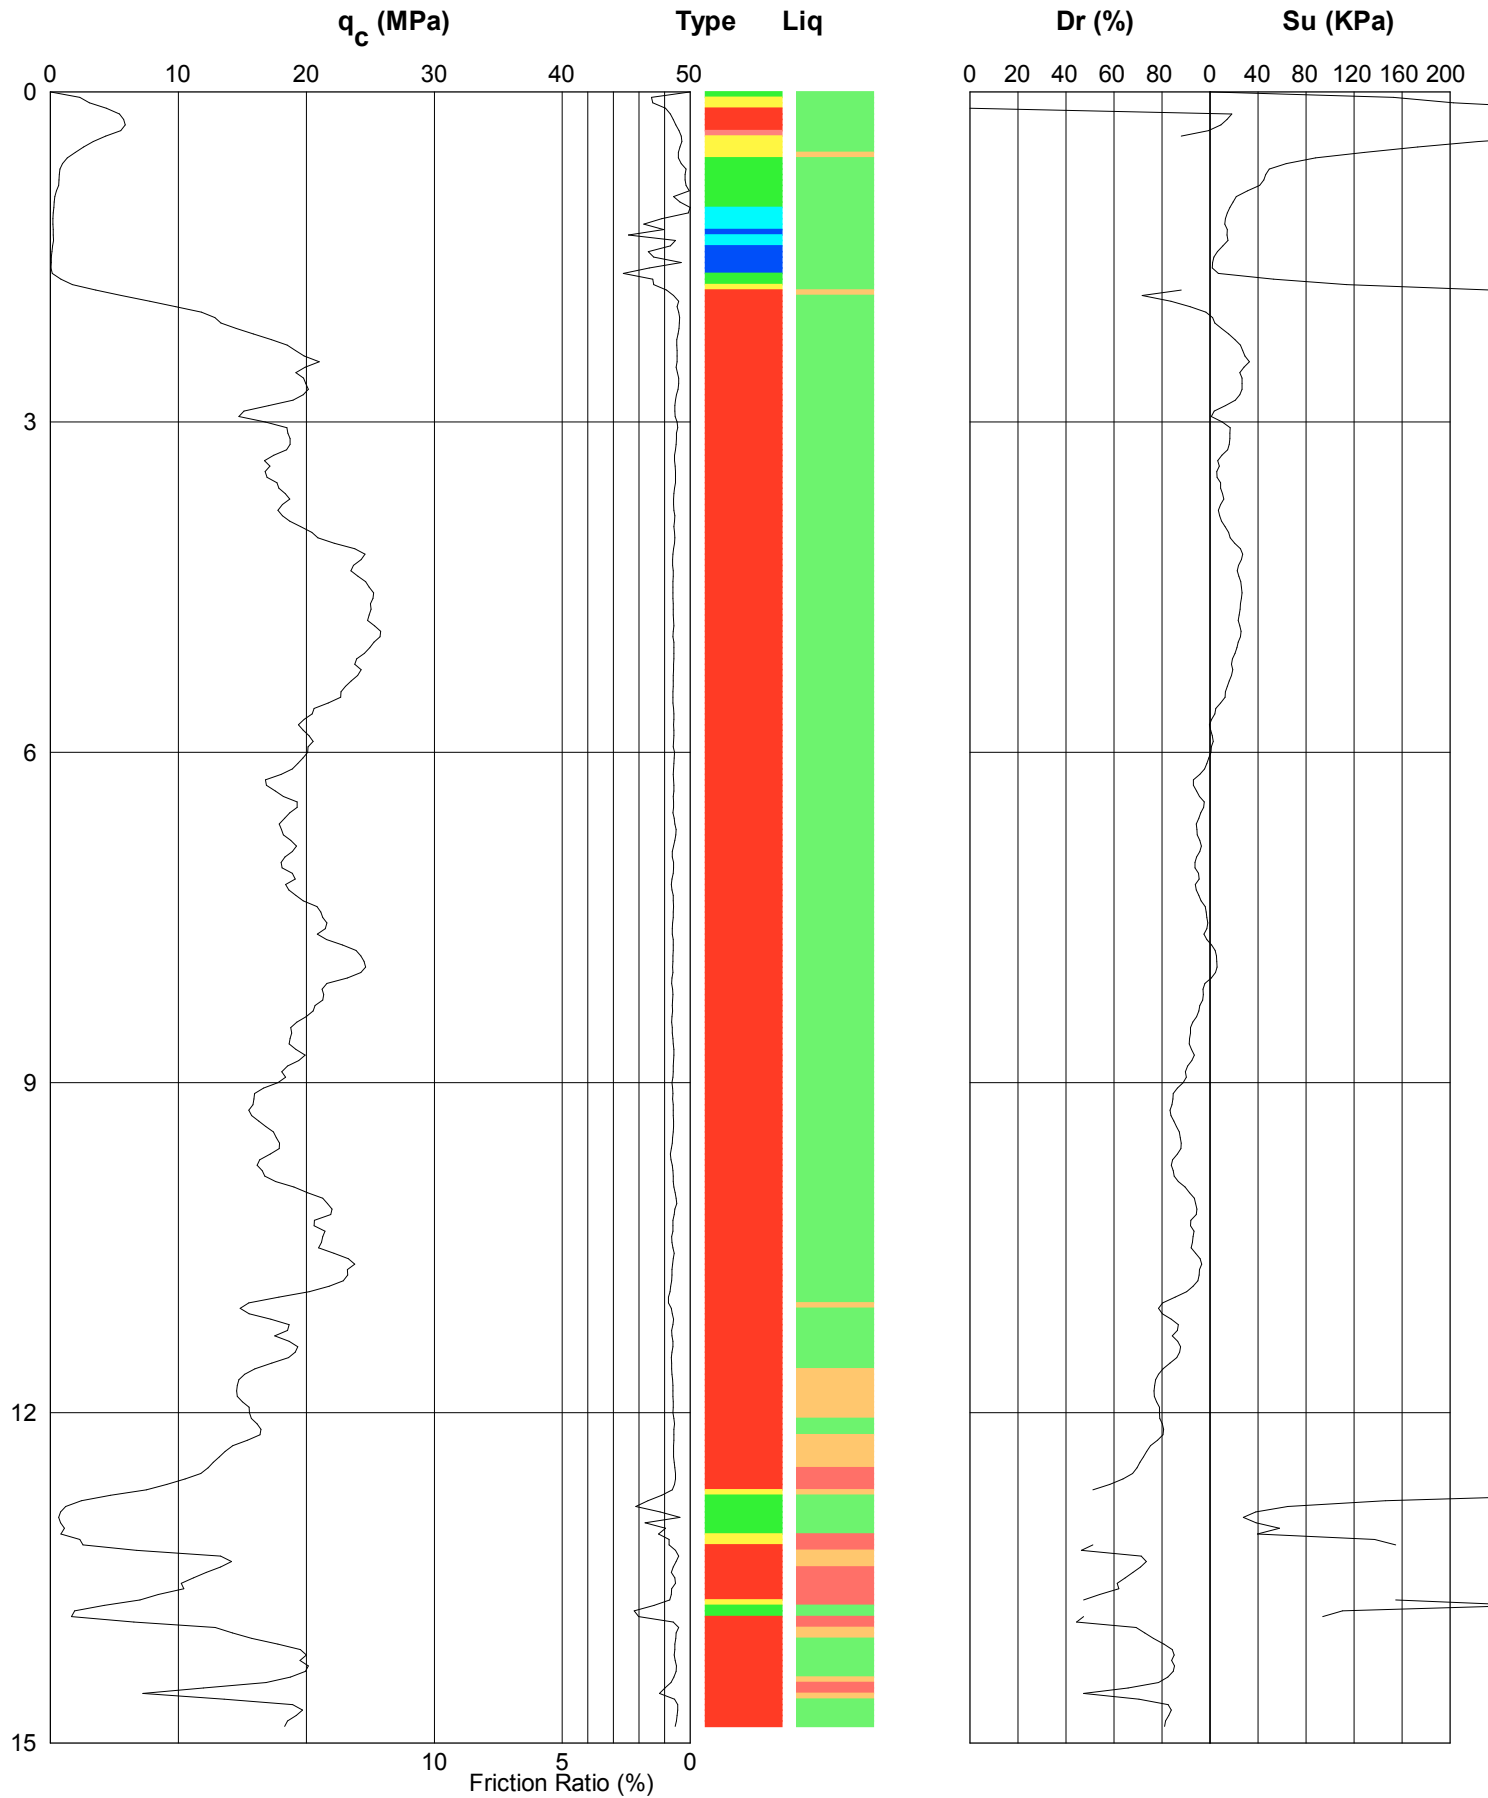
CPT No: CPT120

Remark: Target Depth

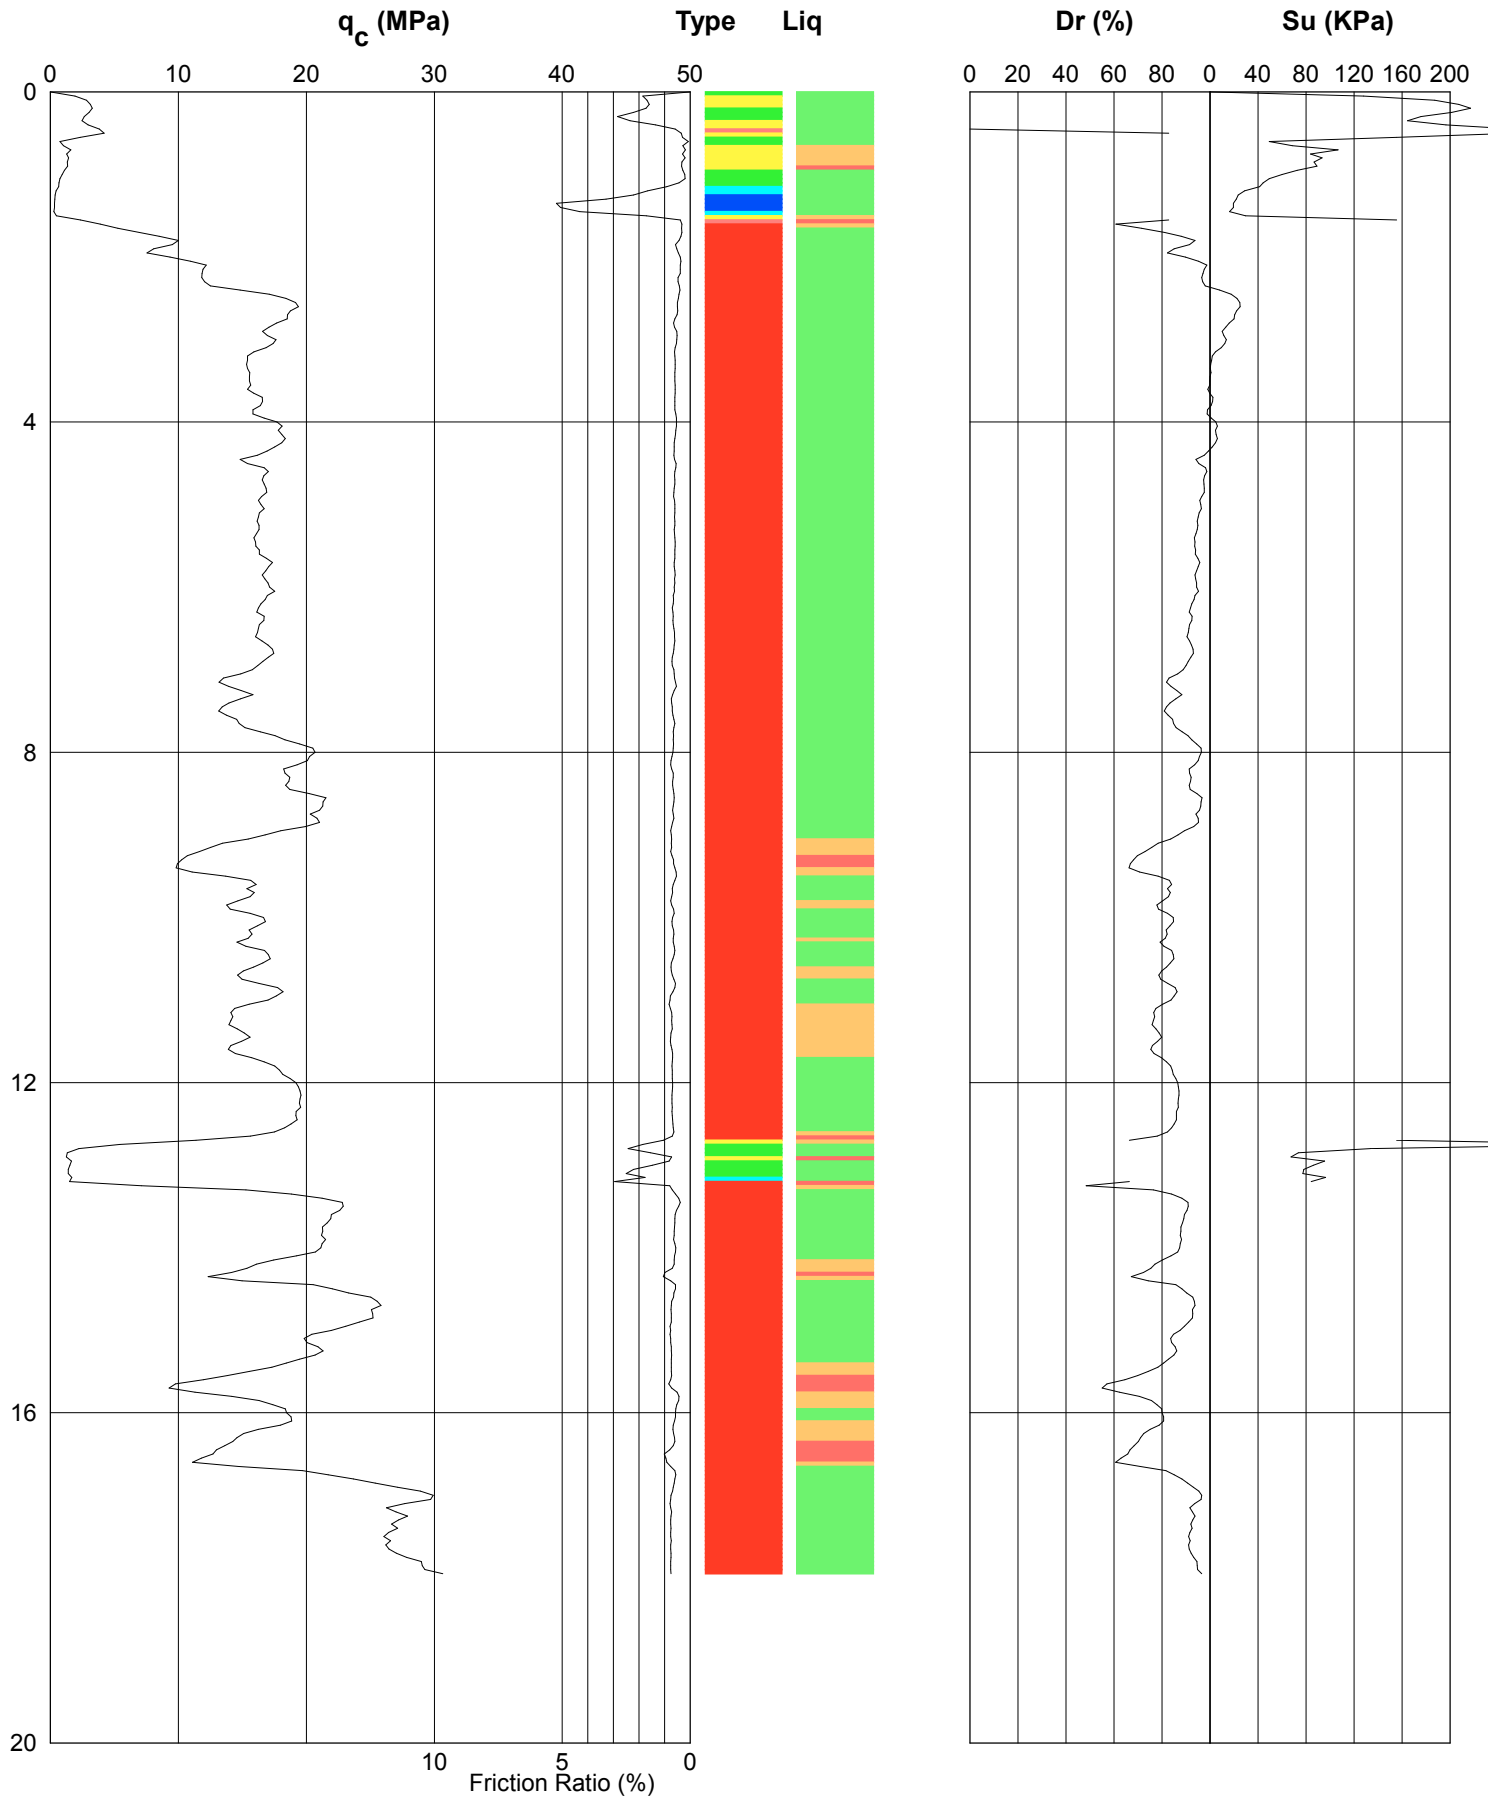
CPT No: CPT121

Remark: Effective Refusal

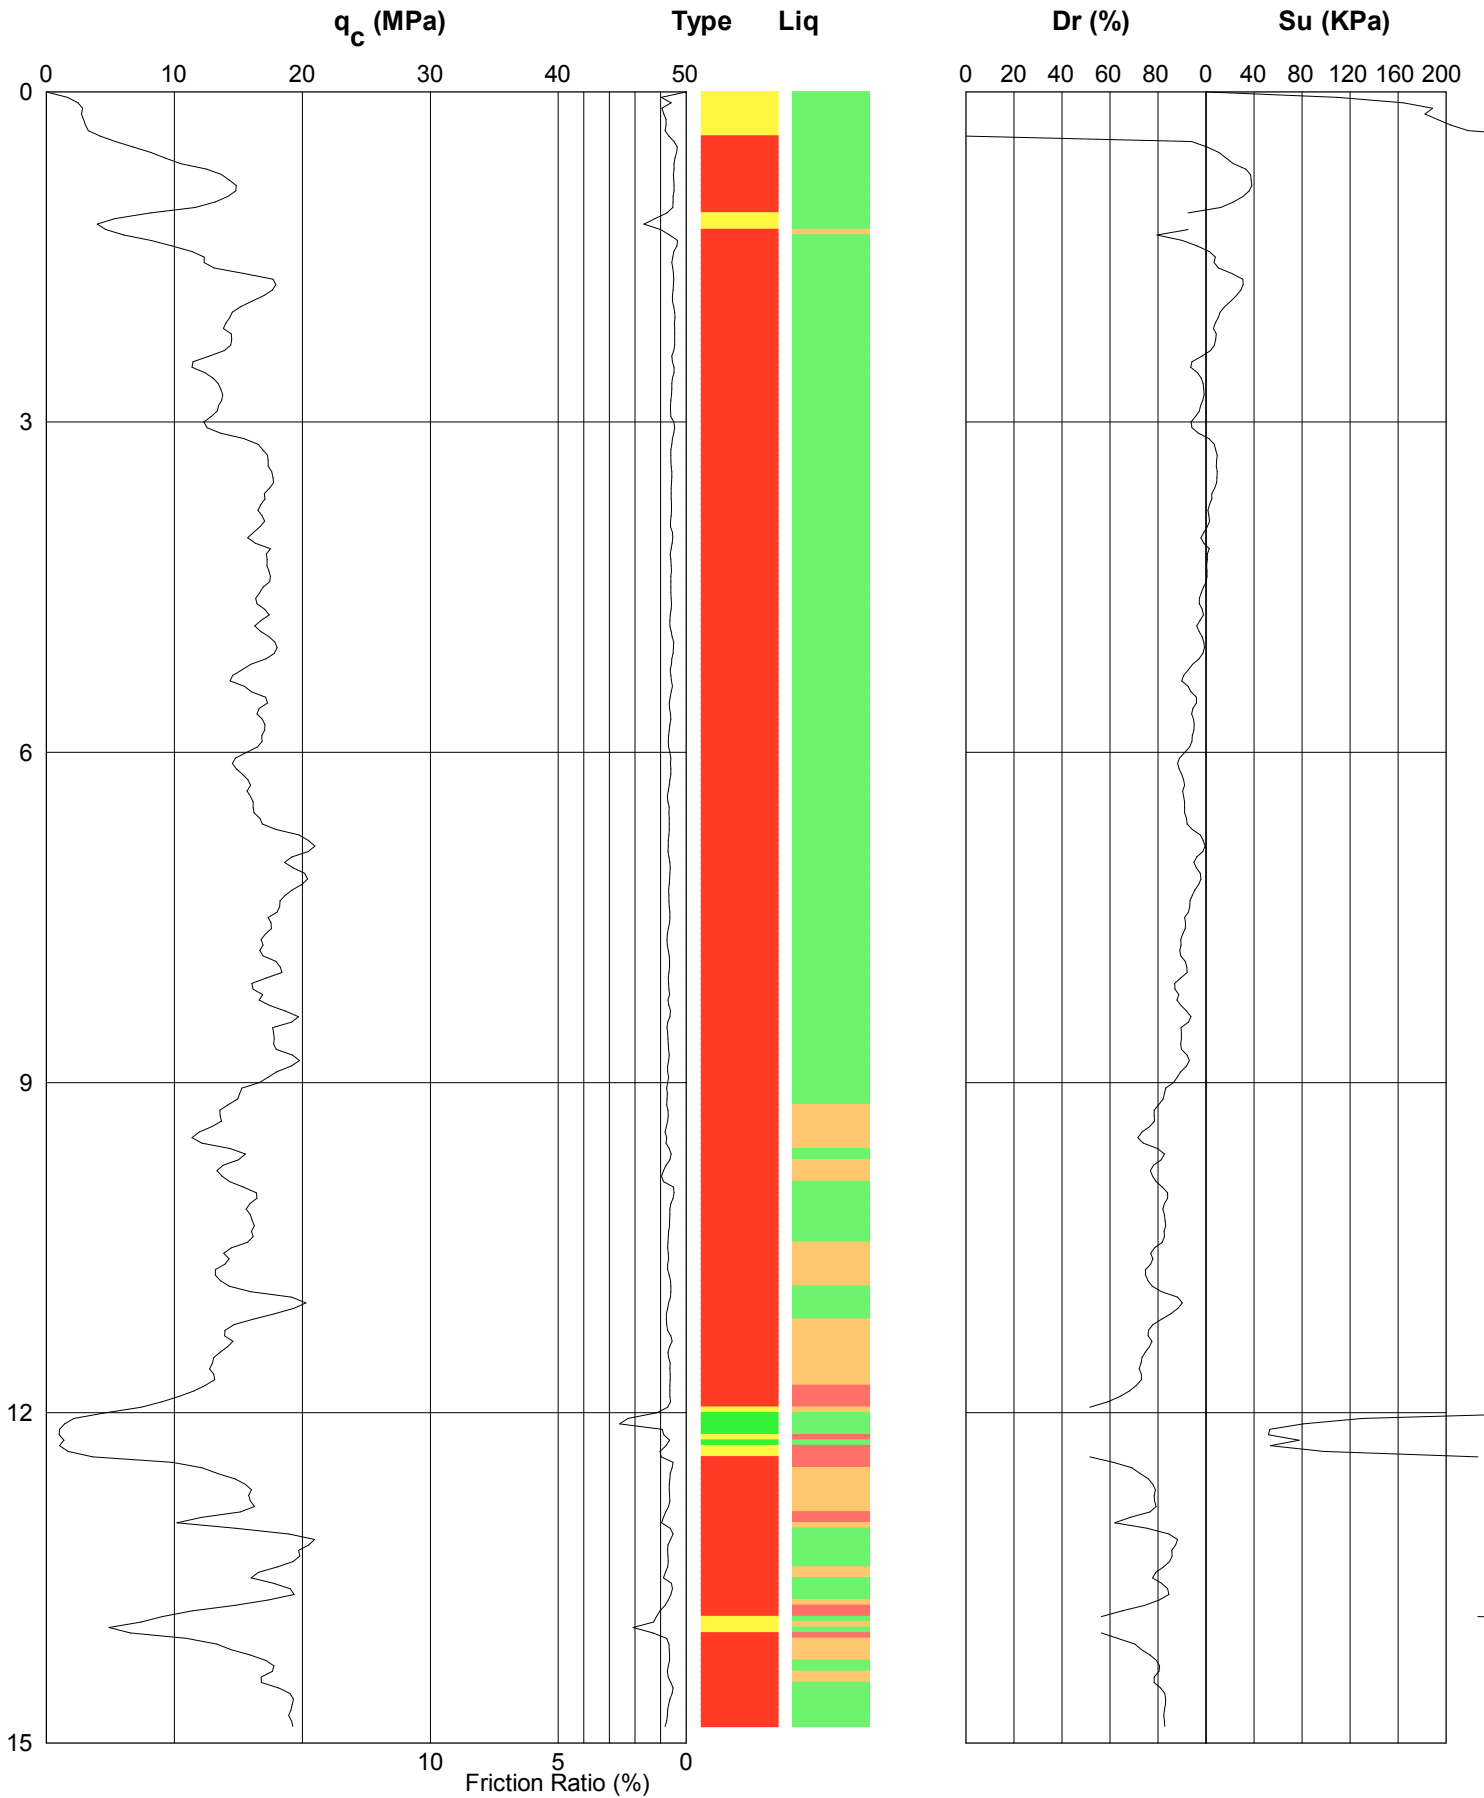
CPT No: CPT122

Remark: Target Depth

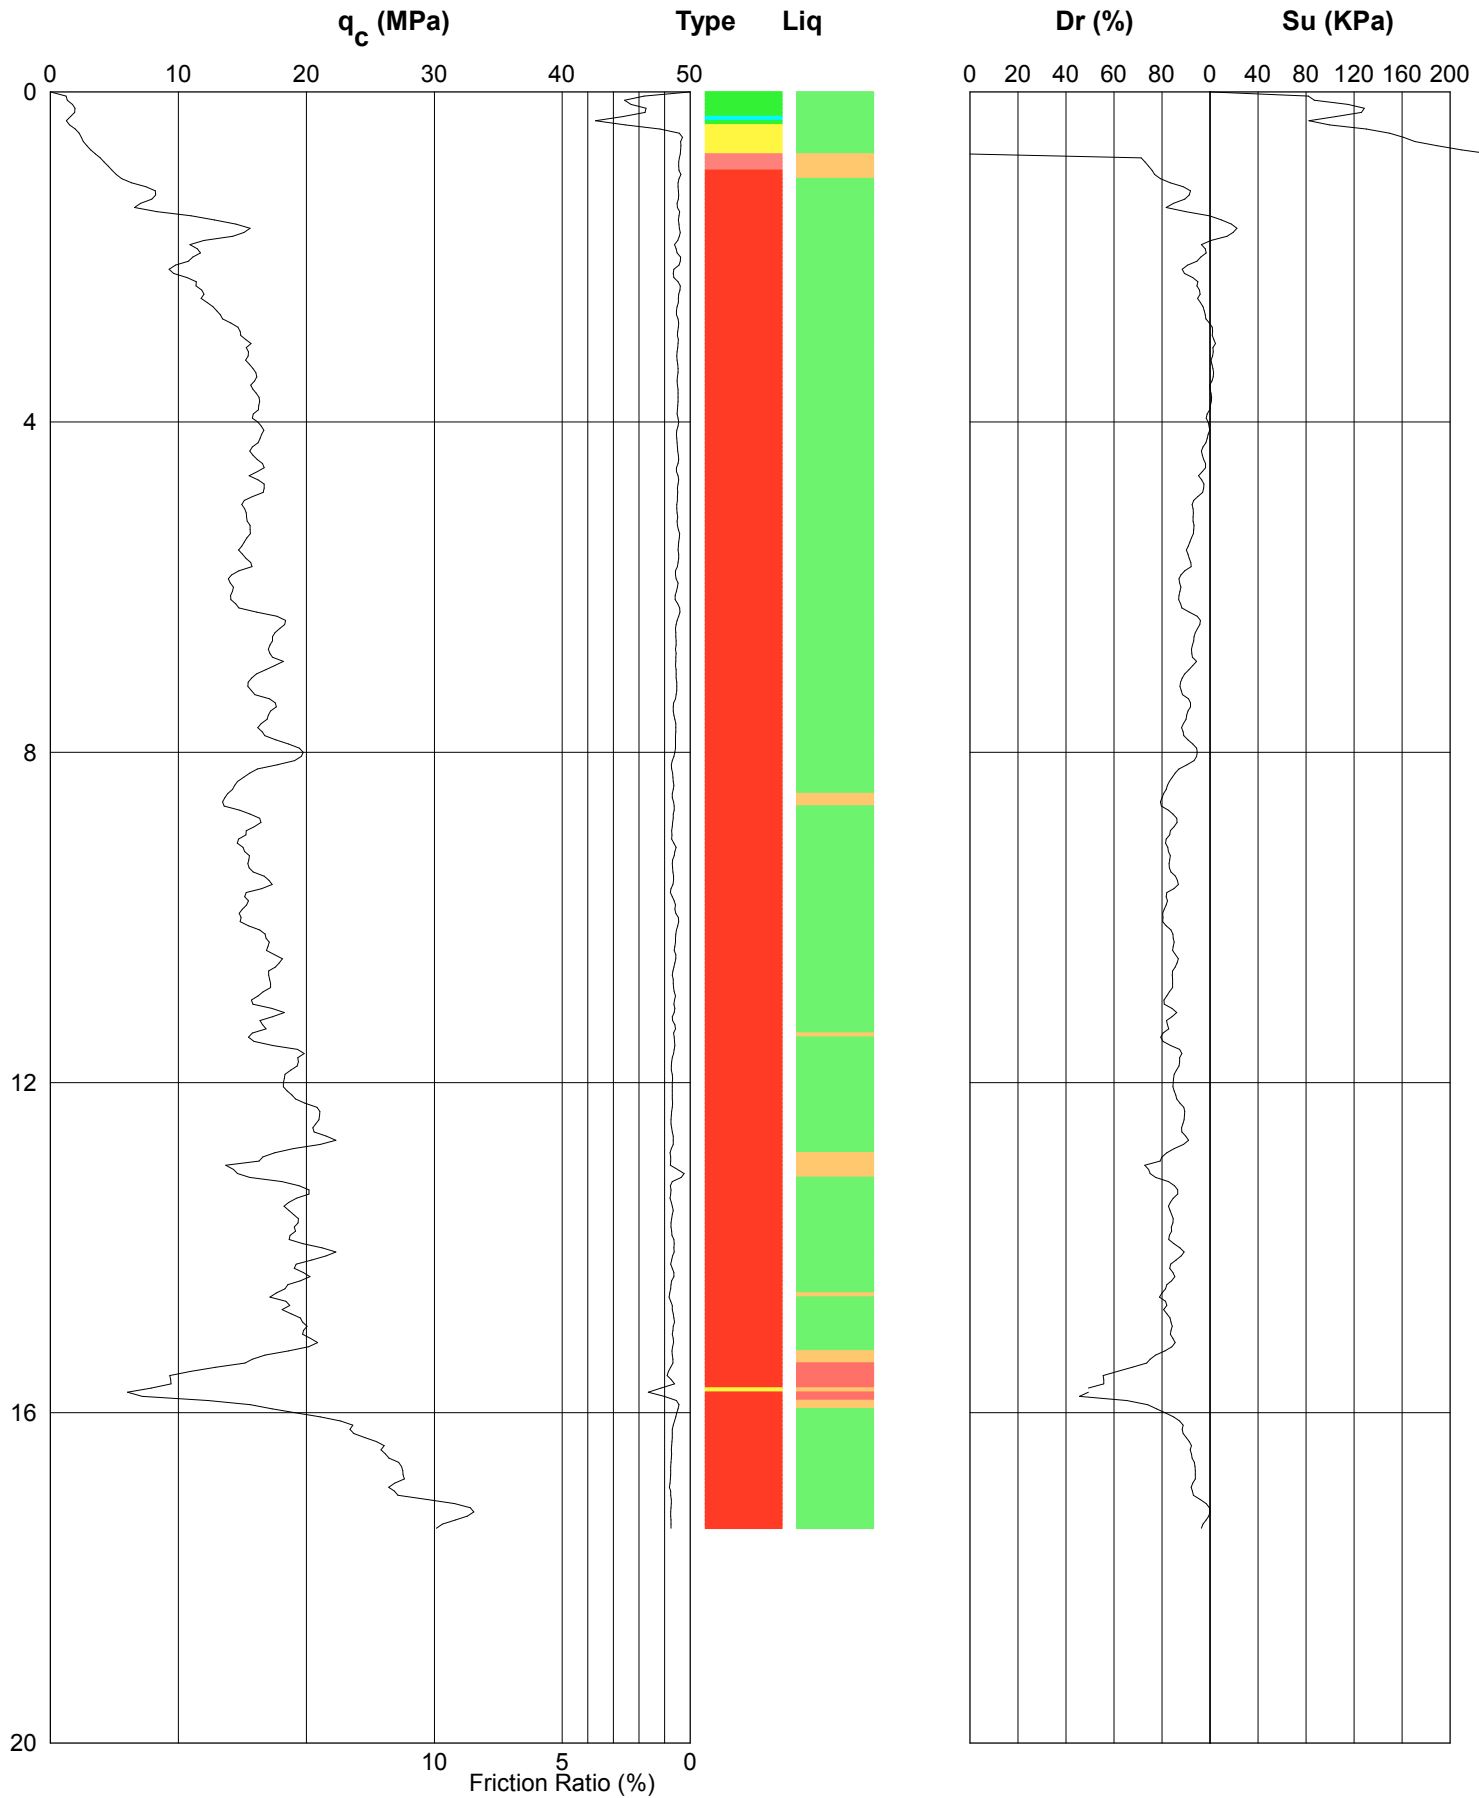
CPT No: CPT123

Remark: Effective Refusal

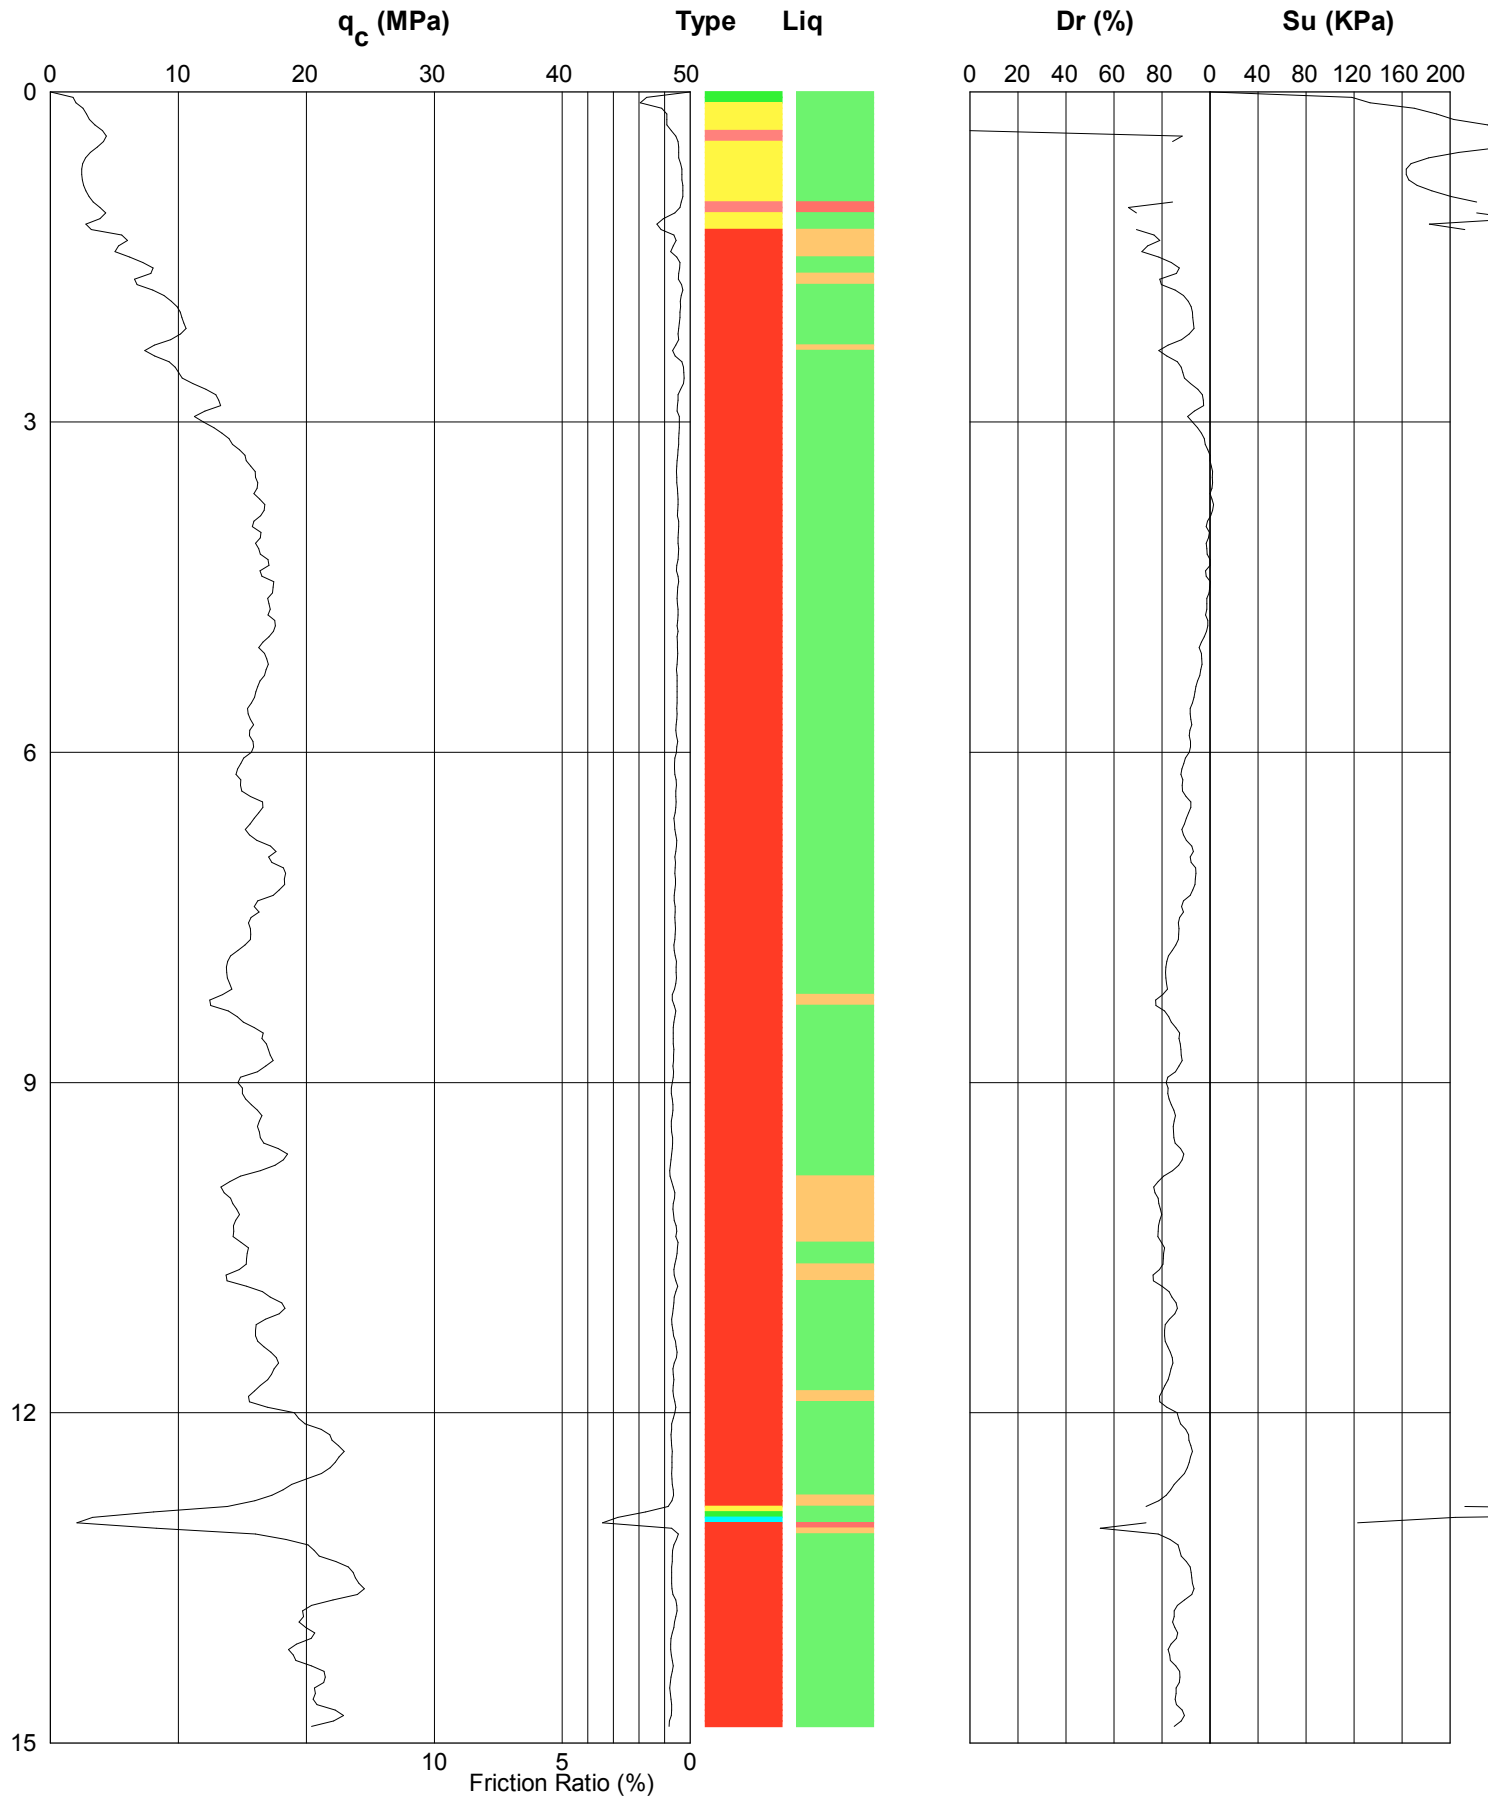
CPT No: CPT124

Remark: Target Depth
