Appendix D

2012 CPT Logs

PIEZOCONE PENETROMETER TEST (CPTU) INTERPRETIVE REPORT

Location: Prestons Subdivision, Christchurch

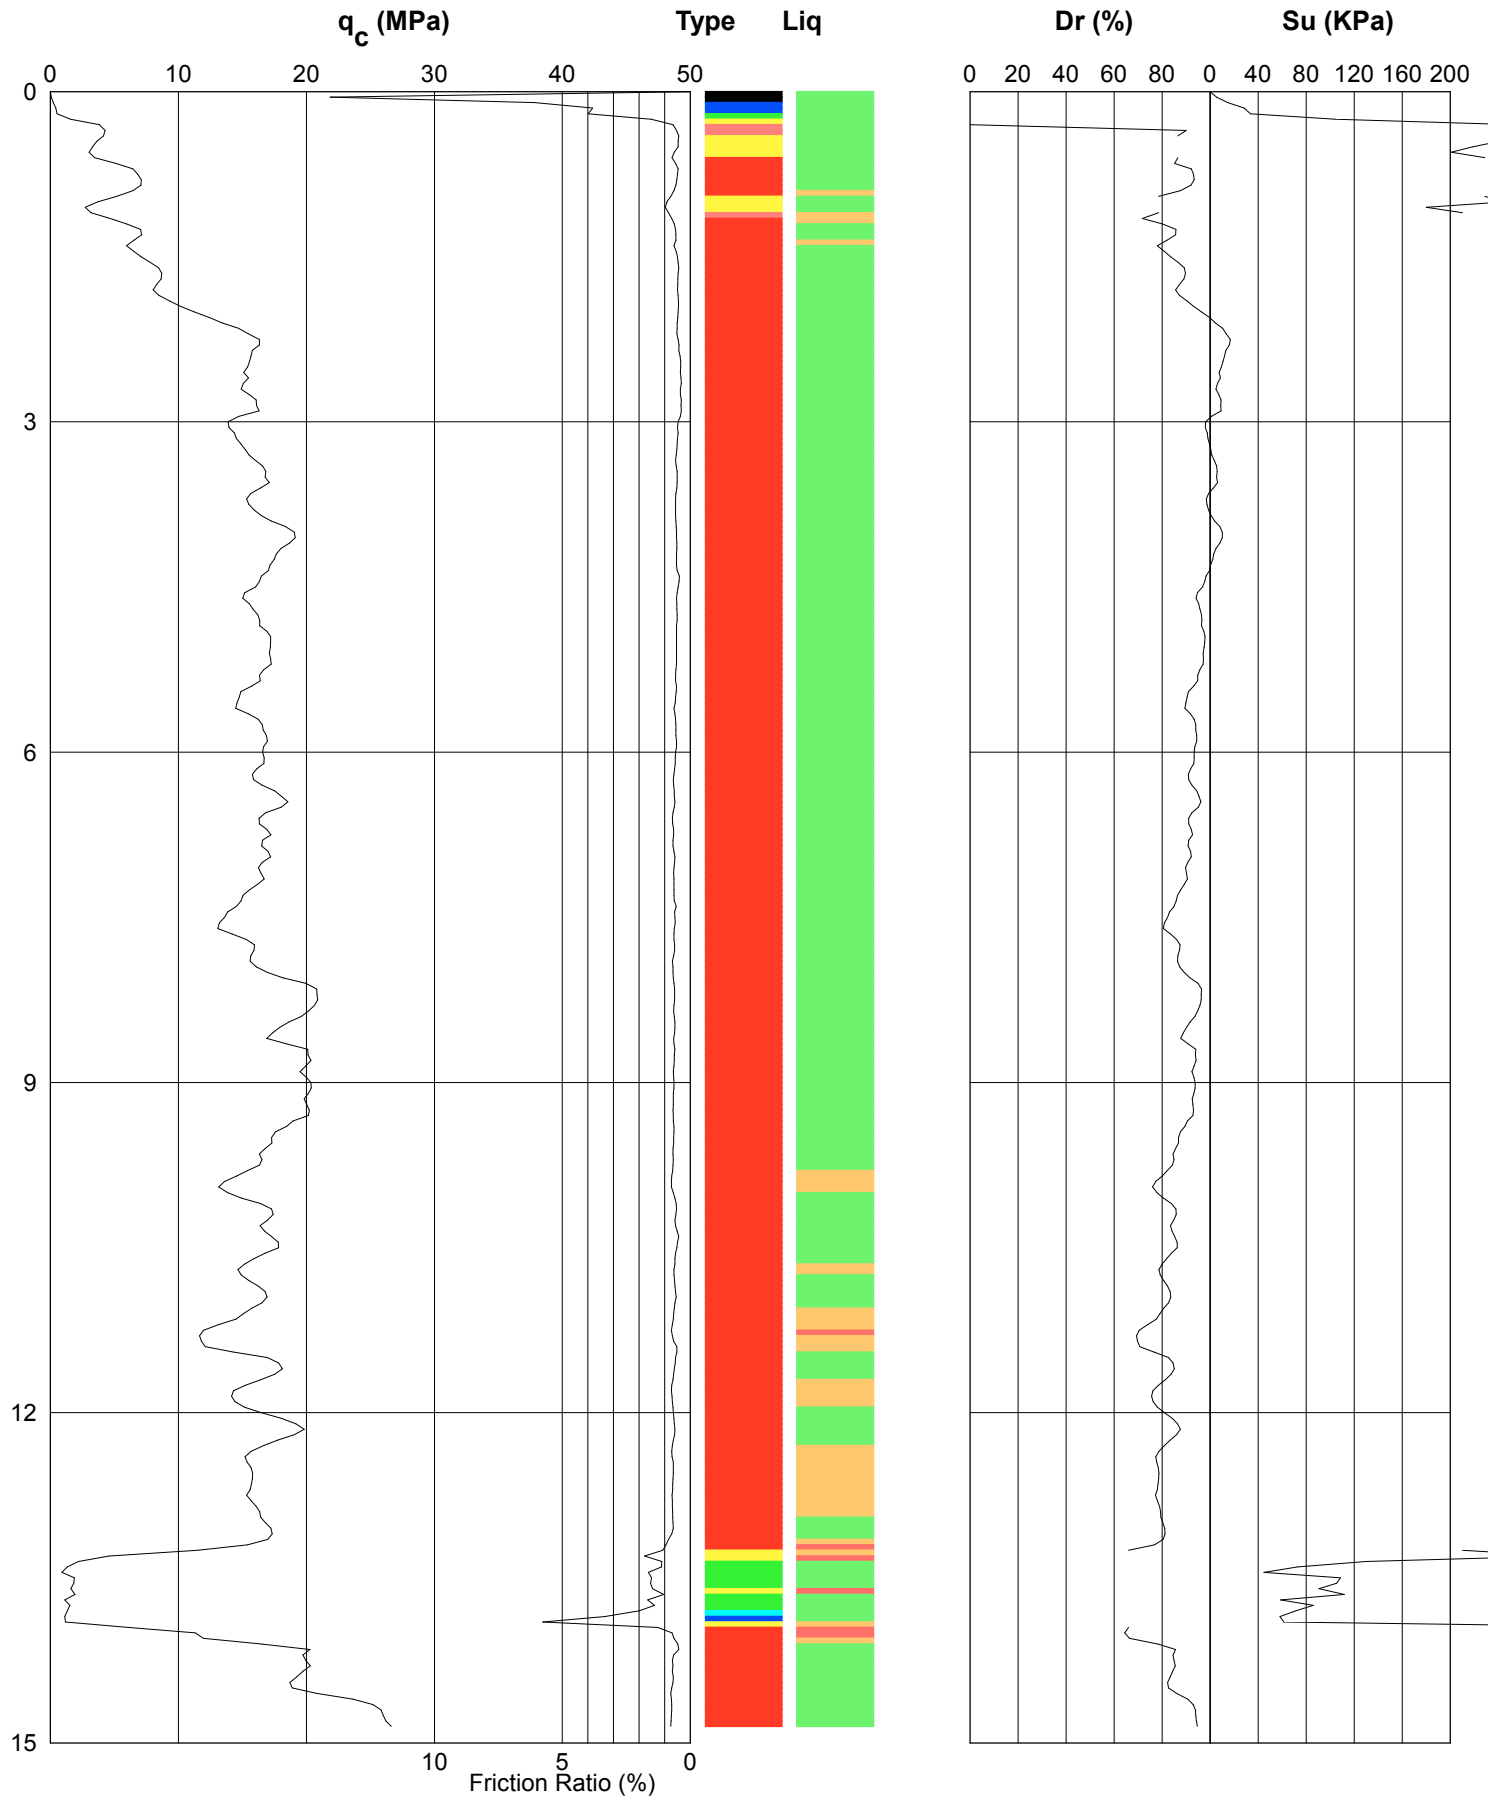
CPT No: CPT125

Remark: Target Depth

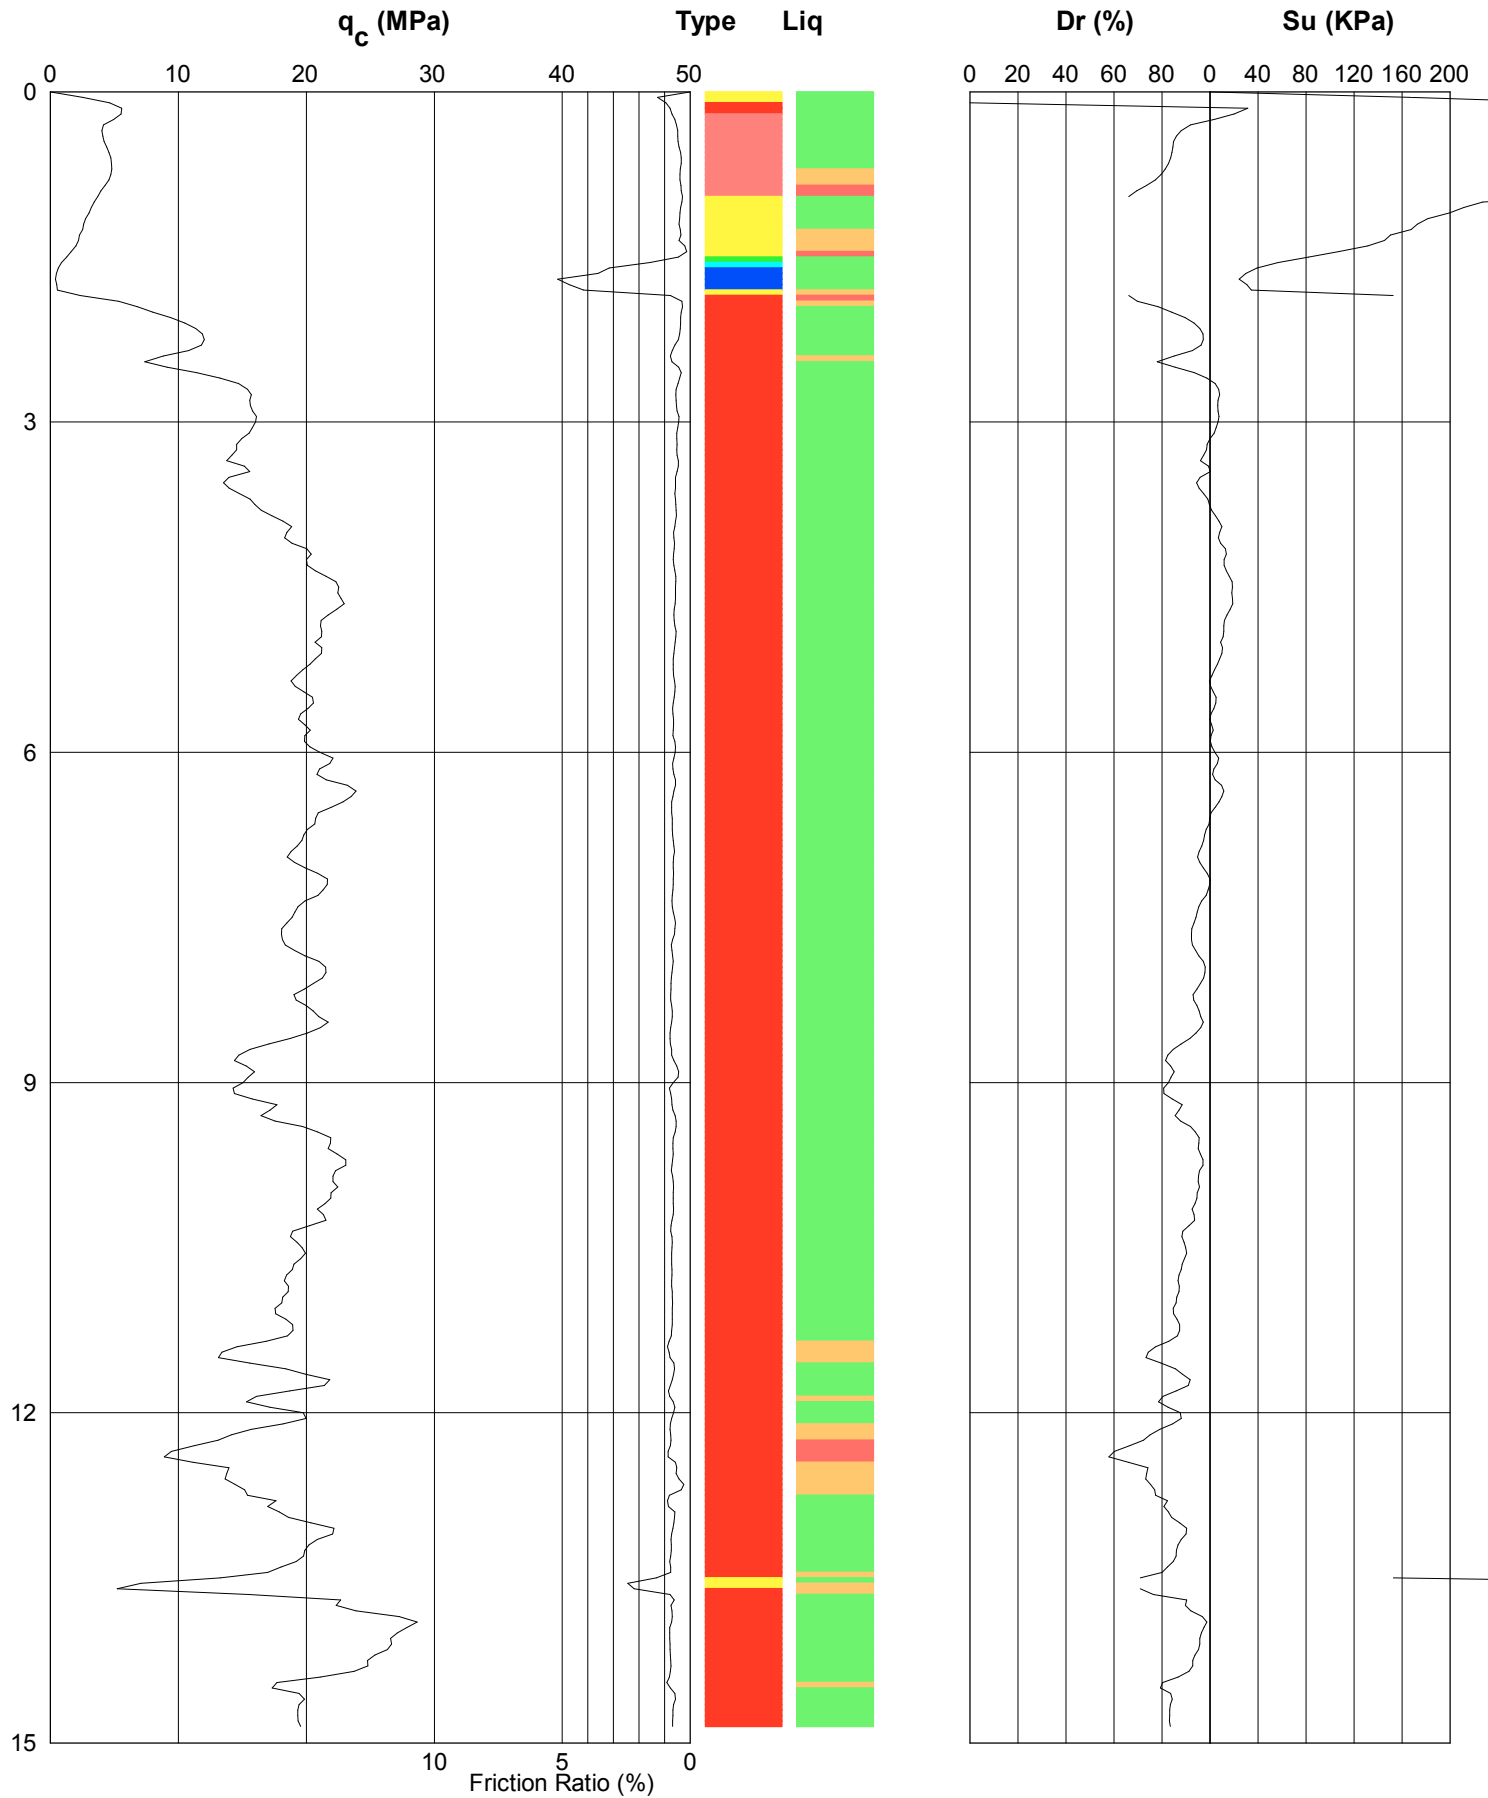
Job No: 10071
 CPT No: CPT126
 Project: Aurecon NZ Ltd
 Location: Prestons Subdivision, Christchurch

Date: 30-1-2012
 Operator: N Barnes
 Remark: Target Depth

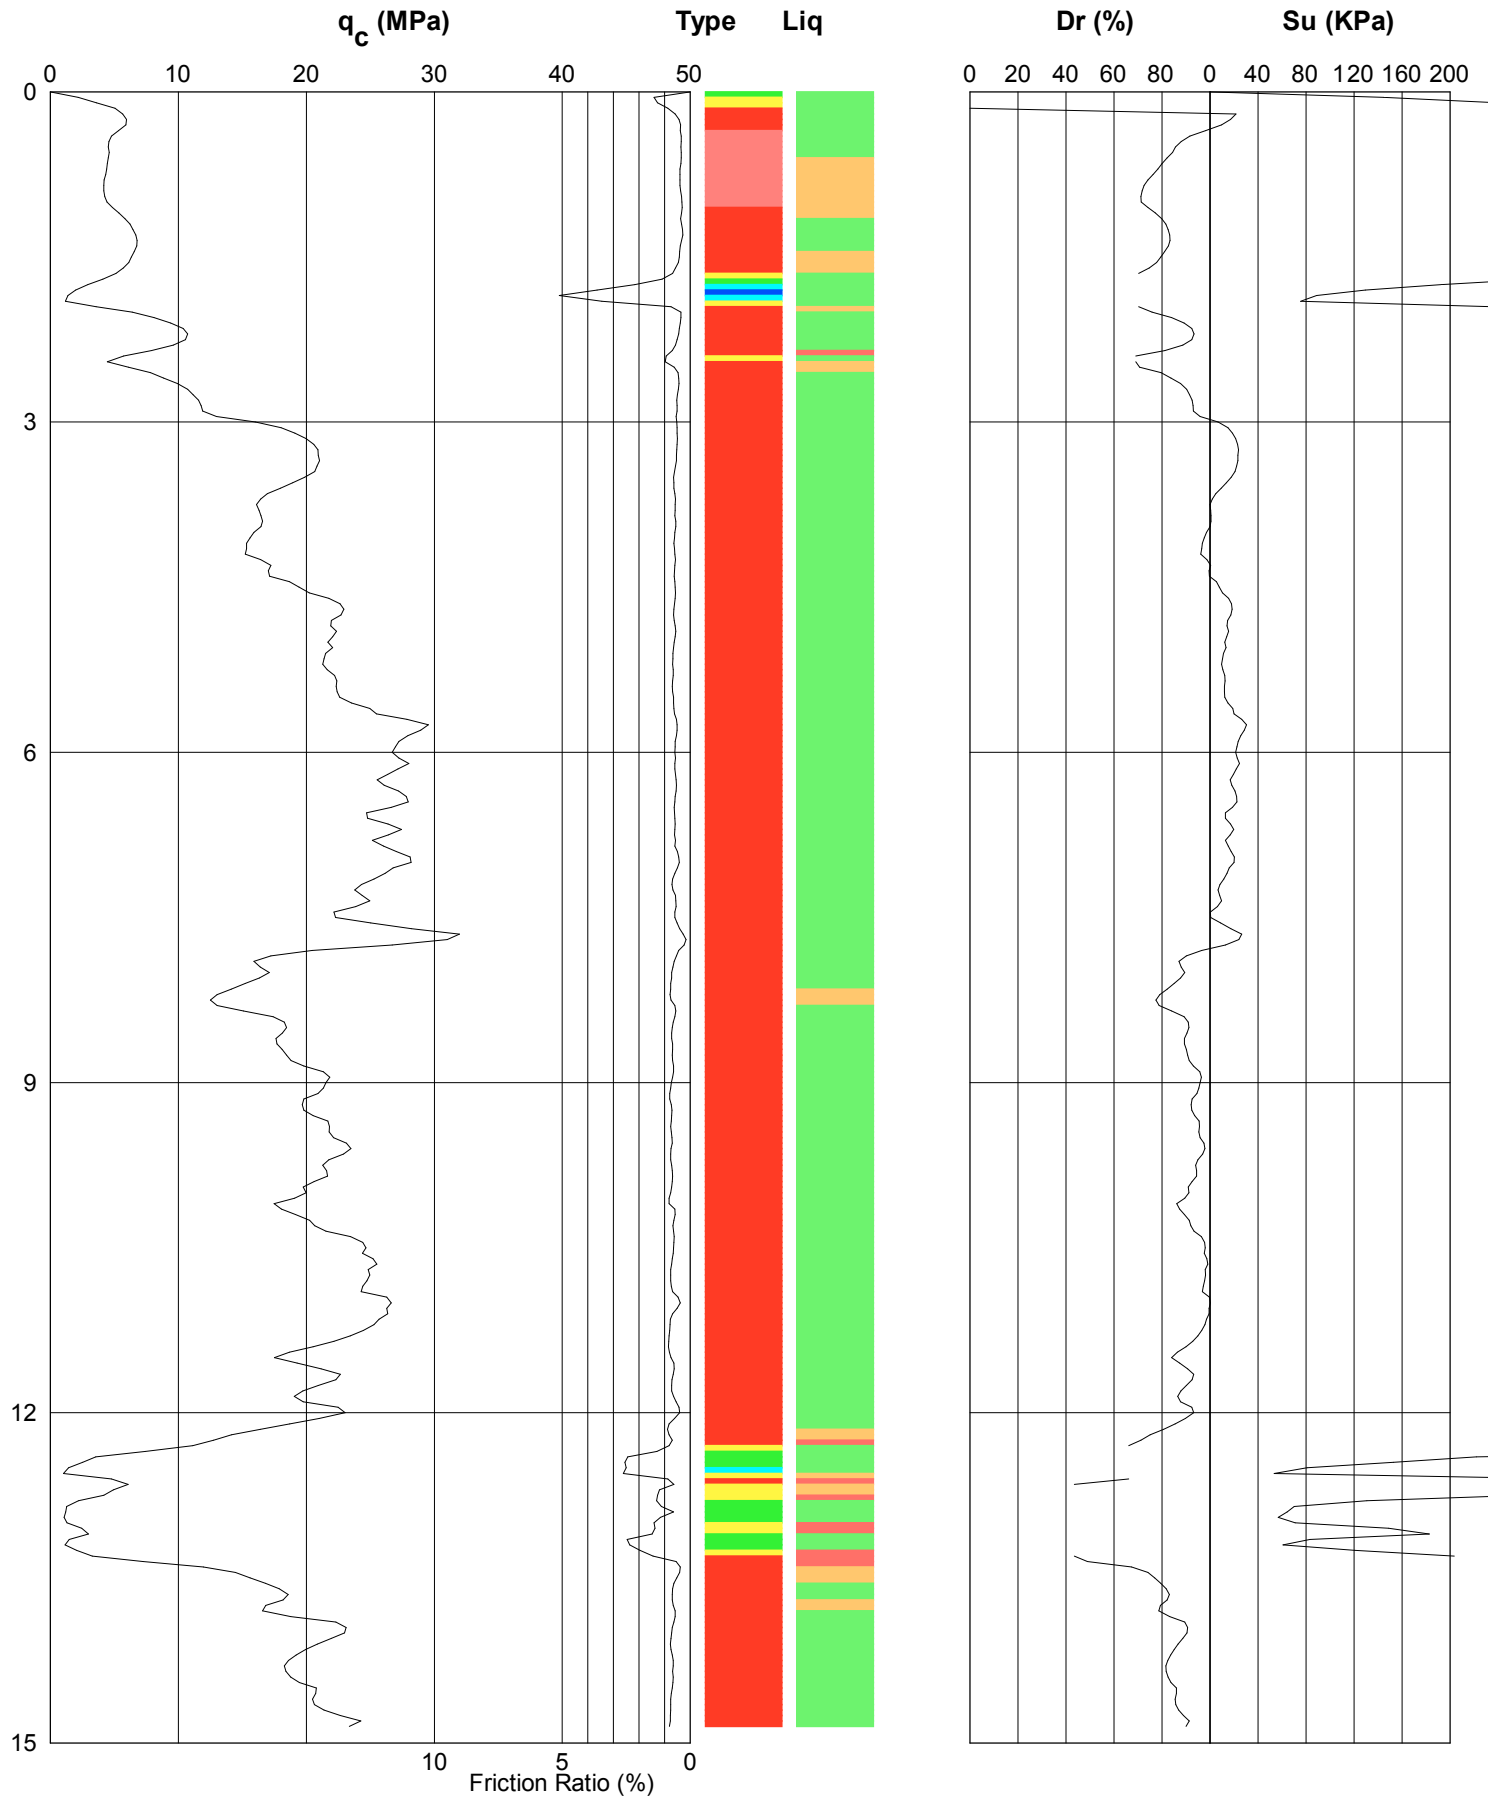
CPT No: CPT127

Remark: Target Depth

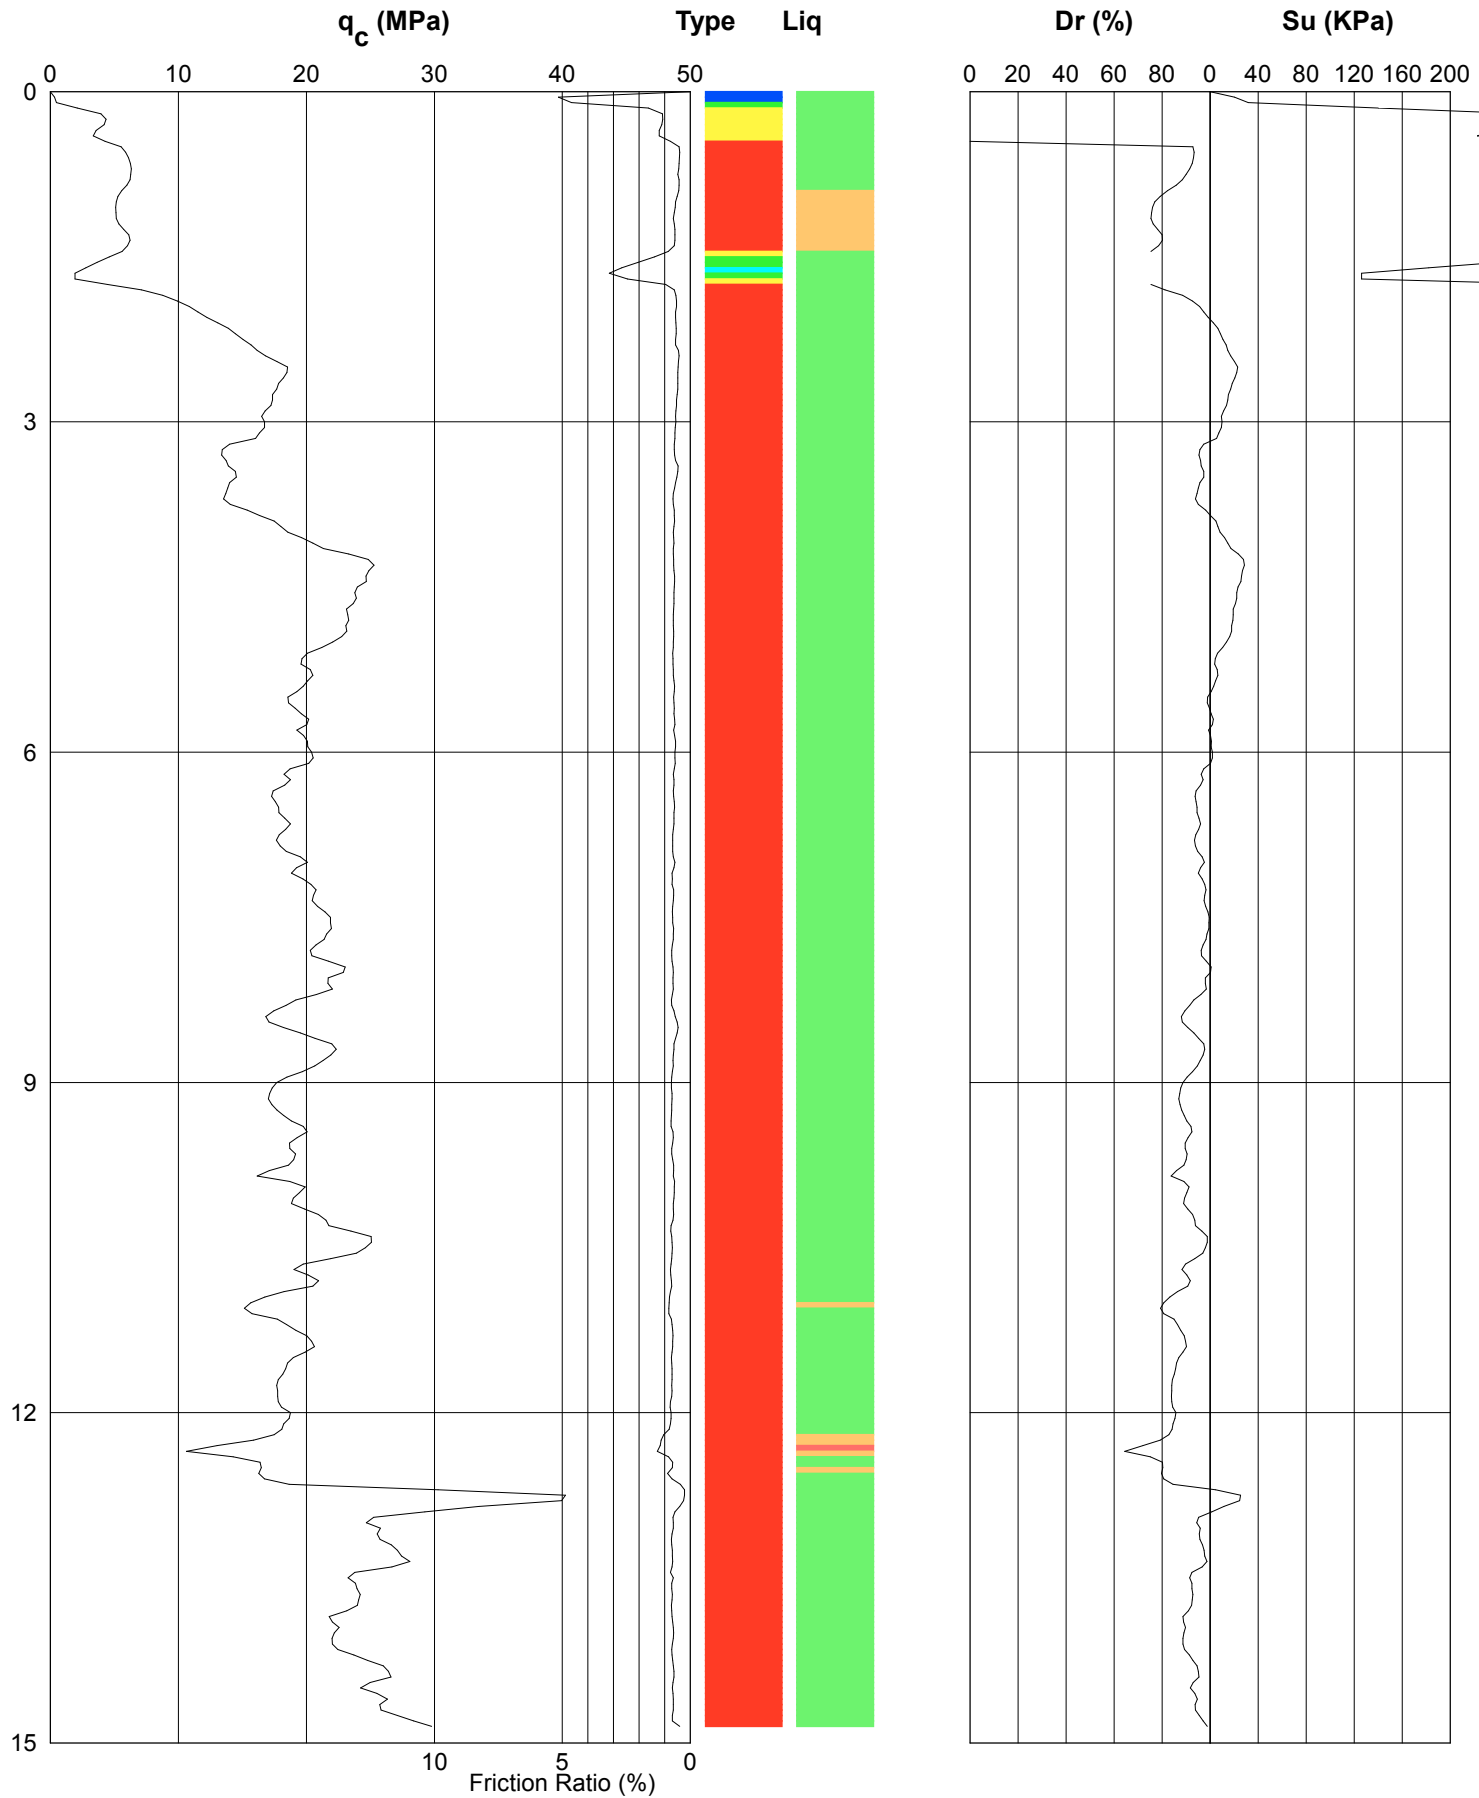
CPT No: CPT128

Remark: Target Depth

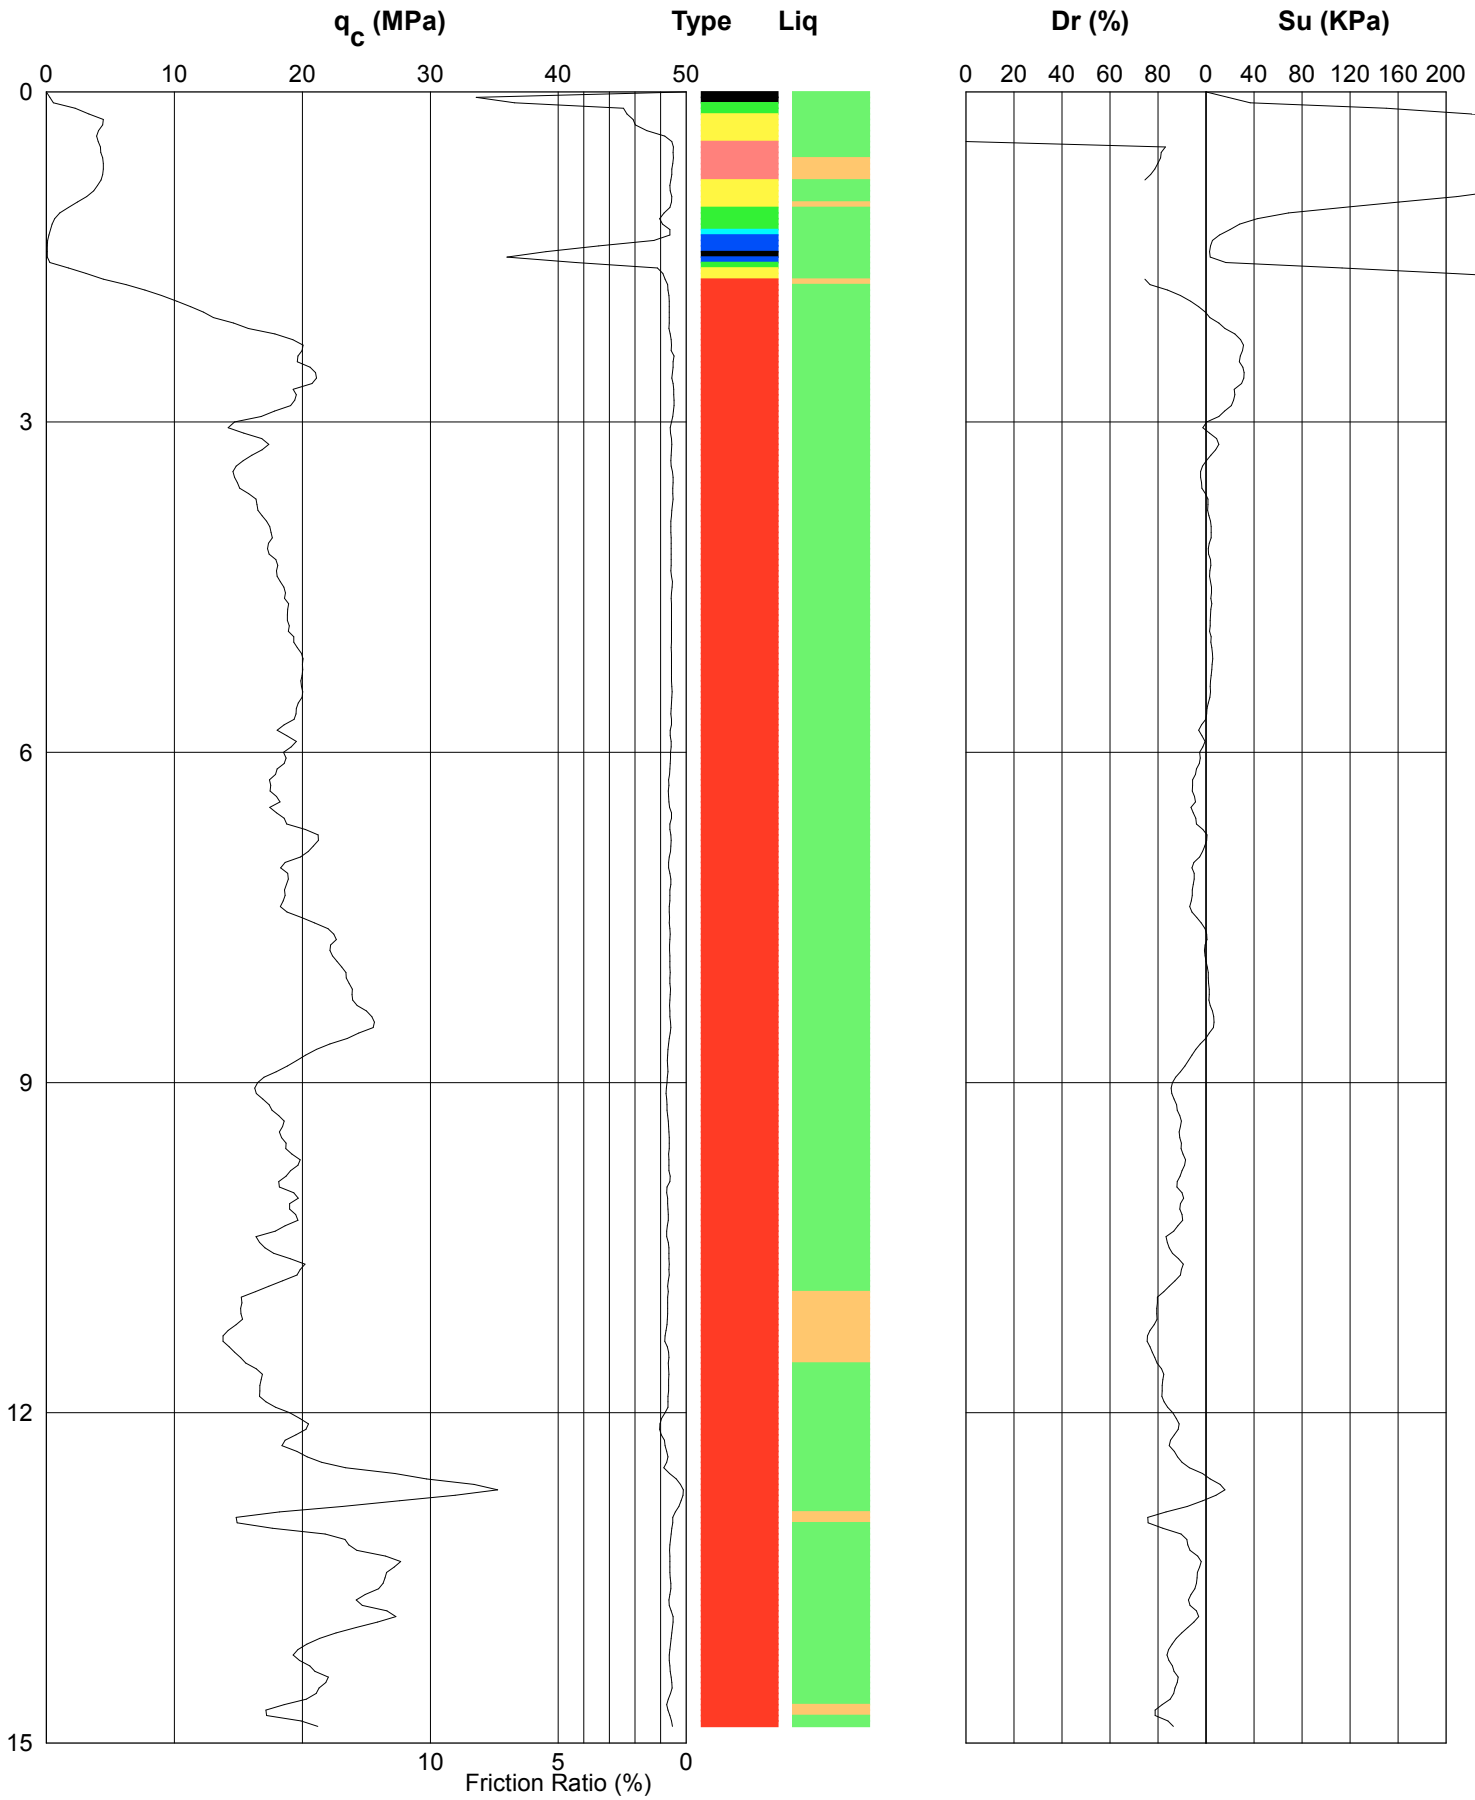
CPT No: CPT129

Remark: Target Depth

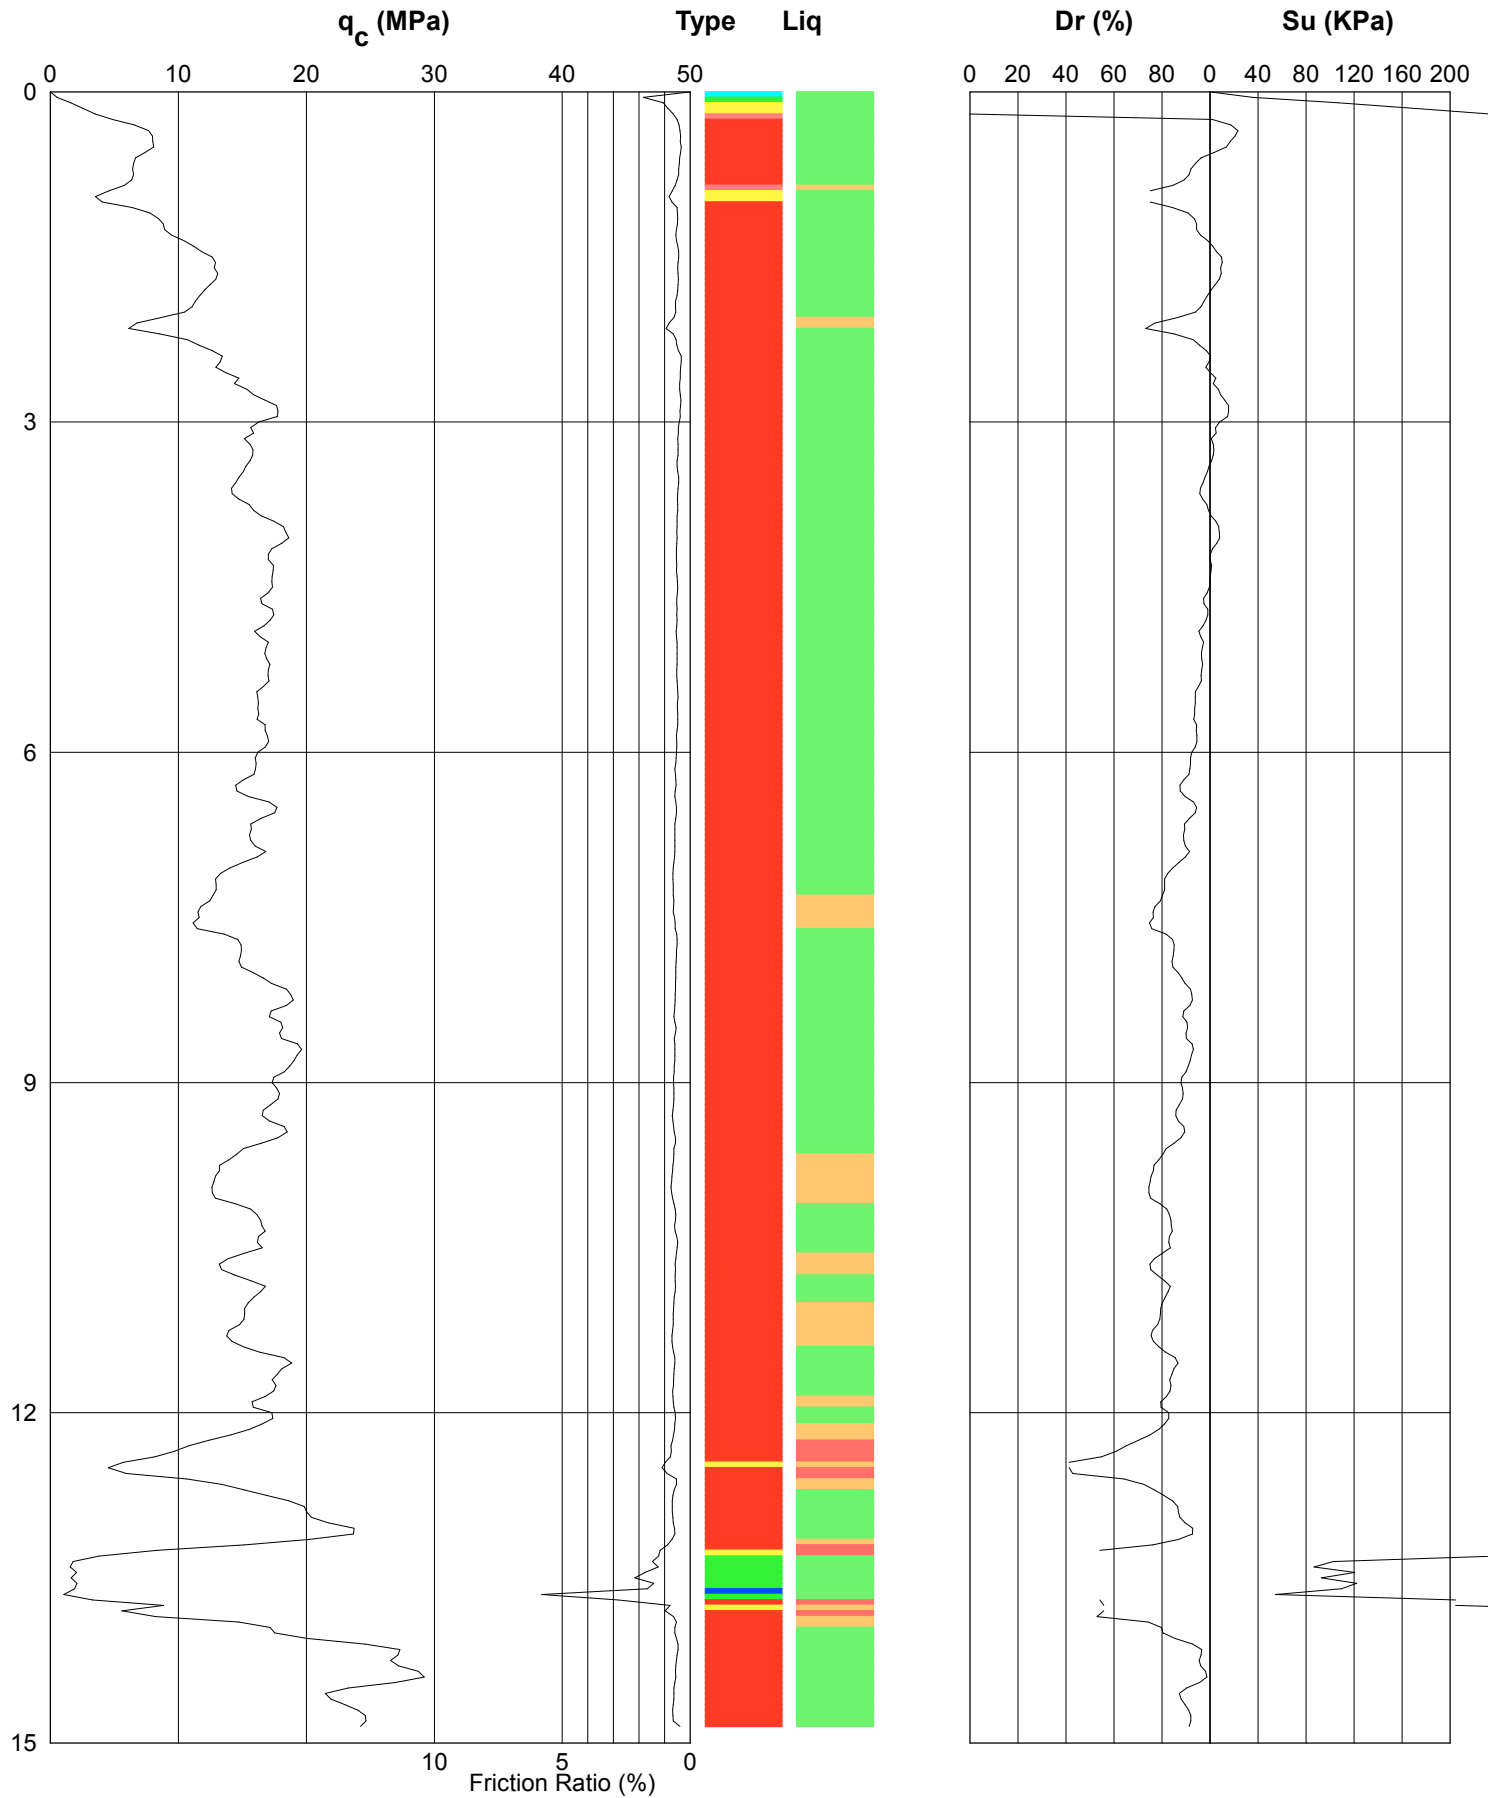
CPT No: CPT130

Remark: Target Depth

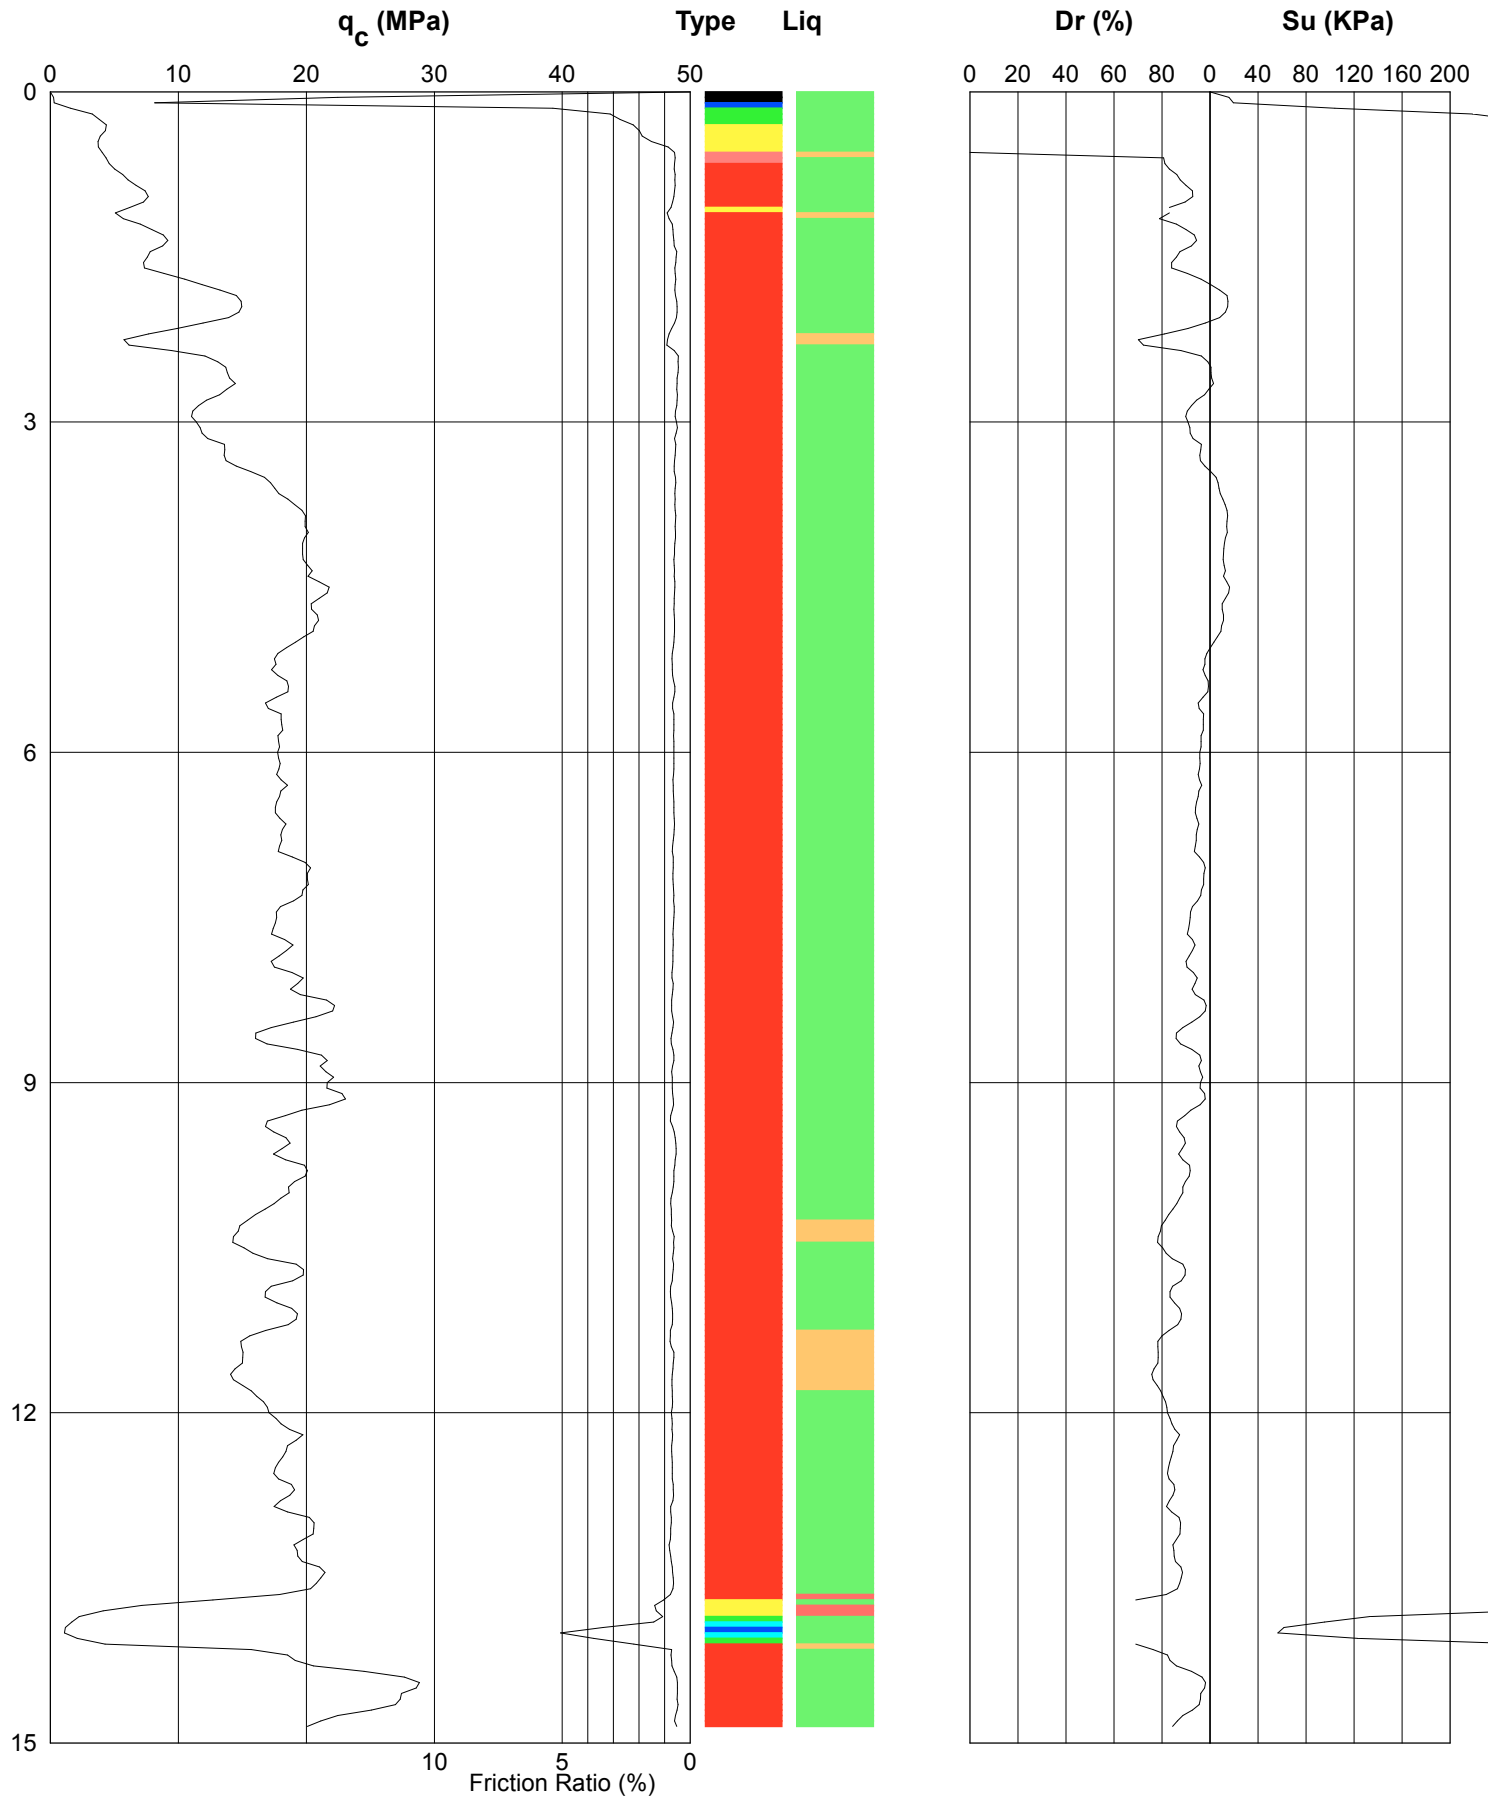
CPT No: CPT131

Remark: Target Depth

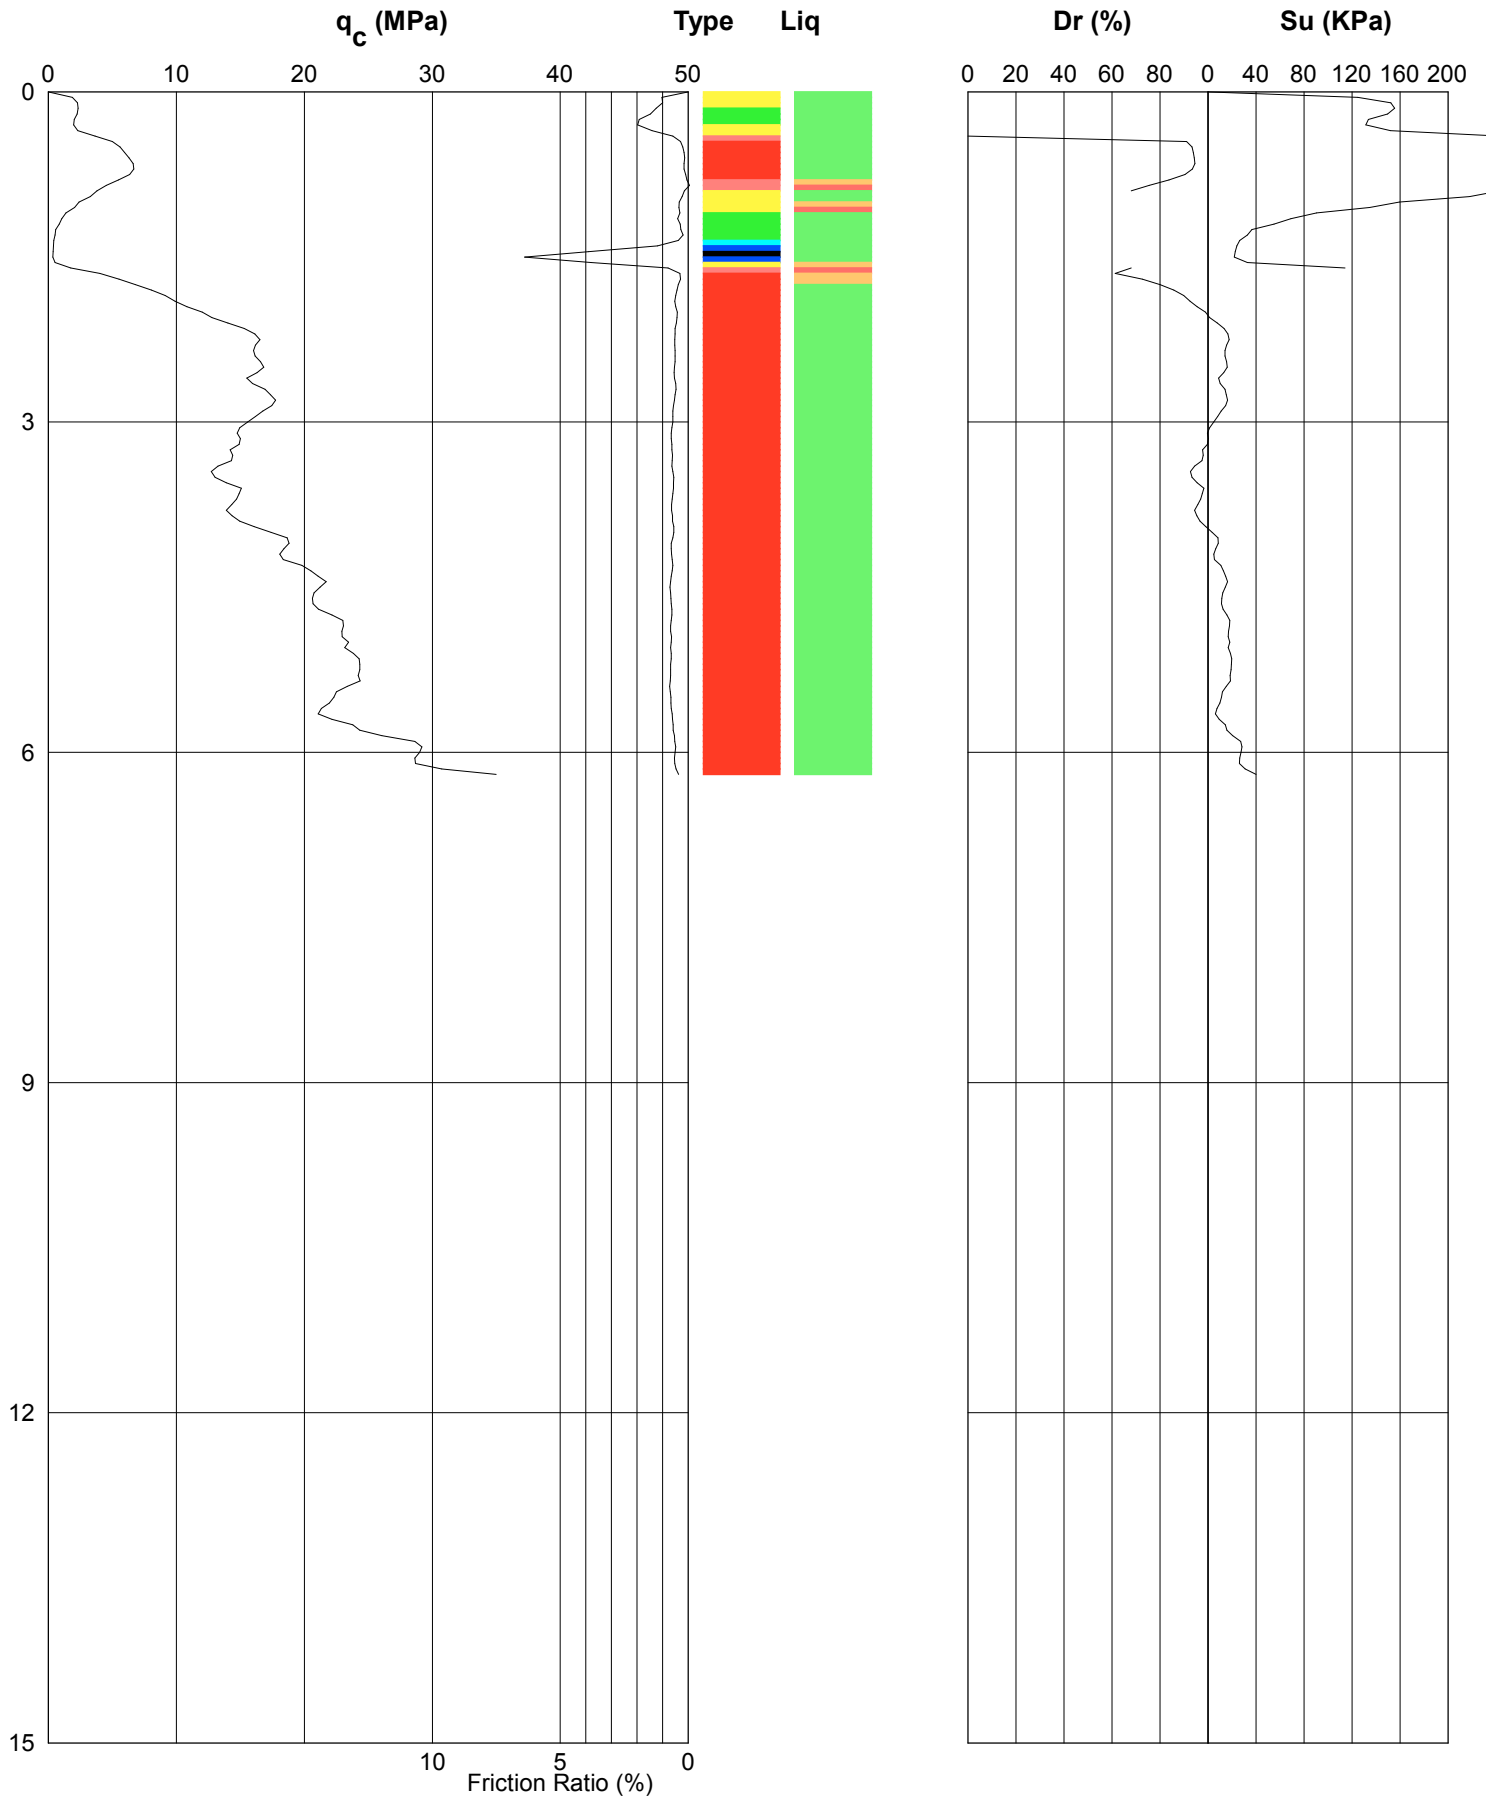
CPT No: CPT132

Remark: Effective Refusal
