Appendix D

2012 CPT Logs

PIEZOCONE PENETROMETER TEST (CPTU) INTERPRETIVE REPORT

Location: Prestons Subdivision, Christchurch

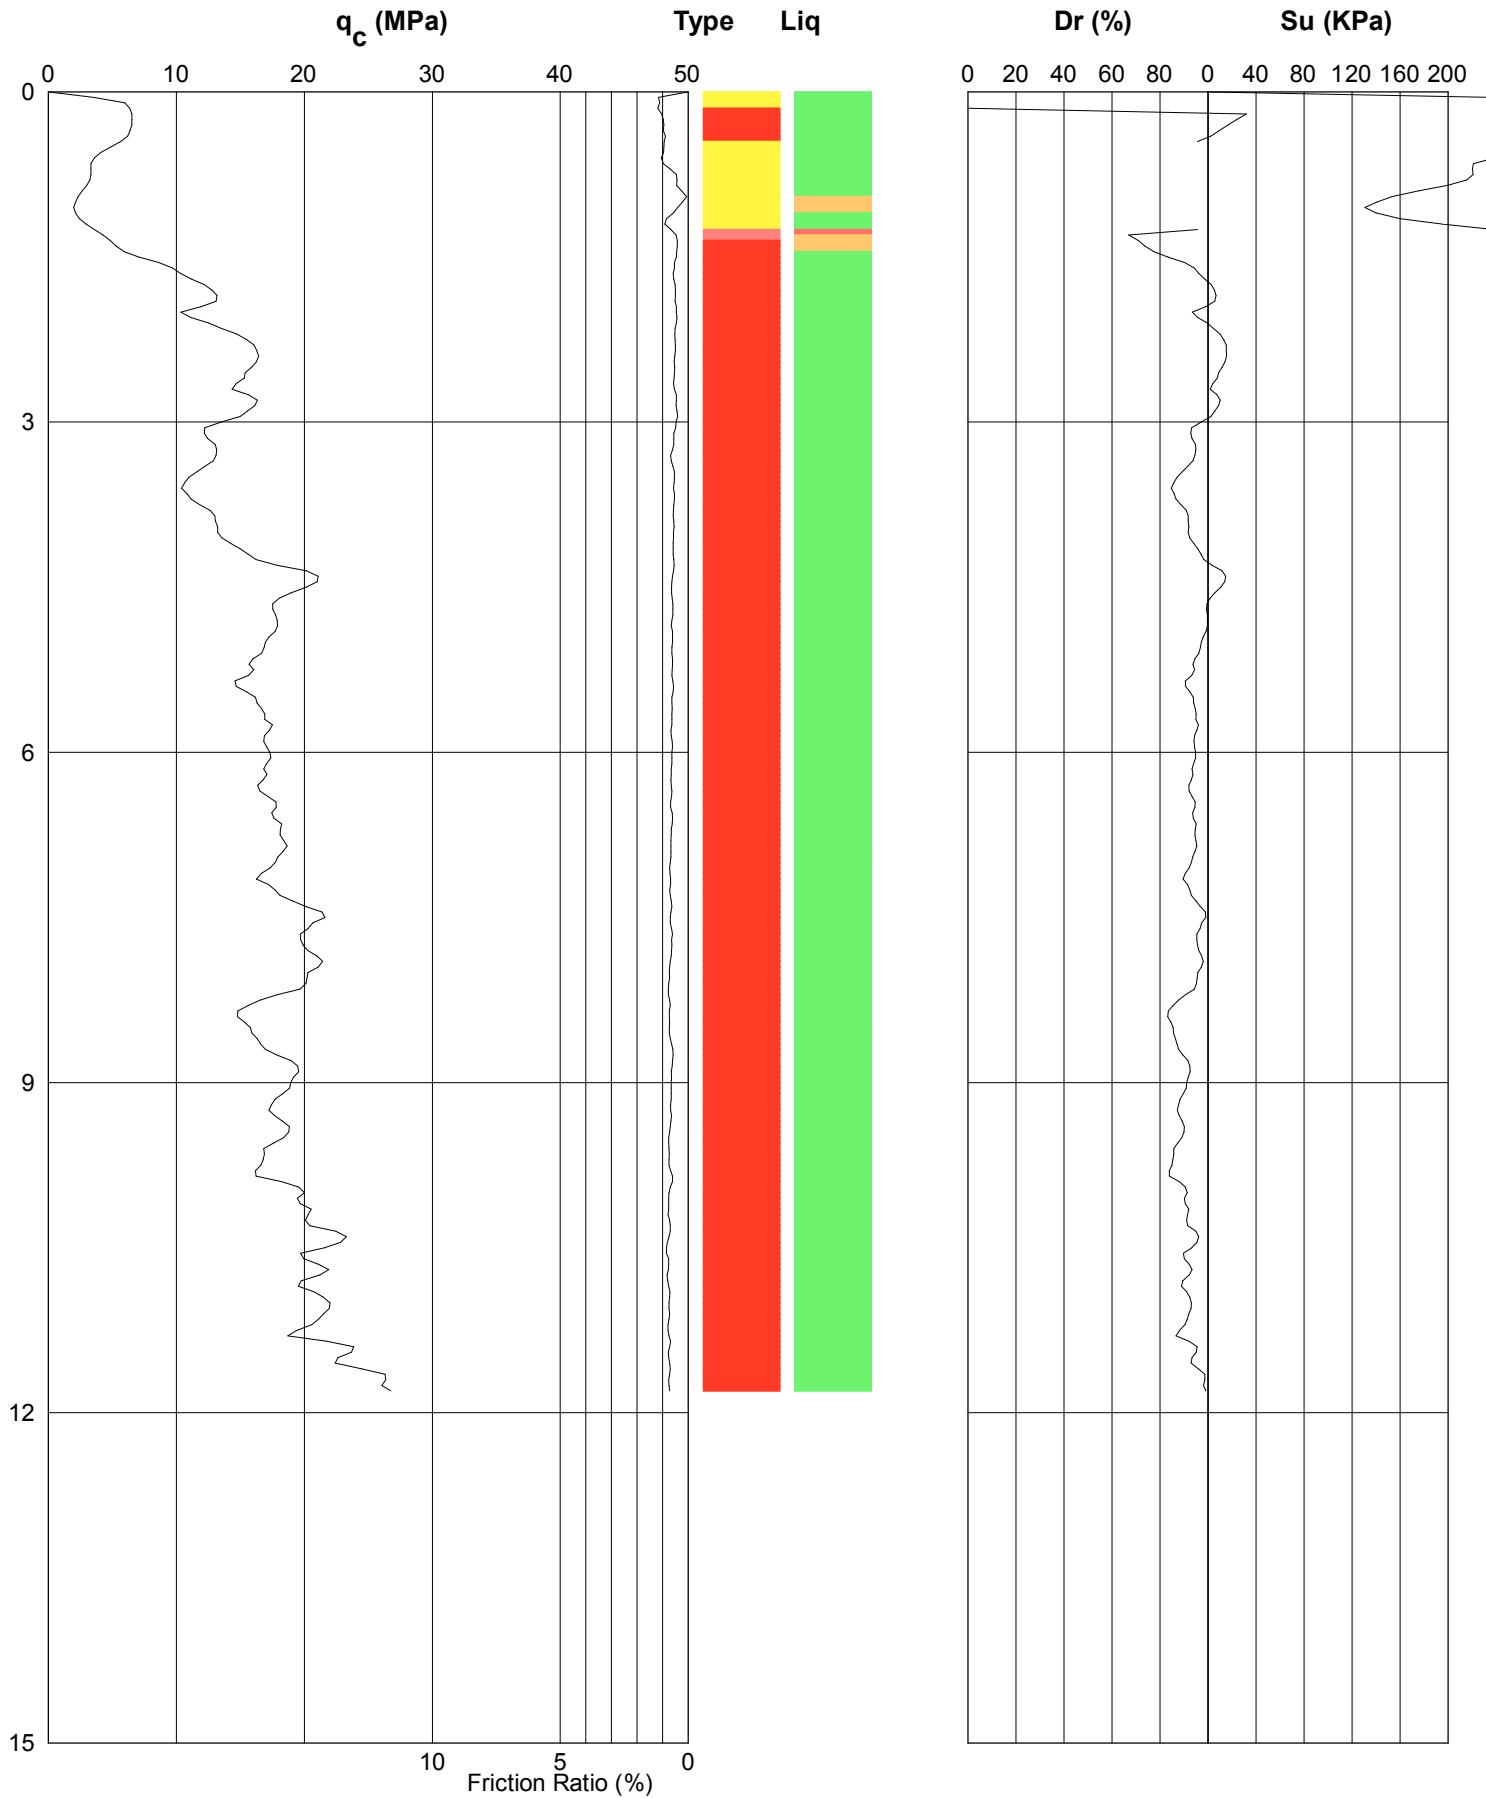
CPT No: CPT133

Remark: Effective Refusal

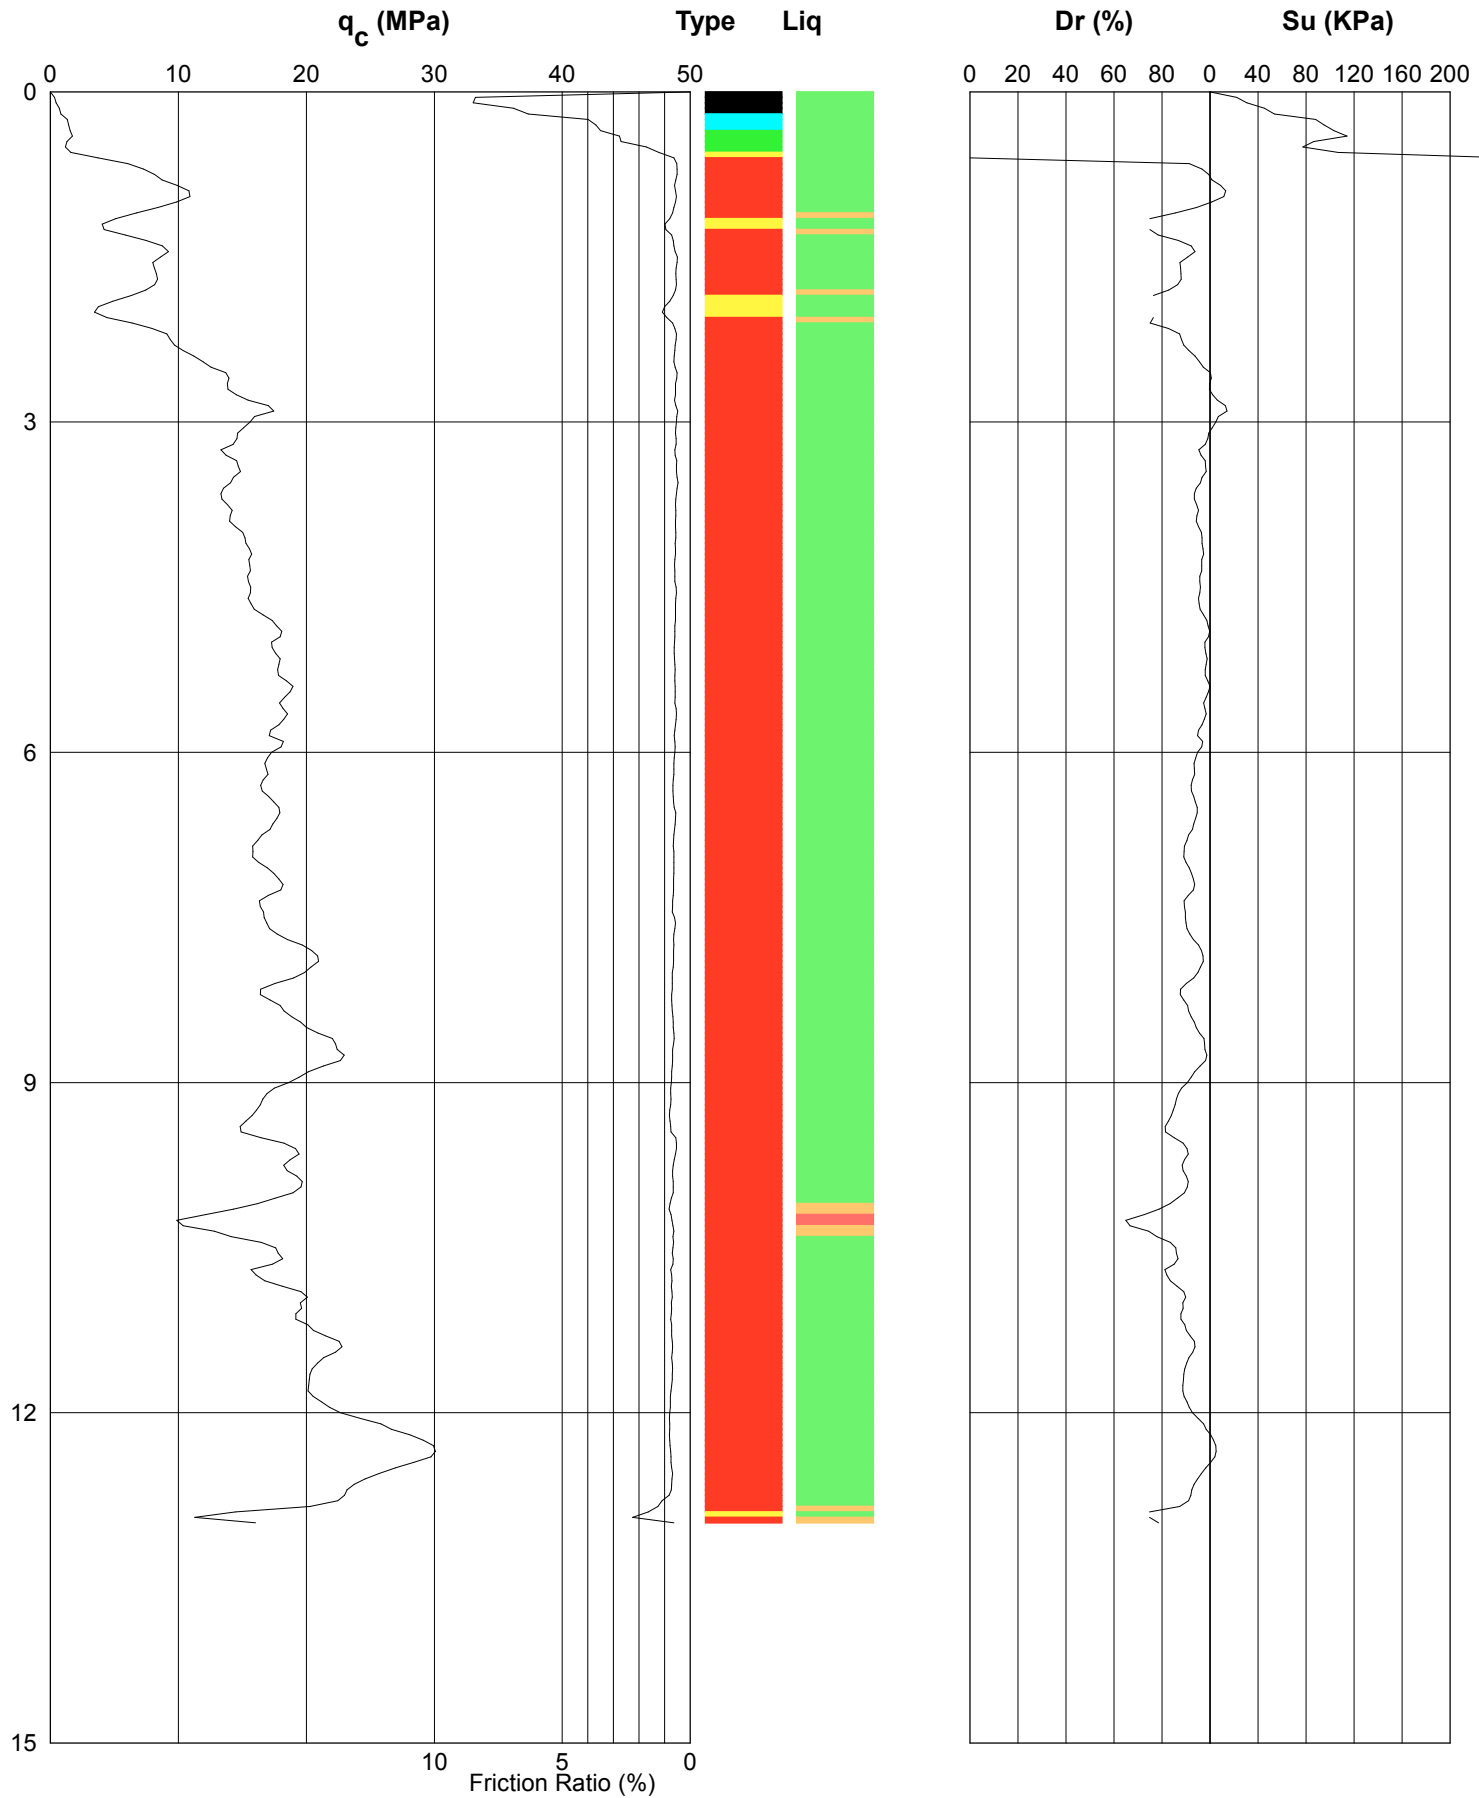
CPT No: CPT134

Remark: Effective Refusal

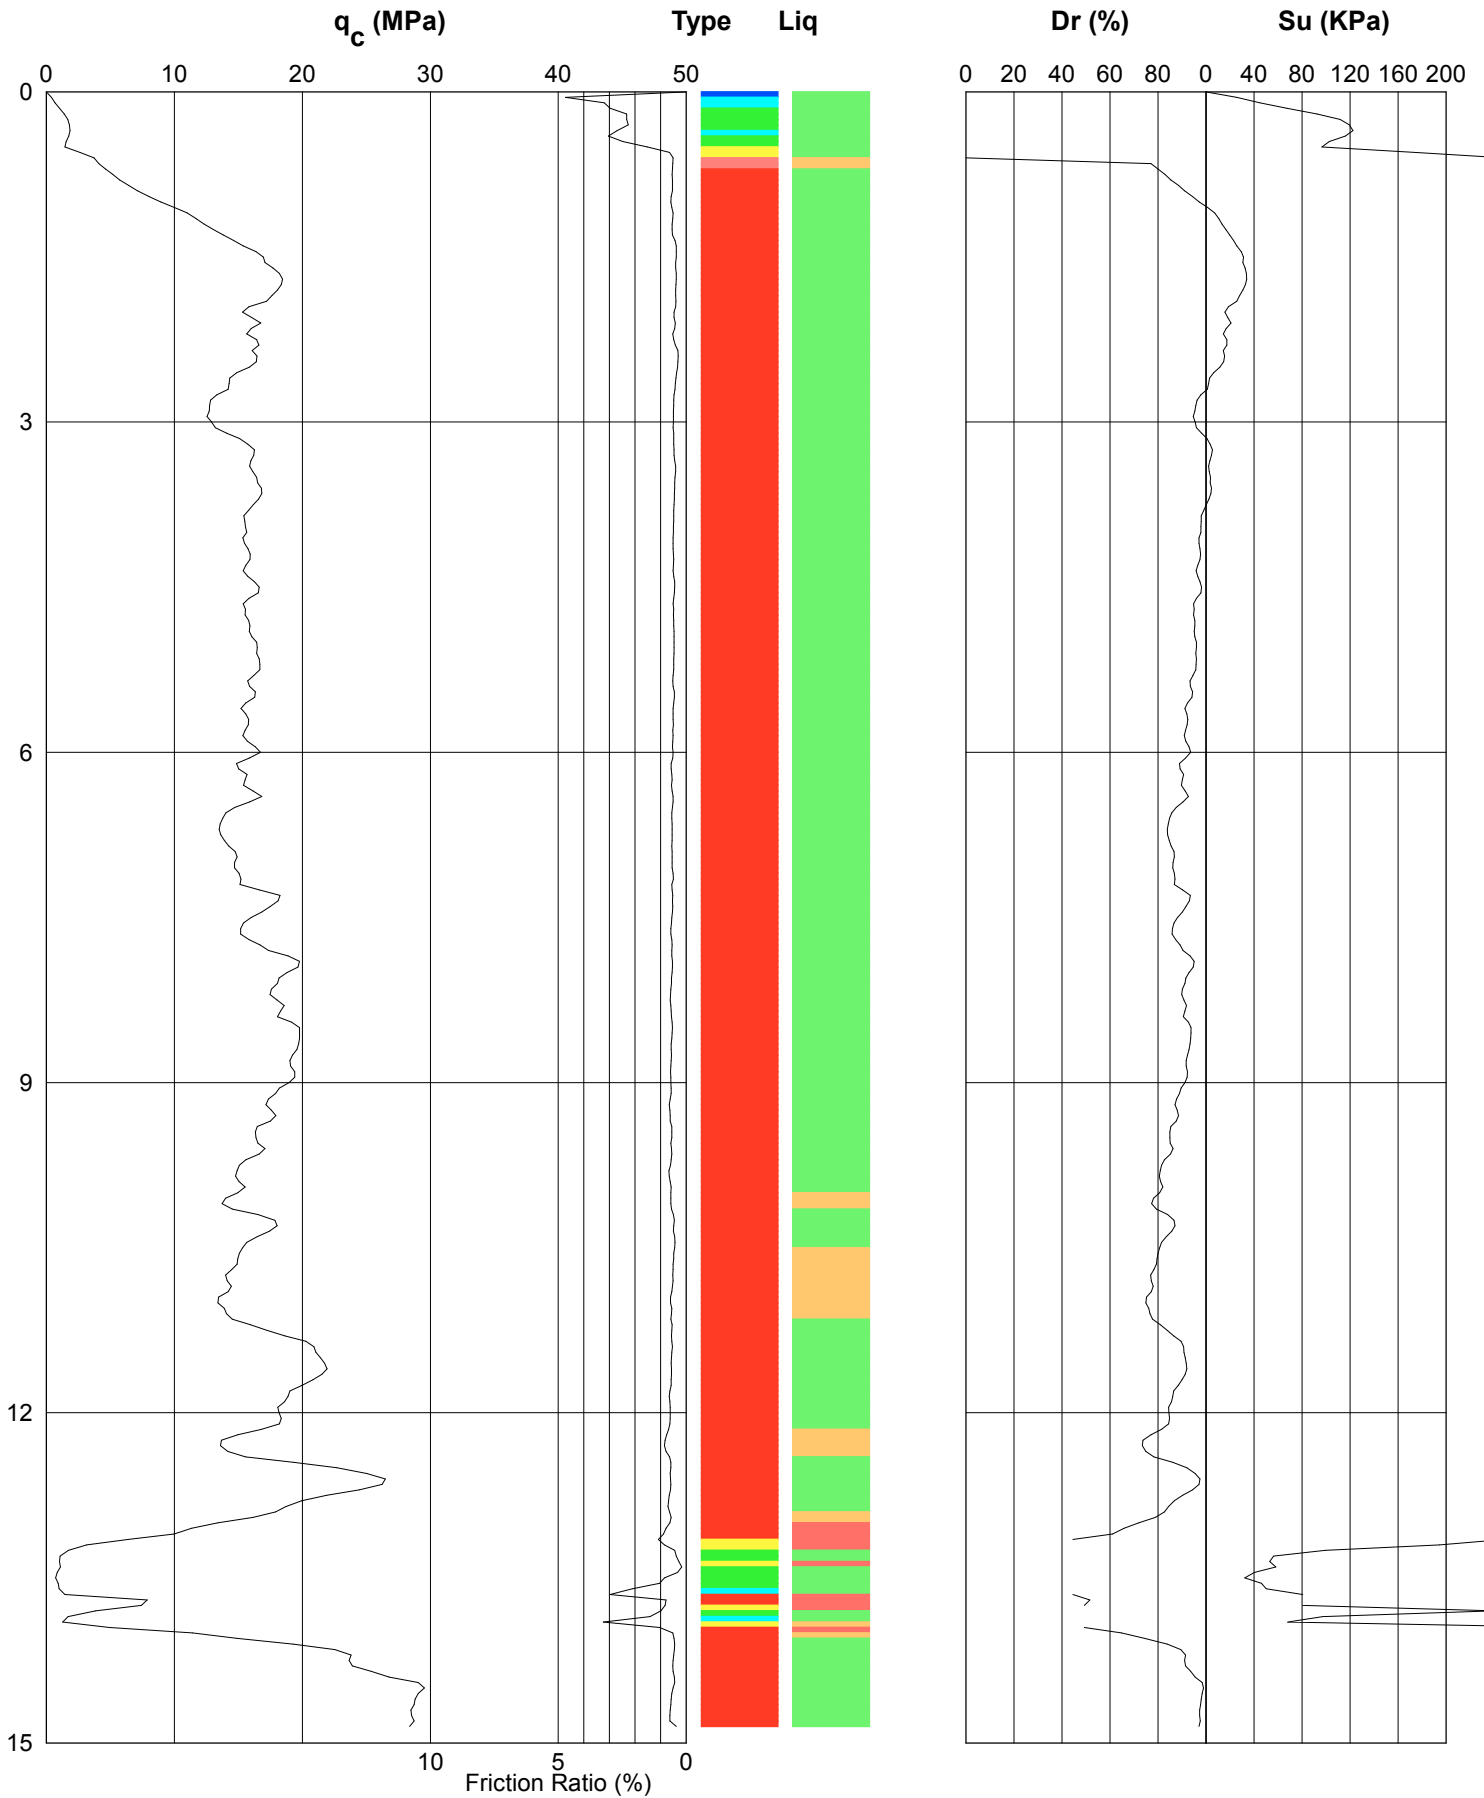
CPT No: CPT135

Remark: Target Depth

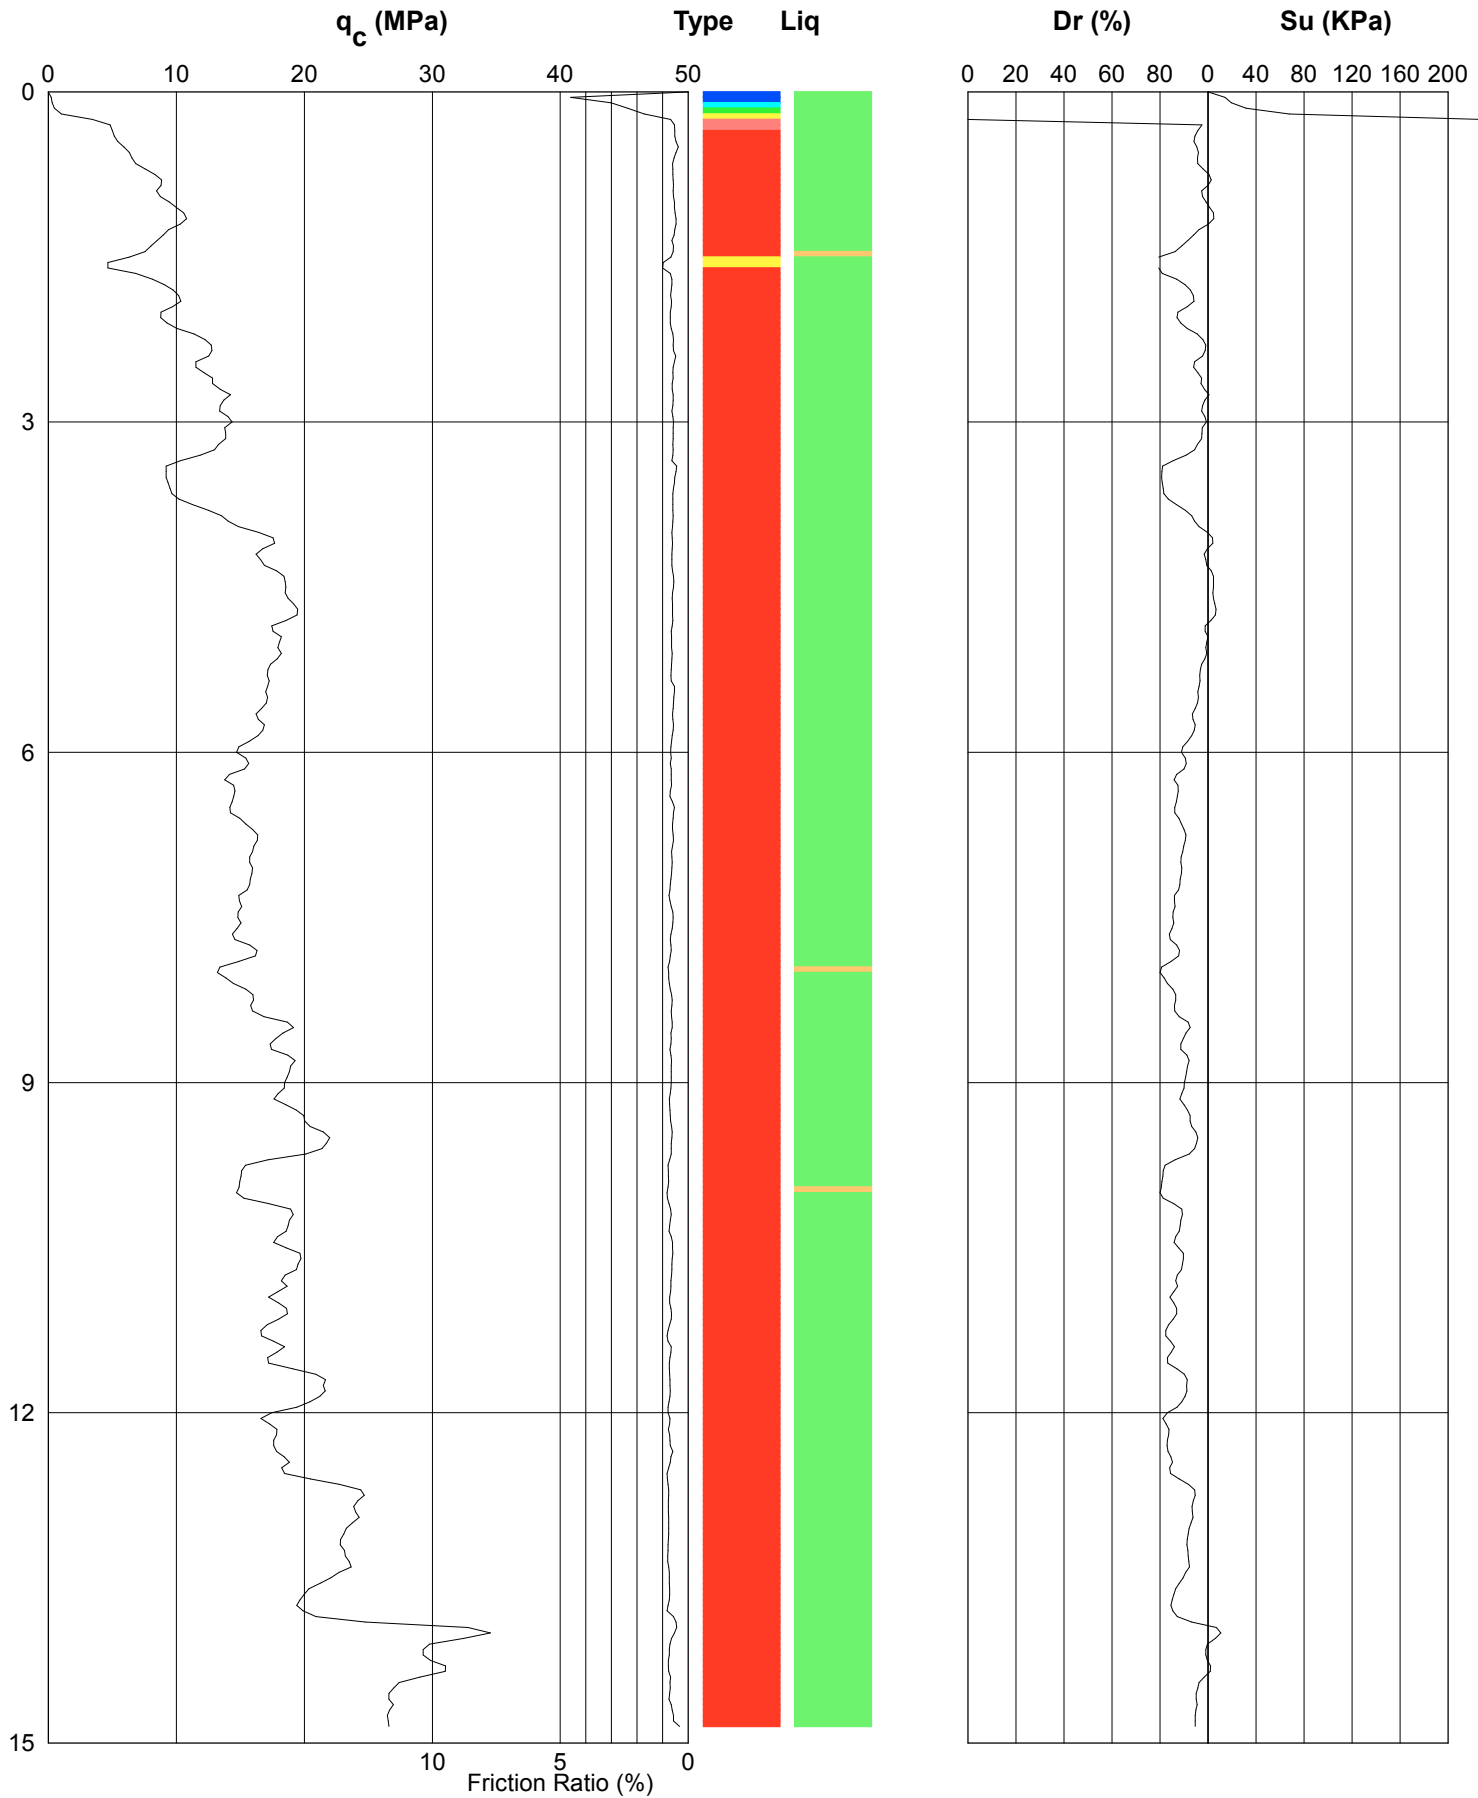
CPT No: CPT136

Remark: Target Depth

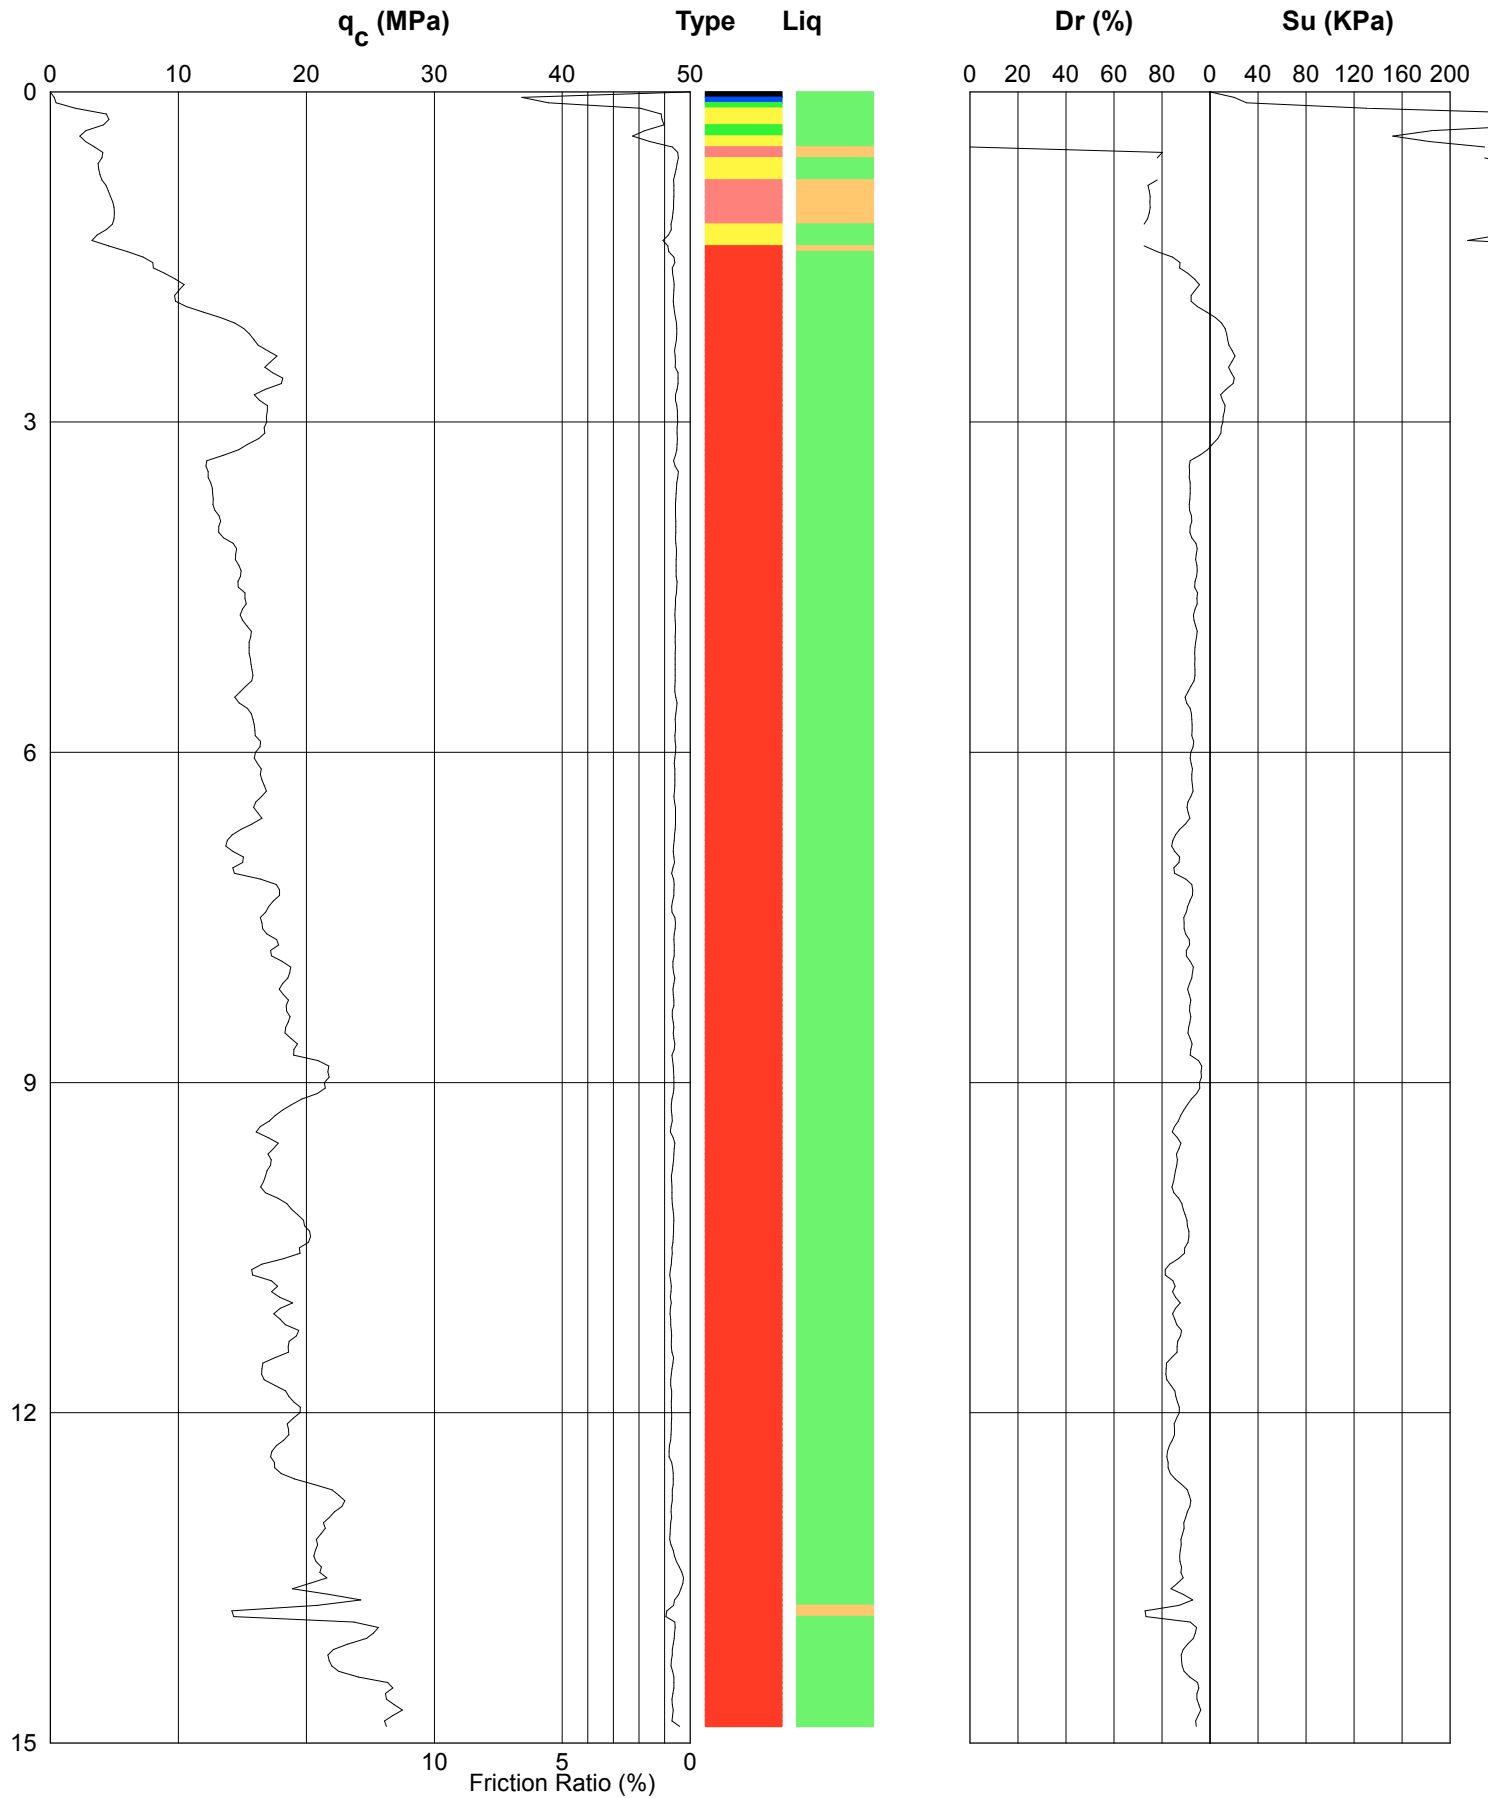
Job No: 10071
 CPT No: CPT137
 Project: Aurecon NZ Ltd
 Location: Prestons Subdivision, Christchurch

Date: 1-03-2012
 Operator: B. Powell
 Remark: Target Depth

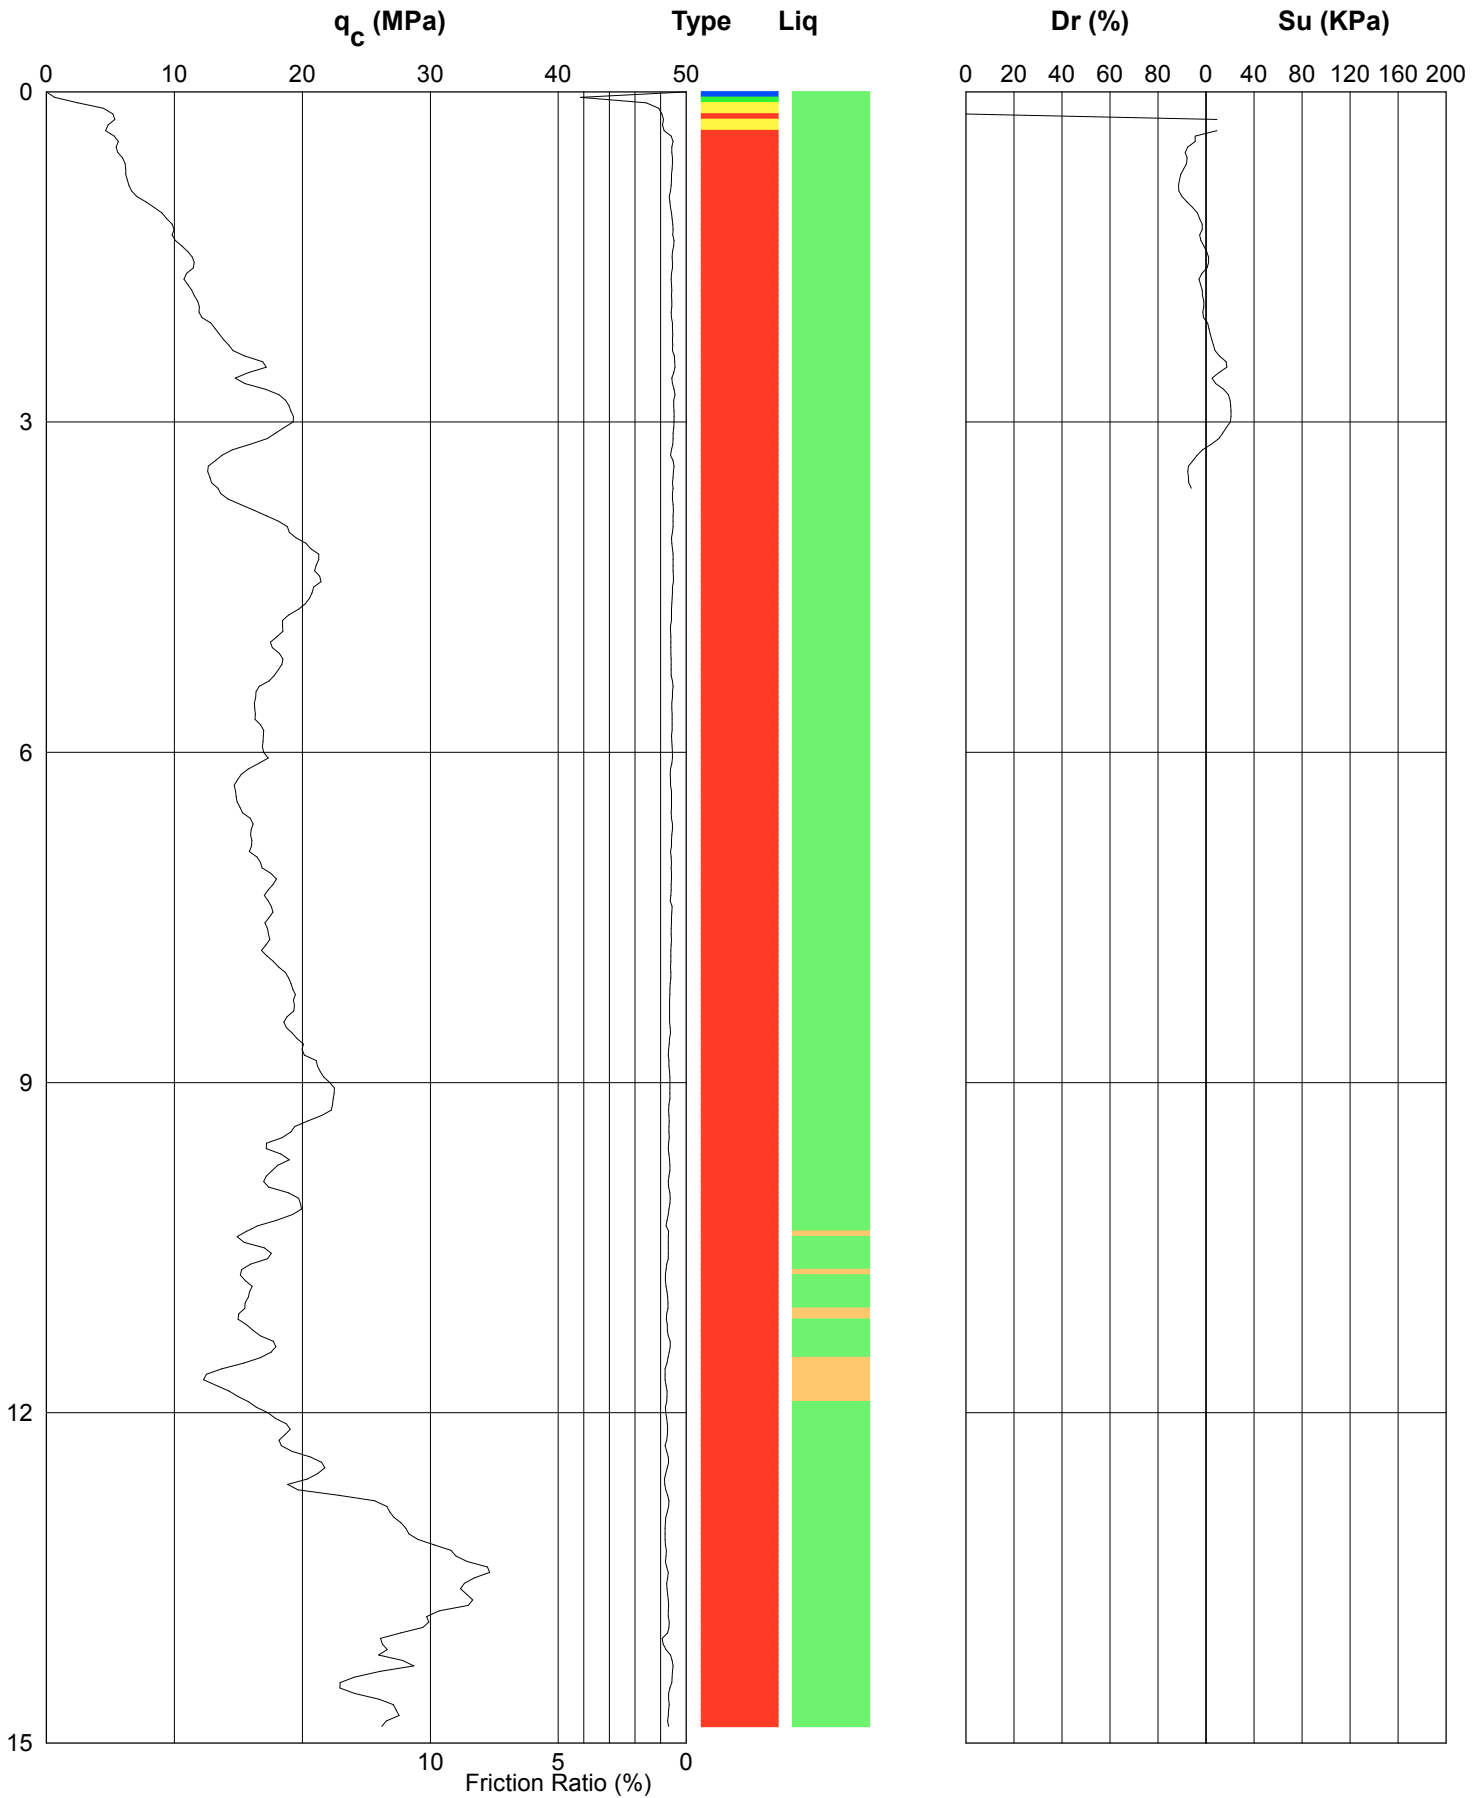
CPT No: CPT138

Remark: Target Depth

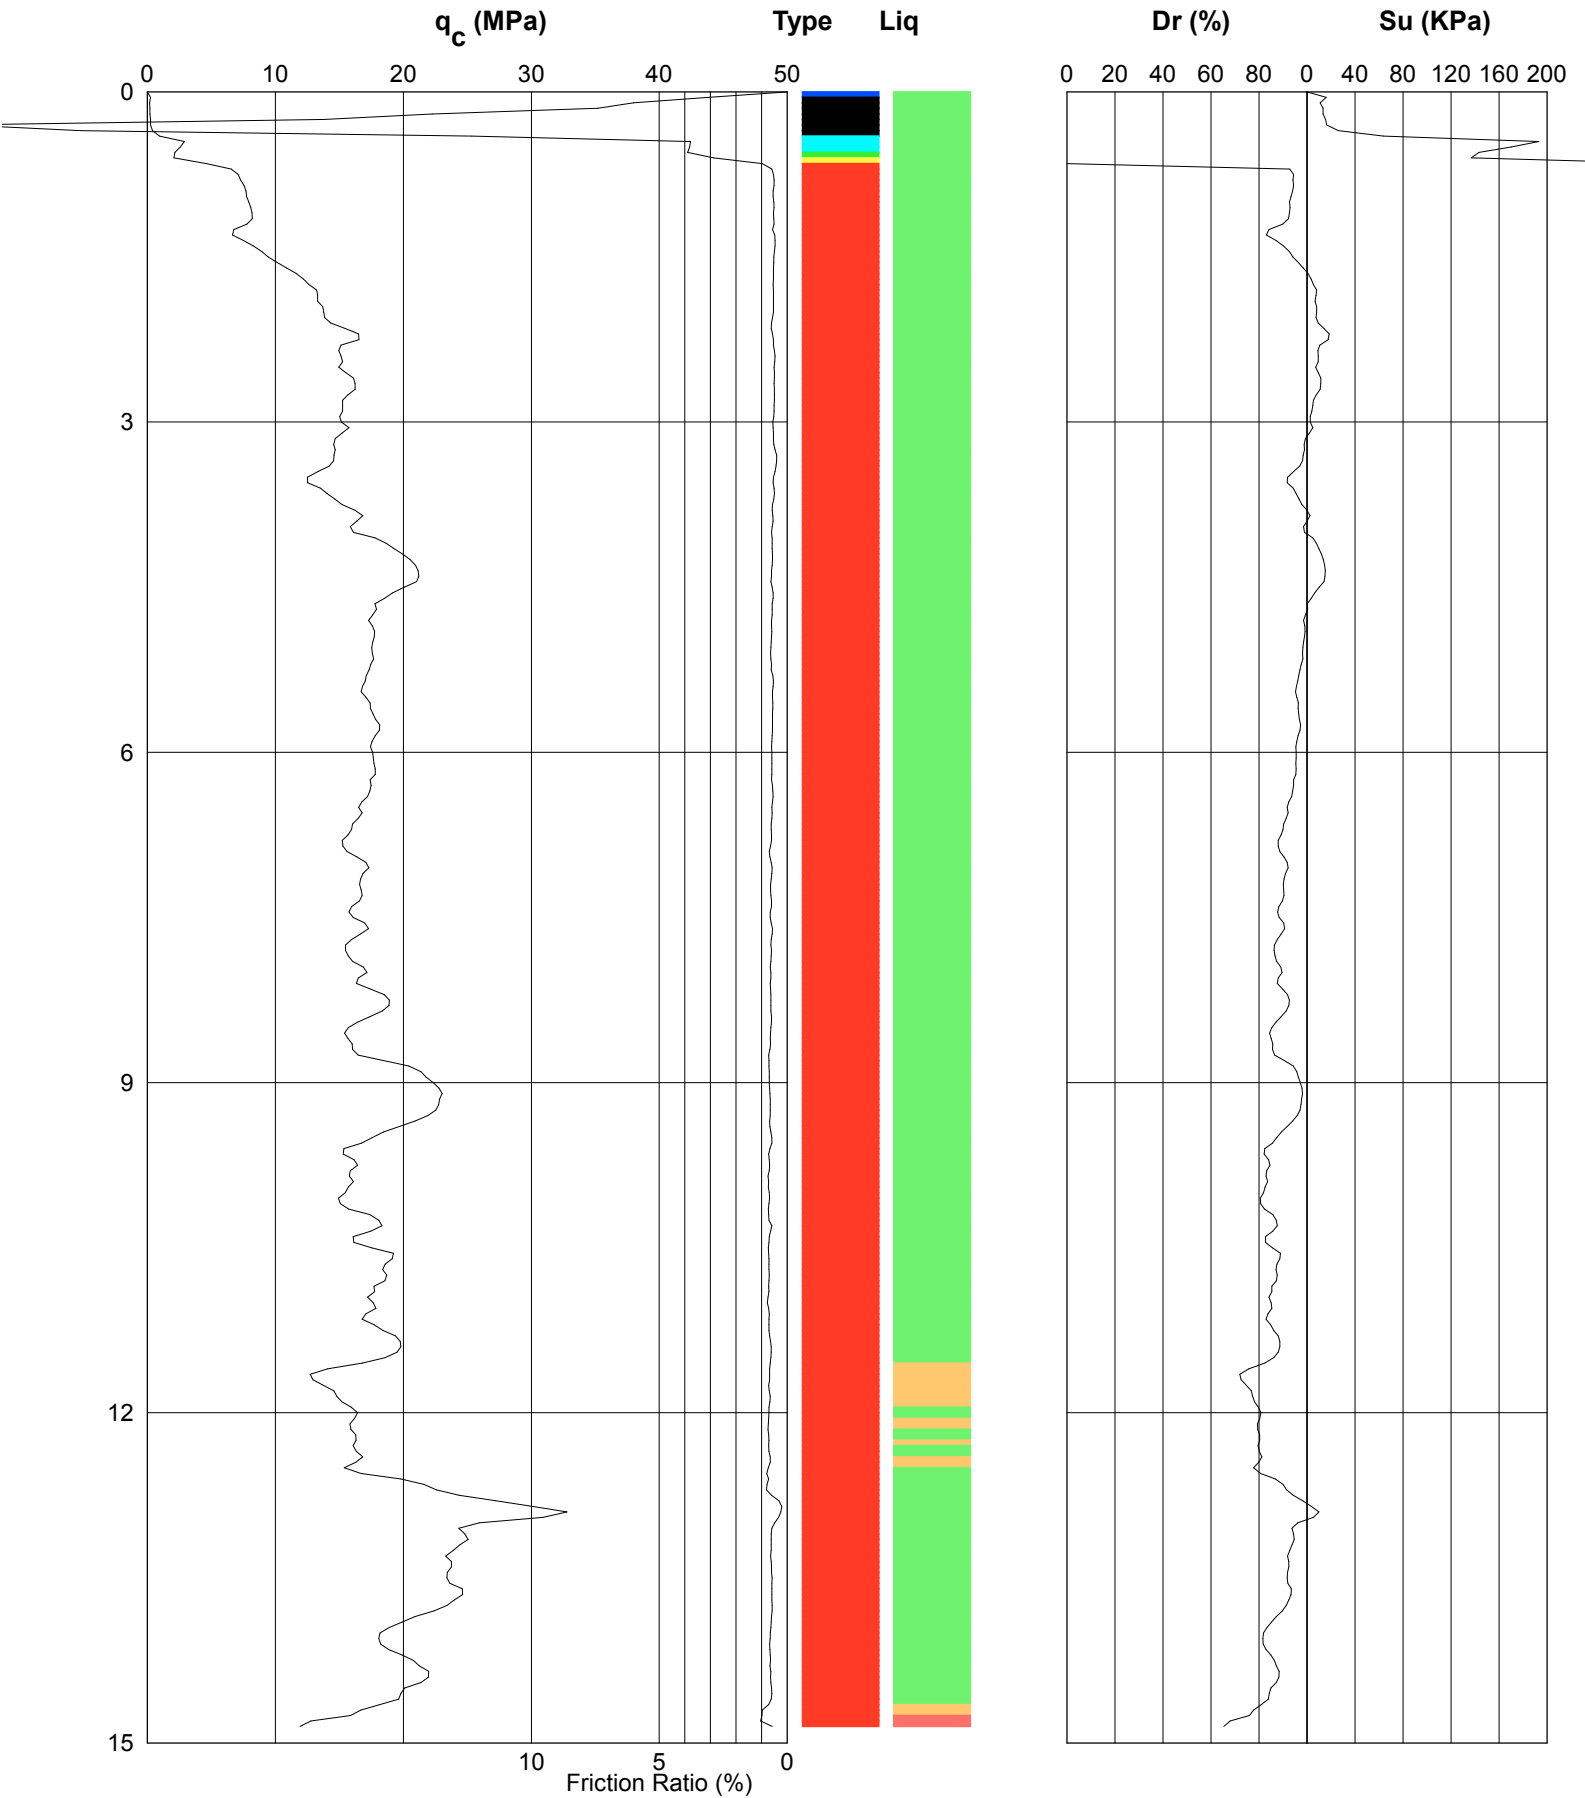
CPT No: CPT139

Remark: Target Depth

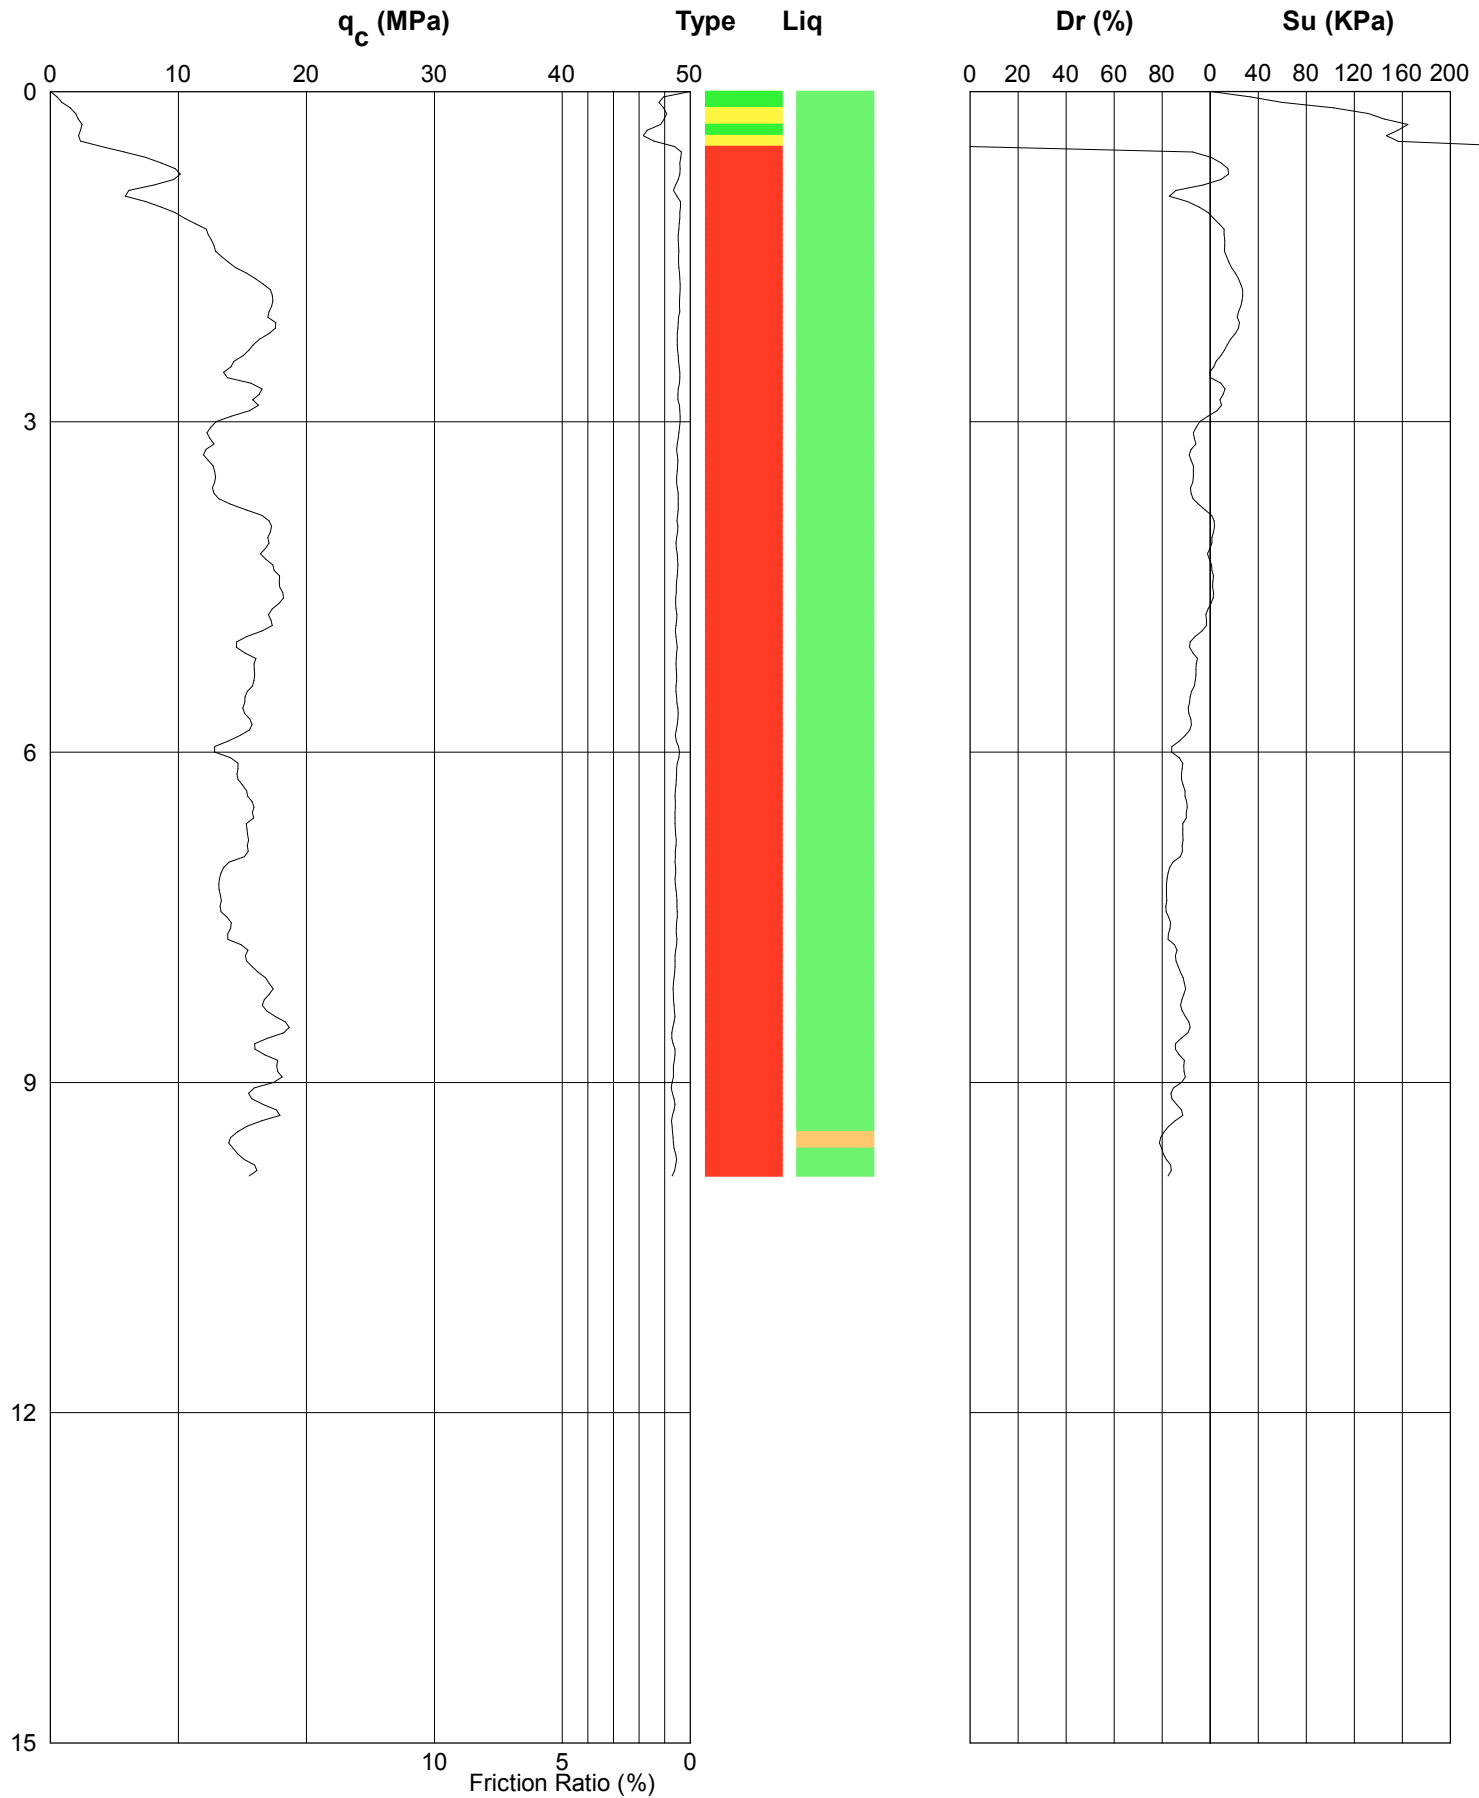
CPT No: CPT140

Remark: Effective Refusal
