Appendix D

2012 CPT Logs

PIEZOCONE PENETROMETER TEST (CPTU) INTERPRETIVE REPORT

Location: Prestons Subdivision, Christchurch

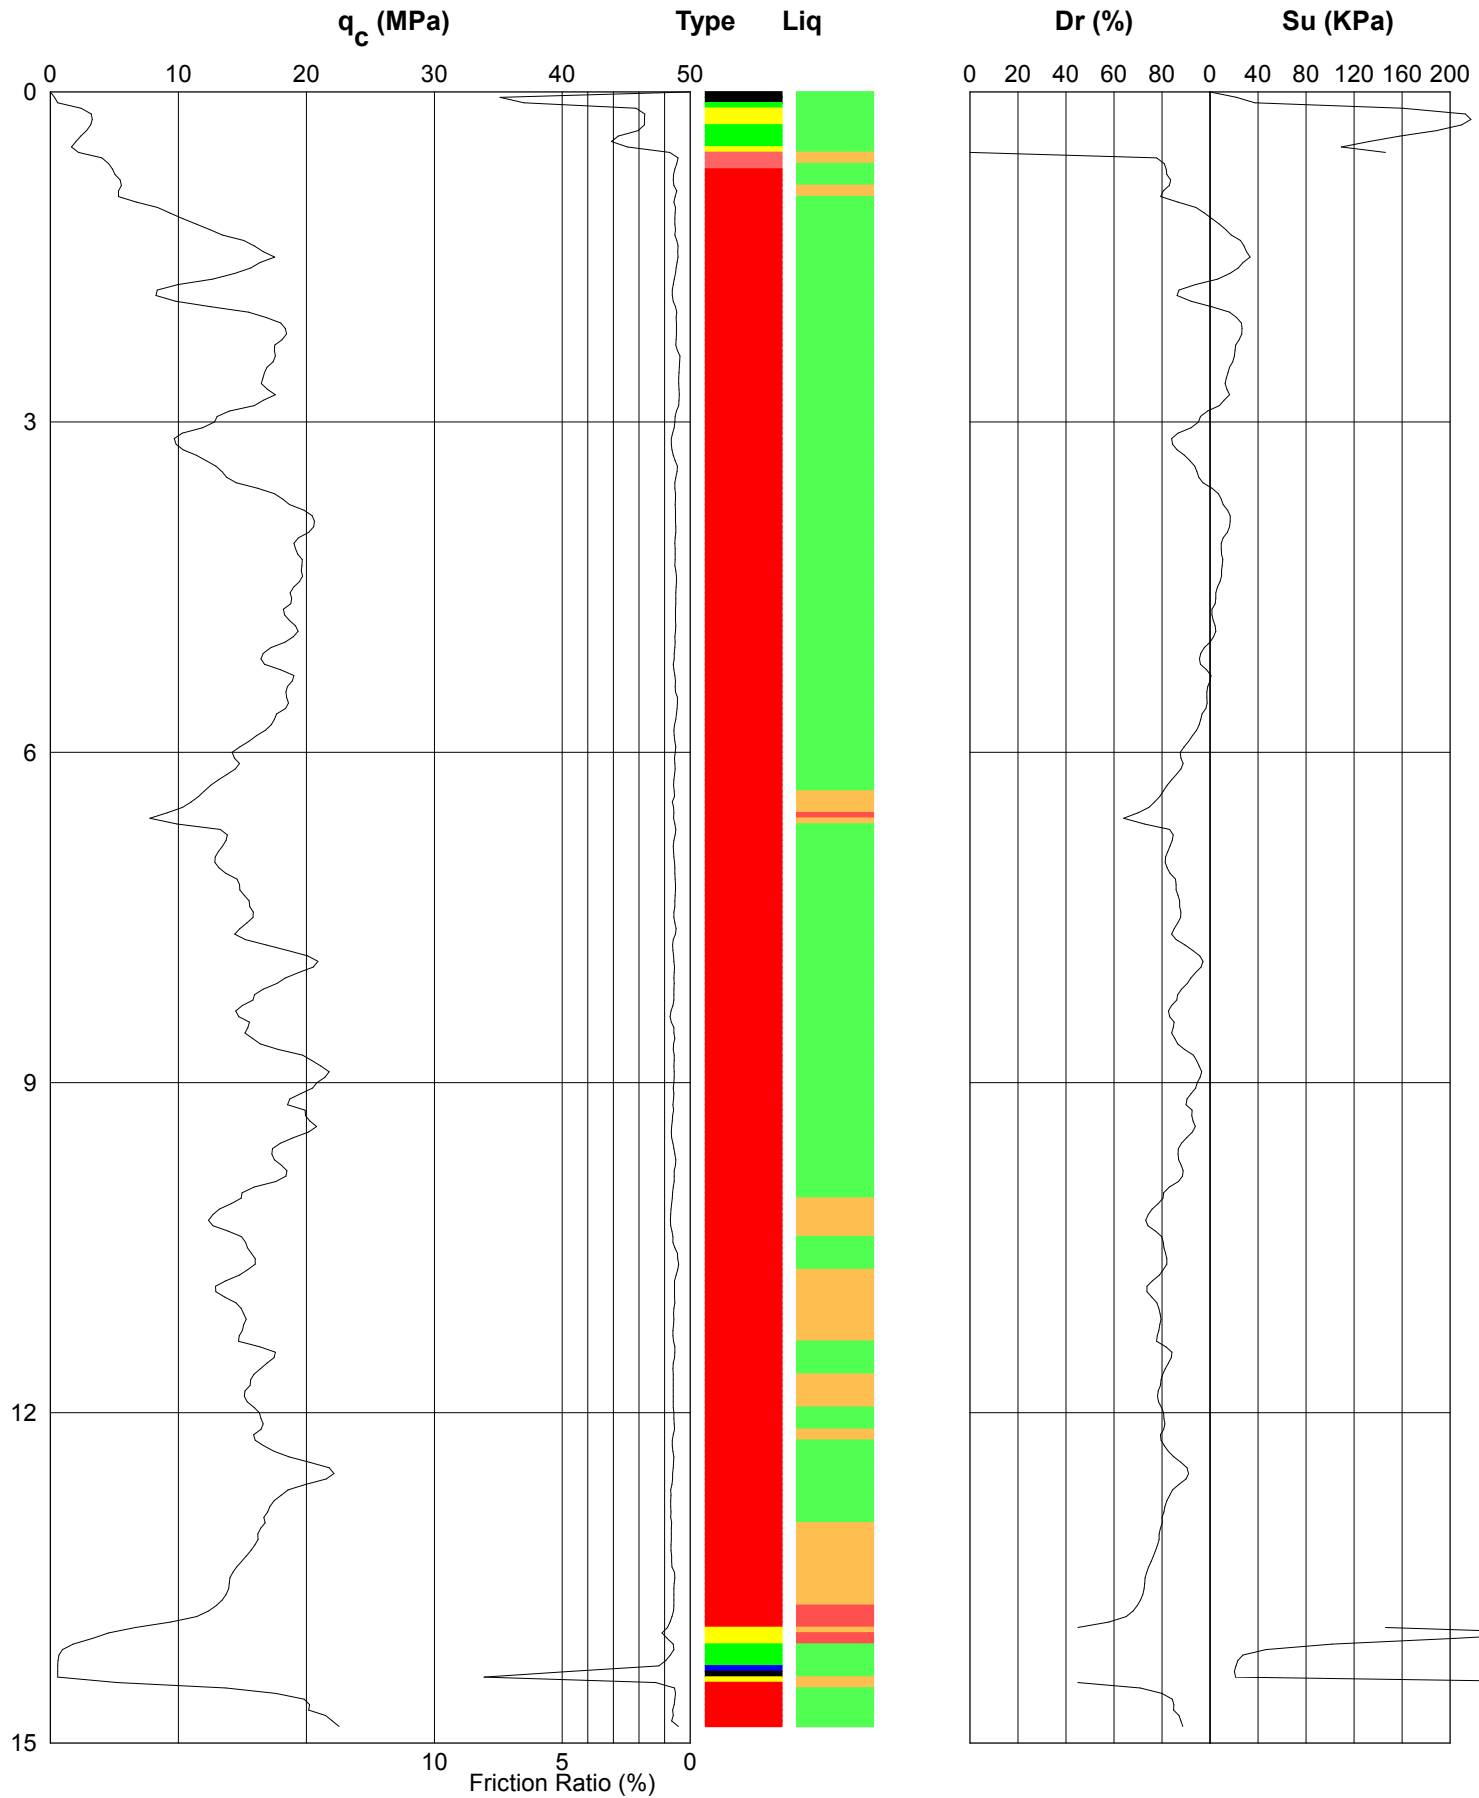
Job No: 10071
 CPT No: CPT141
 Project: Aurecon NZ Ltd
 Location: Prestons Subdivision, Christchurch

Date: 1-03-2012
 Operator: B. Powell
 Remark: Target Depth
