Prestons Park Subdivision

Stages T6, T7 & U2
Geotechnical Completion Report

**CDL Land Development NZ
Ltd**

Reference: 235361

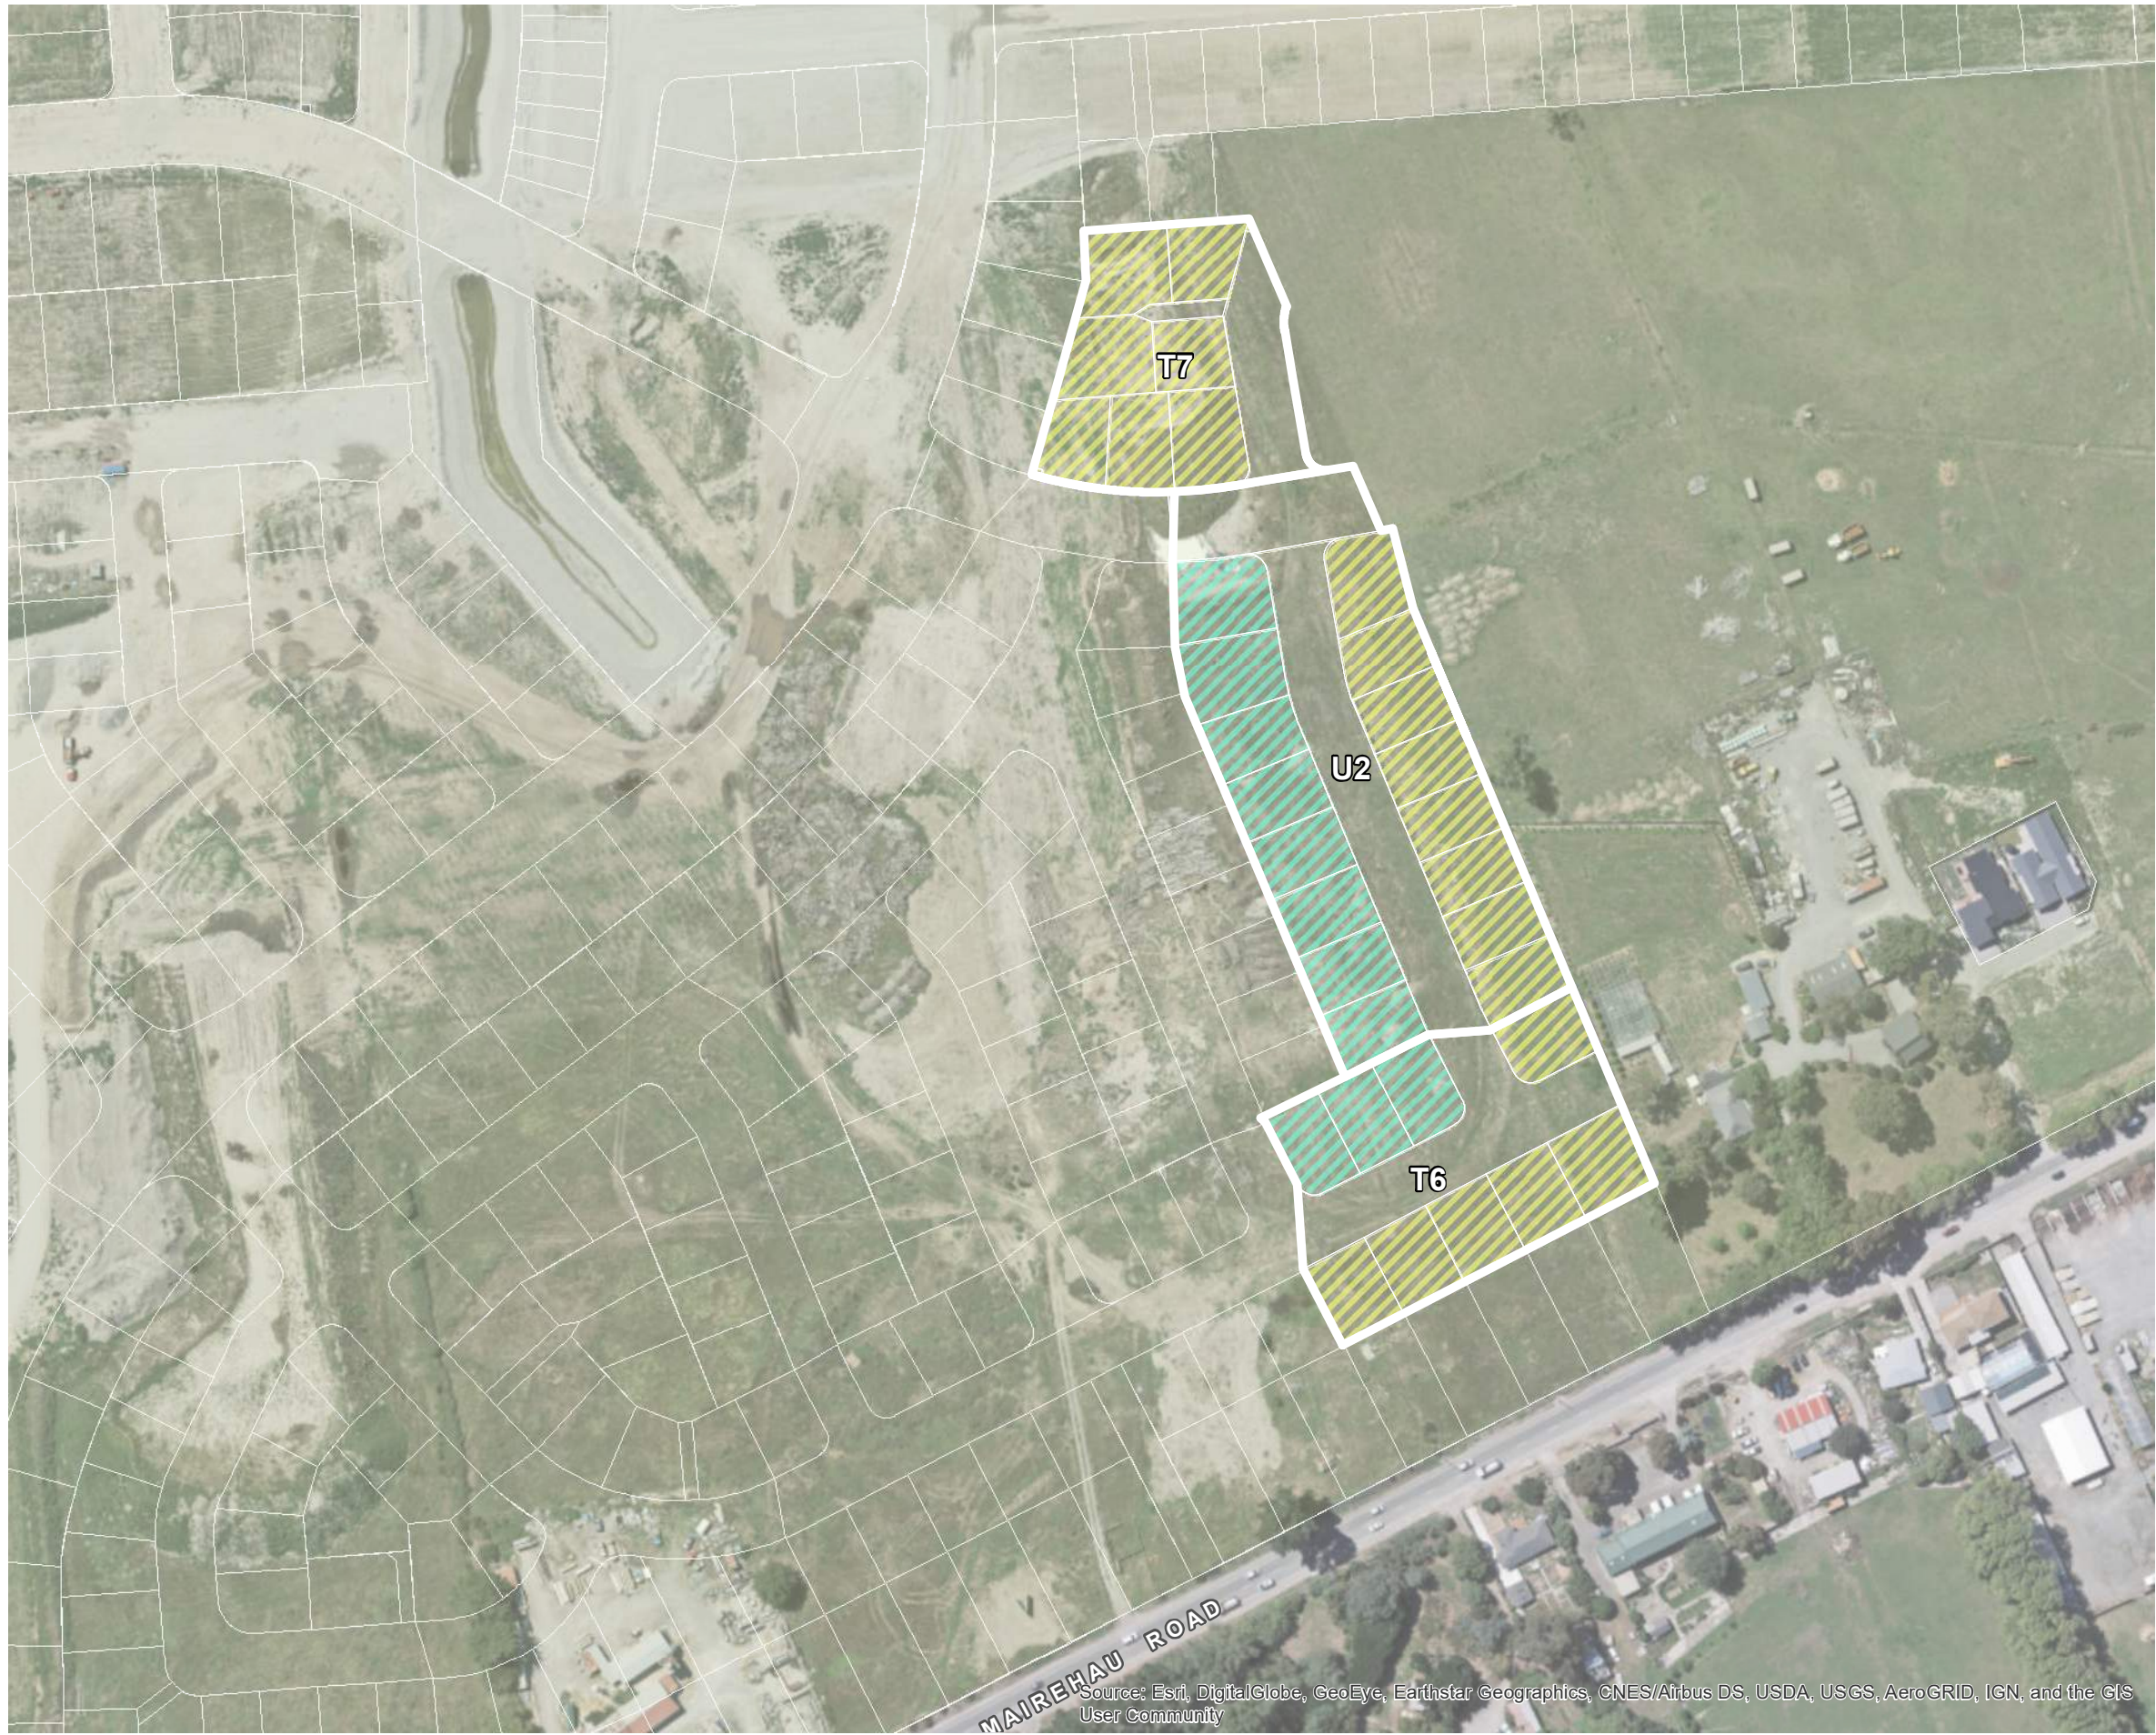
PROJECT No.	235361
SCALE	AS SHOWN
DRAWING No.	FIG 3
REV	A

- NOTES:
1. IMPACT COMPACTION METHODOLOGY INVOLVED EXCAVATION TO THE BOTTOM OF INSITU ORGANIC MATERIAL BEFORE FILLING TO THE DESIGN LEVEL WITH SITE-WON SAND. SAND WAS COMPACTED IN 700mm LIFTS USING A FOUR-SIDED IMPACT COMPACTOR.
 2. STANDARD COMPACTION METHODOLOGY INVOLVED EXCAVATION TO THE BOTTOM OF INSITU ORGANIC MATERIAL BEFORE FILLING TO THE DESIGN LEVEL WITH SITE WON SAND OR IMPORTED GRAVEL. FILL WAS THEN COMPACTED IN 300mm LIFTS USING A VIBRATORY ROLLER.
 3. SEE SECTION THREE OF PRESTONS PARK SUBDIVISION, STAGE T1 & Z1 GEOTECHNICAL COMPLETION REPORT FOR FURTHER DETAILS.

PROJECT
PRESTONS SOUTH STAGES T6, T7 & U2
TITLE
GROUND IMPROVEMENT

The clients brief for the Prestons Park subdivision was to develop the land to Technical Category 1 performance where possible. In order to do this, liquefaction was mitigated using ground improvement measures specified in Section 3.2. Ground improvement was carried out in T6, T7 and U2 as detailed below and shown in Figure 3 in Appendix A.

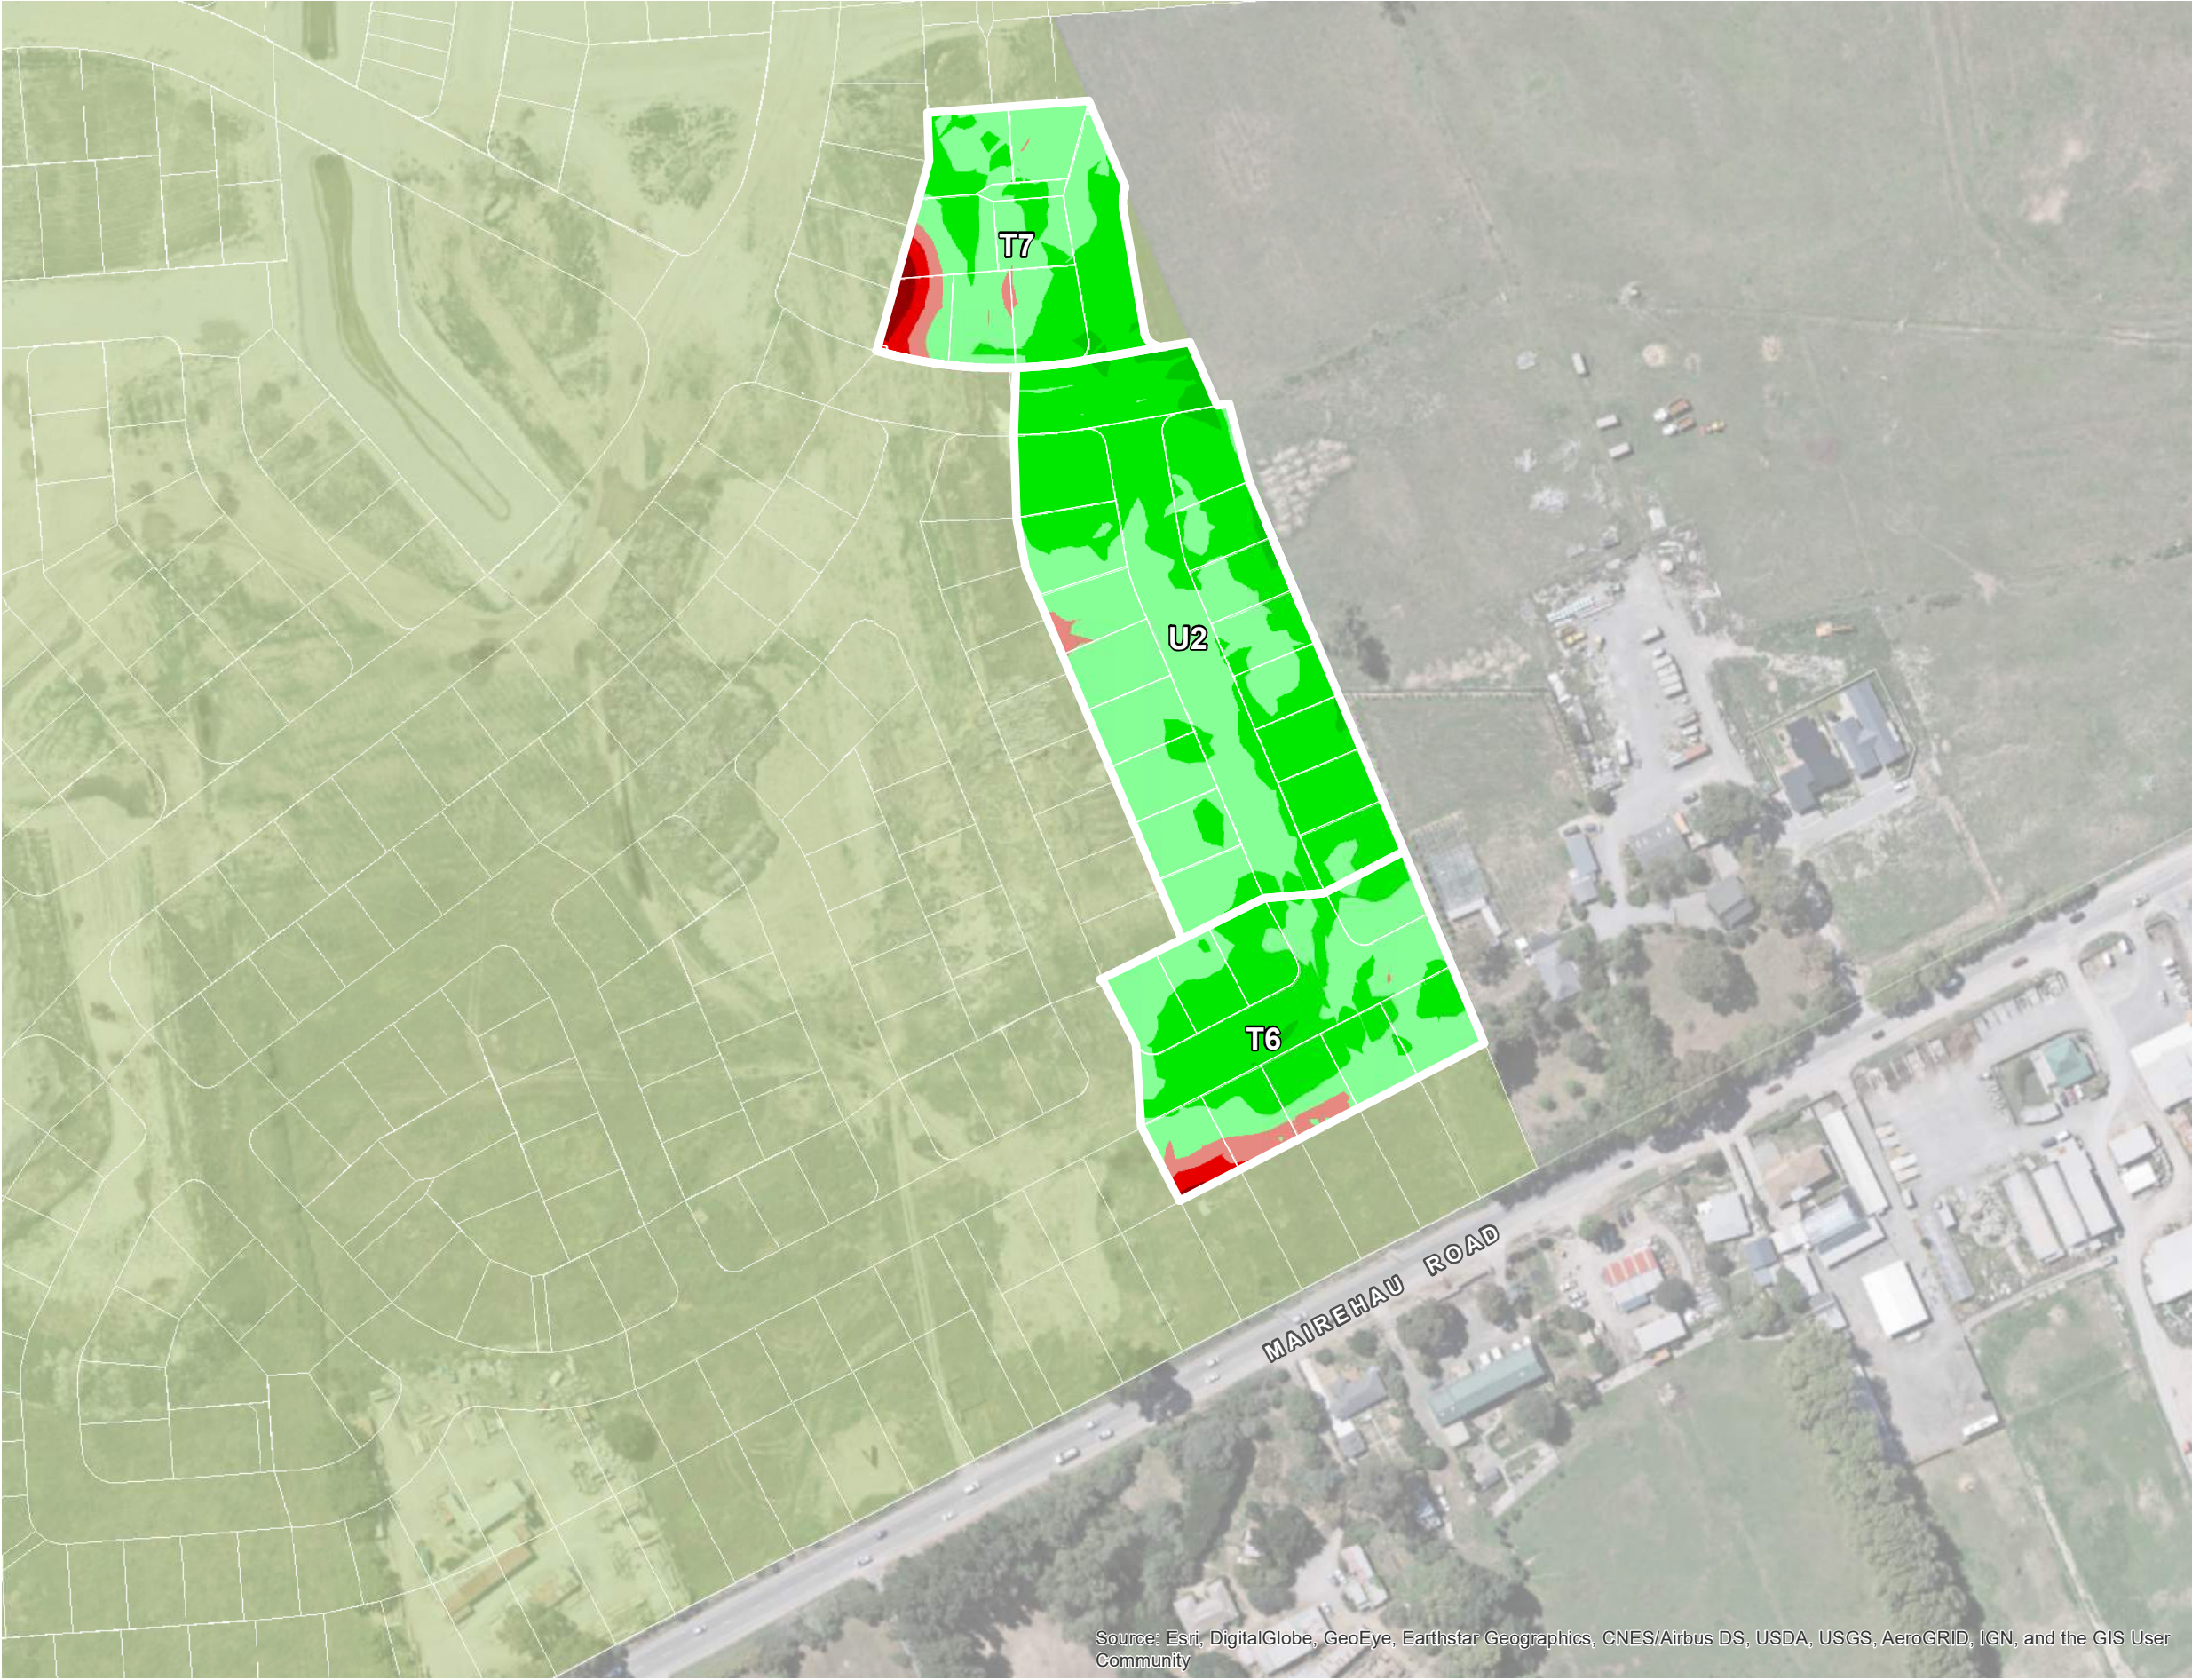
PROJECT No.	235361
SCALE	AS SHOWN
DRAWING No.	FIG 4
REV	A

PROJECT
PRESTONS SOUTH STAGES T6, T7 & U2
TITLE
CUT FILL BANDING

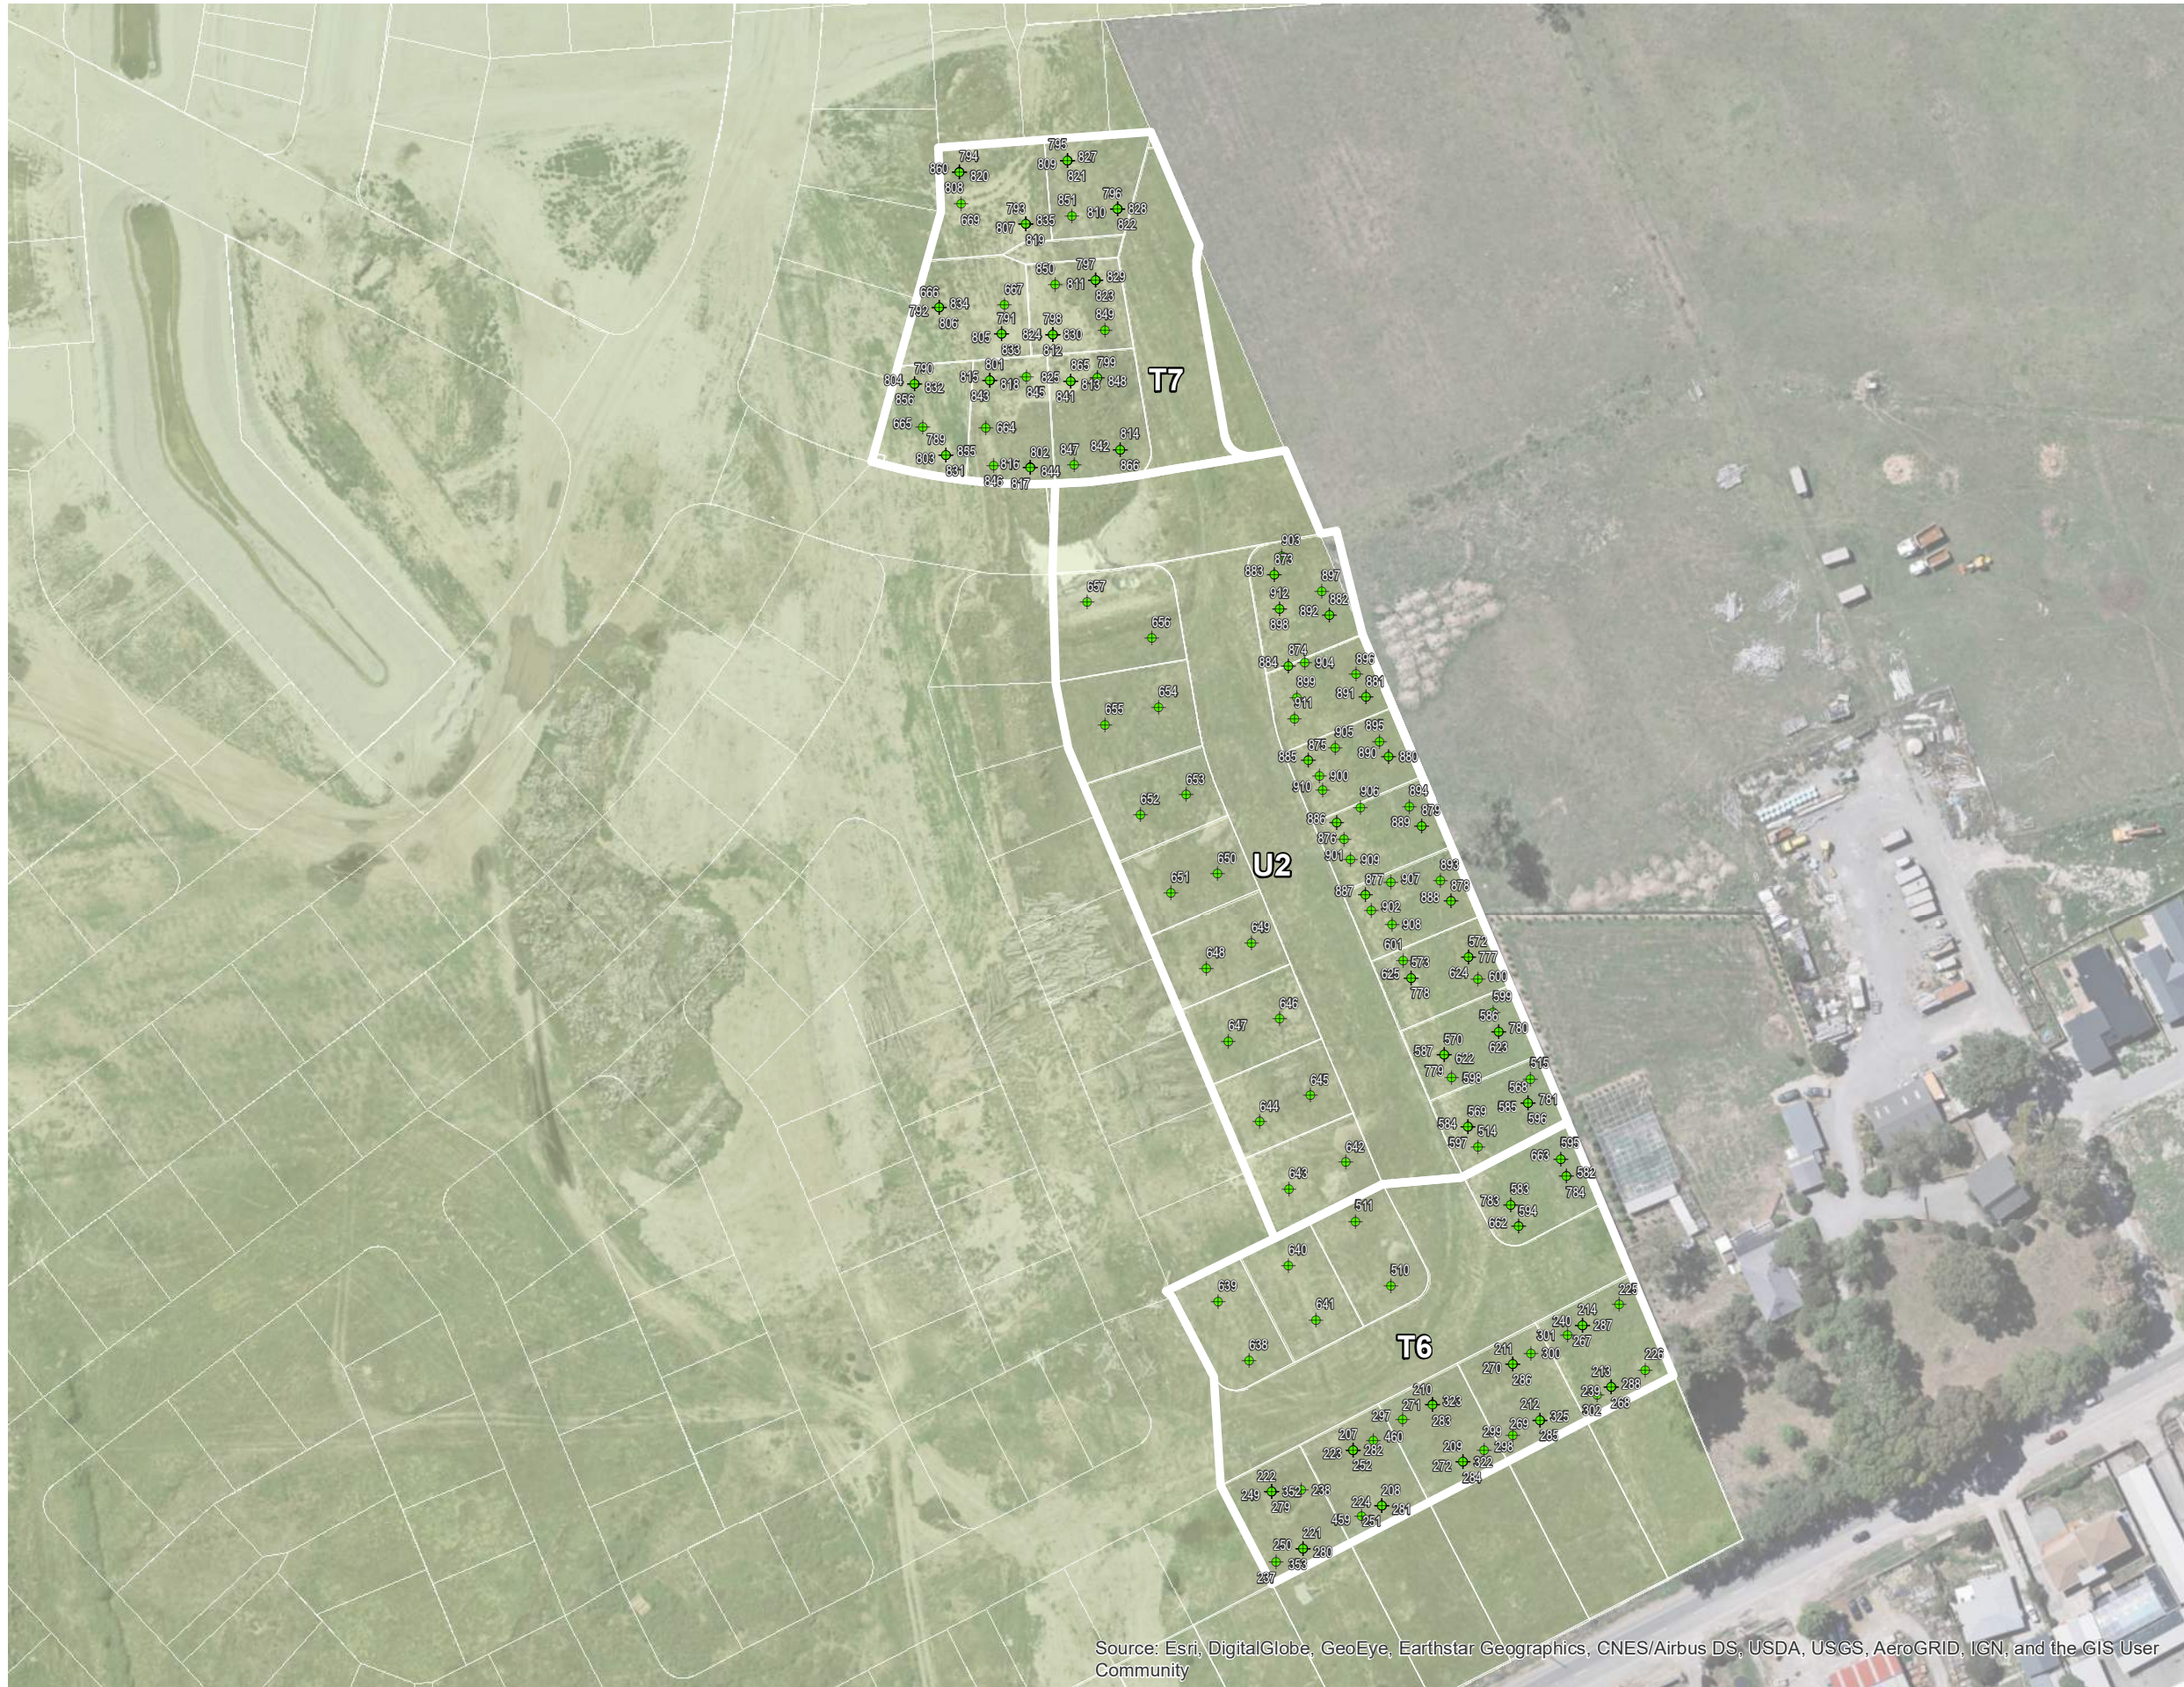
PROJECT No.	
235361	
SCALE	SIZE
AS SHOWN	A3
DRAWING No.	REV
FIG 5	A

PROJECT
PRESTONS SOUTH STAGES T6, T7 & U2
TITLE
NDM TESTING LOCATIONS

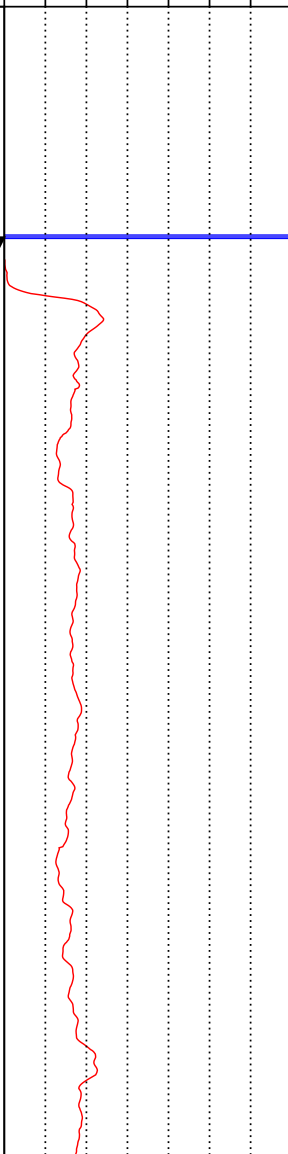
CONE PENETRATION TEST (CPT) REPORT

**Location: Stage U2, T6 and T7
Prestons Park, Christchurch**

Following completion of the earthworks and topsoil placement throughout Stages T6, T7 & U2, a series of CPT tests have been carried out to confirm the ground conditions. The frequency of the CPT testing carried out was approximately three tests per hectare for the post earthworks assessment. The post earthworks CPTs are presented in Appendix B and the locations are shown in Figure 6 in Appendix A.
