# Appendix C

## 2018 CPT Logs

**Client:** Aurecon  
**Project:** Prestons Law Block

**Site Location:** Marshland, Christchurch

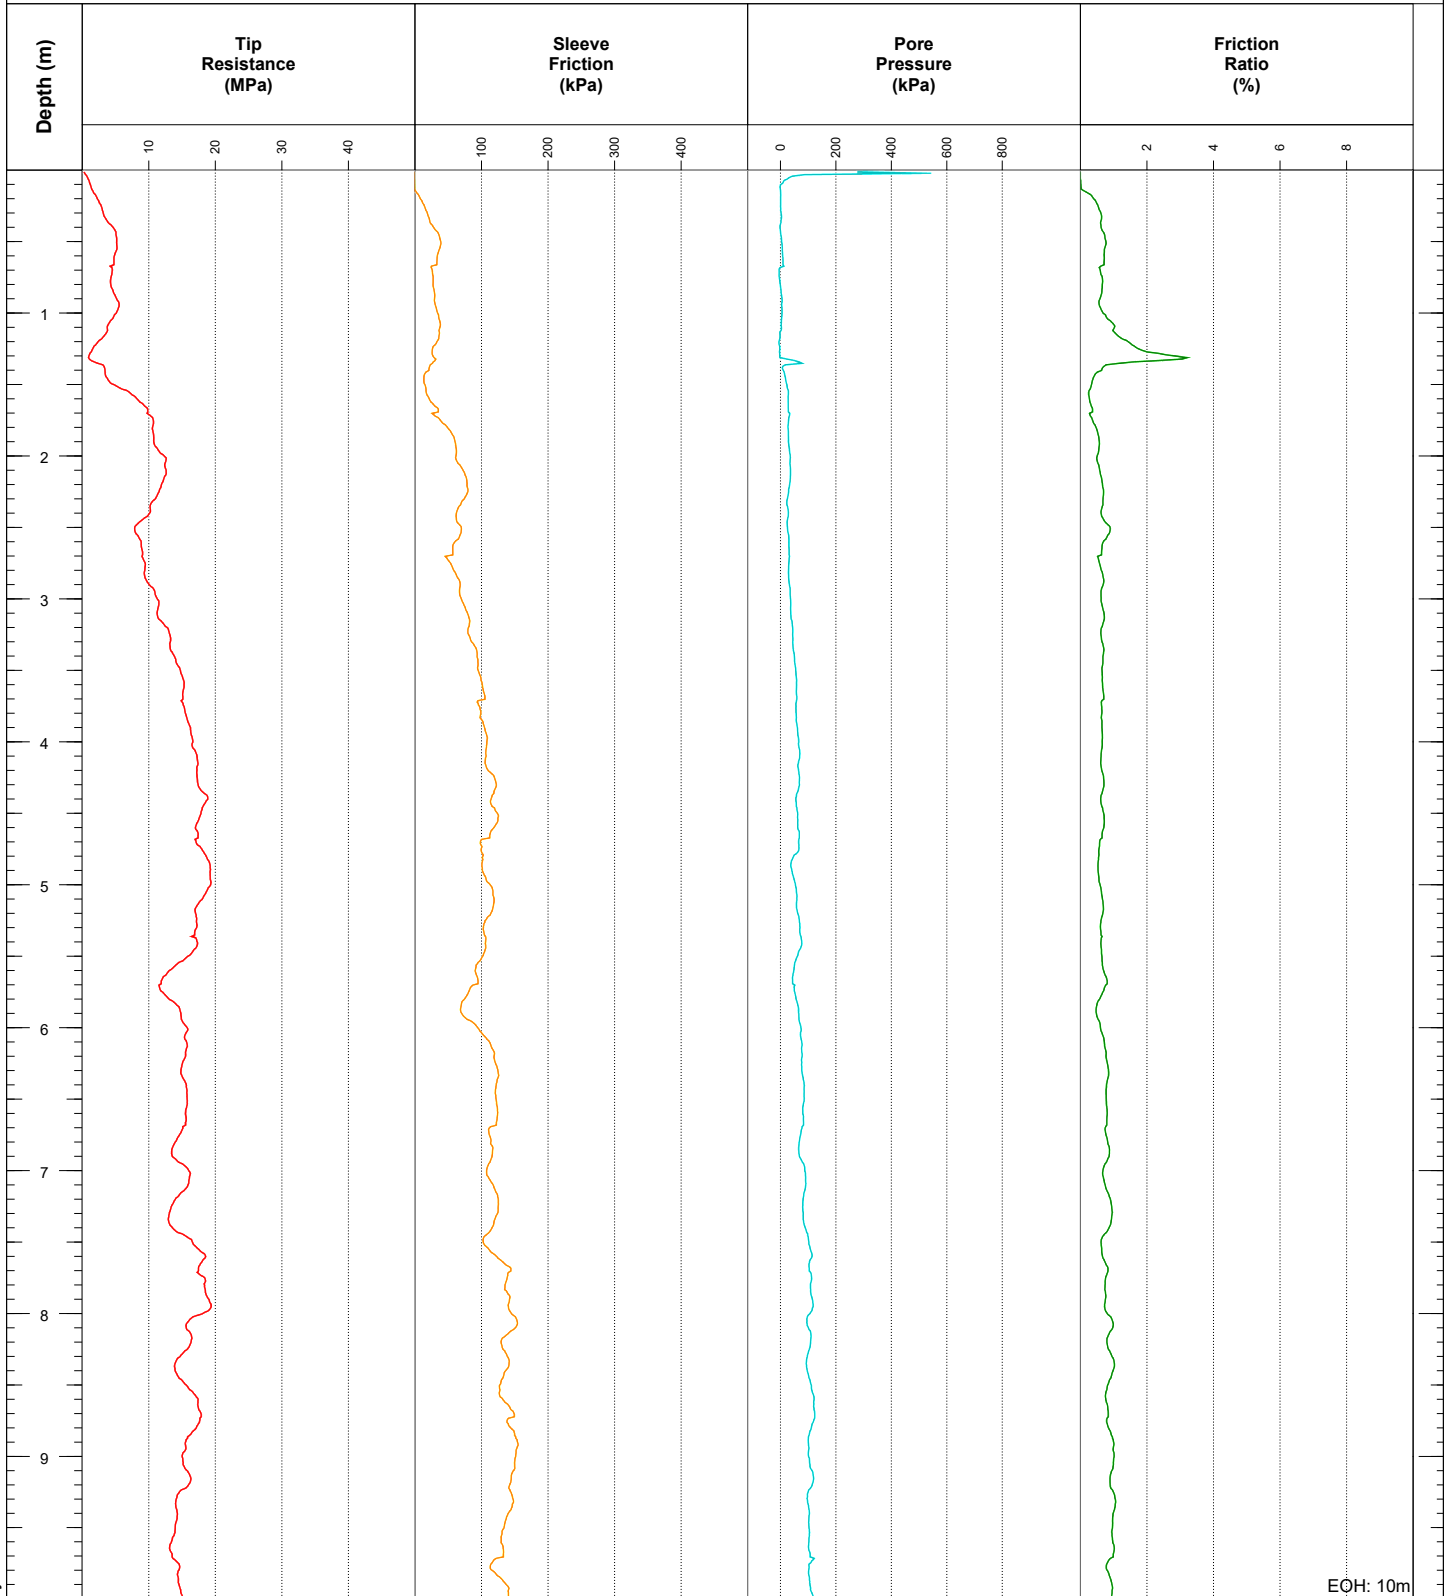
**Test Label:** CPT101

CPTu testing carried out to ASTM Standard D5778-12  
10cm-sq Pagani piezocone used for each CPTu test  
CPTu refusal at 50MPa on the tip, 500kPa on the friction sleeve or at 2500kPa pore pressure

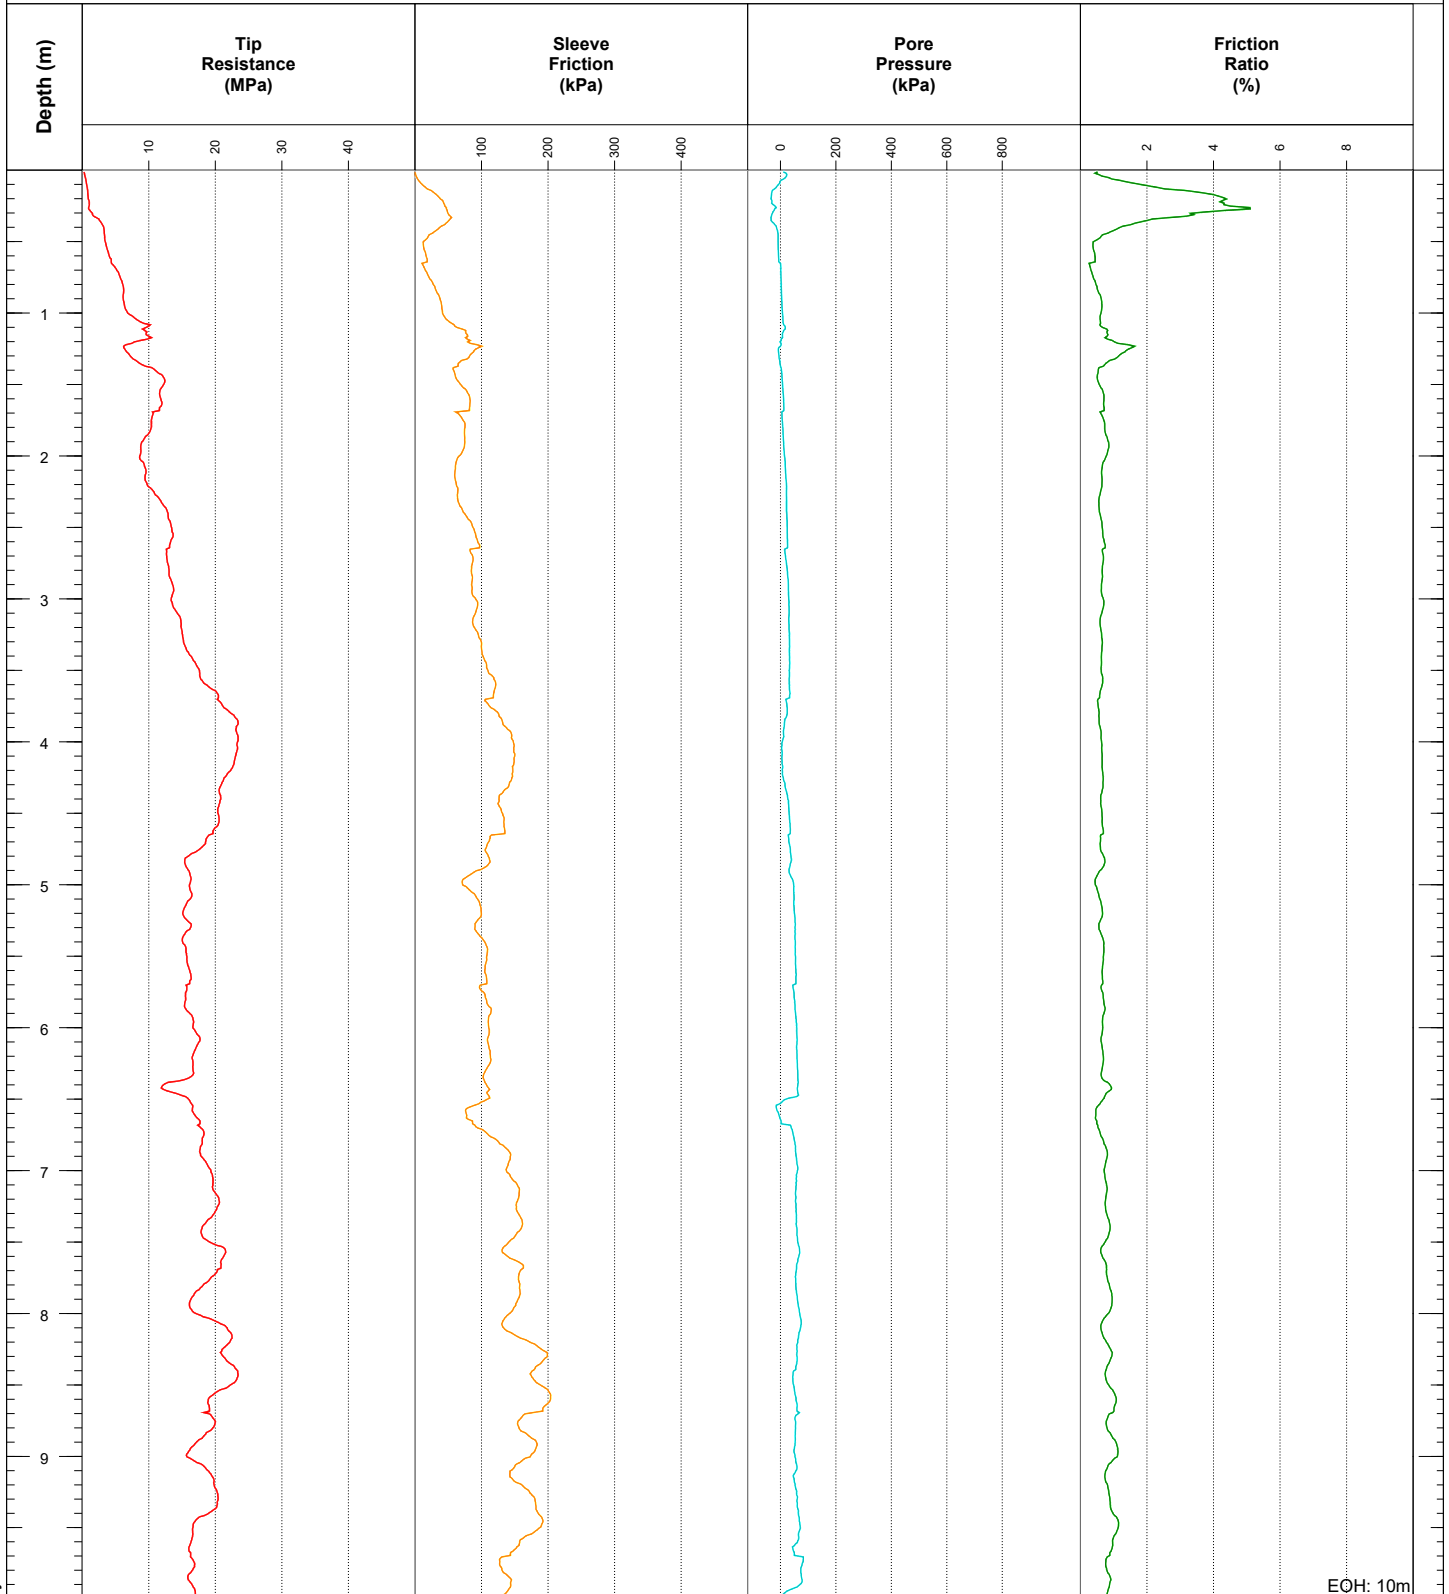
**Test Label:** CPT102

CPTu testing carried out to ASTM Standard D5778-12  
10cm-sq Pagani piezocone used for each CPTu test  
CPTu refusal at 50MPa on the tip, 500kPa on the friction sleeve or at 2500kPa pore pressure

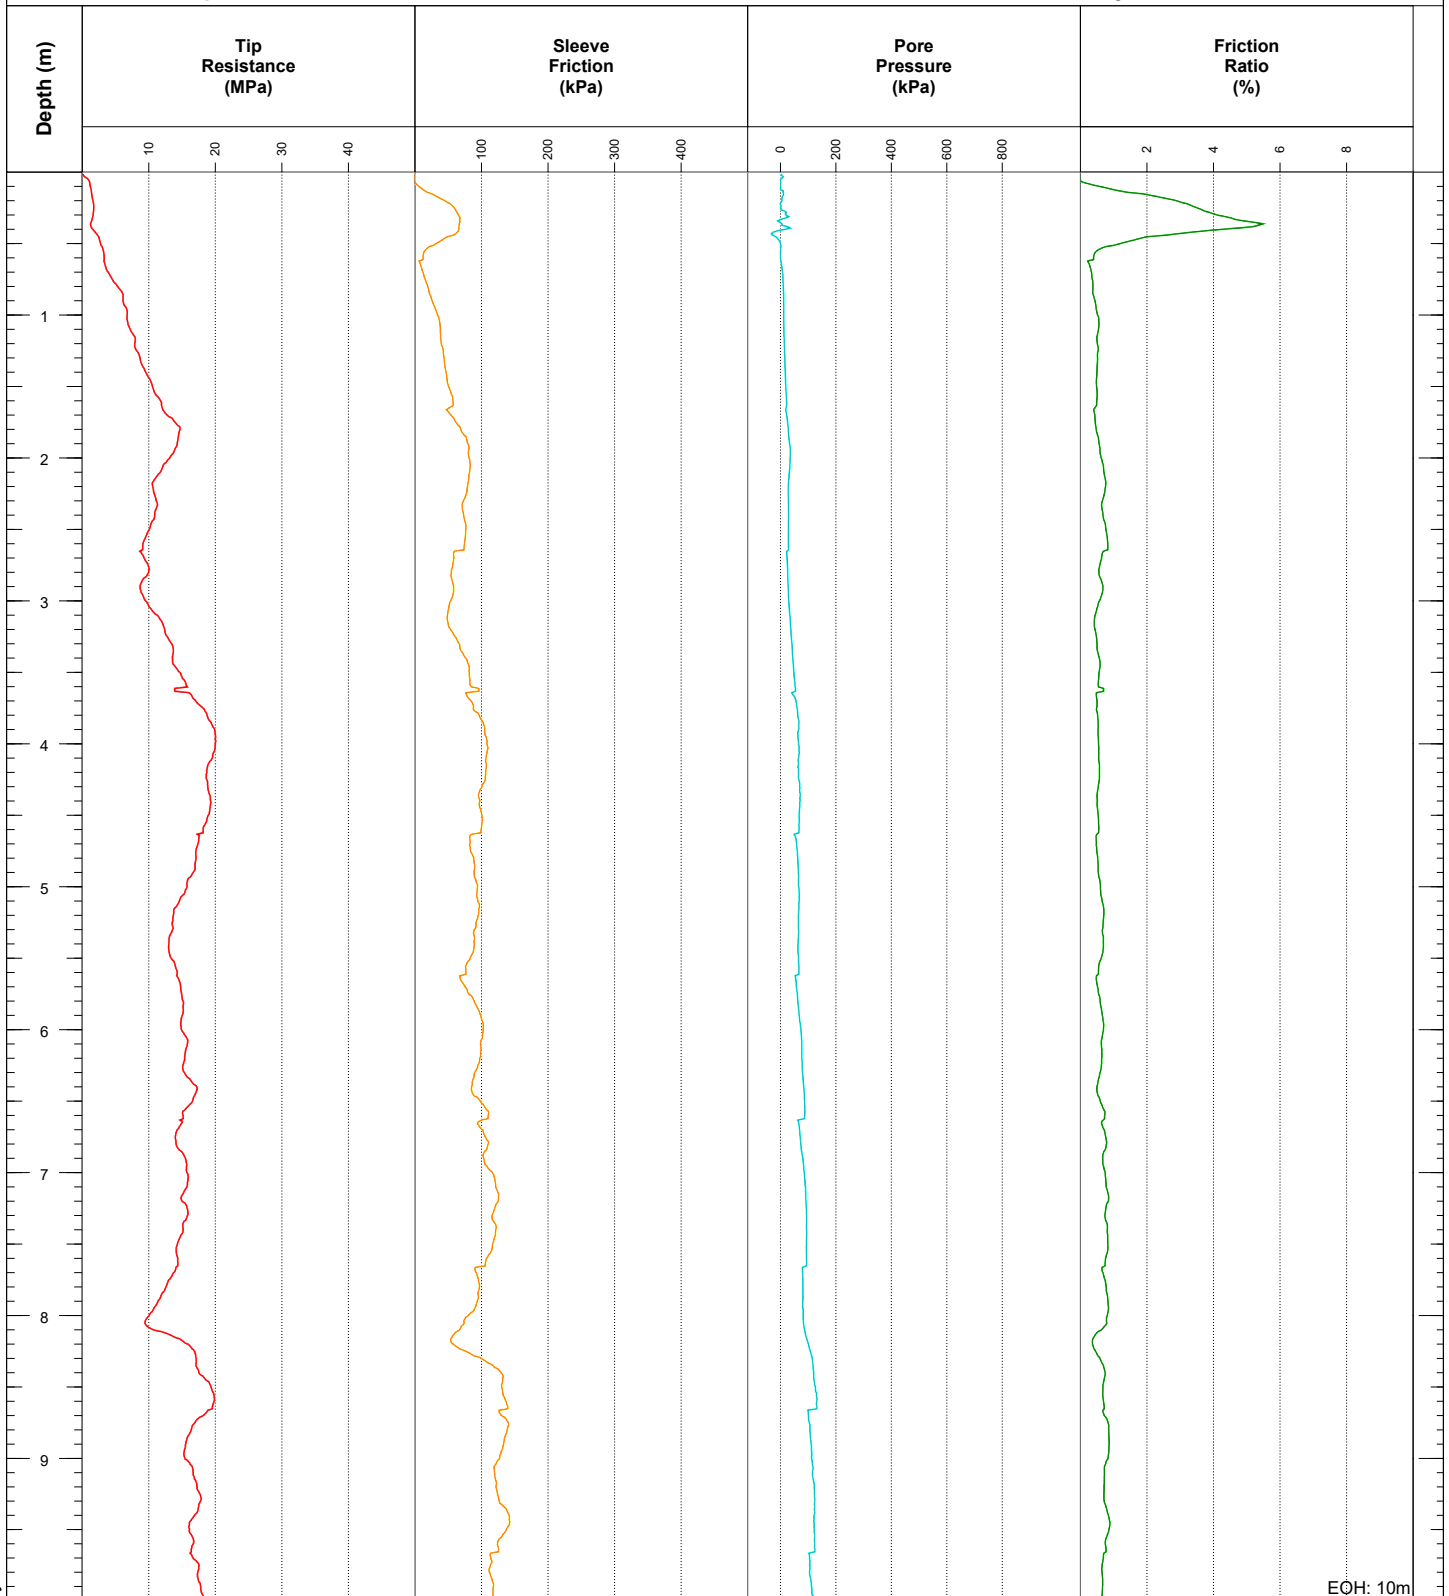
**Test Label:** CPT103

CPTu testing carried out to ASTM Standard D5778-12  
10cm-sq Pagani piezocone used for each CPTu test  
CPTu refusal at 50MPa on the tip, 500kPa on the friction sleeve or at 2500kPa pore pressure

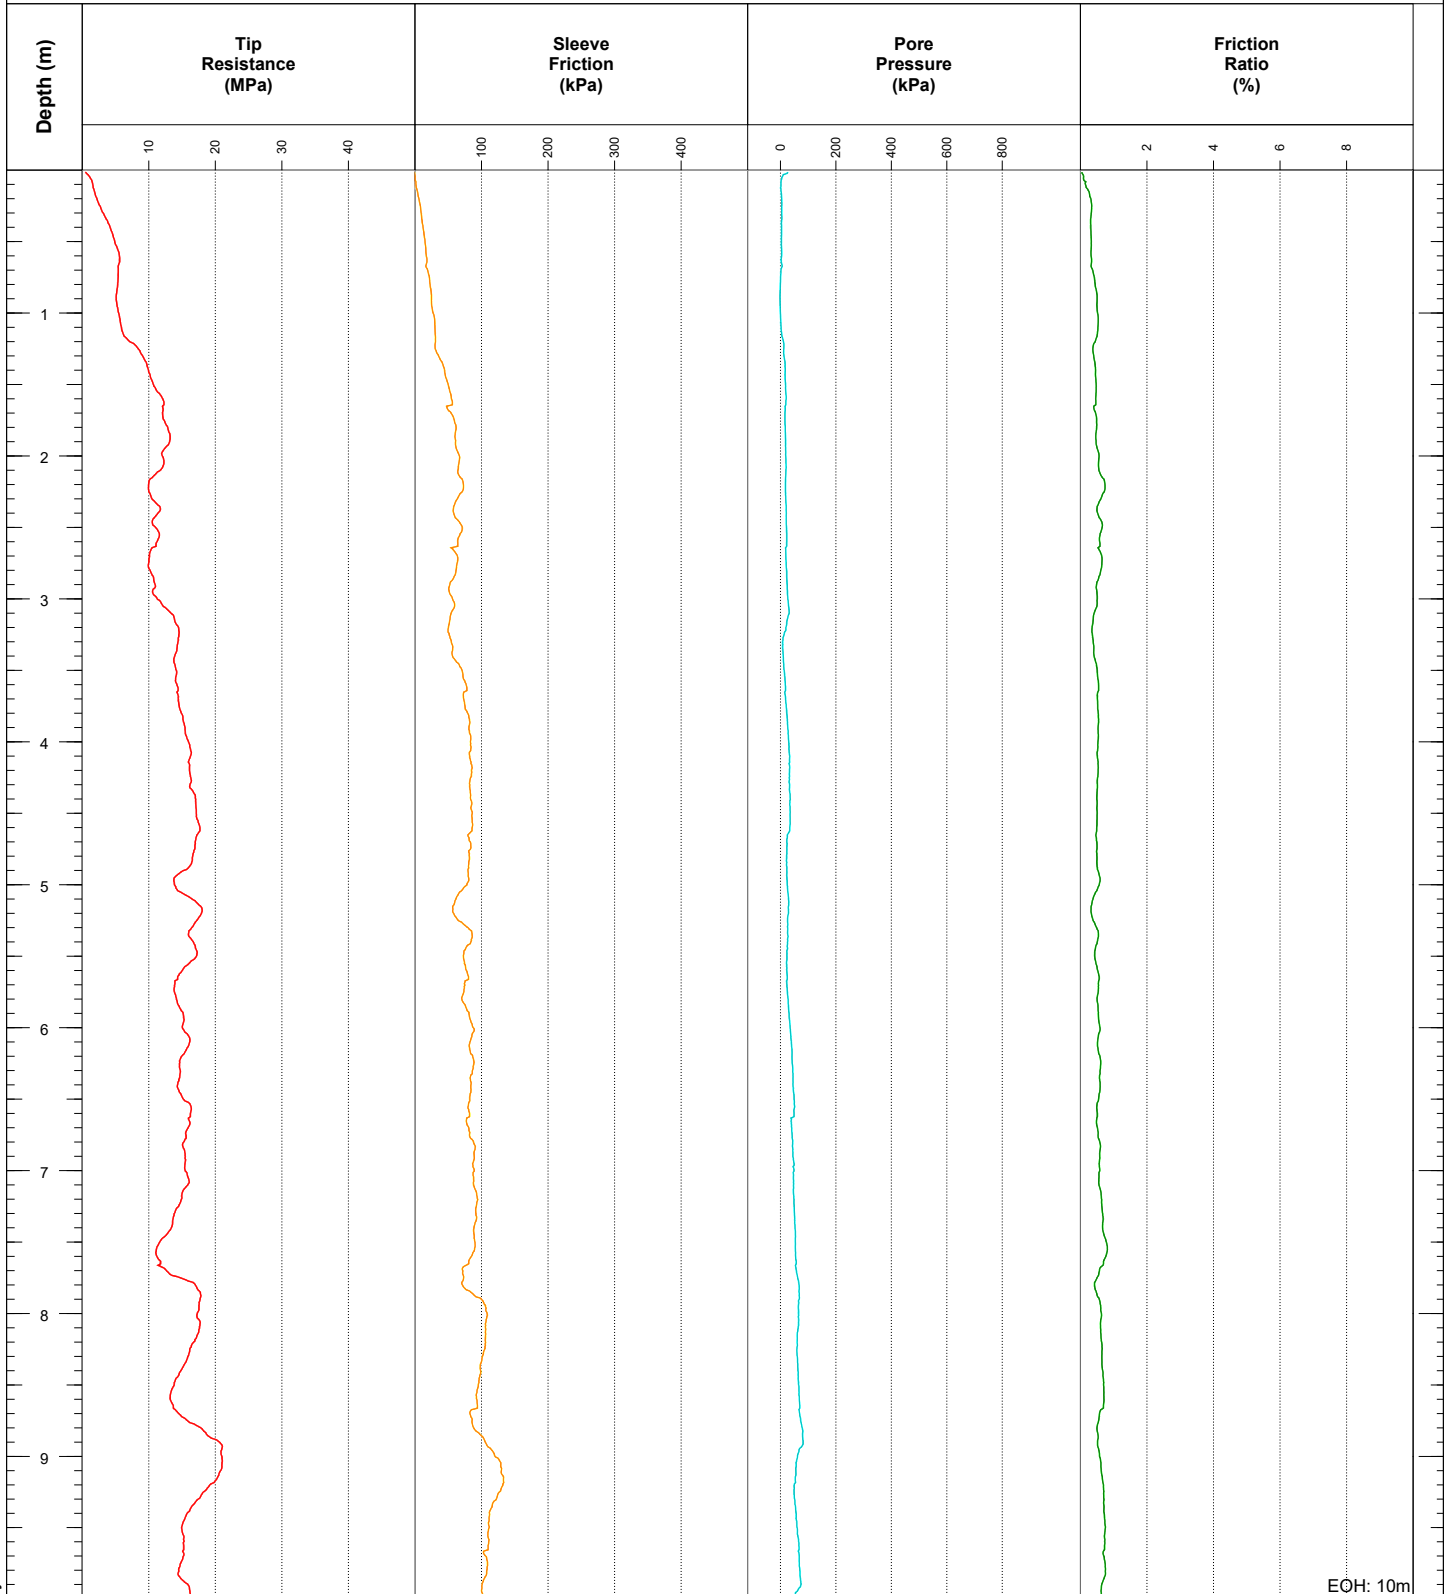
Test Label: CPT104

CPTu testing carried out to ASTM Standard D5778-12  
10cm-sq Pagani piezocone used for each CPTu test  
CPTu refusal at 50MPa on the tip, 500kPa on the friction sleeve or at 2500kPa pore pressure

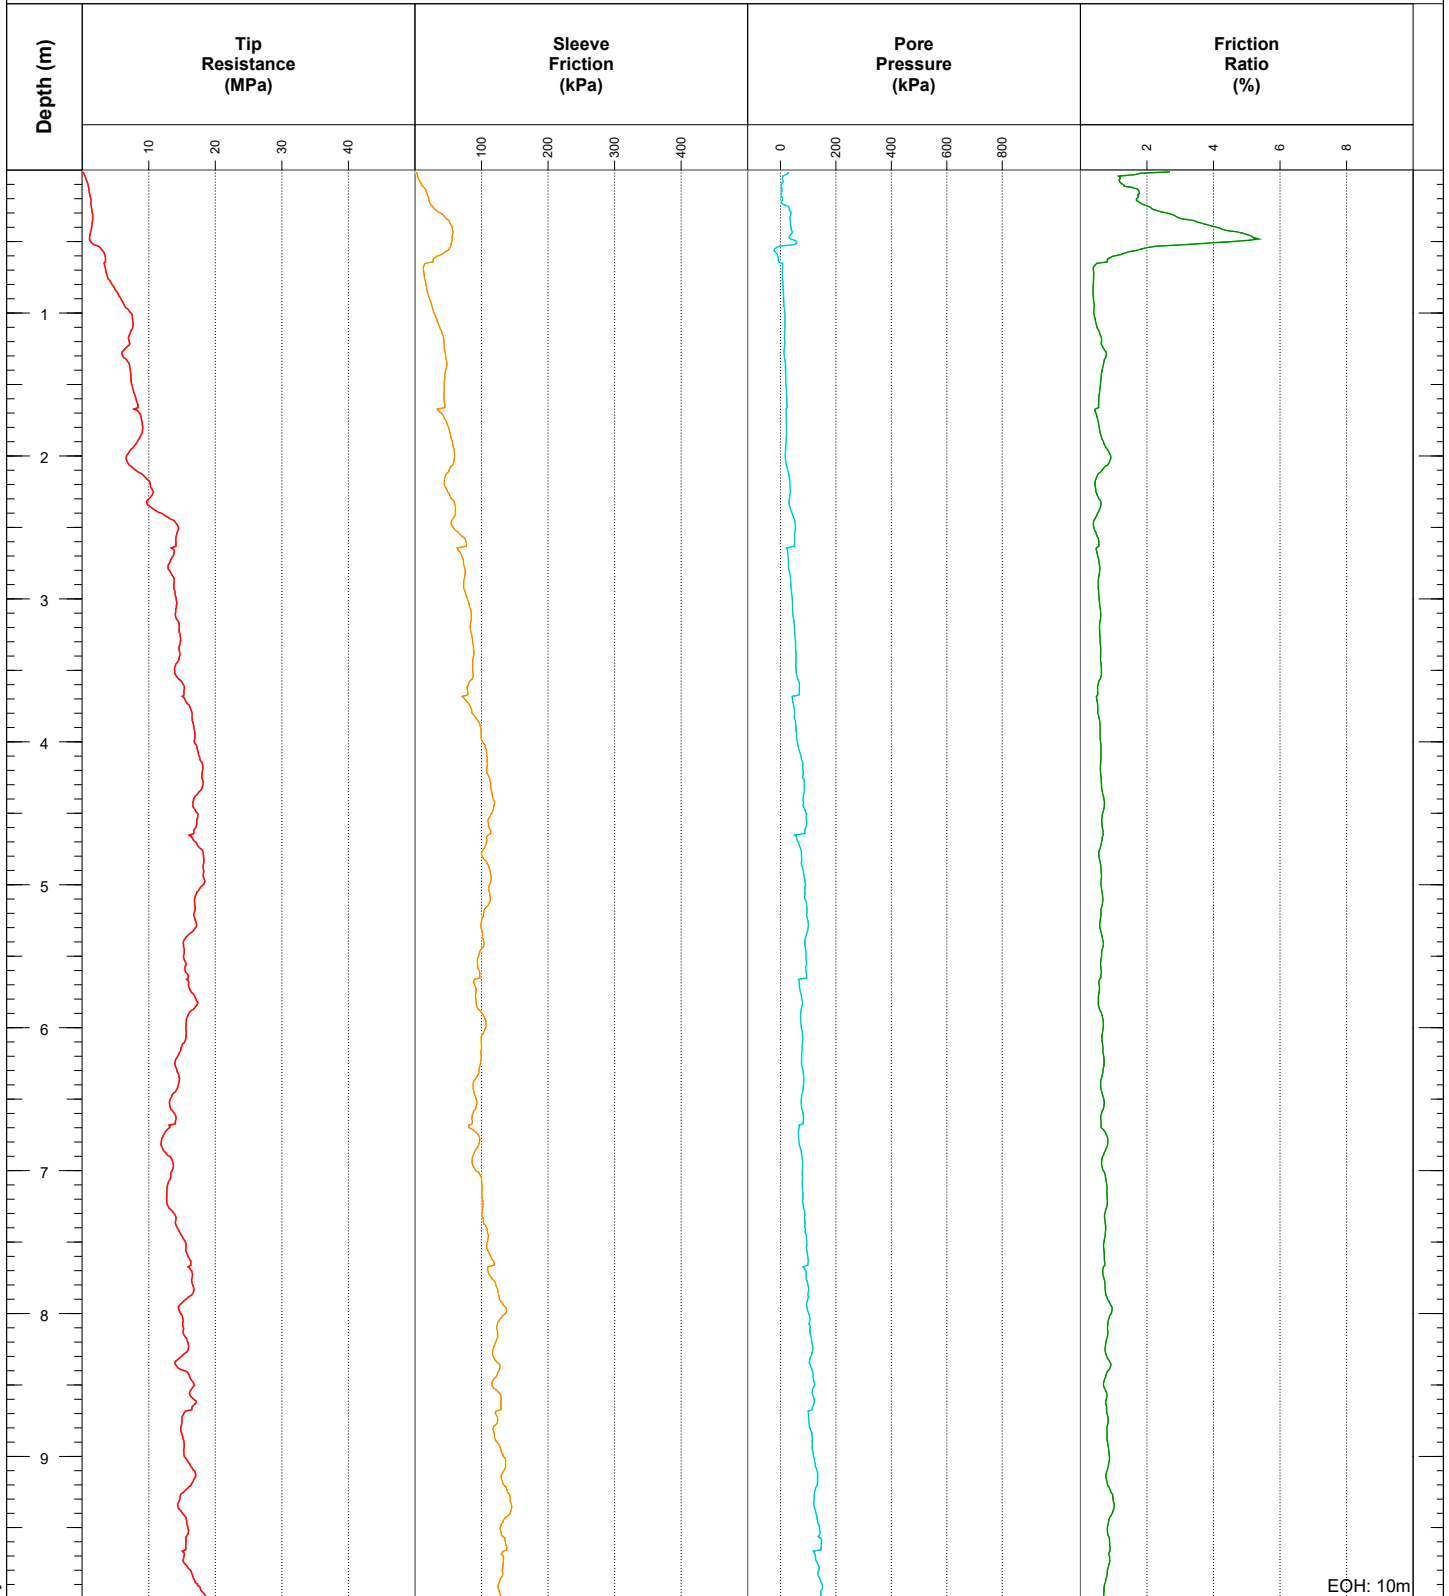
**Test Label:** CPT105

CPTu testing carried out to ASTM Standard D5778-12  
10cm-sq Pagani piezocone used for each CPTu test  
CPTu refusal at 50MPa on the tip, 500kPa on the friction sleeve or at 2500kPa pore pressure

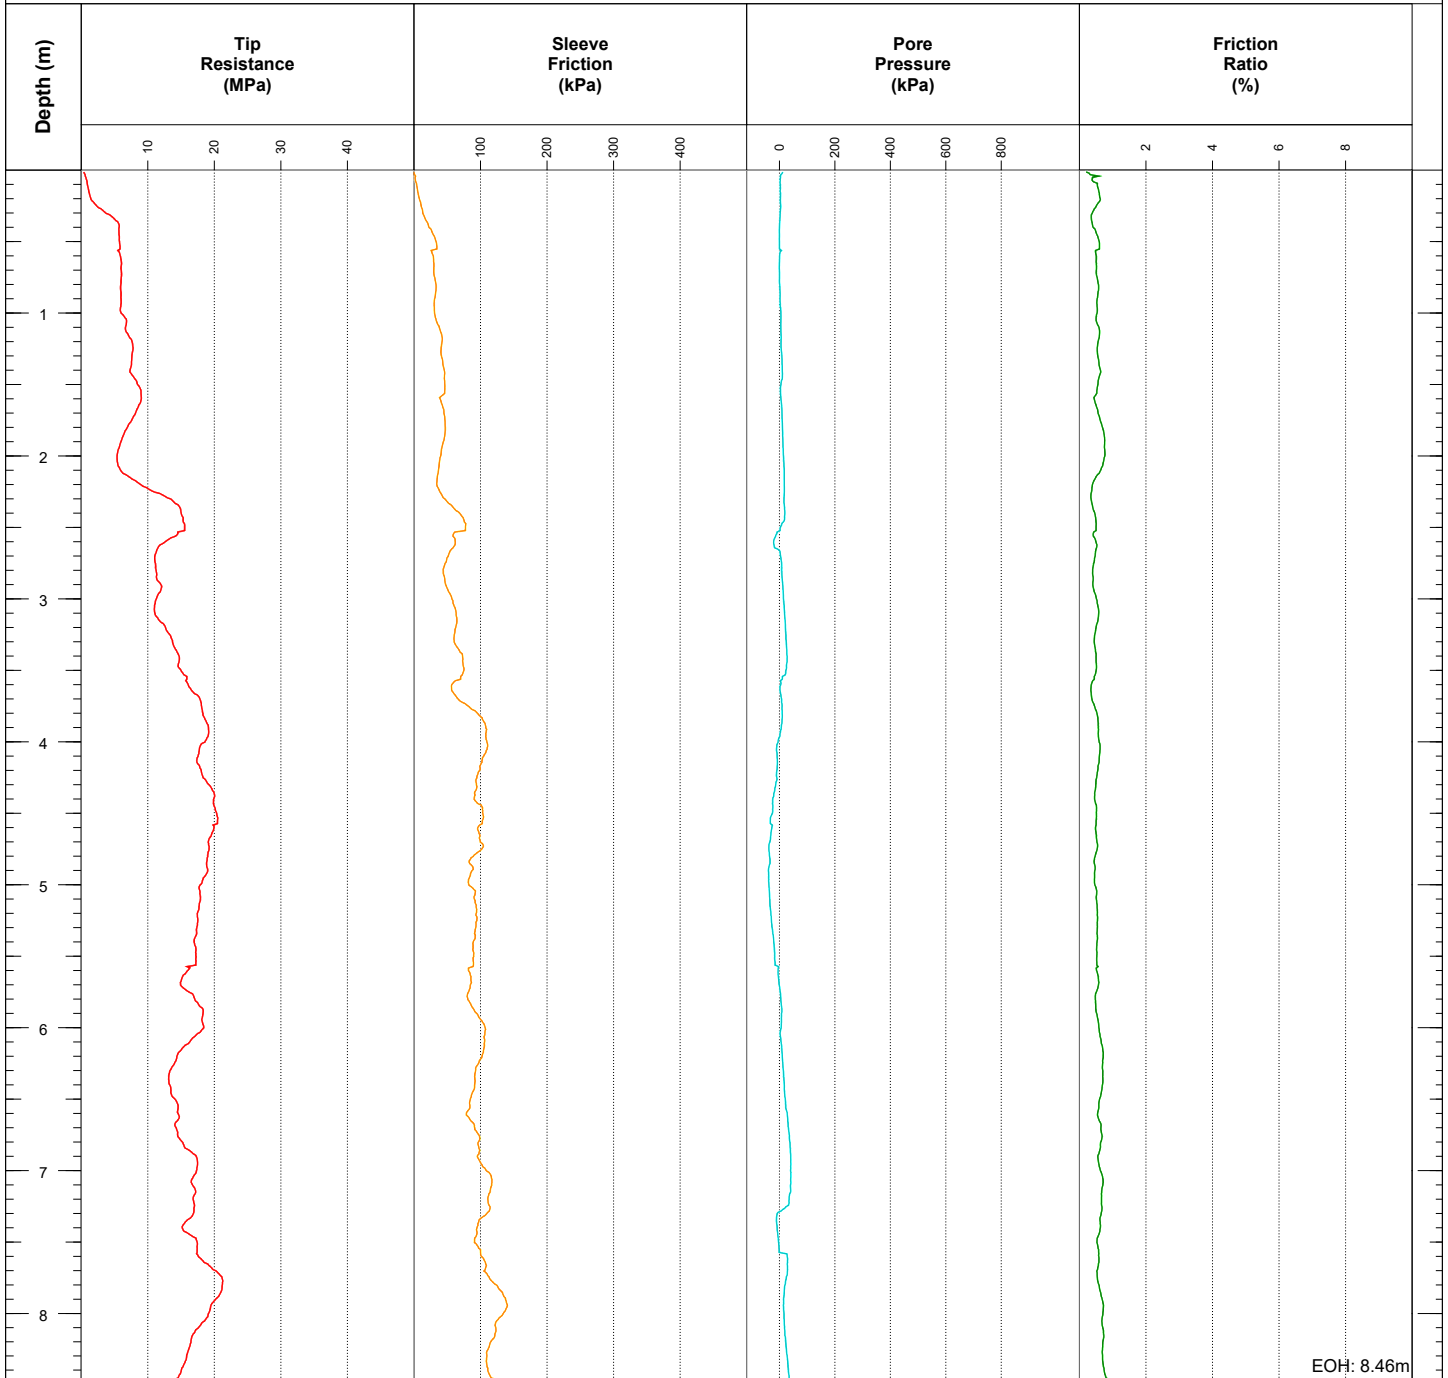
**Test Label:** CPT106

**EOH Reason:** Anchor Refusal

CPTu testing carried out to ASTM Standard D5778-12  
10cm-sq Pagani piezocone used for each CPTu test  
CPTu refusal at 50MPa on the tip, 500kPa on the friction sleeve or at 2500kPa pore pressure

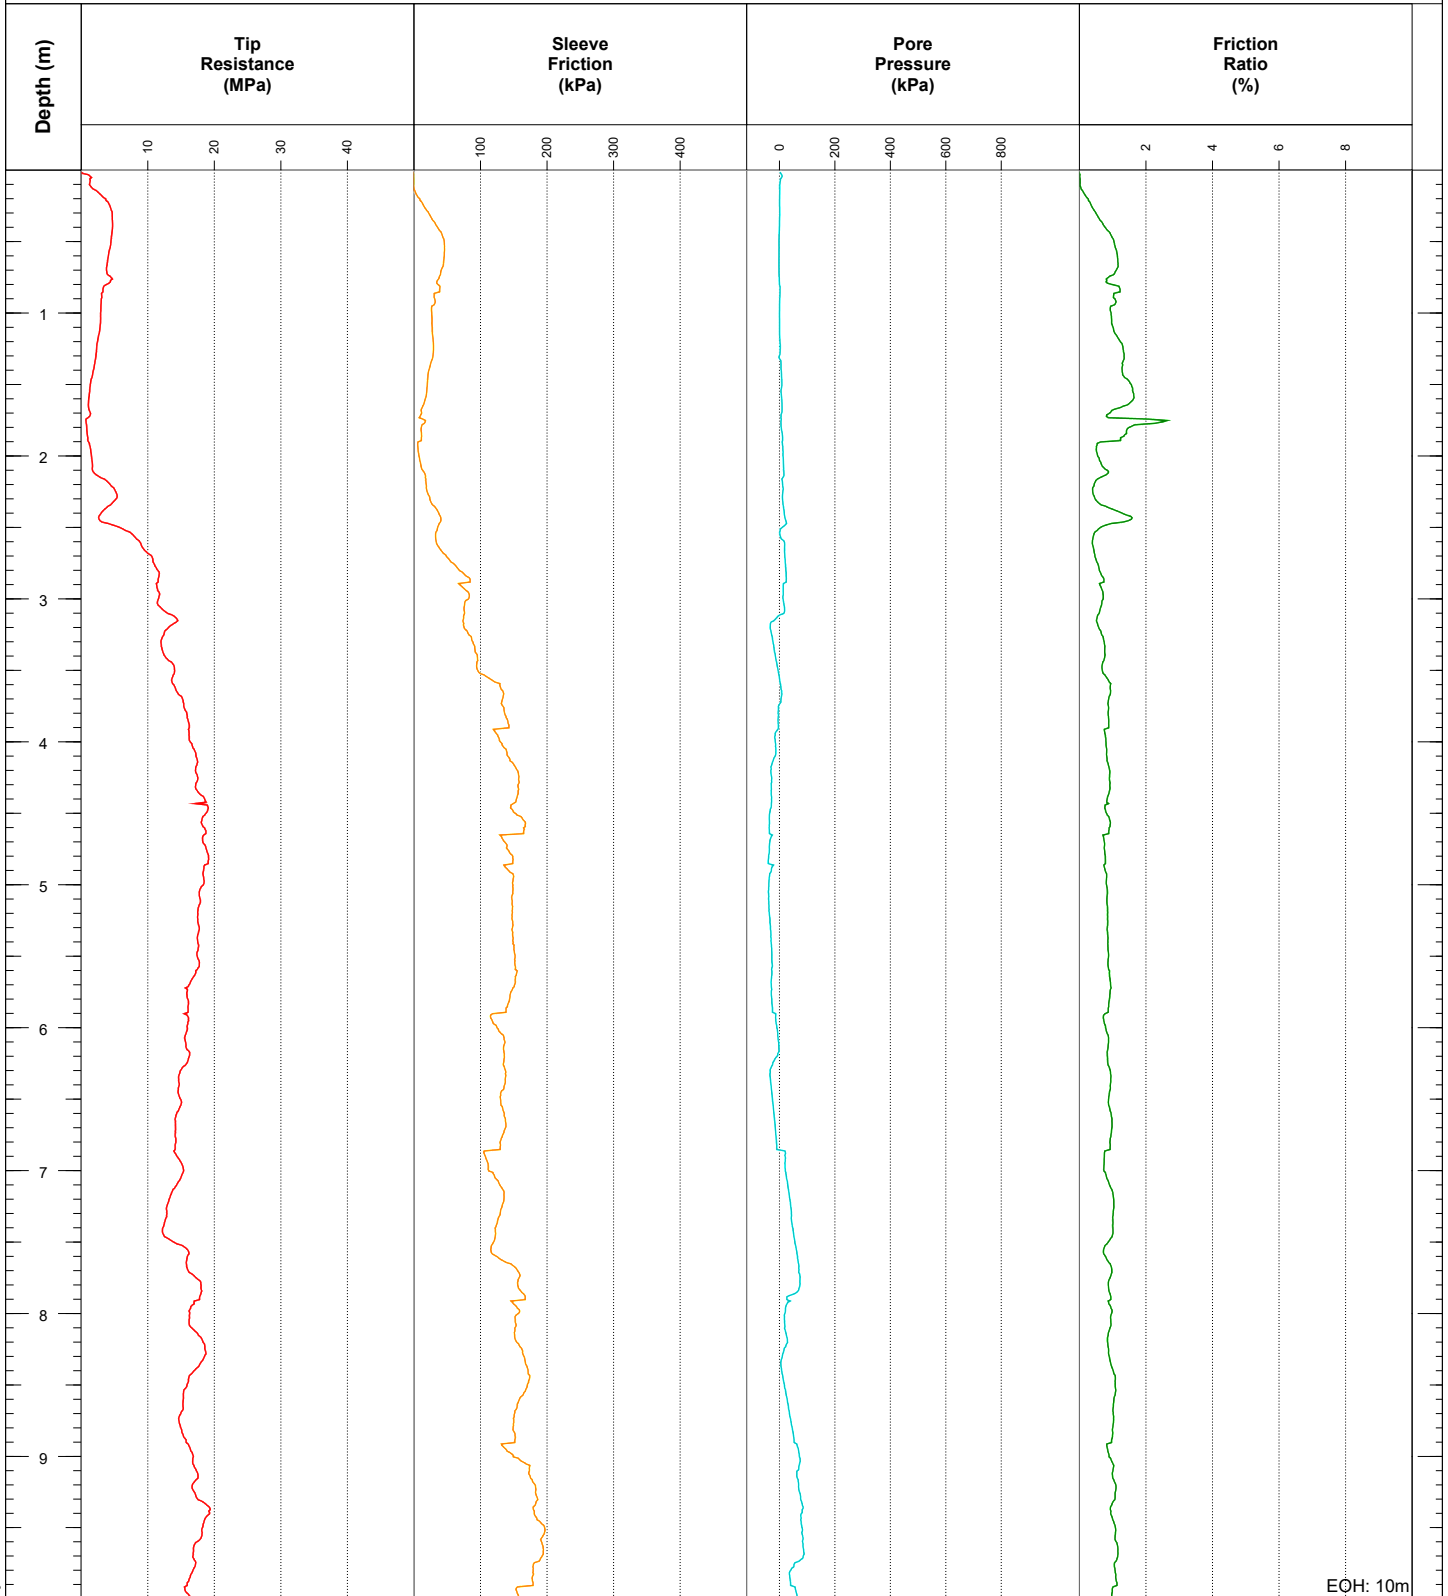
**Test Label:** CPT107

CPTu testing carried out to ASTM Standard D5778-12  
10cm-sq Pagani piezocone used for each CPTu test  
CPTu refusal at 50MPa on the tip, 500kPa on the friction sleeve or at 2500kPa pore pressure

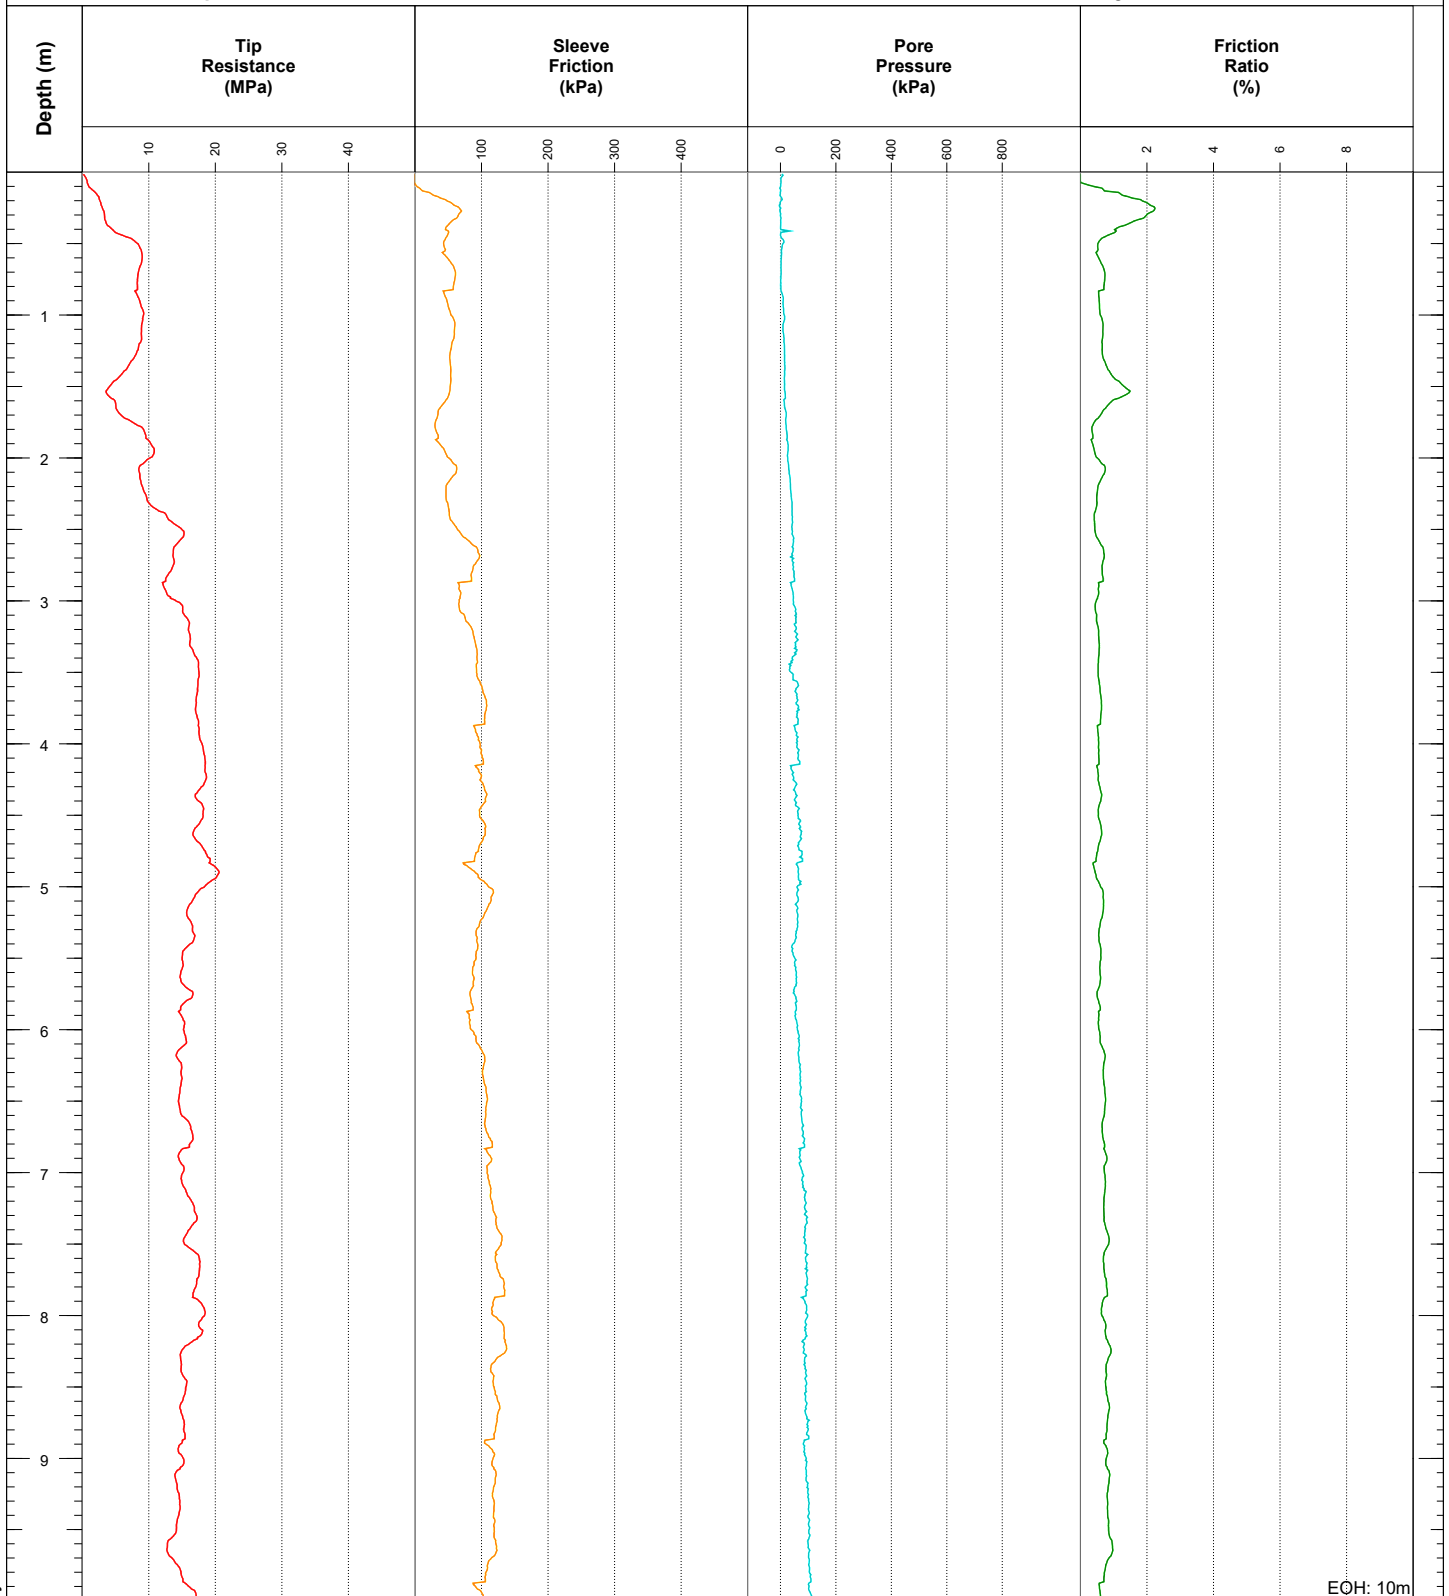
**Test Label:** CPT108

CPTu testing carried out to ASTM Standard D5778-12  
10cm-sq Pagani piezocone used for each CPTu test  
CPTu refusal at 50MPa on the tip, 500kPa on the friction sleeve or at 2500kPa pore pressure

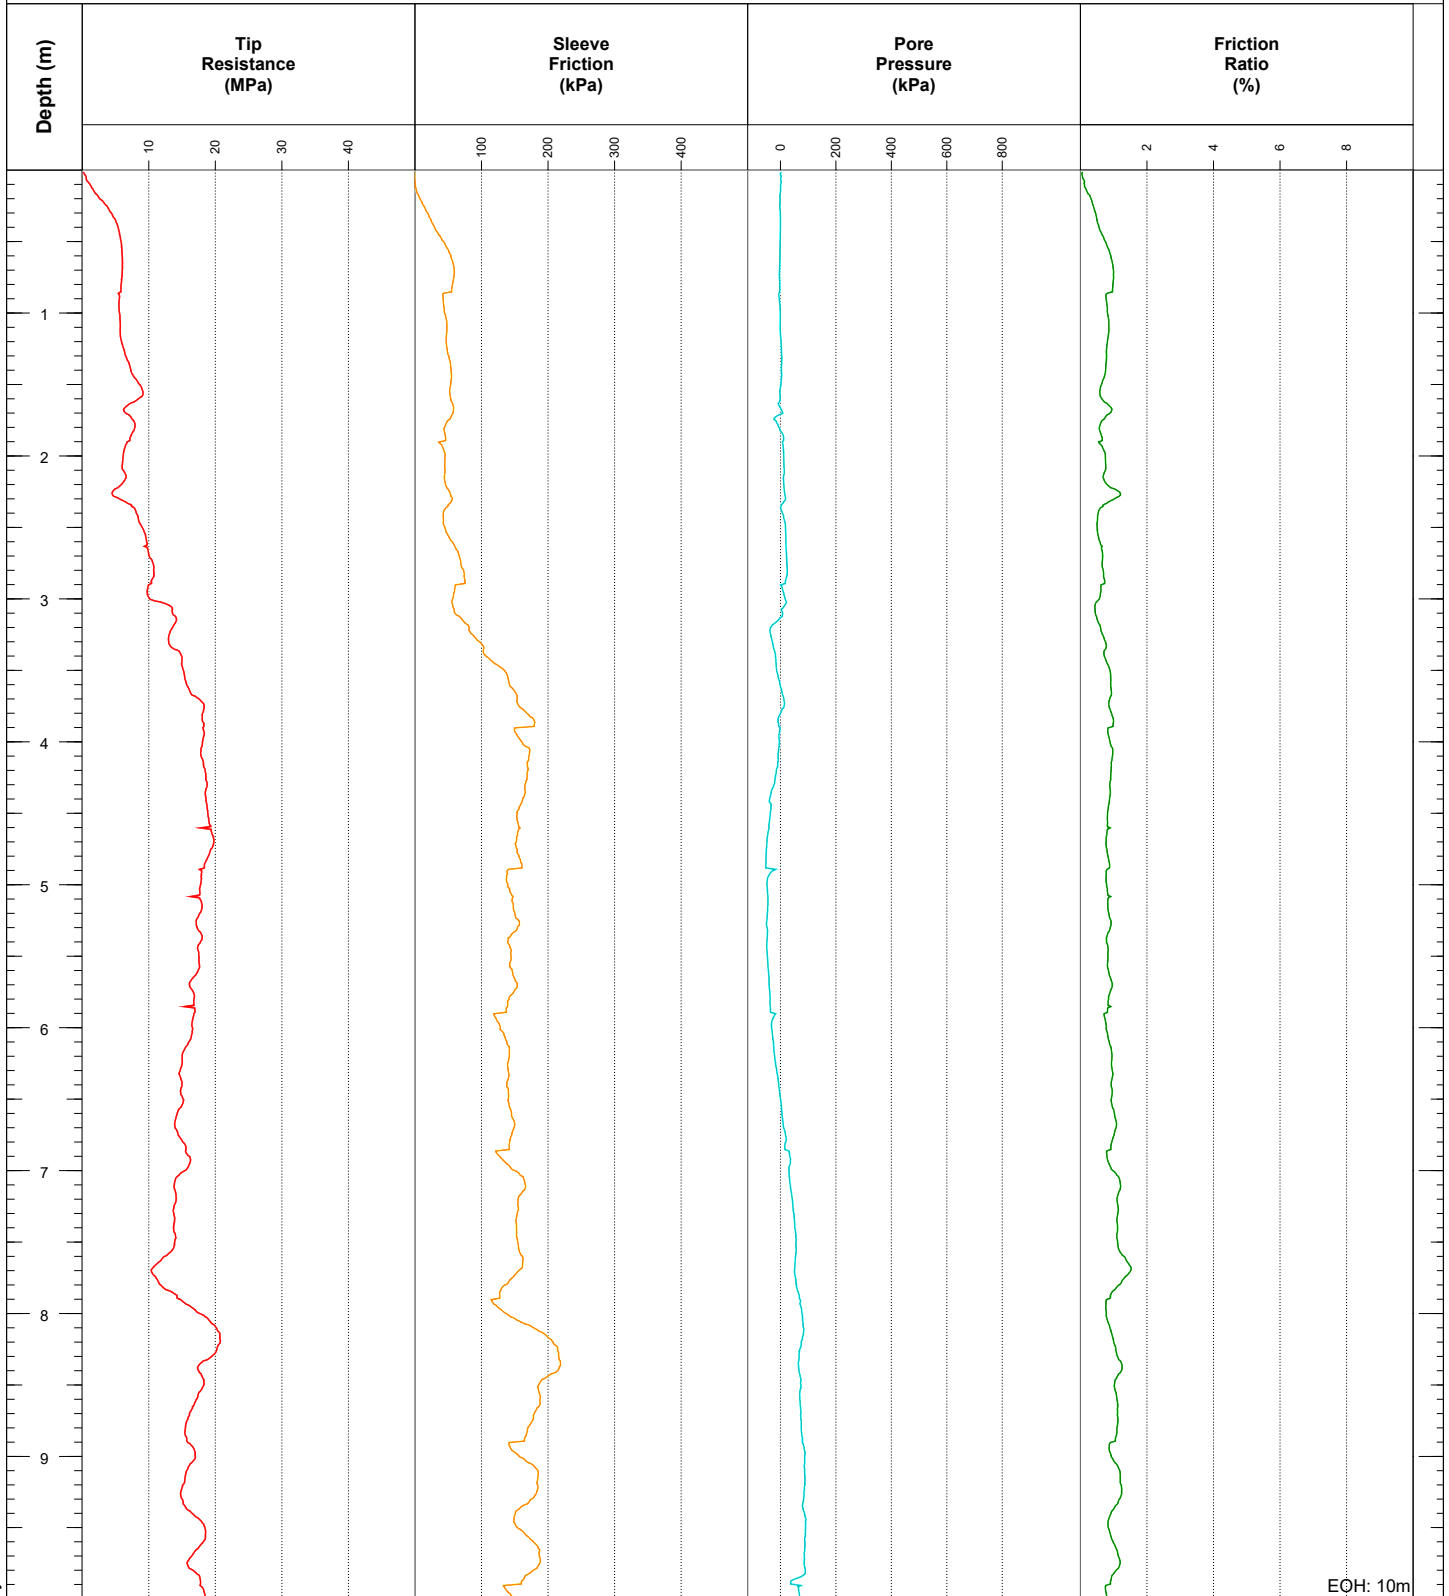
**Test Label:** CPT109

CPTu testing carried out to ASTM Standard D5778-12  
10cm-sq Pagani piezocone used for each CPTu test  
CPTu refusal at 50MPa on the tip, 500kPa on the friction sleeve or at 2500kPa pore pressure
