# Appendix C

## 2018 CPT Logs

**Client:** Aurecon  
**Project:** Prestons Law Block

**Site Location:** Marshland, Christchurch

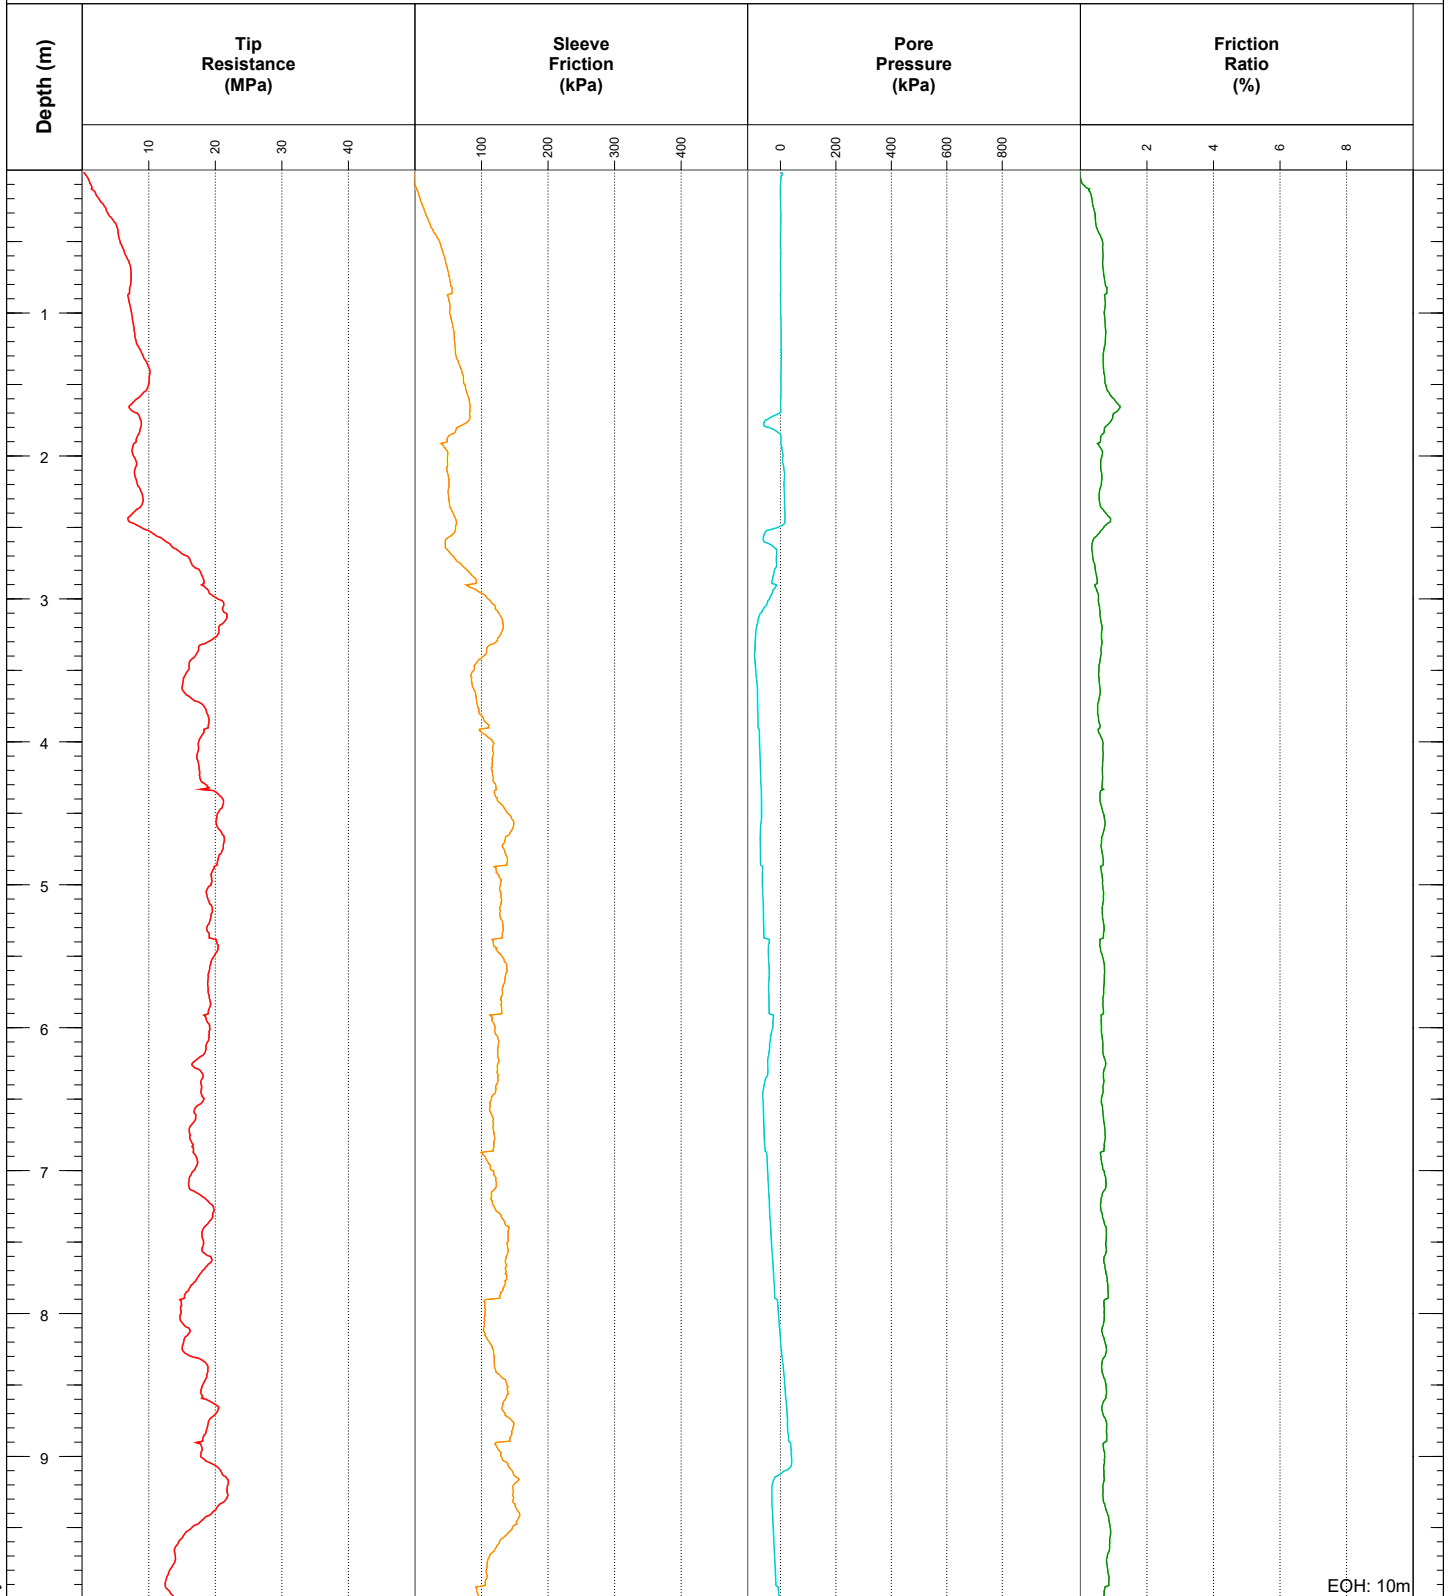
**Test Label:** CPT110

CPTu testing carried out to ASTM Standard D5778-12  
10cm-sq Pagani piezocone used for each CPTu test  
CPTu refusal at 50MPa on the tip, 500kPa on the friction sleeve or at 2500kPa pore pressure

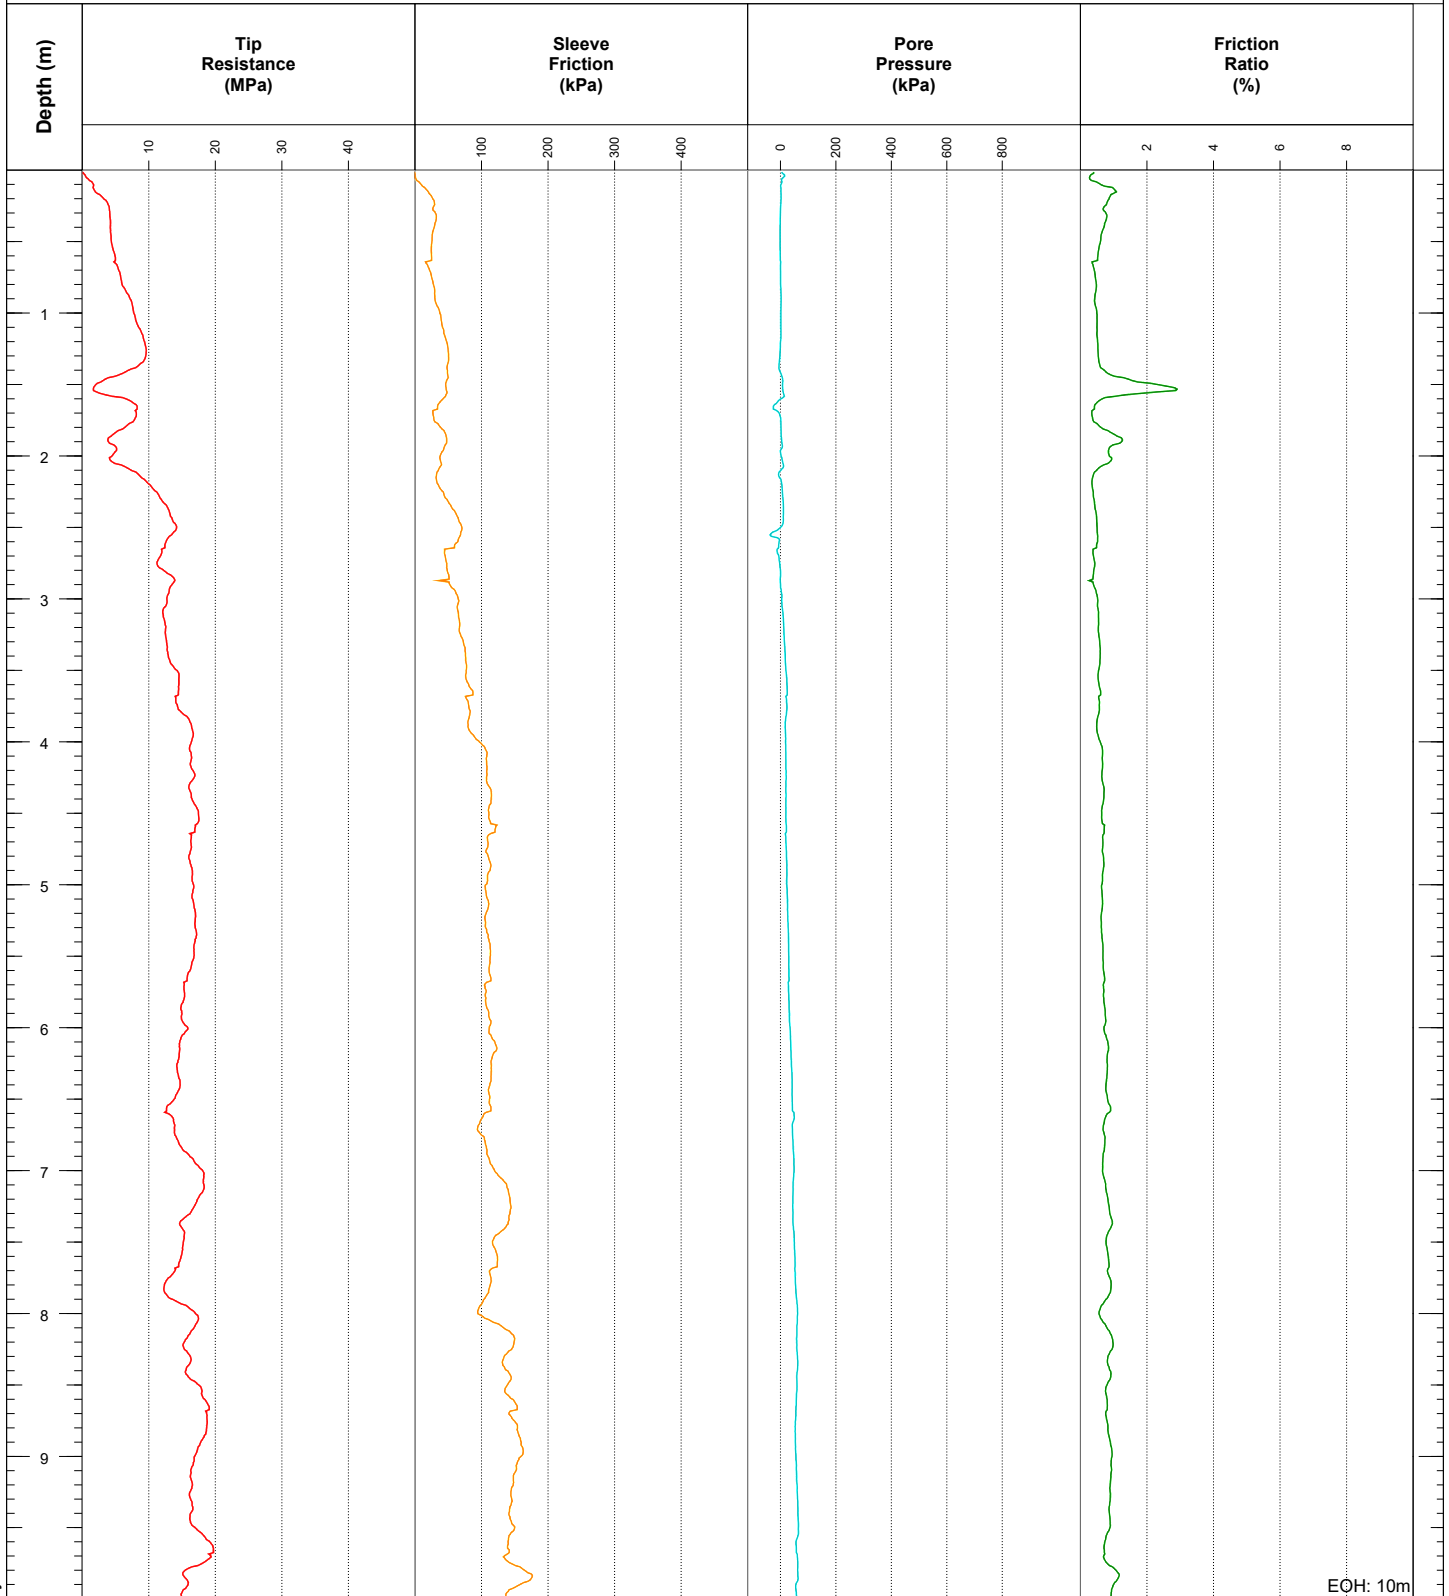
**Test Label:** CPT111

CPTu testing carried out to ASTM Standard D5778-12  
10cm-sq Pagani piezocone used for each CPTu test  
CPTu refusal at 50MPa on the tip, 500kPa on the friction sleeve or at 2500kPa pore pressure

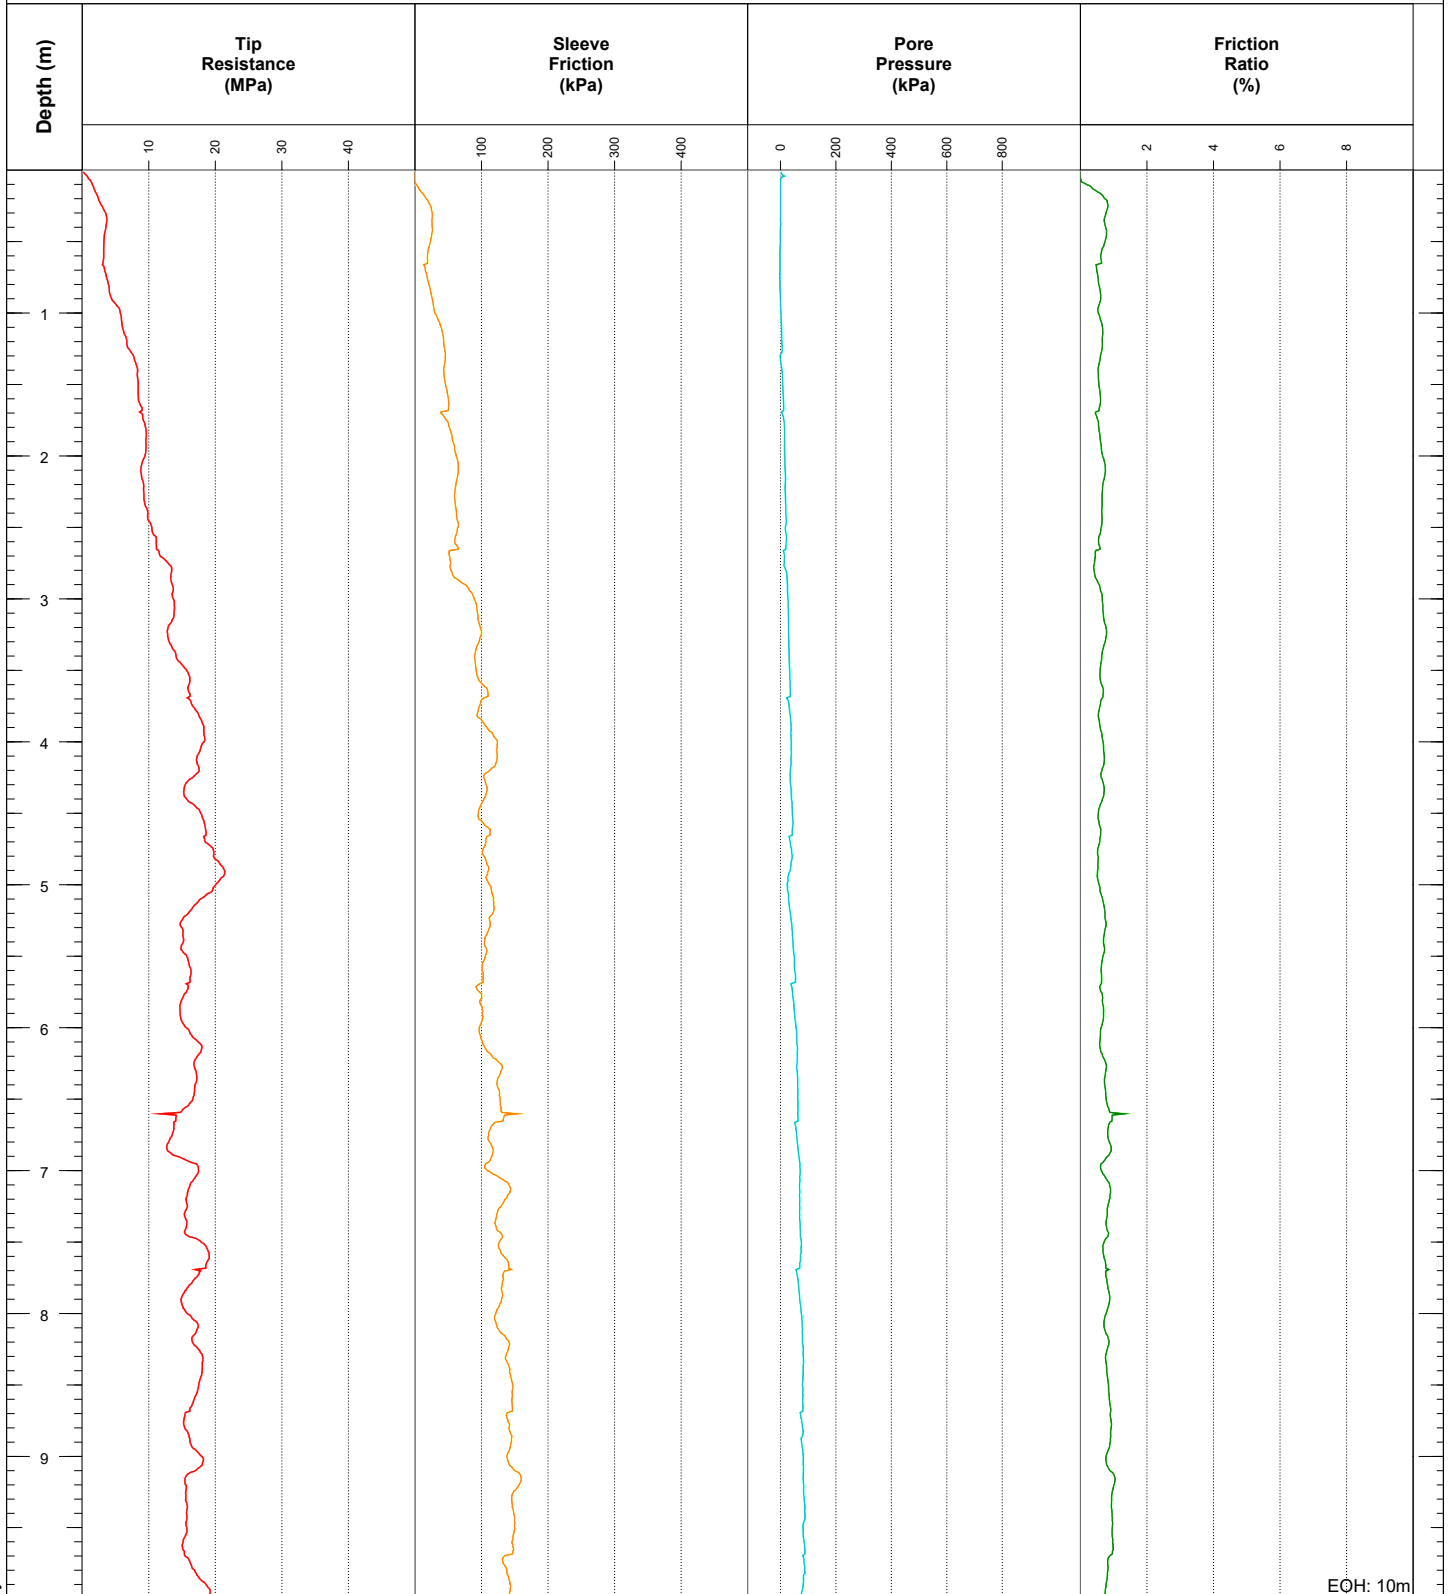
**Test Label:** CPT112

CPTu testing carried out to ASTM Standard D5778-12  
10cm-sq Pagani piezocone used for each CPTu test  
CPTu refusal at 50MPa on the tip, 500kPa on the friction sleeve or at 2500kPa pore pressure

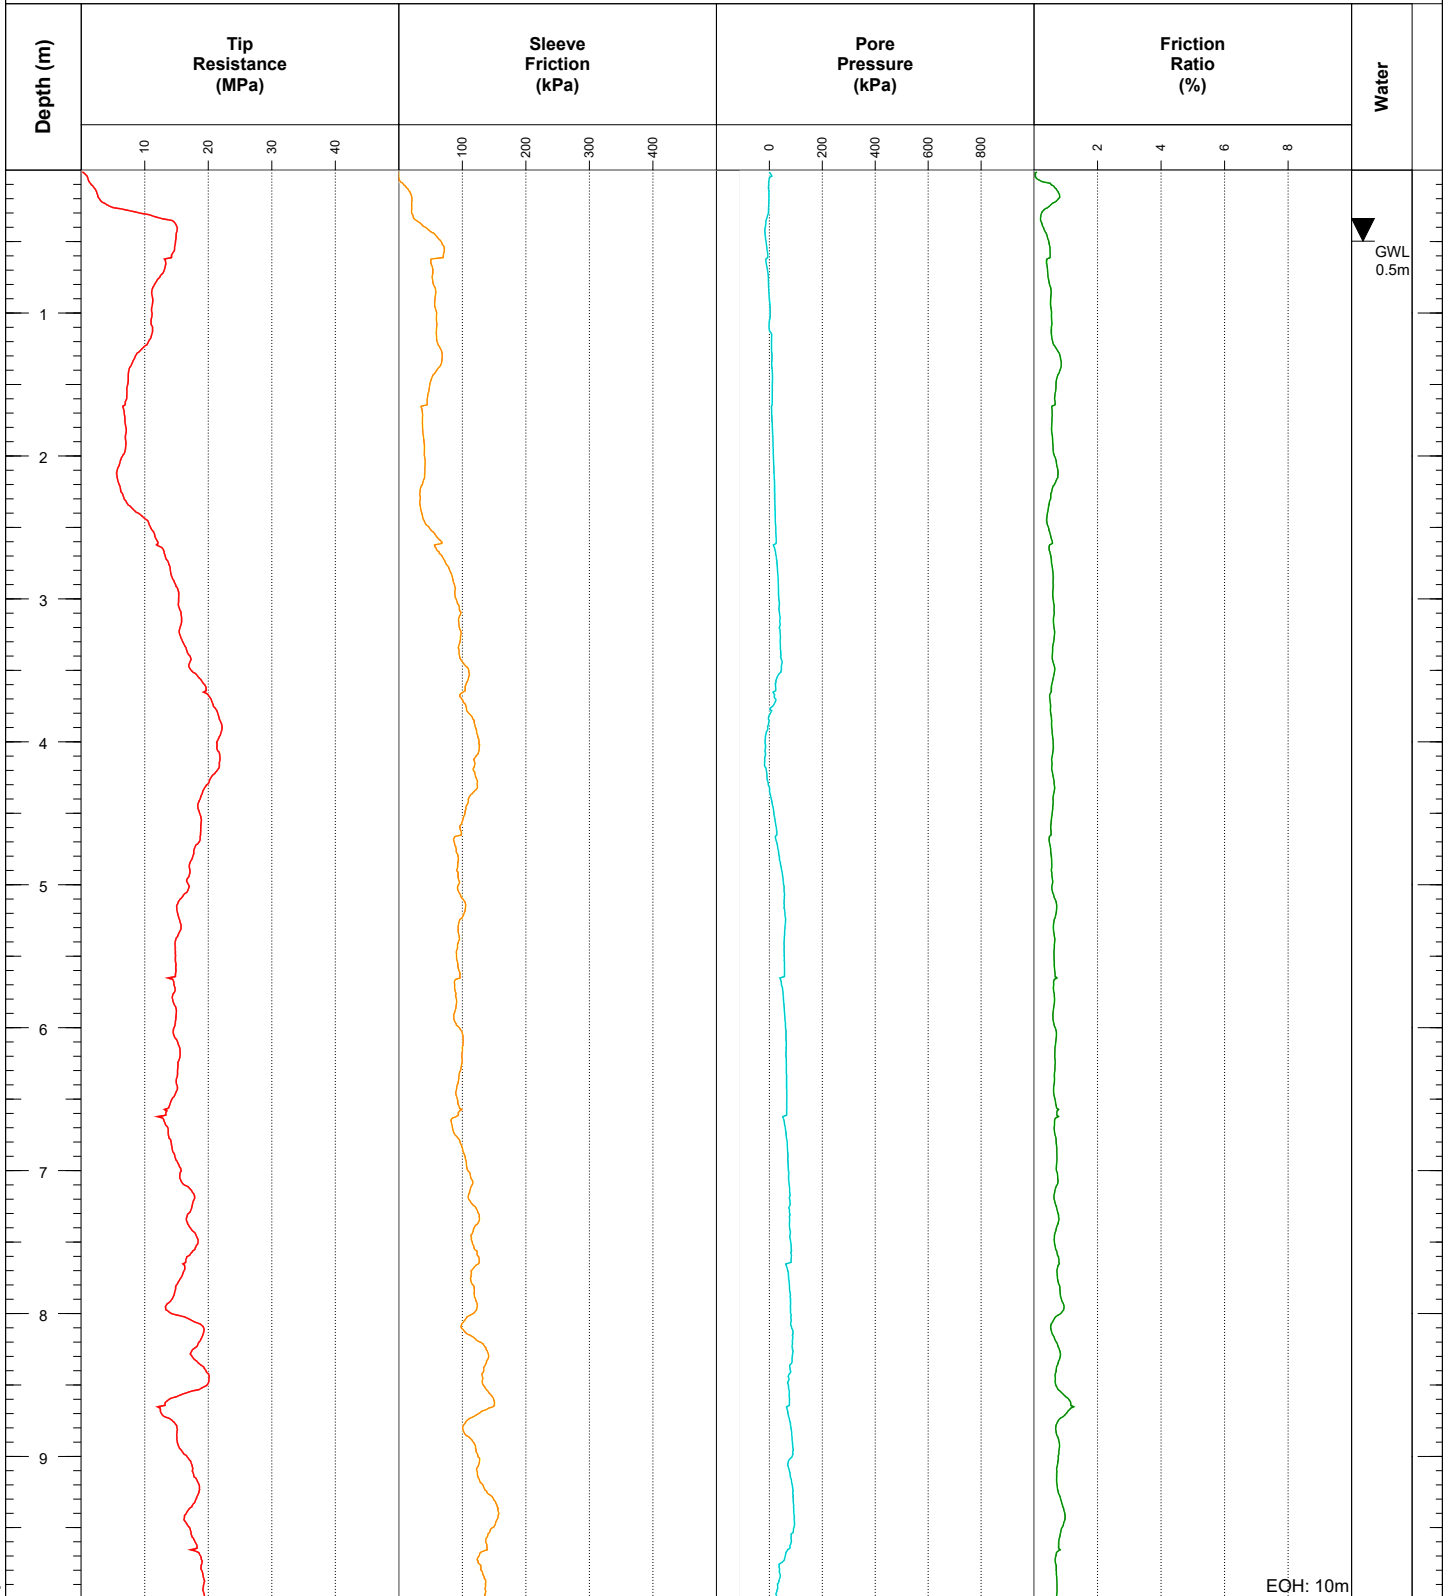
Test Label: CPT113

CPTu testing carried out to ASTM Standard D5778-12  
10cm-sq Pagani piezocone used for each CPTu test  
CPTu refusal at 50MPa on the tip, 500kPa on the friction sleeve or at 2500kPa pore pressure

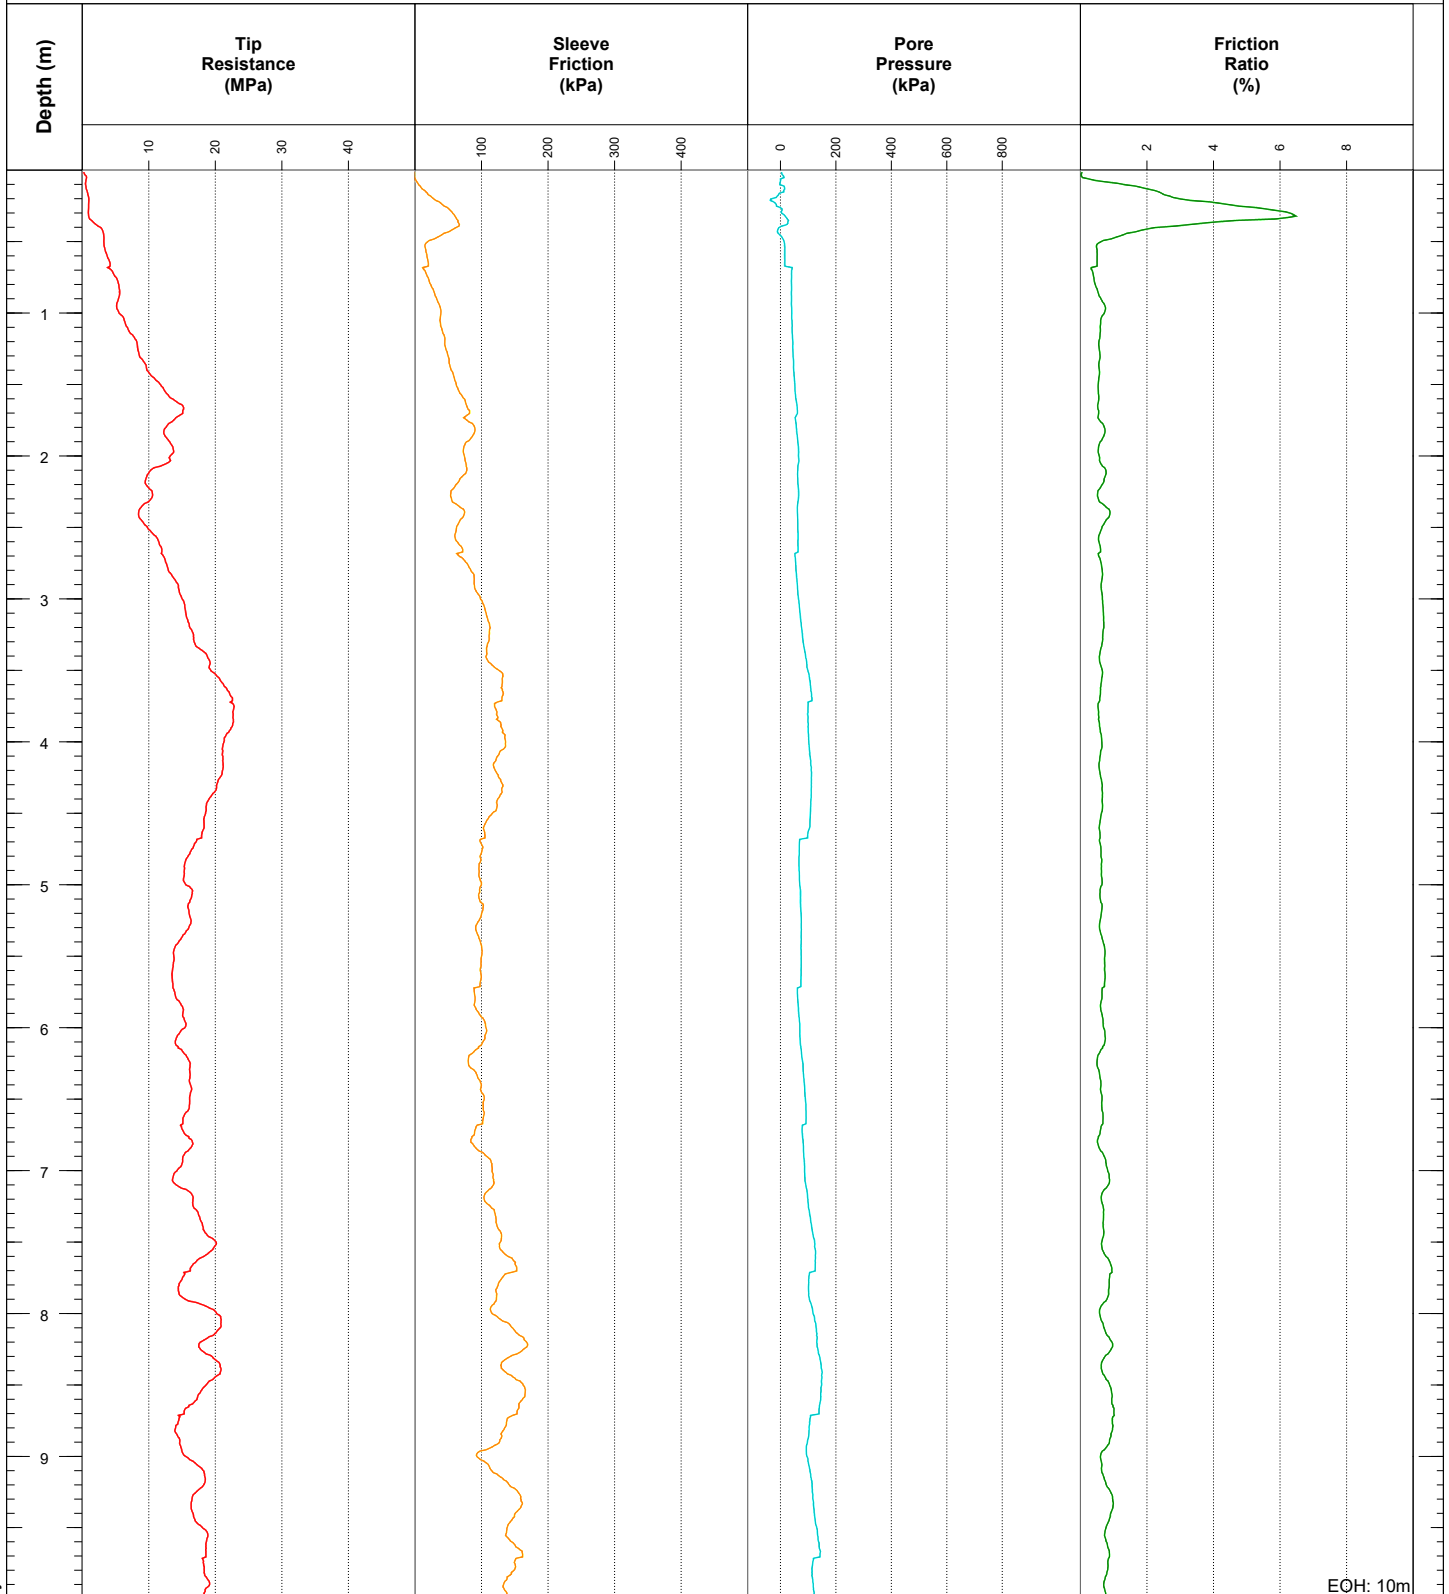
**Test Label:** CPT114

CPTu testing carried out to ASTM Standard D5778-12  
10cm-sq Pagani piezocone used for each CPTu test  
CPTu refusal at 50MPa on the tip, 500kPa on the friction sleeve or at 2500kPa pore pressure

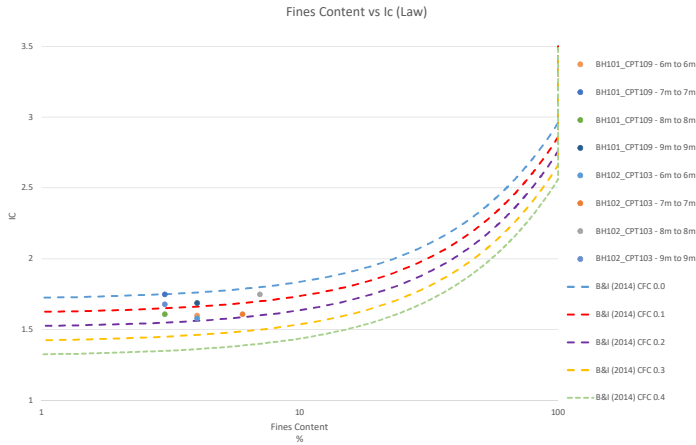
Figure: Plot of Fines Content (FC) against Soil Behaviour Type Index (I<sub>c</sub>)
