Prestons Subdivision  
GEOTECHNICAL REPORT FOR LOT 870  
CDL Land NZ Limited

30 April 2021  
Revision: 1  
Reference: 235361

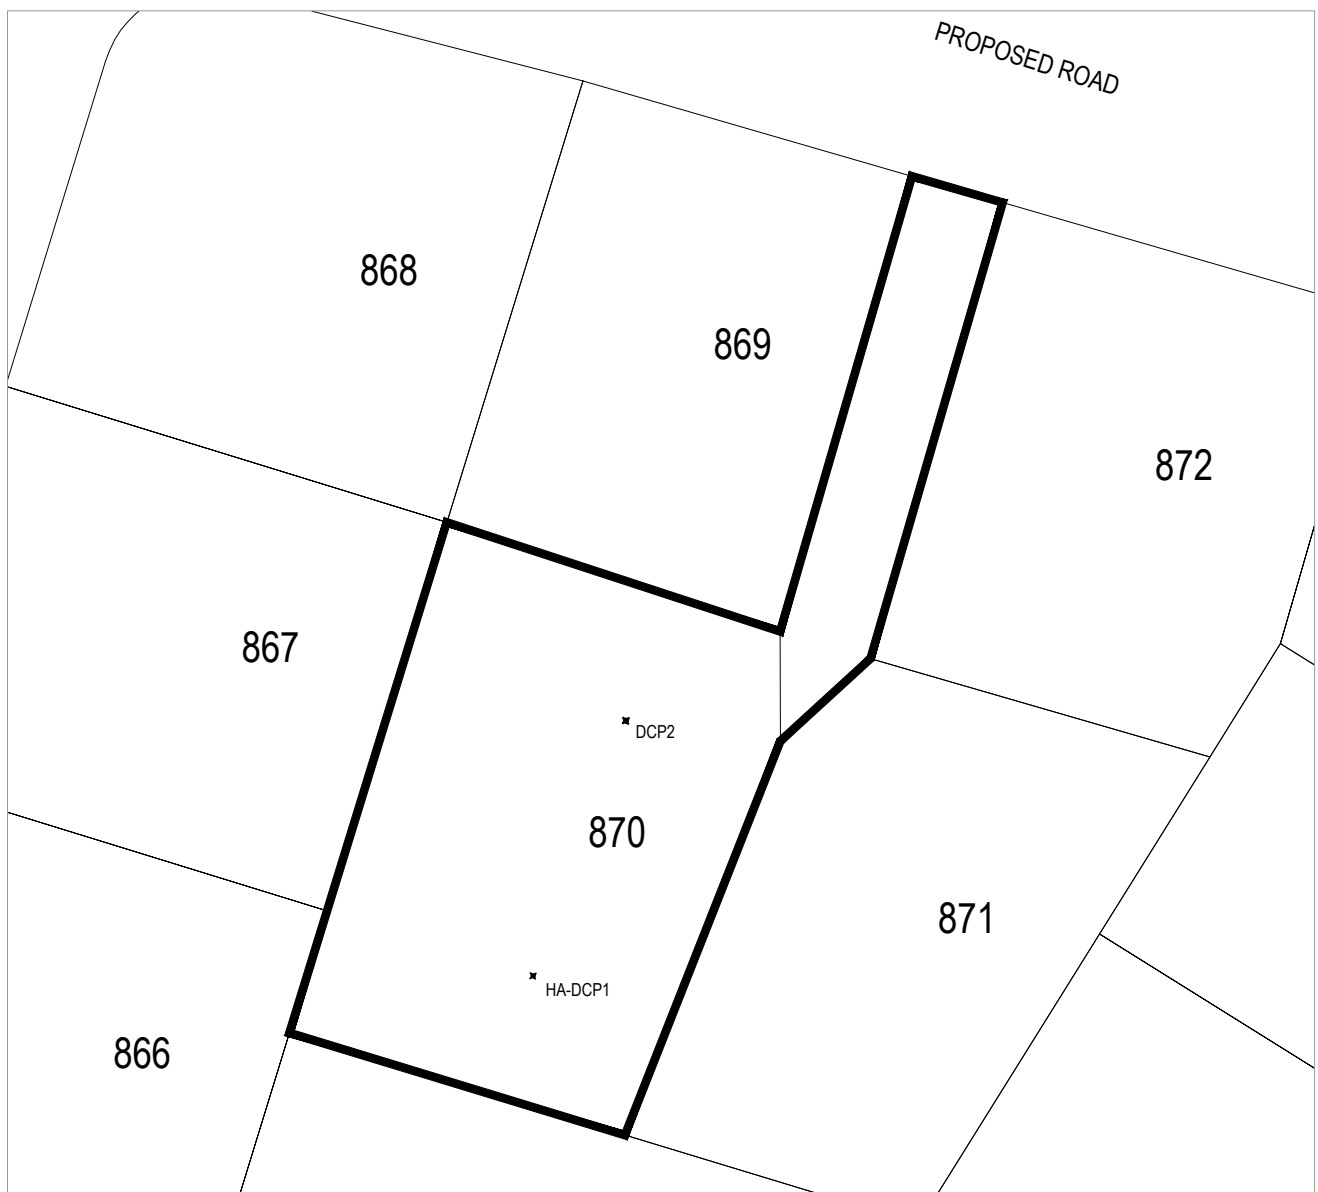
PROJECT
PRESTONS PARK
TITLE
LOT 870 SITE LOCATION PLAN FIGURE 1

This building consent report is for Lot 870 which is located in Stage 4 of the Prestons South Subdivision development (refer Figure 1 in Appendix A). The lot is bordered by residential lots to the north, south, east and west with an access driveway to the northwest.
