Prestons Subdivision
GEOTECHNICAL REPORT FOR LOT 873
CDL Land NZ Limited

30 April 2021
Revision: 1
Reference: 235361

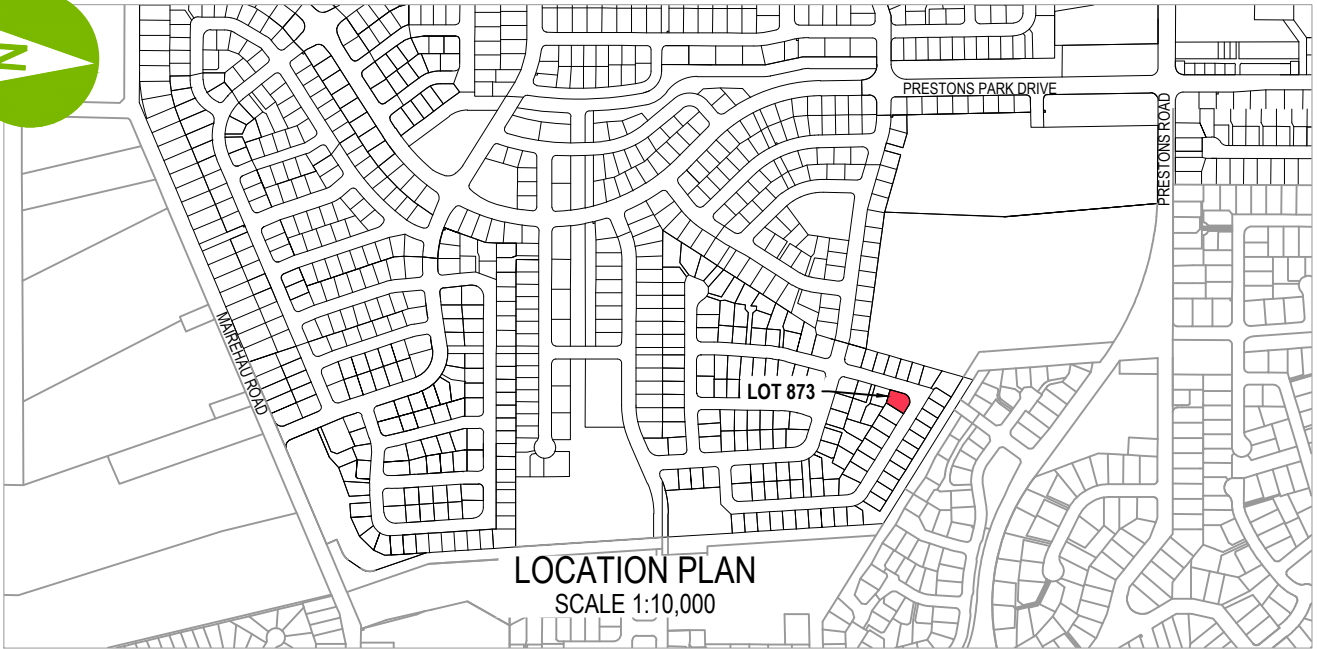
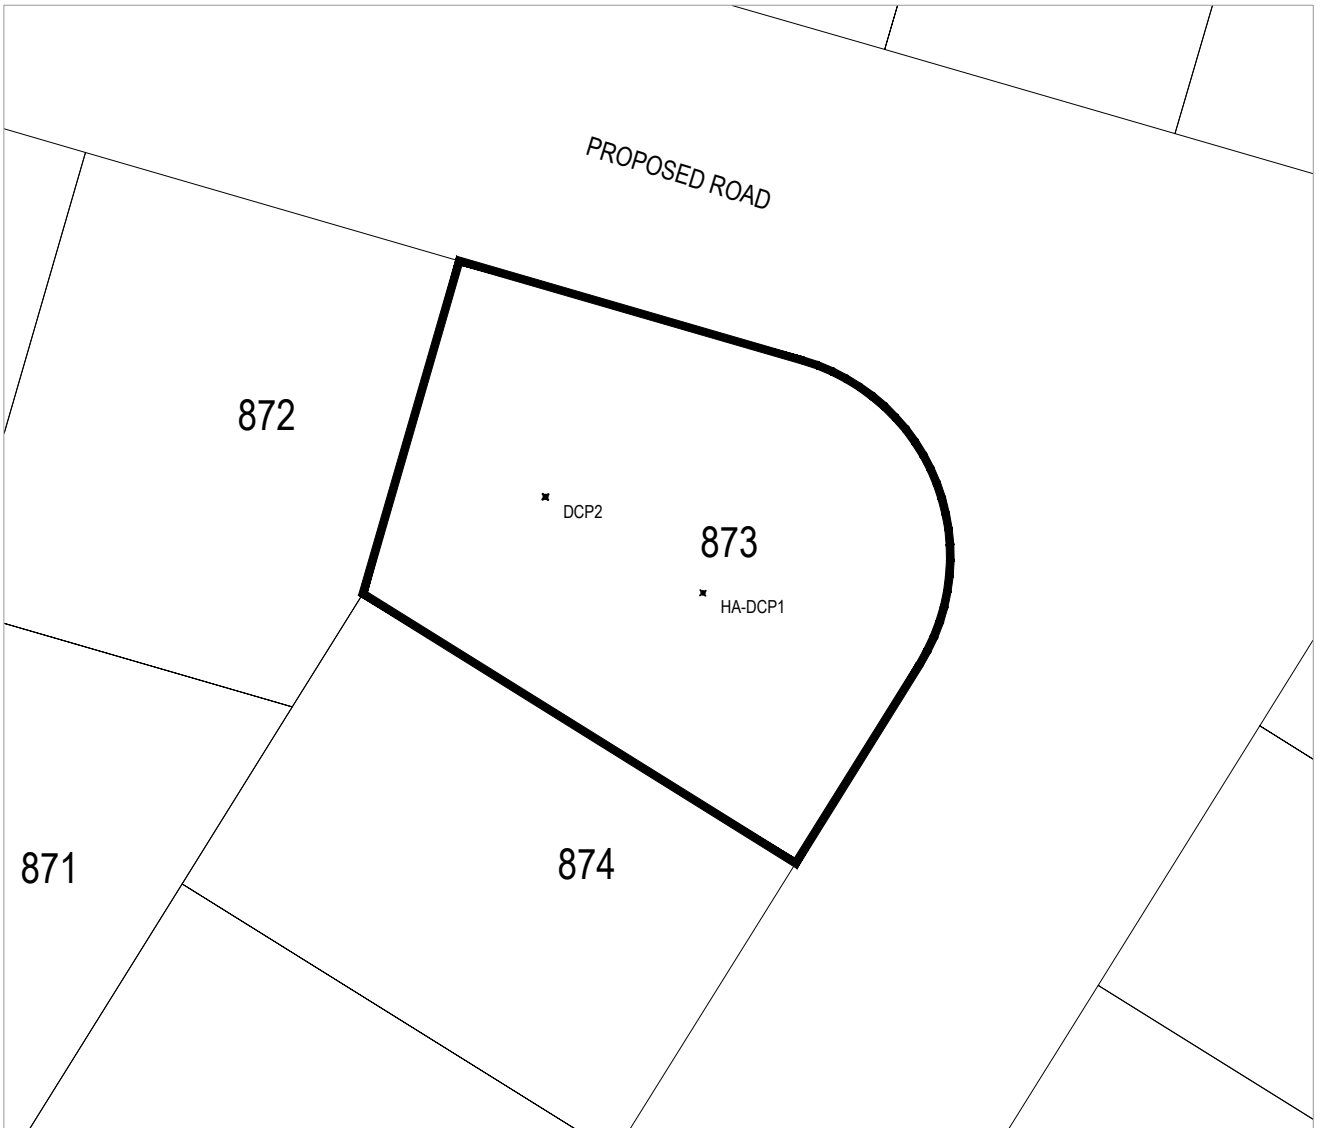
PROJECT	
PRESTONS PARK	
TITLE	
LOT 873 SITE LOCATION PLAN FIGURE 1

This building consent report is for Lot 873 which is located in Stage 4 of the Prestons South Subdivision development (refer Figure 1 in Appendix A). The lot is bordered by residential lots to the south and east and an access road to the north and west.
