**Prestons Subdivision**  
**GEOTECHNICAL REPORT FOR LOT 875**  
**CDL Land NZ Limited**

**30 April 2021**  
**Revision: 1**  
**Reference: 235361**

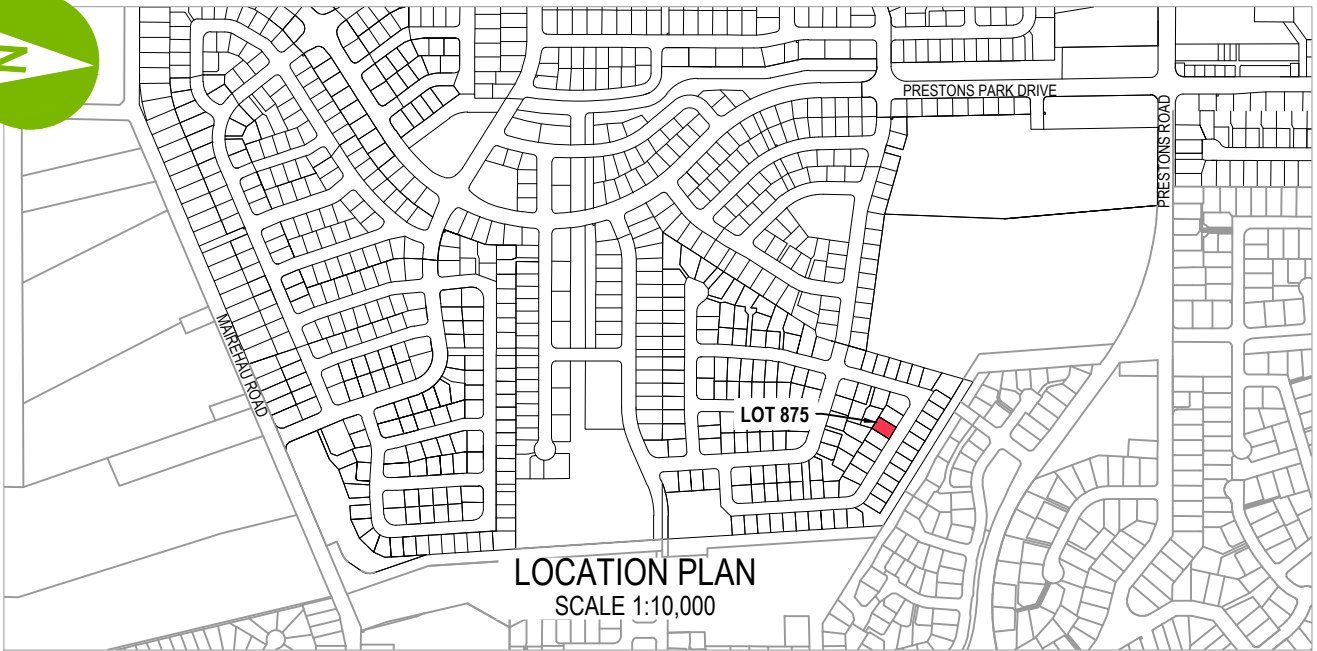
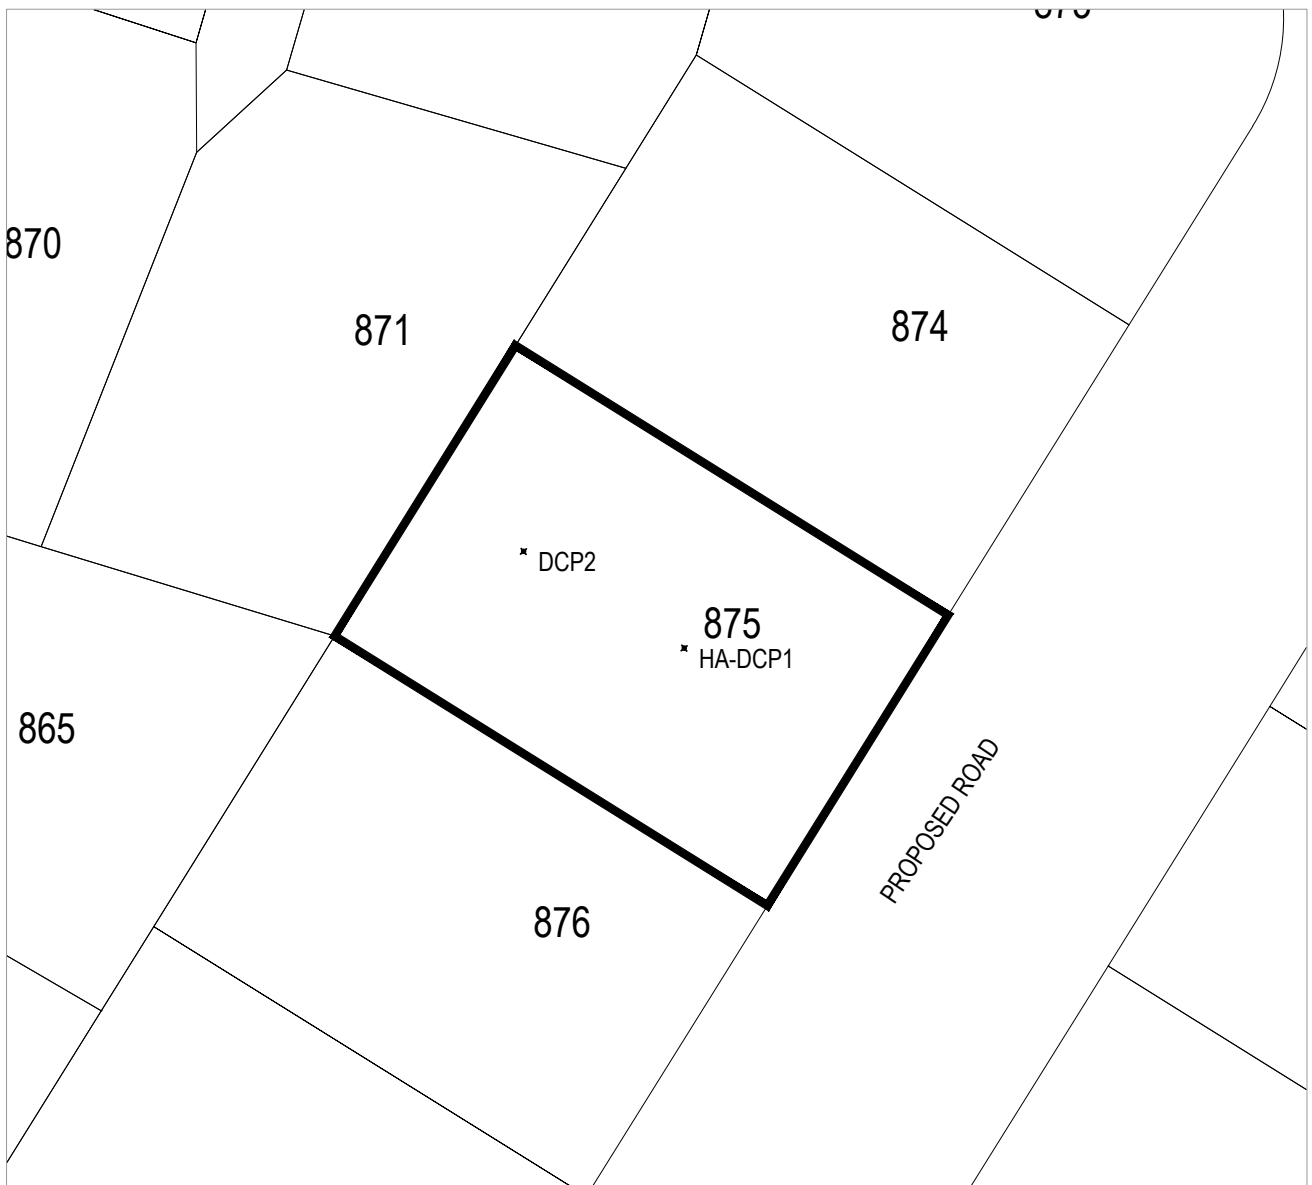
PROJECT
PRESTONS PARK
TITLE
LOT 875 SITE LOCATION PLAN FIGURE 1

This building consent report is for Lot 875 which is located in Stage 4 of the Prestons South Subdivision development (refer Figure 1 in Appendix A). The lot is bordered by residential lots to the south, east and west and an access road to the north.
